SURVEY

Drawing:  
Existing Monument Elevations  
C78

Job Title:  
**Heritage Restoration of Falmouth's  
Ponsharden Cemeteries**

Job No: **J20-077** Dwg No: **1006** Rev: **A**

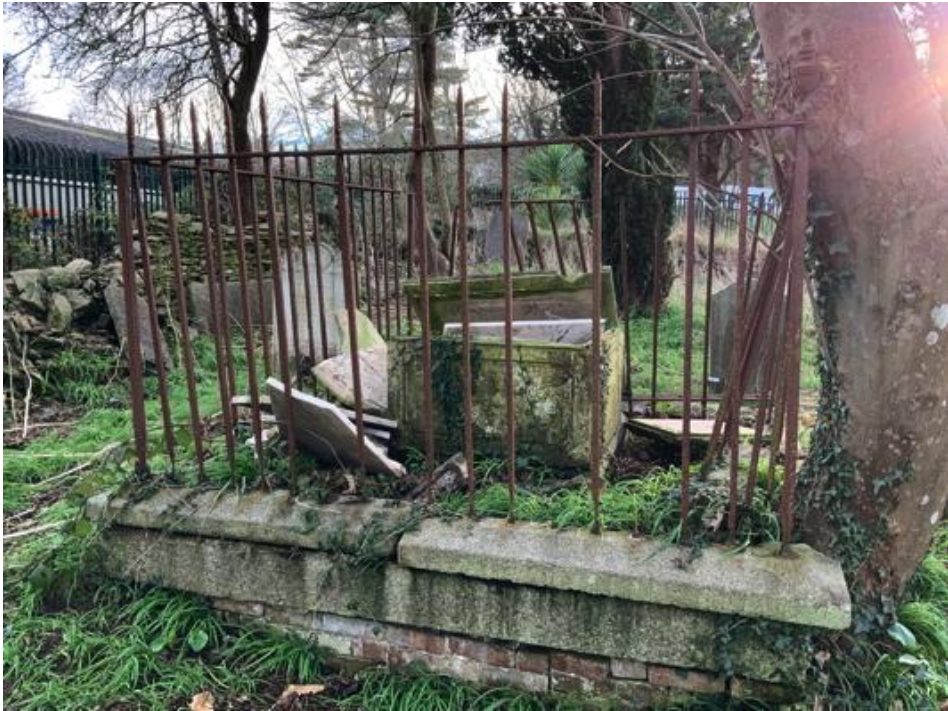
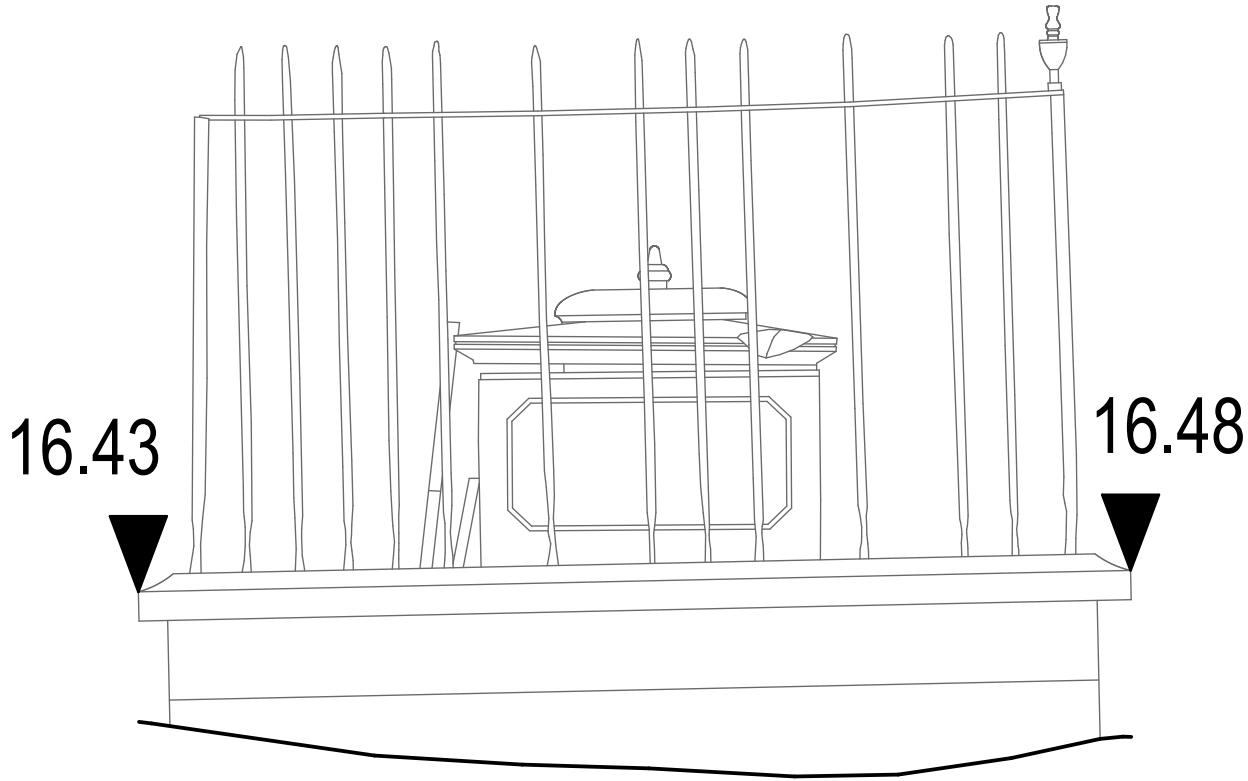
NORTH ELEVATION

The tomb and railings have suffered further damage since the original survey and drawings were created. The photographs show its condition as at the end of January 2021, whilst the drawings show its condition in March 2020.

The main differences are that the south railings and gate have been pushed further against the monument, the stone lid has been dislodged and the top cap has come off and is lying within the railings. The south panel of the tomb has suffered the loss of the top section where previously it was only fractured. The east panel has been dislodged and there has been additional fracture damage to the panels. The additional repairs required have been included in the repair drawings and the Proforma Condition and Repairs Schedule.

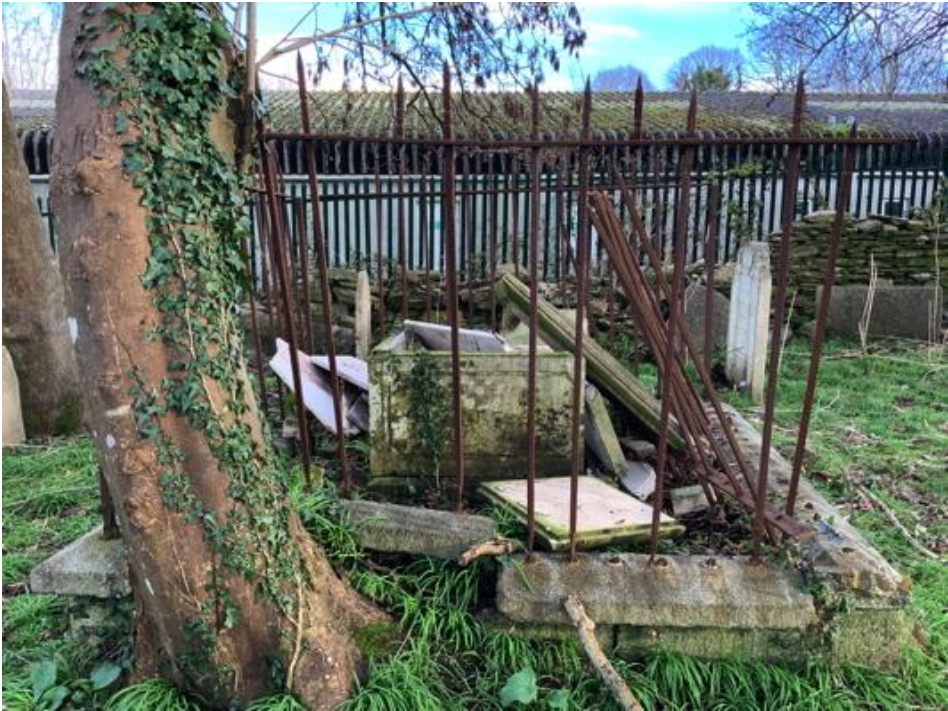
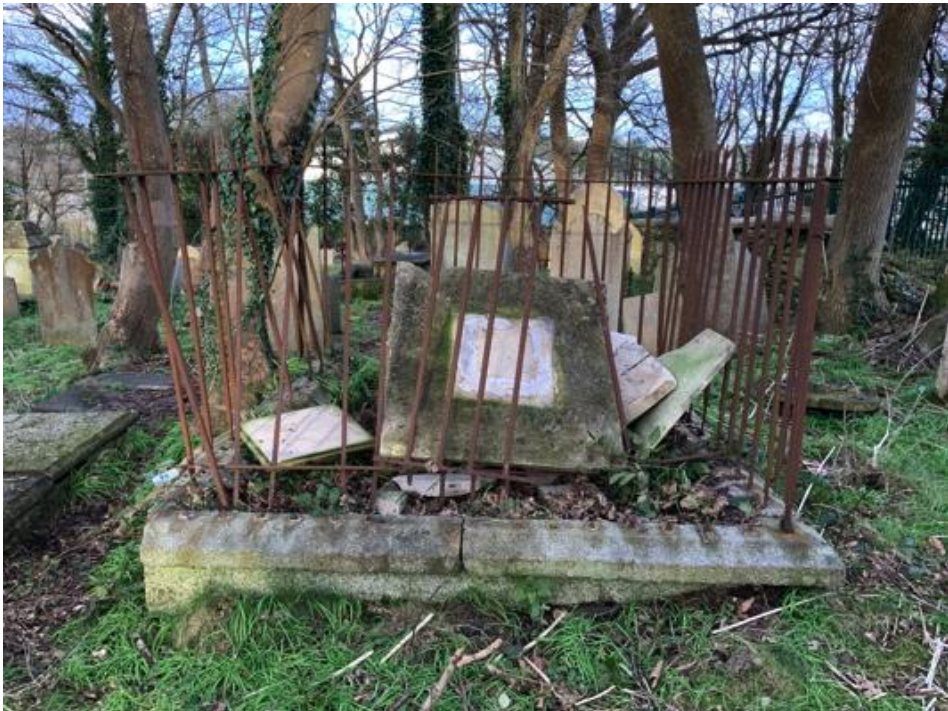
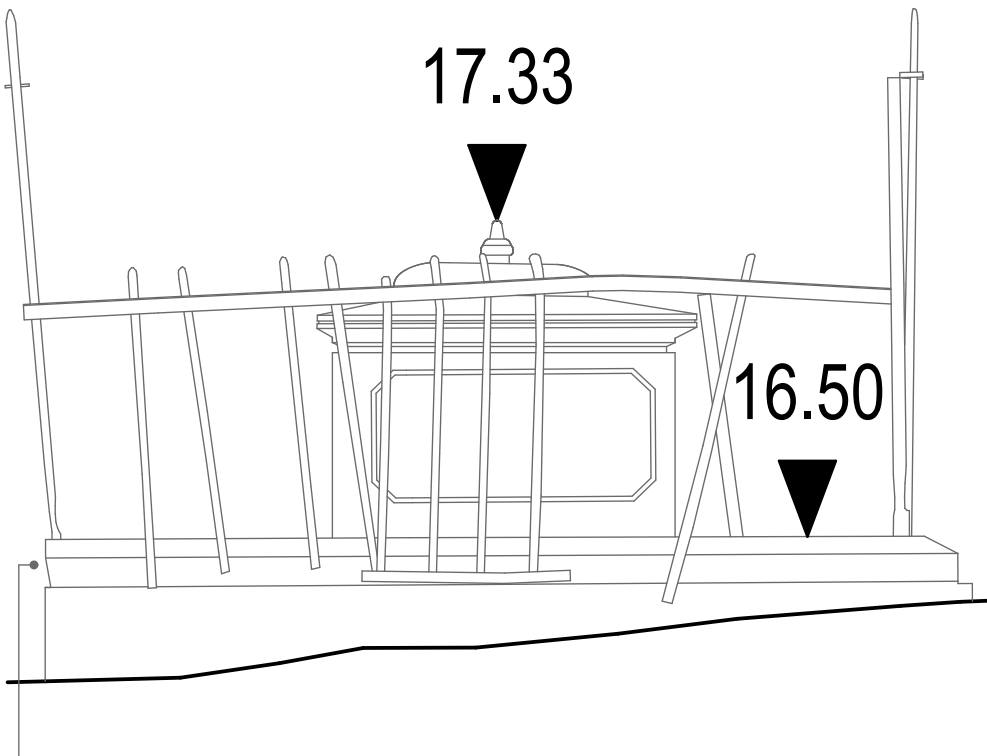
SOUTH ELEVATION

The tomb and railings have suffered further damage since the original survey and drawings were created. The photographs show its condition as at the end of January 2021, whilst the drawings show its condition in March 2020.

The main differences are that the south railings and gate have been pushed further against the monument, the stone lid has been dislodged and the top cap has come off and is lying within the railings. The south panel of the tomb has suffered the loss of the top section where previously it was only fractured. The east panel has been dislodged and there has been additional fracture damage to the panels. The additional repairs required have been included in the repair drawings and the Proforma Condition and Repairs Schedule.

Existing 25mm thick marble top panels previously taken down and stored within tomb and leant against railings. Panels are broken into approximately 25 pieces of varying sizes, but all are believed to survive. 100 x 100mm square section limestone corner pieces to upper section are stored within tomb or are on floor inside railings. Assume that three corner posts are broken into two pieces.
