## **Asbestos Reinspection Report**

## **Mitie FM - Home Office Contract**

**4-3934-04**  
**Tamworth**  
**Ryton**  
**CV8 3EN**

Report Ref: A-12844 VI  
Report Date: 26/04/2024  
Issued On: 29/04/2024  
Page: 1 of 9  
Doc Control: SD(AM-MES-S)008T May 2023

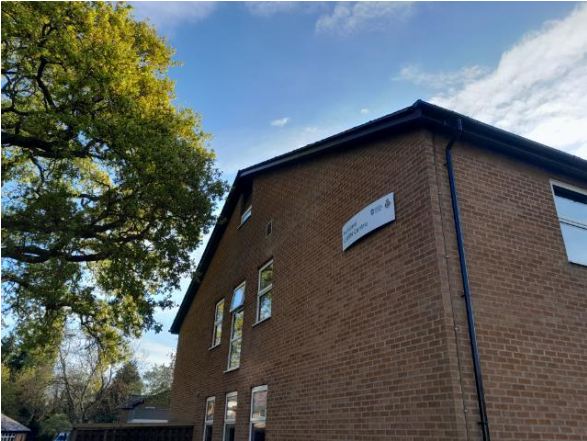
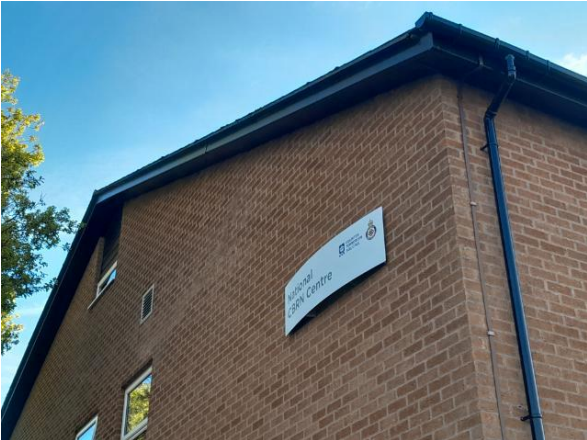
Sample Reference Number	
<a href="#">PS Undercloak</a>	
Sample Date	26/04/2024
Inspection Interval	12 months
Next Inspection	26/04/2025
Inspection Type	Re-Inspection
Surveyor 1	Tony Bark
Surveyor 2

Sample Location	
Building	Tamworth
Floor	External
Sub Area	001 / Main Building
Component	Undercloak
Quantity	25 lin m
Lab Ref	
Accessibility	Difficult
Type	Previously Sampled

Material Assessment		
Product	I. Cement Product	
Condition	I. Low Damage	
Surface	0. Composite materials containing asbestos, reinforced plastics, resins, vinyl tiles	
Type	I. Chrysotile	
Score	3	Band - D
Very Low Risk

Notes
Reinspection 2024. No change to condition. Continue to manage.

Priority Assessment	
Normal Occupant Activity	
Main	0. Rare Disturbance
Secondary	0. Rare Disturbance
Likelihood of Disturbance	
Location	0. Outdoors
Accessibility	0. Usually Inaccessible or Unlikely to be disturbed
Extent / Amount	2. 10m - 50m
Human Exposure Potential	
Occupants	0. None
Frequency of Use	0. Infrequent
Average Use Time	0. < 1 Hour
Maintenance Activity	
Type	0. Minor Disturbance
Frequency	1. <= 1 per Year
Score	2

Overall Score	
Material + Priority Assessment =	5
Recommended Action	
Manage
