Asbestos Demolition Survey

Admin Block
Armthorpe Academy
Mere Lane
Armthorpe
Doncaster
DN3 2DA

Service Type	Demolition Survey		
Report Revision Number	1	Surveyors	Declan Hughes
TEAMS Job Number	J008822	Survey Date	2 Aug 2021
Site Address:	Admin Block Armthorpe Academy Mere Lane Armthorpe Doncaster DN3 2DA	Bulk Analysis Laboratory	N/A
		Sample Analysis Date	5 Aug 2021

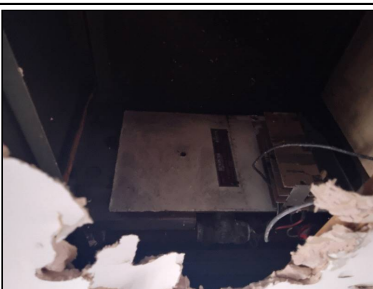
Survey Date:	Lead Surveyor	Survey Type	Floor	Analysis
	2 Aug 2021	Declan Hughes	Demolition Survey	Ground Floor	Chrysotile (1)
	Building	Room	Item	Quantity	
	Admin Block	Reception G/01	insulating board panel to warm air fans	1m²	
	Sample No (S,SP,P,As)	Product Type	Surface Treatment	Condition	Accessibility
	AA002142 (S)	Asbestos Insulating Board (2)	Unsealed (2)	Low Damage (1)	Occasionally likely to be disturbed
	Material Risk Score				
	6				
Recommended action	Remove				
Surveyor comments	located to ceiling & vertical units, approx 0.5 m2 each

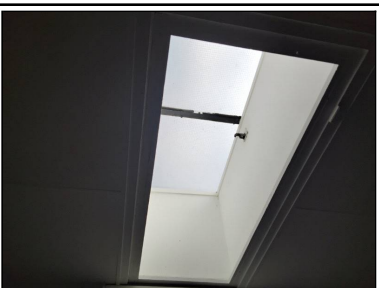
Survey Date:	Lead Surveyor	Survey Type	Floor	Analysis
	2 Aug 2021	Declan Hughes	Demolition Survey	Ground Floor	No Asbestos Detected
	Building	Room	Item	Quantity	
	Admin Block	Reception G/01	putty to skylights	5no.	
	Sample No (S,SP,P,As)	Product Type	Surface Treatment	Condition	Accessibility
	AA002143 (S)	N/A	N/A	N/A	N/A
	Material Risk Score				
N/A					
Recommended action	No further action required				
Surveyor comments	N/A

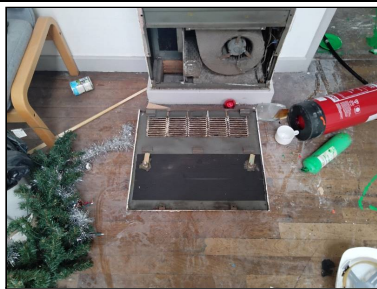
Survey Date:	Lead Surveyor	Survey Type	Floor	Analysis
	2 Aug 2021	Declan Hughes	Demolition Survey	Ground Floor	Chrysotile (1)
	Building	Room	Item	Quantity	
	Admin Block	Reception G/01	bituminous lining to warm air fan	1no.	
	Sample No (S,SP,P,As)	Product Type	Surface Treatment	Condition	Accessibility
	AA002144 (S)	Well Bound Material (1)	Completely Sealed (0)	Low Damage (1)	Occasionally likely to be disturbed
	Material Risk Score				
	3				
Recommended action	Remove				
Surveyor comments	located to vertical unit

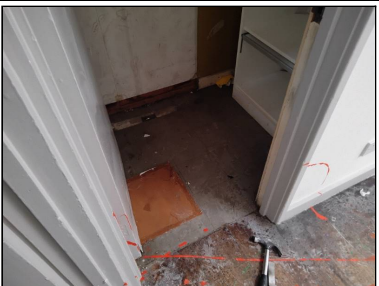
Survey Date:	Lead Surveyor	Survey Type	Floor	Analysis
	2 Aug 2021	Declan Hughes	Demolition Survey	Ground Floor	Chrysotile (1)
	Building	Room	Item	Quantity	
	Admin Block	Reception G/01	thermoplastic tile & adhesive floor covering	2m²	
	Sample No (S,SP,P,As)	Product Type	Surface Treatment	Condition	Accessibility
	AA002145 (S)	Reinforced Composite (1)	Completely Sealed (0)	Low Damage (1)	Routinely disturbed
	Material Risk Score				
	3				
Recommended action	Remove				
Surveyor comments	adhesive present to tile and floor

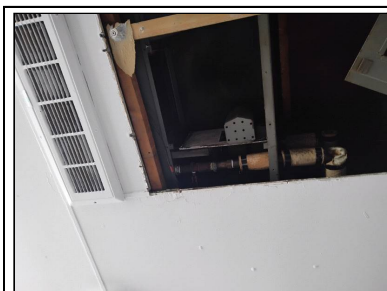
Building	Floor	Room	Item	Material	Risk assessment Score	Tentative Recommendations
Admin Block	Ground Floor	Staff Room G/02	insulating board	Asbestos Insulating Board	MEDIUM (7) R2	Remove

Survey Date:	Lead Surveyor	Survey Type	Floor	Analysis
2 Aug 2021	Declan Hughes	Demolition Survey	Ground Floor	Chrysotile (1)
Building	Room	Item	Quantity	
Admin Block	Staff Room G/02	insulating board panel to warm air fan	0.5m ²	
Sample No (S,SP,P,As)	Product Type	Surface Treatment	Condition	Accessibility
As AA002142 (SP)	Asbestos Insulating Board (2)	Unsealed (2)	Medium Damage (2)	Occasionally likely to be disturbed
Material Risk Score				
7				
Recommended action	Remove			
Surveyor comments	1 no unit visible

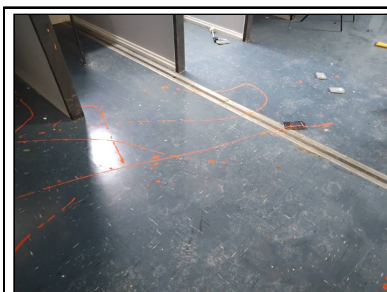
Survey Date:	Lead Surveyor	Survey Type	Floor	Analysis
2 Aug 2021	Declan Hughes	Demolition Survey	Ground Floor	No Asbestos Detected
Building	Room	Item	Quantity	
Admin Block	I.T Suite G/03	thermoplastic floor tile & adhesive floor covering	100m ²	
Sample No (S,SP,P,As)	Product Type	Surface Treatment	Condition	Accessibility
AA002146 (S)	N/A	N/A	N/A	N/A
Material Risk Score				
N/A				
Recommended action	No further action required			
Surveyor comments	adhesive present to tiles & floor

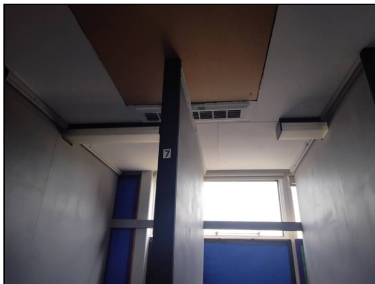
Survey Date:	Lead Surveyor	Survey Type	Floor	Analysis
	2 Aug 2021	Declan Hughes	Demolition Survey	Ground Floor	Chrysotile (1)
	Building	Room	Item	Quantity	
	Admin Block	I.T Suite G/03	insulating board panel to warm air fan	0.5m²	
	Sample No (S,SP,P,As)	Product Type	Surface Treatment	Condition	Accessibility
	As AA002142 (SP)	Asbestos Insulating Board (2)	Unsealed (2)	Low Damage (1)	Occasionally likely to be disturbed
	Material Risk Score				
	6				
Recommended action	Remove				
Surveyor comments	located to ceiling unit

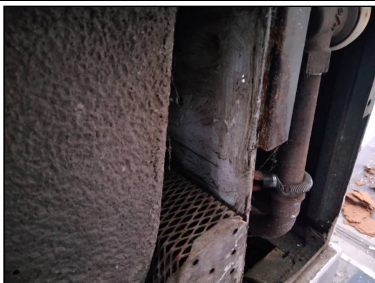
Survey Date:	Lead Surveyor	Survey Type	Floor	Analysis
	2 Aug 2021	Declan Hughes	Demolition Survey	Ground Floor	Chrysotile (1)
	Building	Room	Item	Quantity	
	Admin Block	I.T Suite G/03	insulating board panel to warm air fan	0.5m²	
	Sample No (S,SP,P,As)	Product Type	Surface Treatment	Condition	Accessibility
	As AA002142 (SP)	Asbestos Insulating Board (2)	Unsealed (2)	Low Damage (1)	Occasionally likely to be disturbed
	Material Risk Score				
	6				
Recommended action	Remove				
Surveyor comments	located to wall unit

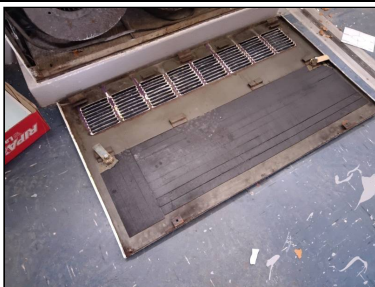
Survey Date:	Lead Surveyor	Survey Type	Floor	Analysis
	2 Aug 2021	Declan Hughes	Demolition Survey	Ground Floor	Chrysotile (1)
	Building	Room	Item	Quantity	
	Admin Block	I.T Suite G/03	bituminous lining to warm air fan	1no.	
	Sample No (S,SP,P,As)	Product Type	Surface Treatment	Condition	Accessibility
	As AA002144 (SP)	Well Bound Material (1)	Completely Sealed (0)	Low Damage (1)	Occasionally likely to be disturbed
	Material Risk Score				
	3				
Recommended action	Remove				
Surveyor comments	located to warm air heater

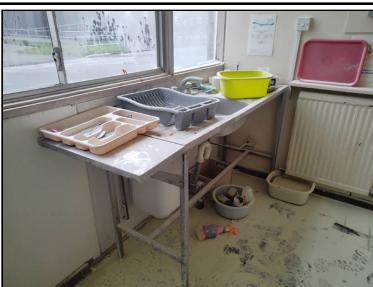
Survey Date:	Lead Surveyor	Survey Type	Floor	Analysis
	2 Aug 2021	Declan Hughes	Demolition Survey	Ground Floor	Chrysotile (1)
	Building	Room	Item	Quantity	
	Admin Block	Kitchen G/04	bituminous pad beneath sink	2no.	
	Sample No (S,SP,P,As)	Product Type	Surface Treatment	Condition	Accessibility
	AA002147 (S)	Well Bound Material (1)	Completely Sealed (0)	Low Damage (1)	Occasionally likely to be disturbed
	Material Risk Score				
3					
Recommended action	Remove				
Surveyor comments	N/A

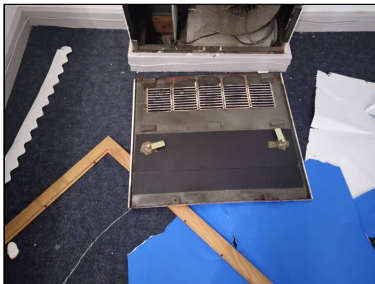
Survey Date:	Lead Surveyor	Survey Type	Floor	Analysis
	2 Aug 2021	Declan Hughes	Demolition Survey	Ground Floor	Chrysotile (1)
	Building	Room	Item	Quantity	
	Admin Block	Classroom G/05	bituminous lining to warm air fan	1no.	
	Sample No (S,SP,P,As)	Product Type	Surface Treatment	Condition	Accessibility
	As AA002144 (SP)	Well Bound Material (1)	Completely Sealed (0)	Low Damage (1)	Occasionally likely to be disturbed
	Material Risk Score				
	3				
Recommended action	Remove				
Surveyor comments	located to vertical unit

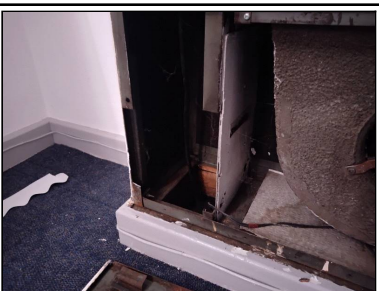
Survey Date:	Lead Surveyor	Survey Type	Floor	Analysis
	2 Aug 2021	Declan Hughes	Demolition Survey	Ground Floor	Chrysotile (1)
	Building	Room	Item	Quantity	
	Admin Block	Classroom G/05	insulating board panel	0.5m²	
	Sample No (S,SP,P,As)	Product Type	Surface Treatment	Condition	Accessibility
	As AA002142 (SP)	Asbestos Insulating Board (2)	Unsealed (2)	Low Damage (1)	Occasionally likely to be disturbed
	Material Risk Score				
	6				
Recommended action	Remove				
Surveyor comments	located to vertical units

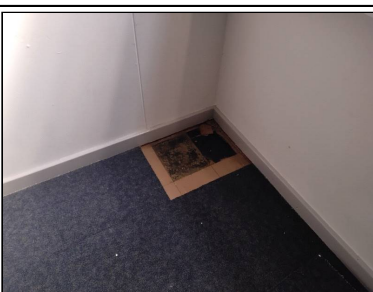
Survey Date:	Lead Surveyor	Survey Type	Floor	Analysis
	2 Aug 2021	Declan Hughes	Demolition Survey	Ground Floor	Chrysotile (1)
	Building	Room	Item	Quantity	
	Admin Block	Classroom G/05	thermoplastic floor tiles & adhesive to floor	50m²	
	Sample No (S,SP,P,As)	Product Type	Surface Treatment	Condition	Accessibility
	AA002148 (S)	Reinforced Composite (1)	Completely Sealed (0)	Medium Damage (2)	Occasionally likely to be disturbed
	Material Risk Score				
4					
Recommended action	Remove				
Surveyor comments	N/A

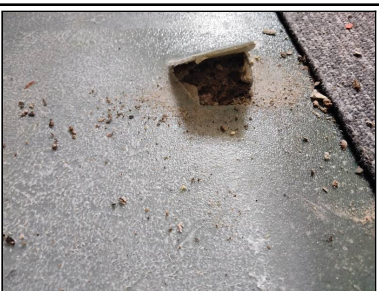
Survey Date:	Lead Surveyor	Survey Type	Floor	Analysis
	2 Aug 2021	Declan Hughes	Demolition Survey	Ground Floor	No Asbestos Detected
	Building	Room	Item	Quantity	
	Admin Block	Circulation & Store G/06	bituminous adhesive to floor	30m²	
	Sample No (S,SP,P,As)	Product Type	Surface Treatment	Condition	Accessibility
	AA002149 (S)	N/A	N/A	N/A	N/A
	Material Risk Score				
	N/A				
Recommended action	No further action required				
Surveyor comments	N/A

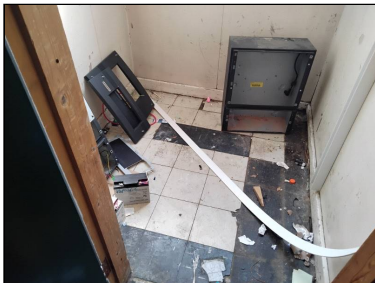
Survey Date:	Lead Surveyor	Survey Type	Floor	Analysis
	2 Aug 2021	Declan Hughes	Demolition Survey	Ground Floor	Chrysotile (1)
	Building	Room	Item	Quantity	
	Admin Block	Circulation & Store G/06	thermoplastic floor tiles (white) & adhesive to floor	2m²	
	Sample No (S,SP,P,As)	Product Type	Surface Treatment	Condition	Accessibility
	AA002150 (S)	Reinforced Composite (1)	Completely Sealed (0)	Medium Damage (2)	Routinely disturbed
	Material Risk Score				
	4				
Recommended action	Remove				
Surveyor comments	adhesive present to tile & floor

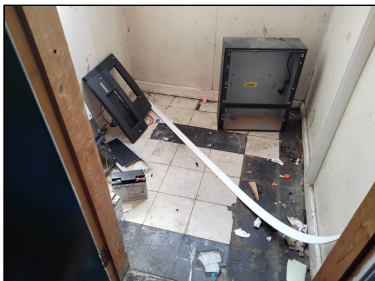
Survey Date:	Lead Surveyor	Survey Type	Floor	Analysis
	2 Aug 2021	Declan Hughes	Demolition Survey	Ground Floor	Chrysotile (1)
	Building	Room	Item	Quantity	
	Admin Block	Circulation & Store G/06	thermoplastic floor tiles (black) & adhesive floor covering	1m²	
	Sample No (S,SP,P,As)	Product Type	Surface Treatment	Condition	Accessibility
	AA002151 (S)	Reinforced Composite (1)	Completely Sealed (0)	Medium Damage (2)	Routinely disturbed
	Material Risk Score				
	4				
Recommended action	Remove				
Surveyor comments	N/A

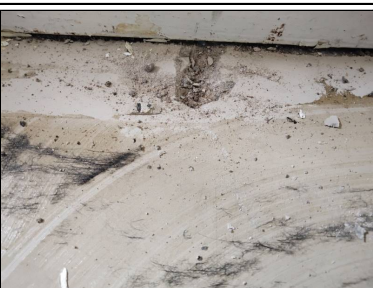
Survey Date:	Lead Surveyor	Survey Type	Floor	Analysis
	2 Aug 2021	Declan Hughes	Demolition Survey	Ground Floor	No Asbestos Detected
	Building	Room	Item	Quantity	
	Admin Block	Meeting Room G/07	bituminous adhesive to floor	25m²	
	Sample No (S,SP,P,As)	Product Type	Surface Treatment	Condition	Accessibility
	As AA002149 (SP)	N/A	N/A	N/A	N/A
	Material Risk Score				
	N/A				
Recommended action	No further action required				
Surveyor comments	N/A

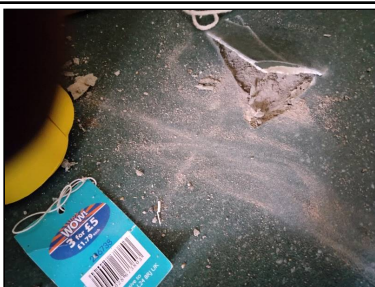
Survey Date:	Lead Surveyor	Survey Type	Floor	Analysis
	2 Aug 2021	Declan Hughes	Demolition Survey	Ground Floor	No Asbestos Detected
	Building	Room	Item	Quantity	
	Admin Block	Store G/08	bituminous adhesive to floor	16m²	
	Sample No (S,SP,P,As)	Product Type	Surface Treatment	Condition	Accessibility
	As AA002149 (SP)	N/A	N/A	N/A	N/A
	Material Risk Score				
	N/A				
Recommended action	No further action required				
Surveyor comments	N/A

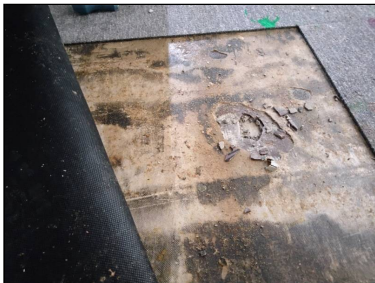
Survey Date:	Lead Surveyor	Survey Type	Floor	Analysis
	2 Aug 2021	Declan Hughes	Demolition Survey	Ground Floor	No Asbestos Detected
	Building	Room	Item	Quantity	
	Admin Block	Circulation G/09	thermoplastic tile & adhesive to floor	30m²	
	Sample No (S,SP,P,As)	Product Type	Surface Treatment	Condition	Accessibility
	AA002152 (S)	N/A	N/A	N/A	N/A
	Material Risk Score				
	N/A				
Recommended action	No further action required				
Surveyor comments	adhesive present to tile & floor

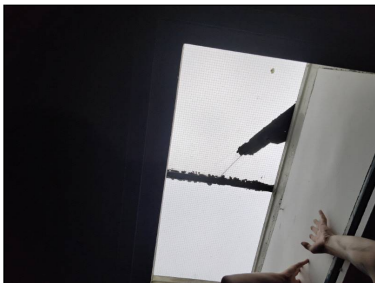
Survey Date:	Lead Surveyor	Survey Type	Floor	Analysis
	2 Aug 2021	Declan Hughes	Demolition Survey	Ground Floor	No Asbestos Detected
	Building	Room	Item	Quantity	
	Admin Block	Circulation G/09	putty to skylights	1no.	
	Sample No (S,SP,P,As)	Product Type	Surface Treatment	Condition	Accessibility
	As AA002143 (SP)	N/A	N/A	N/A	N/A
	Material Risk Score				
	N/A				
Recommended action	No further action required				
Surveyor comments	N/A

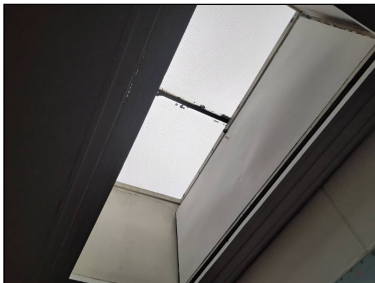
Survey Date:	Lead Surveyor	Survey Type	Floor	Analysis
	2 Aug 2021	Declan Hughes	Demolition Survey	Ground Floor	No Asbestos Detected
	Building	Room	Item	Quantity	
	Admin Block	Learning Zone G/10	putty to skylights	2no.	
	Sample No (S,SP,P,As)	Product Type	Surface Treatment	Condition	Accessibility
	As AA002143 (SP)	N/A	N/A	N/A	N/A
	Material Risk Score				
	N/A				
Recommended action	No further action required				
Surveyor comments	N/A

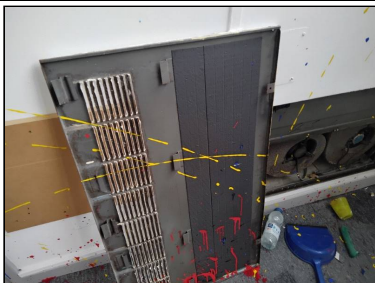
Survey Date:	Lead Surveyor	Survey Type	Floor	Analysis
	2 Aug 2021	Declan Hughes	Demolition Survey	Ground Floor	Chrysotile (1)
	Building	Room	Item	Quantity	
	Admin Block	Learning Zone G/10	bituminous lining to warm air fan	1no.	
	Sample No (S,SP,P,As)	Product Type	Surface Treatment	Condition	Accessibility
	As AA002144 (SP)	Well Bound Material (1)	Completely Sealed (0)	Low Damage (1)	Occasionally likely to be disturbed
	Material Risk Score				
	3				
Recommended action	Remove				
Surveyor comments	located to vertical unit

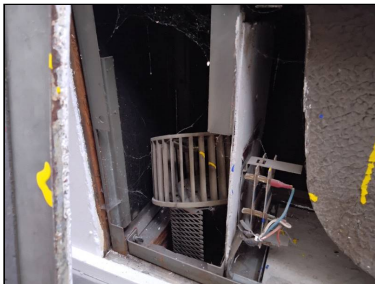
Survey Date:	Lead Surveyor	Survey Type	Floor	Analysis
	2 Aug 2021	Declan Hughes	Demolition Survey	Ground Floor	Chrysotile (1)
	Building	Room	Item	Quantity	
	Admin Block	Learning Zone G/10	insulating board panel to warm air fans	0.5m²	
	Sample No (S,SP,P,As)	Product Type	Surface Treatment	Condition	Accessibility
	As AA002142 (SP)	Asbestos Insulating Board (2)	Unsealed (2)	Low Damage (1)	Occasionally likely to be disturbed
	Material Risk Score				
6					
Recommended action	Remove				
Surveyor comments	located to ceiling & vertical unit

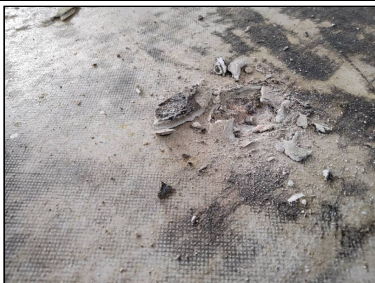
Survey Date:	Lead Surveyor	Survey Type	Floor	Analysis
	2 Aug 2021	Declan Hughes	Demolition Survey	Ground Floor	No Asbestos Detected
	Building	Room	Item	Quantity	
	Admin Block	Learning Zone G/10	bituminous adhesive to floor	75m²	
	Sample No (S,SP,P,As)	Product Type	Surface Treatment	Condition	Accessibility
	As AA002149 (SP)	N/A	N/A	N/A	N/A
	Material Risk Score				
	N/A				
Recommended action	No further action required				
Surveyor comments	N/A

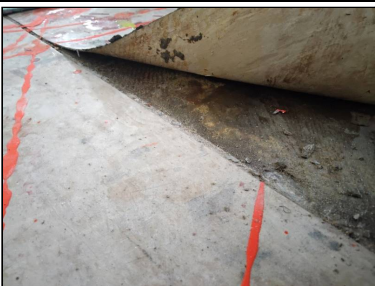
Survey Date:	Lead Surveyor	Survey Type	Floor	Analysis
	2 Aug 2021	Declan Hughes	Demolition Survey	Ground Floor	No Asbestos Detected
	Building	Room	Item	Quantity	
	Admin Block	Store G/11	bituminous adhesive to floor	45m ²	
	Sample No (S,SP,P,As)	Product Type	Surface Treatment	Condition	Accessibility
	As AA002149 (SP)	N/A	N/A	N/A	N/A
Material Risk Score					
N/A					
Recommended action	No further action required				
Surveyor comments	N/A

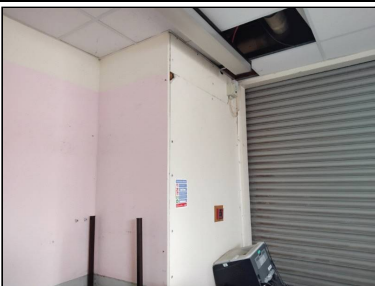
Survey Date:	Lead Surveyor	Survey Type	Floor	Analysis
	2 Aug 2021	Declan Hughes	Demolition Survey	Ground Floor	No Asbestos Detected
	Building	Room	Item	Quantity	
	Admin Block	Store G/11	insulating board riser boxing	8m ²	
	Sample No (S,SP,P,As)	Product Type	Surface Treatment	Condition	Accessibility
	AA002153 (S)	N/A	N/A	N/A	N/A
Material Risk Score					
N/A					
Recommended action	No further action required				
Surveyor comments	N/A

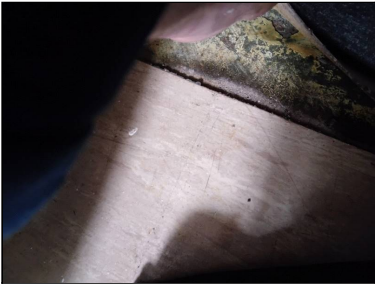
Survey Date:	Lead Surveyor	Survey Type	Floor	Analysis
	2 Aug 2021	Declan Hughes	Demolition Survey	Ground Floor	No Asbestos Detected
	Building	Room	Item	Quantity	
	Admin Block	Classroom & Store G/12	bituminous adhesive to floor	42m ²	
	Sample No (S,SP,P,As)	Product Type	Surface Treatment	Condition	Accessibility
	As AA002149 (SP)	N/A	N/A	N/A	N/A
Material Risk Score					
N/A					
Recommended action	No further action required				
Surveyor comments	N/A

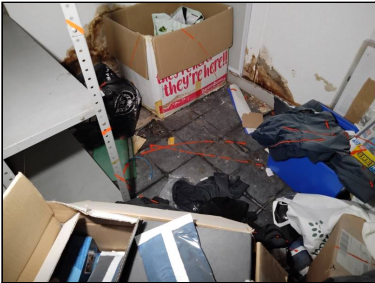
Survey Date:	Lead Surveyor	Survey Type	Floor	Analysis
	2 Aug 2021	Declan Hughes	Demolition Survey	Ground Floor	Chrysotile (1)
	Building	Room	Item	Quantity	
	Admin Block	Classroom & Store G/12	thermoplastic floor tiles (black) & adhesive floor covering	6m ²	
	Sample No (S,SP,P,As)	Product Type	Surface Treatment	Condition	Accessibility
	AA002154 (S)	Reinforced Composite (1)	Completely Sealed (0)	Medium Damage (2)	Routinely disturbed
Material Risk Score					
4					
Recommended action	Remove				
Surveyor comments	located within store

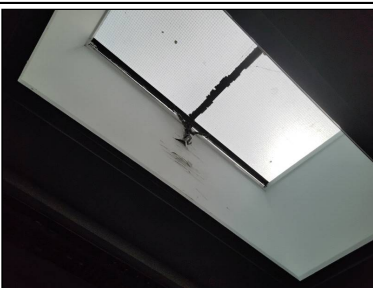
Survey Date:	Lead Surveyor	Survey Type	Floor	Analysis
	2 Aug 2021	Declan Hughes	Demolition Survey	Ground Floor	No Asbestos Detected
	Building	Room	Item	Quantity	
	Admin Block	Office G/13	putty to skylights	1no.	
	Sample No (S,SP,P,As)	Product Type	Surface Treatment	Condition	Accessibility
	As AA002143 (SP)	N/A	N/A	N/A	N/A
	Material Risk Score				
N/A					
Recommended action	No further action required				
Surveyor comments	N/A

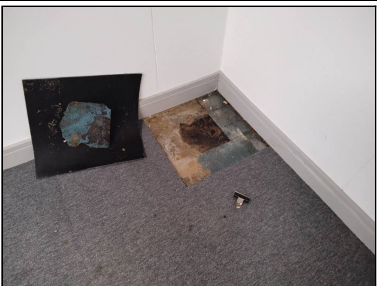
Survey Date:	Lead Surveyor	Survey Type	Floor	Analysis
	2 Aug 2021	Declan Hughes	Demolition Survey	Ground Floor	Chrysotile (1)
	Building	Room	Item	Quantity	
	Admin Block	Office G/13	thermoplastic floor tile bituminous & adhesive to floor	6m²	
	Sample No (S,SP,P,As)	Product Type	Surface Treatment	Condition	Accessibility
	AA002155 (S)	Reinforced Composite (1)	Completely Sealed (0)	Low Damage (1)	Easily disturbed
	Material Risk Score				
3					
Recommended action	Remove				
Surveyor comments	adhesive present to tile & floor

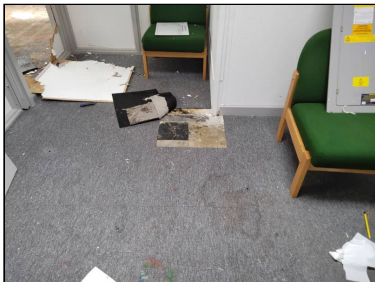
Survey Date:	Lead Surveyor	Survey Type	Floor	Analysis
	2 Aug 2021	Declan Hughes	Demolition Survey	Ground Floor	Chrysotile (1)
	Building	Room	Item	Quantity	
	Admin Block	Office G/13	thermoplastic floor tile & bituminous adhesive to floor	20m²	
	Sample No (S,SP,P,As)	Product Type	Surface Treatment	Condition	Accessibility
	AA002156 (S)	Reinforced Composite (1)	Completely Sealed (0)	Low Damage (1)	Occasionally likely to be disturbed
	Material Risk Score				
3					
Recommended action	Remove				
Surveyor comments	adhesive present to tile and floor

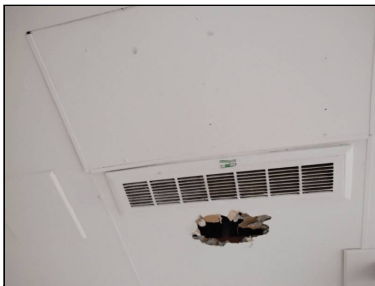
Survey Date:	Lead Surveyor	Survey Type	Floor	Analysis
	2 Aug 2021	Declan Hughes	Demolition Survey	Ground Floor	Chrysotile (1)
	Building	Room	Item	Quantity	
	Admin Block	General Office & Store G/14	insulating board panel to warm air fan	0.5m²	
	Sample No (S,SP,P,As)	Product Type	Surface Treatment	Condition	Accessibility
	As AA002142 (SP)	Asbestos Insulating Board (2)	Unsealed (2)	Low Damage (1)	Occasionally likely to be disturbed
	Material Risk Score				
	6				
Recommended action	Remove				
Surveyor comments	located to ceiling unit

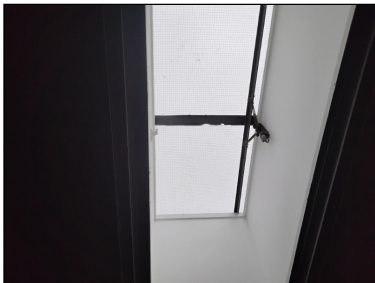
Survey Date:	Lead Surveyor	Survey Type	Floor	Analysis
	2 Aug 2021	Declan Hughes	Demolition Survey	Ground Floor	No Asbestos Detected
	Building	Room	Item	Quantity	
	Admin Block	General Office & Store G/14	putty to skylights	4no.	
	Sample No (S,SP,P,As)	Product Type	Surface Treatment	Condition	Accessibility
	As AA002143 (SP)	N/A	N/A	N/A	N/A
	Material Risk Score				
	N/A				
Recommended action	No further action required				
Surveyor comments	N/A

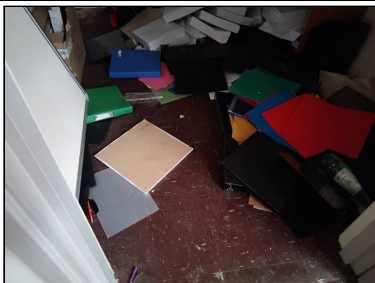
Survey Date:	Lead Surveyor	Survey Type	Floor	Analysis
	2 Aug 2021	Declan Hughes	Demolition Survey	Ground Floor	No Asbestos Detected
	Building	Room	Item	Quantity	
	Admin Block	General Office & Store G/14	thermoplastic tile & adhesive floor covering	8m²	
	Sample No (S,SP,P,As)	Product Type	Surface Treatment	Condition	Accessibility
	AA002157 (S)	N/A	N/A	N/A	N/A
	Material Risk Score				
N/A					
Recommended action	No further action required				
Surveyor comments	adhesive present to tile and floor

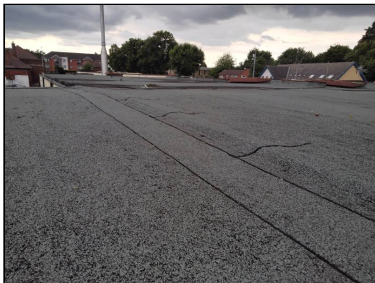
Survey Date:	Lead Surveyor	Survey Type	Floor	Analysis
	2 Aug 2021	Declan Hughes	Demolition Survey	External	No Asbestos Detected
	Building	Room	Item	Quantity	
	Admin Block	Externals E/01	bituminous felt roof covering	500m²	
	Sample No (S,SP,P,As)	Product Type	Surface Treatment	Condition	Accessibility
	AA002158 (S)	N/A	N/A	N/A	N/A
	Material Risk Score				
	N/A				
Recommended action	No further action required				
Surveyor comments	N/A

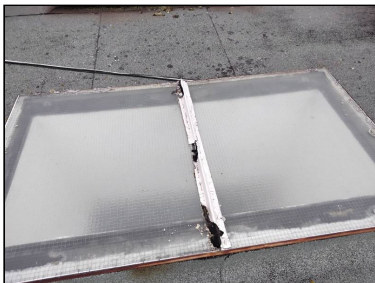
Survey Date:	Lead Surveyor	Survey Type	Floor	Analysis
	2 Aug 2021	Declan Hughes	Demolition Survey	External	No Asbestos Detected
	Building	Room	Item	Quantity	
	Admin Block	Externals E/01	bituminous seal to skylight	14no.	
	Sample No (S,SP,P,As)	Product Type	Surface Treatment	Condition	Accessibility
	AA002159 (S)	N/A	N/A	N/A	N/A
	Material Risk Score				
	N/A				
Recommended action	No further action required				
Surveyor comments	N/A

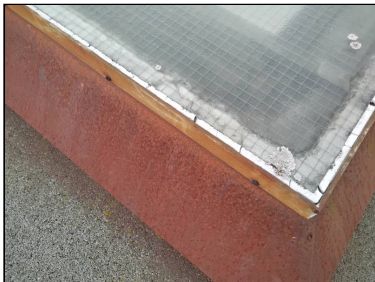
Survey Date:	Lead Surveyor	Survey Type	Floor	Analysis
	2 Aug 2021	Declan Hughes	Demolition Survey	External	No Asbestos Detected
	Building	Room	Item	Quantity	
	Admin Block	Externals E/01	putty seal to skylights	14no.	
	Sample No (S,SP,P,As)	Product Type	Surface Treatment	Condition	Accessibility
	AA002163 (S)	N/A	N/A	N/A	N/A
	Material Risk Score				
	N/A				
Recommended action	No further action required				
Surveyor comments	N/A

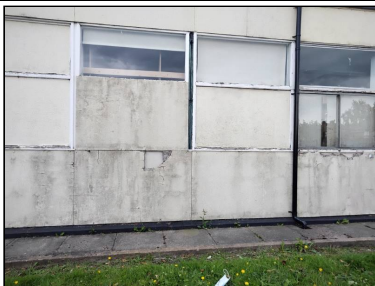
Survey Date:	Lead Surveyor	Survey Type	Floor	Analysis
	2 Aug 2021	Declan Hughes	Demolition Survey	External	No Asbestos Detected
	Building	Room	Item	Quantity	
	Admin Block	Externals E/01	textured coating to external cladding	400m²	
	Sample No (S,SP,P,As)	Product Type	Surface Treatment	Condition	Accessibility
	AA002160 (S)	N/A	N/A	N/A	N/A
	Material Risk Score				
N/A					
Recommended action	No further action required				
Surveyor comments	N/A

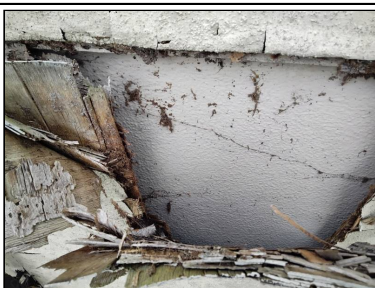
Survey Date:	Lead Surveyor	Survey Type	Floor	Analysis
	2 Aug 2021	Declan Hughes	Demolition Survey	External	No Asbestos Detected
	Building	Room	Item	Quantity	
	Admin Block	Externals E/01	textured coating to panels below windows	Throughout	
	Sample No (S,SP,P,As)	Product Type	Surface Treatment	Condition	Accessibility
	AA002161 (S)	N/A	N/A	N/A	N/A
	Material Risk Score				
	N/A				
Recommended action	No further action required				
Surveyor comments	N/A

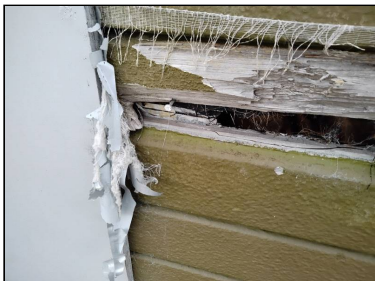
Survey Date:	Lead Surveyor	Survey Type	Floor	Analysis
	2 Aug 2021	Declan Hughes	Demolition Survey	External	No Asbestos Detected
	Building	Room	Item	Quantity	
	Admin Block	Externals E/01	bituminous lining to external cladding	Throughout	
	Sample No (S,SP,P,As)	Product Type	Surface Treatment	Condition	Accessibility
	AA002162 (S)	N/A	N/A	N/A	N/A
		Material Risk Score			
	N/A				
Recommended action	No further action required				
Surveyor comments	N/A
