## REPORT OF INSPECTION

<b>Client:</b>	London Borough of Lambeth
<b>Site:</b>	Clapham Common
<b>Date of Inspection:</b>	14 <sup>th</sup> November 2016
<b>Type of facility:</b>	8 x tennis courts, 3 x cricket practice Wickets
<b>Size (approximately):</b>	45.4m x 34.7m (block of 3 courts), 74.3m x 34.7m (block of 5 courts). Cricket wickets 4m x 28m each bay
<b>Stage of construction inspected:</b>	Condition survey
<b>Items of work undertaken during visit:</b>	Visual inspection, slip resistance, porosity, dimensions, surface regularity, levels, thickness of layers, cricket ball rebound.

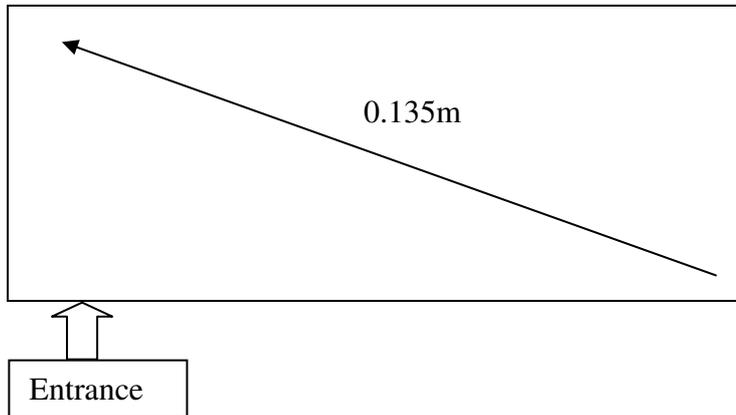
Block of 5

- Both blocks of tennis courts were both in good condition. The surfacing was colour coated green although the coating had worn considerably.
- There were very few surface irregularities found on the courts beneath the 3m straight edge. Those that were found were 10mm depressions around the edges of the courts.

The tennis courts are in good condition and do not require any immediate action.

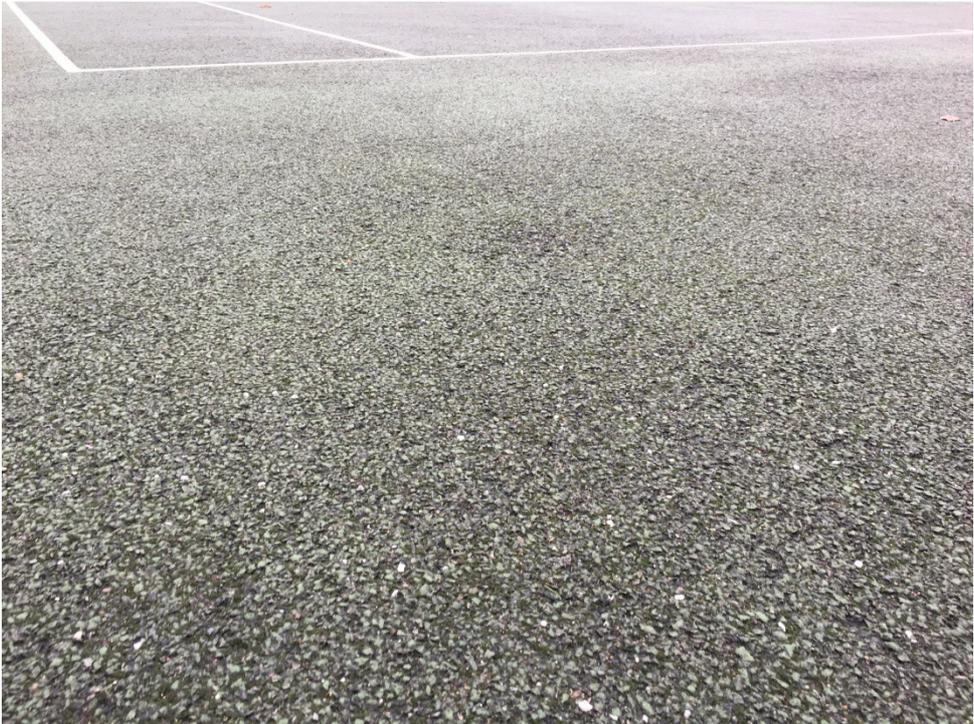
**Close up of surface**

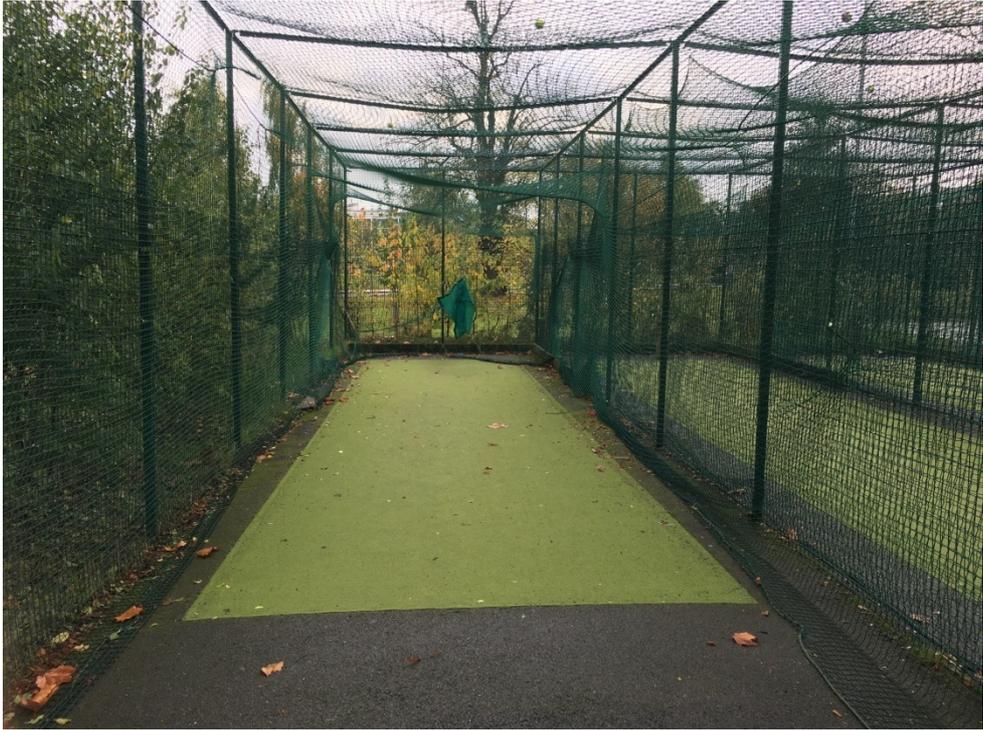
- The cricket wickets are in poor condition and the carpet requires replacement. The nets were torn and ripped in places and had lost anchorage in places to the tubular steel cage.

**General view of cricket wicket**

The cricket wickets are in very poor condition and carpet replacement is considered necessary. We estimate the cost of replacement for all three bays at £6,000. Some base correction will also be needed at the batting end of all three wickets (included in above estimate). We recommend that prices are sought from specialist contractors and that an ECB approved surface is installed.

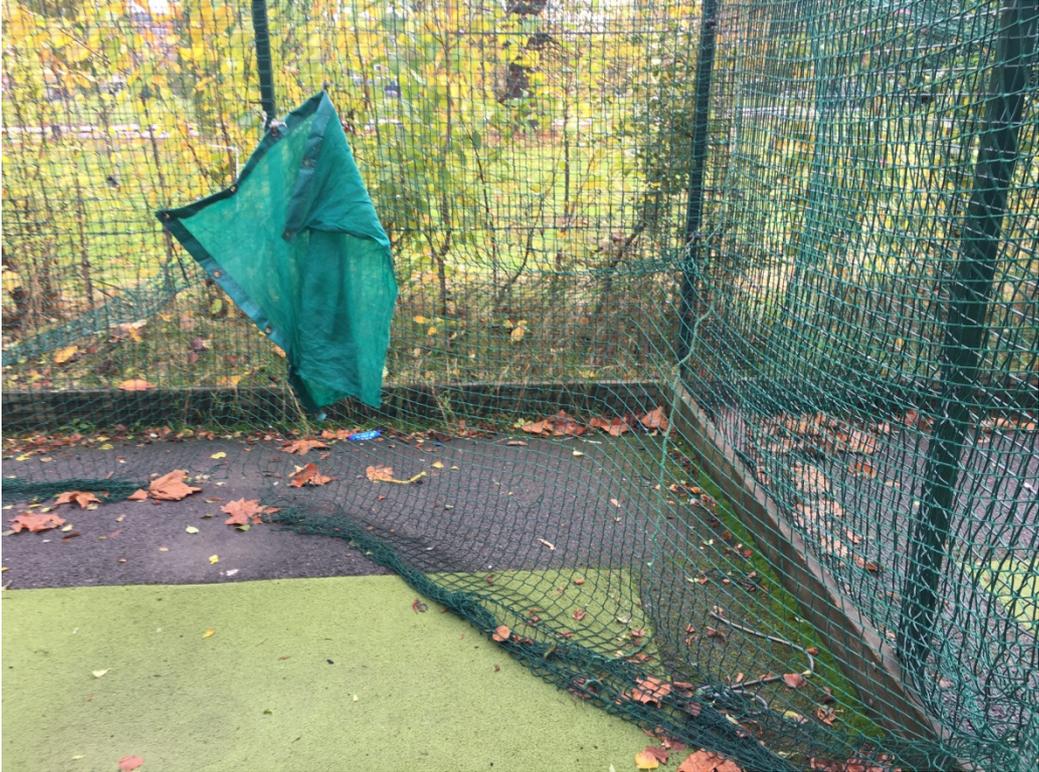
**Net defects**

Repairs are needed to the cricket nets. The debris and leaves on the cricket surface should be brushed on a regular basis.

The client should budget for carpet replacement every 5 years. The client should budget for batting cage replacement every 10 years. Nets should last for five years if kept in good repair. They should be checked regularly for holes and gaps and repairs made immediately if necessary. A three bay full roof cage with netting will cost in the order of £8,000 to supply and install.

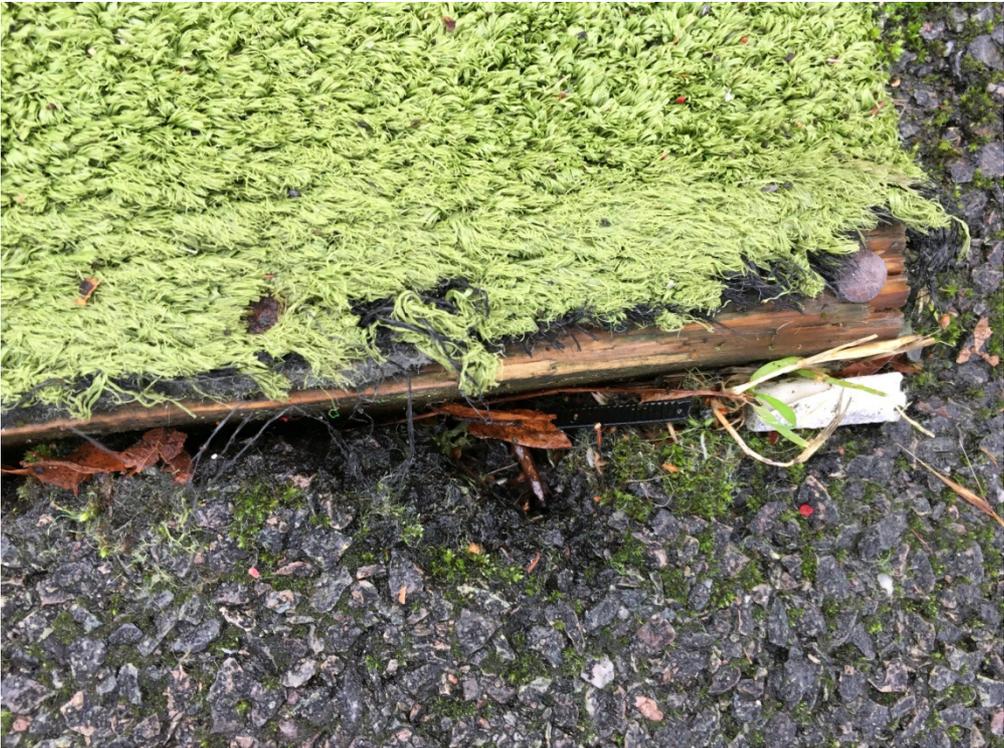
- The cricket carpet was installed onto a macadam base. The edges of the carpet are nailed to wooden edgings but in some locations the fixing has failed.

**Carpet separated from the base**

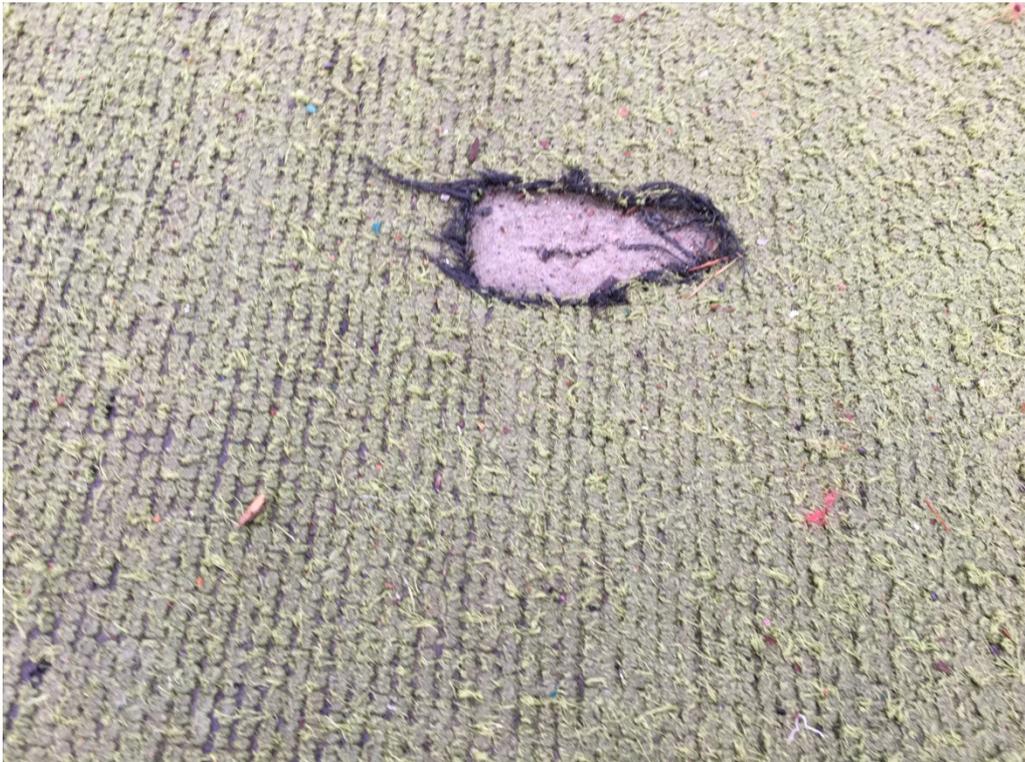
- The 2m straight edge survey revealed depressions varying from 13mm to 18mm. These were located at the batting end of each bay. The carpet was worn through to the backing at the batting end of each bay.

**Carpet worn the backing and base**
