## **Asbestos Management Survey Report**

King Street Toilets  
King Street  
Odiham  
Hampshire  
RG29 1NB

On behalf of  
**Odiham Parish Council**

Project Reference: PR03927

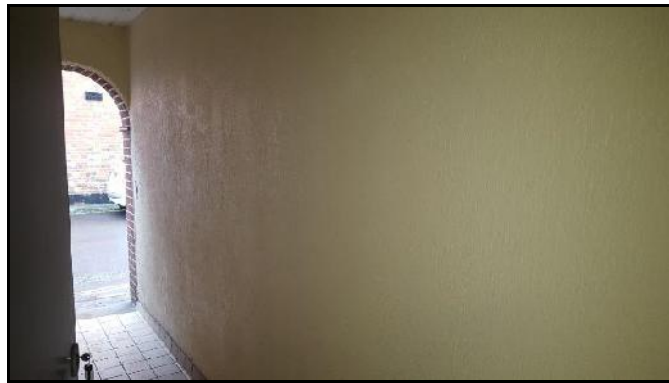
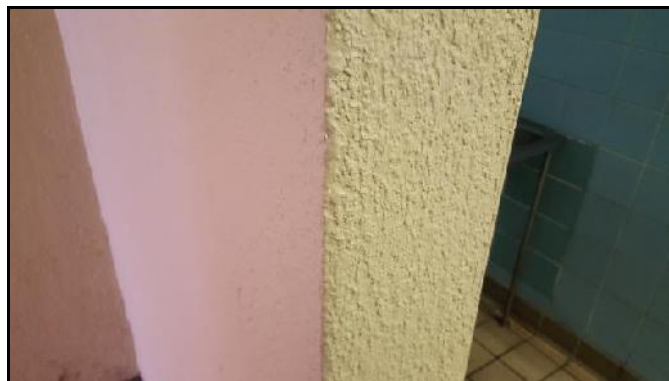
<b>Building</b>	Main
<b>Floor</b>	0
<b>Room Number</b>	001
<b>Room Description</b>	Ladies Toilet
<b>Sample Code</b>	S001
<b>Material Description</b>	Wall Finish - Textured Coating
<b>Analysis Result</b>	No Asbestos Detected
<b>Extent:</b>	40 m <sup>2</sup>

<b>Product Type</b>	1
<b>Surface Treatment</b>	1
<b>Extent of Damage</b>	1
<b>Asbestos Type</b>	0
<b>TOTAL SCORE</b>	N/A
<b>Recommendation</b>	No Further Action

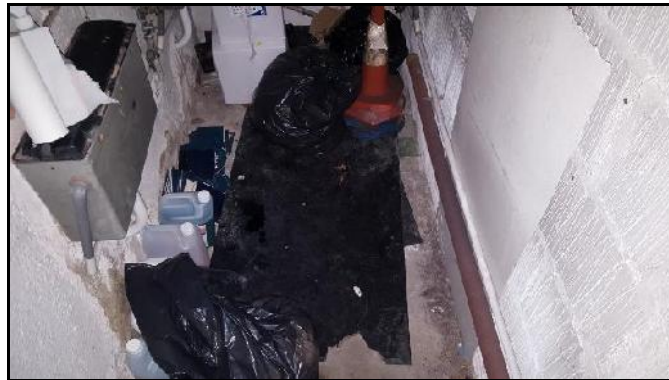
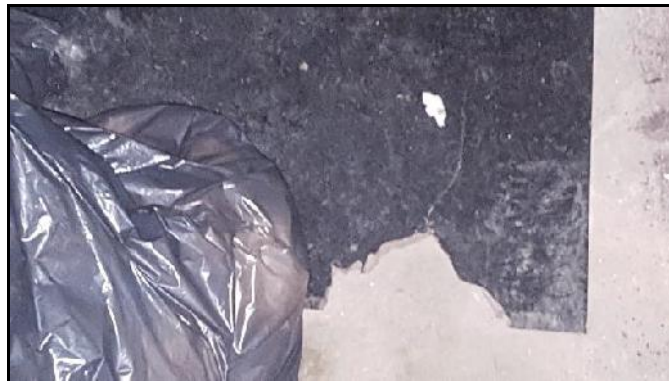
<b>Building</b>	Main
<b>Floor</b>	0
<b>Room Number</b>	002
<b>Room Description</b>	Cleaning Cupboard
<b>Sample Code</b>	S002
<b>Material Description</b>	Covering to Floor - Vinyl / Thermoplastic
<b>Analysis Result</b>	No Asbestos Detected
<b>Extent:</b>	2 m <sup>2</sup>

<b>Product Type</b>	1
<b>Surface Treatment</b>	0
<b>Extent of Damage</b>	2
<b>Asbestos Type</b>	0
<b>TOTAL SCORE</b>	N/A
<b>Recommendation</b>	No Further Action

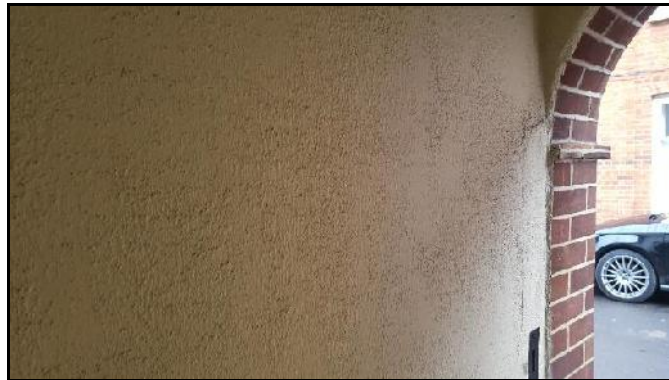
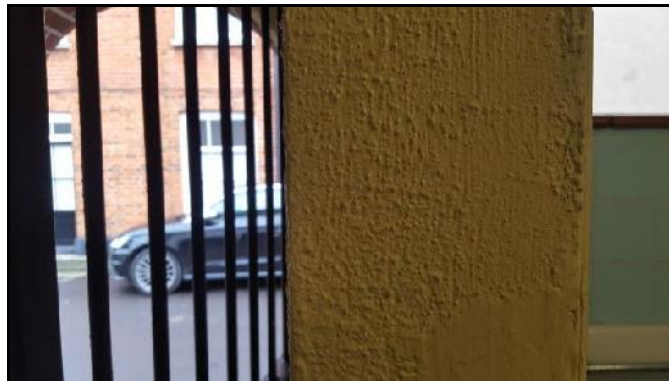
<b>Building</b>	Main
<b>Floor</b>	1
<b>Room Number</b>	004
<b>Room Description</b>	Male Toilet
<b>Sample Code</b>	X001
<b>Material Description</b>	Wall Finish - Textured Coating
<b>Analysis Result</b>	No Asbestos Detected
<b>Extent:</b>	15 m <sup>2</sup>

<b>Product Type</b>	1
<b>Surface Treatment</b>	1
<b>Extent of Damage</b>	1
<b>Asbestos Type</b>	0
<b>TOTAL SCORE</b>	N/A
<b>Recommendation</b>	No Further Action
