# Wakefield College ASBESTOS REFURBISHMENT & DEMOLITION SURVEY INSPECTION REPORT

## A Block Wakefield

Survey Date: 18 February 2013

Job Number: W13-00415

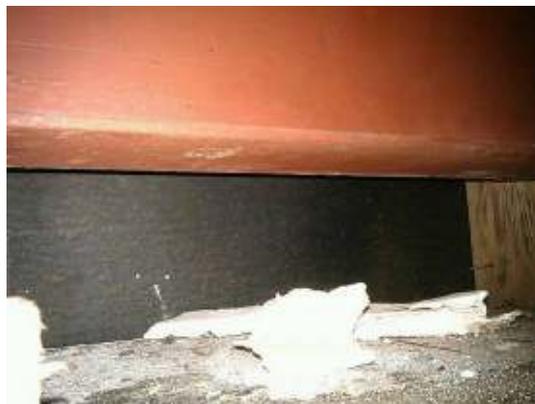
<b>Sample Number</b>	2	<b>Condition</b>	
<b>Extent</b>	50m x 1m x 5mm	<b>Surface Treatment</b>	Bitumen Bonded
<b>Debris Present</b>	No	<b>HSE Licensable Material</b>	<b>No</b>
<b>Asbestos Type</b>	<b>Chrysotile</b>

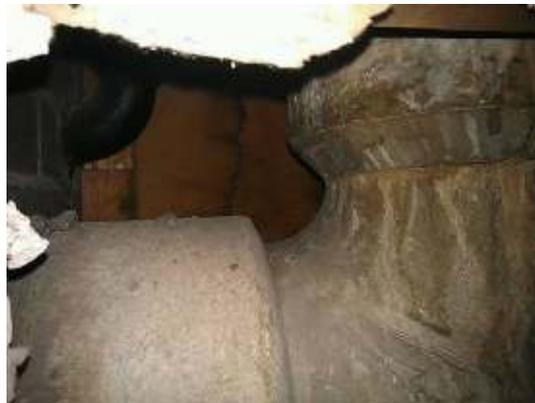
<b>Sample Number</b>	3	<b>Condition</b>	Medium damage
<b>Extent</b>	50m x 0.5m x 10mm	<b>Surface Treatment</b>	Unsealed
<b>Debris Present</b>	No	<b>HSE Licensable Material</b>	<b>No</b>
<b>Asbestos Type</b>	<b>Chrysotile / Amosite</b>

**Comments** The riser R2 runs the full height of the building and so does the cement flue inside

**Recommendations** This material is defined as Non-Licensable and if it is to be removed, it should be done using an HSE licensed removal contractor or by employees who are sufficiently trained and following the guidance in the HSE Asbestos Essentials Task Manual (HSG 210). The recent update in the Control of Asbestos Regulations (2012) requires work on some non-licensed asbestos containing materials to be notified to the appropriate authority and this should be established prior to any removal works.

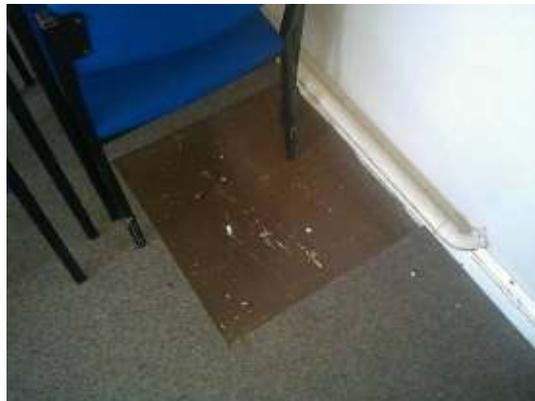
<b>Sample Number</b>	5	<b>Condition</b>	Low damage
<b>Extent</b>	5m x 5m x 5mm	<b>Surface Treatment</b>	Bitumen Bonded
<b>Debris Present</b>	No	<b>HSE Licensable Material</b>	<b>No</b>
<b>Asbestos Type</b>	<b>Chrysotile</b>

**Recommendations** This material is defined as Non-Licensable and if it is to be removed, it should be done using an HSE licensed removal contractor or by employees who are sufficiently trained and following the guidance in the HSE Asbestos Essentials Task Manual (HSG 210). The recent update in the Control of Asbestos Regulations (2012) requires work on some non-licensed asbestos containing materials to be notified to the appropriate authority and this should be established prior to any removal works.

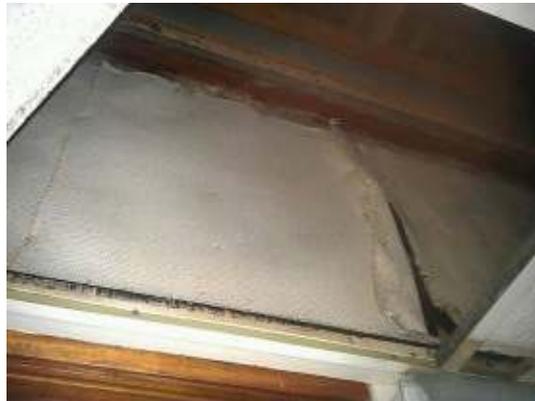
<b>Sample Number</b>	6	<b>Condition</b>	Medium damage
<b>Extent</b>	4M X 1M X 5MM	<b>Surface Treatment</b>	Unsealed
<b>Debris Present</b>	No	<b>HSE Licensable Material</b>	<b>Yes</b>
<b>Asbestos Type</b>	Chrysotile

**Recommendations** This material is defined as Licensable and Notifiable and if it is to be removed, it should only be done using an HSE Licensed removal contractor.

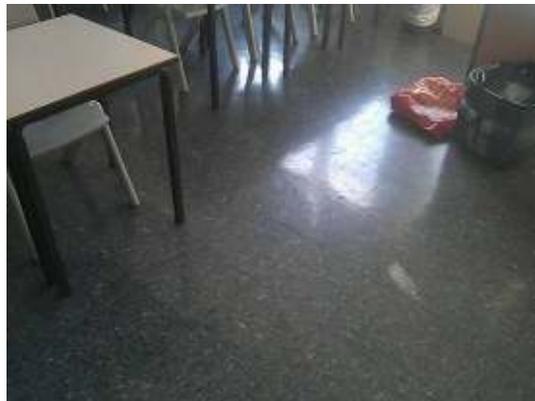
<b>Sample Number</b>	7	<b>Condition</b>	Low damage
<b>Extent</b>	5m x 5m x 5mm	<b>Surface Treatment</b>	Bitumen Bonded
<b>Debris Present</b>	No	<b>HSE Licensable Material</b>	<b>No</b>
<b>Asbestos Type</b>	<b>Chrysotile</b>

**Recommendations** This material is defined as Non-Licensable and if it is to be removed, it should be done using an HSE licensed removal contractor or by employees who are sufficiently trained and following the guidance in the HSE Asbestos Essentials Task Manual (HSG 210). The recent update in the Control of Asbestos Regulations (2012) requires work on some non-licensed asbestos containing materials to be notified to the appropriate authority and this should be established prior to any removal works.

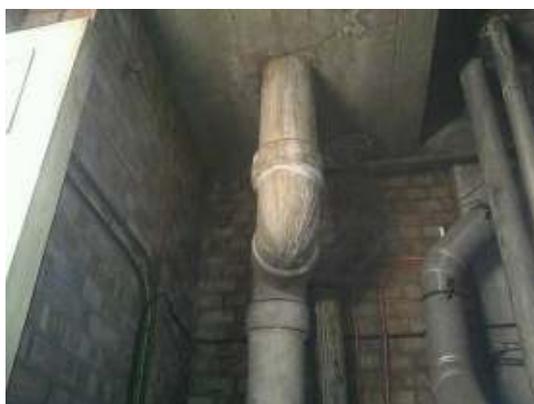
<b>Sample Number</b>	8	<b>Condition</b>	Low damage
<b>Extent</b>	50m x 0.5m x 10mm	<b>Surface Treatment</b>	Unsealed
<b>Debris Present</b>	No	<b>HSE Licensable Material</b>	<b>No</b>
<b>Asbestos Type</b>	<b>Chrysotile / Amosite</b>

**Comments** Flue pipe is in an open riser in the corner of the room, the riser runs the full height of the building as does the flue pipe

**Recommendations** This material is defined as Non-Licensable and if it is to be removed, it should be done using an HSE licensed removal contractor or by employees who are sufficiently trained and following the guidance in the HSE Asbestos Essentials Task Manual (HSG 210). The recent update in the Control of Asbestos Regulations (2012) requires work on some non-licensed asbestos containing materials to be notified to the appropriate authority and this should be established prior to any removal works.

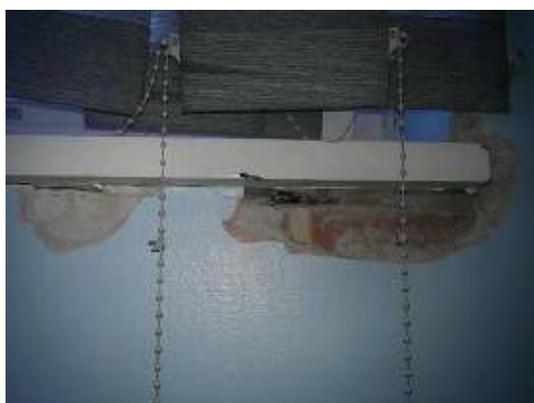
<b>Sample Number</b>	9	<b>Condition</b>	Low damage
<b>Extent</b>	50m x 100mm x 5mm	<b>Surface Treatment</b>	Bitumen Bonded
<b>Debris Present</b>	No	<b>HSE Licensable Material</b>	<b>No</b>
<b>Asbestos Type</b>	<b>Chrysotile</b>

**Comments** This material is presumed to be present under all similar window sills within the building.

**Recommendations** This material is defined as Non-Licensable and if it is to be removed, it should be done using an HSE licensed removal contractor or by employees who are sufficiently trained and following the guidance in the HSE Asbestos Essentials Task Manual (HSG 210). The recent update in the Control of Asbestos Regulations (2012) requires work on some non-licensed asbestos containing materials to be notified to the appropriate authority and this should be established prior to any removal works.

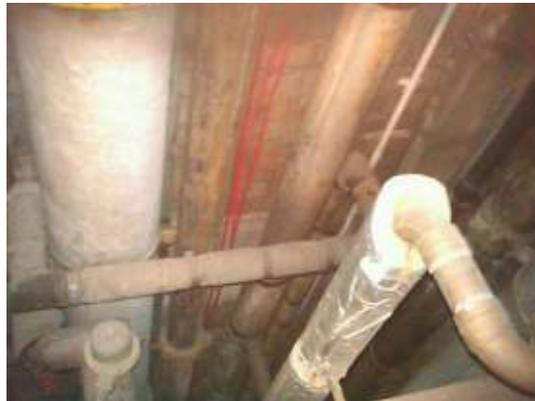
<b>Sample Number</b>	10	<b>Condition</b>	High damage
<b>Extent</b>	50m x 0.25m x 5mm	<b>Surface Treatment</b>	Unsealed
<b>Debris Present</b>	Yes	<b>HSE Licensable Material</b>	<b>Yes</b>
<b>Asbestos Type</b>	<b>Chrysotile</b>

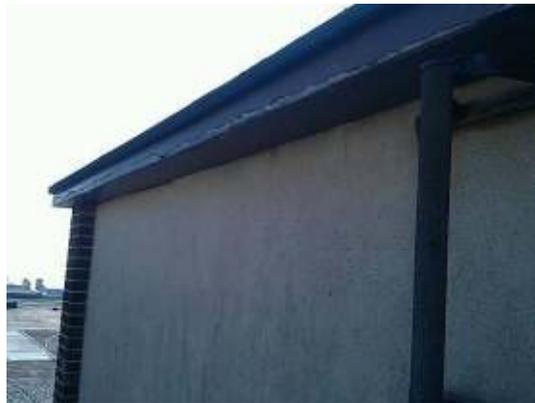
<b>Sample Number</b>	11	<b>Condition</b>	Medium damage
<b>Extent</b>	12m x 200mm x 10mm	<b>Surface Treatment</b>	Unsealed
<b>Debris Present</b>	No	<b>HSE Licensable Material</b>	<b>Yes</b>
<b>Asbestos Type</b>	Crocidolite / Chrysotile

**Comments** Soffit boards are present to all sides of the building.

**Recommendations** This material is defined as Licensable and Notifiable and if it is to be removed, it should only be done using an HSE Licensed removal contractor.

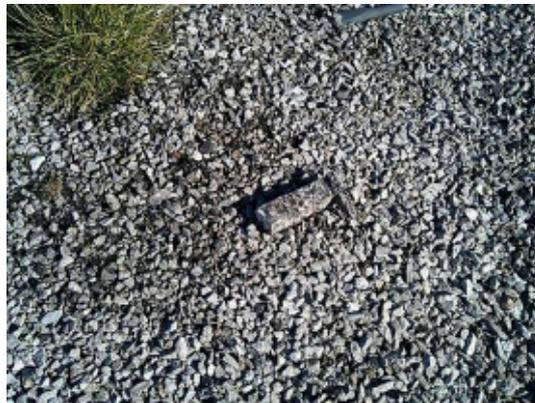
<b>Sample Number</b>	12	<b>Condition</b>	High damage
<b>Extent</b>	50m x 20m x 5mm	<b>Surface Treatment</b>	Unsealed
<b>Debris Present</b>	Yes	<b>HSE Licensable Material</b>	<b>Yes</b>
<b>Asbestos Type</b>	<b>Chrysotile</b>

**Comments** This material is widespread through most of the main flat roof area.

**Recommendations** This material is defined as Non-Licensable and if it is to be removed, it should be done using an HSE licensed removal contractor or by employees who are sufficiently trained and following the guidance in the HSE Asbestos Essentials Task Manual (HSG 210). The recent update in the Control of Asbestos Regulations (2012) requires work on some non-licensed asbestos containing materials to be notified to the appropriate authority and this should be established prior to any removal works.

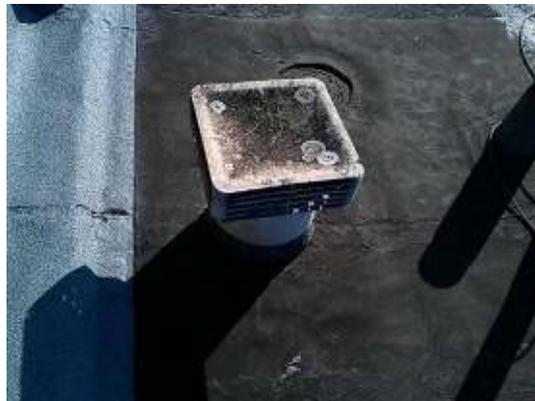
<b>Sample Number</b>	13	<b>Condition</b>	Medium damage
<b>Extent</b>	0.5m x 0.2m x 5mm	<b>Surface Treatment</b>	Unsealed
<b>Debris Present</b>	No	<b>HSE Licensable Material</b>	<b>No</b>
<b>Asbestos Type</b>	<b>Chrysotile / Amosite</b>

**Recommendations** This material is defined as Non-Licensable and if it is to be removed, it should be done using an HSE licensed removal contractor or by employees who are sufficiently trained and following the guidance in the HSE Asbestos Essentials Task Manual (HSG 210). The recent update in the Control of Asbestos Regulations (2012) requires work on some non-licensed asbestos containing materials to be notified to the appropriate authority and this should be established prior to any removal works.

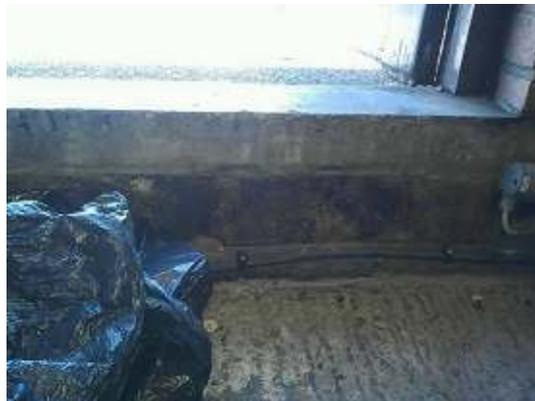
<b>Sample Number</b>	14	<b>Condition</b>	Medium damage
<b>Extent</b>	2mx 200mm x 10mm	<b>Surface Treatment</b>	Bitumen Bonded
<b>Debris Present</b>	No	<b>HSE Licensable Material</b>	<b>No</b>
<b>Asbestos Type</b>	<b>Chrysotile</b>

**Recommendations** This material is defined as Non-Licensable and if it is to be removed, it should be done using an HSE licensed removal contractor or by employees who are sufficiently trained and following the guidance in the HSE Asbestos Essentials Task Manual (HSG 210). The recent update in the Control of Asbestos Regulations (2012) requires work on some non-licensed asbestos containing materials to be notified to the appropriate authority and this should be established prior to any removal works.

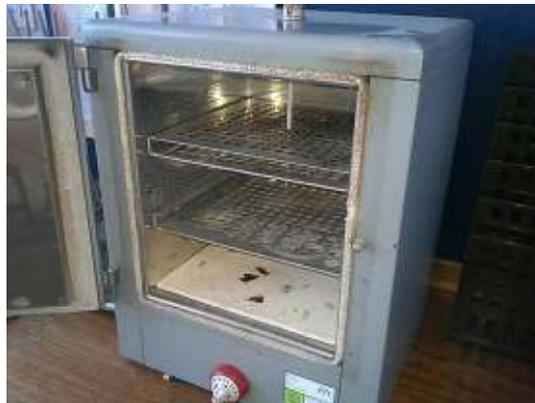
<b>Sample Number</b>	17	<b>Condition</b>	Medium damage
<b>Extent</b>	1m x 5mm	<b>Surface Treatment</b>	Unsealed
<b>Debris Present</b>	No	<b>HSE Licensable Material</b>	<b>No</b>
<b>Asbestos Type</b>	<b>Chrysotile</b>

**Comments** There are several mobile desk top ovens within the room.

**Recommendations** This material is defined as Non-Licensable and if it is to be removed, it should be done using an HSE licensed removal contractor or by employees who are sufficiently trained and following the guidance in the HSE Asbestos Essentials Task Manual (HSG 210). The recent update in the Control of Asbestos Regulations (2012) requires work on some non-licensed asbestos containing materials to be notified to the appropriate authority and this should be established prior to any removal works.

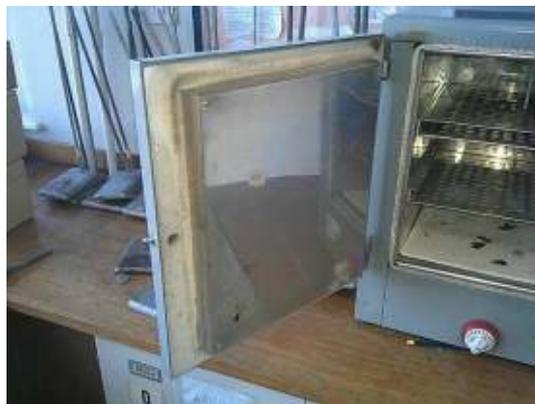
<b>Sample Number</b>	18	<b>Condition</b>	Medium damage
<b>Extent</b>	0.2m x 0.2m x 5mm	<b>Surface Treatment</b>	Unsealed
<b>Debris Present</b>	No	<b>HSE Licensable Material</b>	<b>No</b>
<b>Asbestos Type</b>	<b>Chrysotile</b>

**Comments** There are several mobile desk top ovens within the room.

**Recommendations** This material is defined as Licensable and Notifiable and if it is to be removed, it should only be done using an HSE Licensed removal contractor.

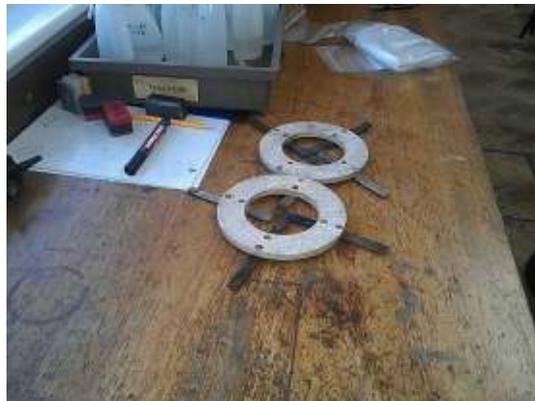
<b>Sample Number</b>	20	<b>Condition</b>	Medium damage
<b>Extent</b>	Various Sizes	<b>Surface Treatment</b>	Unsealed
<b>Debris Present</b>	No	<b>HSE Licensable Material</b>	<b>No</b>
<b>Asbestos Type</b>	<b>Chrysotile</b>

**Recommendations** This material is defined as Non-Licensable and if it is to be removed, it should be done using an HSE licensed removal contractor or by employees who are sufficiently trained and following the guidance in the HSE Asbestos Essentials Task Manual (HSG 210). The recent update in the Control of Asbestos Regulations (2012) requires work on some non-licensed asbestos containing materials to be notified to the appropriate authority and this should be established prior to any removal works.

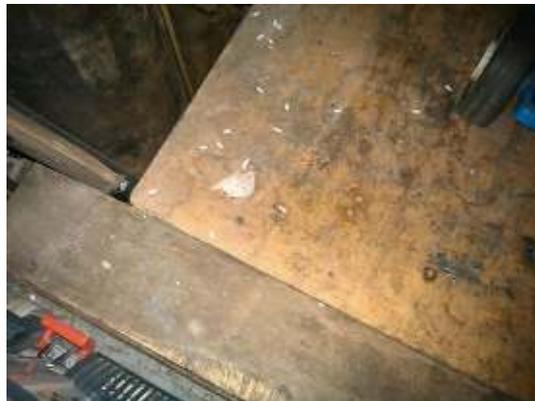
<b>Sample Number</b>	21	<b>Condition</b>	High damage
<b>Extent</b>	20m x 5mm x 5mm	<b>Surface Treatment</b>	Unsealed
<b>Debris Present</b>	Yes	<b>HSE Licensable Material</b>	<b>Yes</b>
<b>Asbestos Type</b>	Chrysotile

**Recommendations** This material is defined as Licensable and Notifiable and if it is to be removed, it should only be done using an HSE Licensed removal contractor.

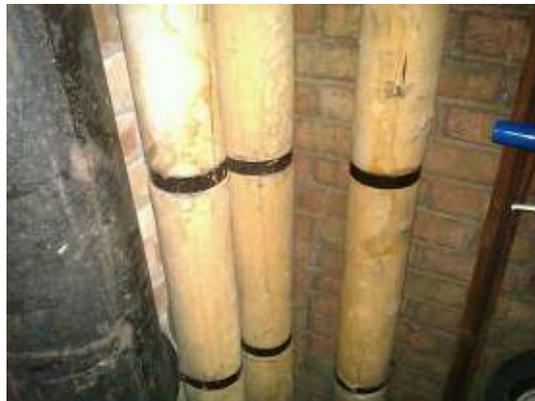
<b>Sample Number</b>	22	<b>Condition</b>	Medium damage
<b>Extent</b>	50m x 50mm x 5mm	<b>Surface Treatment</b>	Unsealed
<b>Debris Present</b>	No	<b>HSE Licensable Material</b>	<b>Yes</b>
<b>Asbestos Type</b>	Chrysotile

**Recommendations** This material is defined as Licensable and Notifiable and if it is to be removed, it should only be done using an HSE Licensed removal contractor.

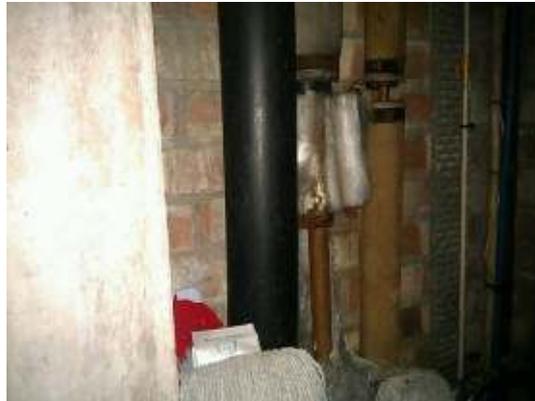
<b>Sample Number</b>	23	<b>Condition</b>	Medium damage
<b>Extent</b>	50m x 50mm x 5mm	<b>Surface Treatment</b>	Unsealed
<b>Debris Present</b>	No	<b>HSE Licensable Material</b>	<b>Yes</b>
<b>Asbestos Type</b>	<b>Chrysotile</b>

**Recommendations** This material is defined as Licensable and Notifiable and if it is to be removed, it should only be done using an HSE Licensed removal contractor.

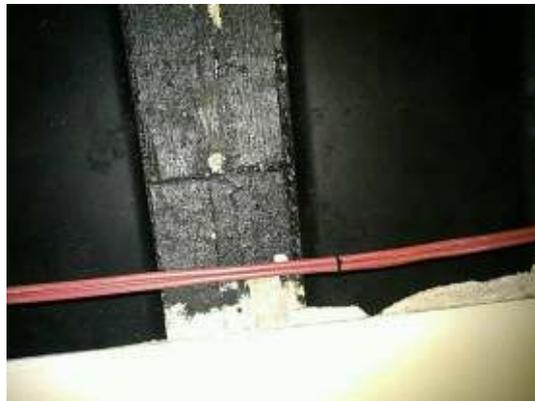
<b>Sample Number</b>	27	<b>Condition</b>	High damage
<b>Extent</b>	40m x 40m x 5mm	<b>Surface Treatment</b>	Unsealed
<b>Debris Present</b>	Yes	<b>HSE Licensable Material</b>	<b>Yes</b>
<b>Asbestos Type</b>	Chrysotile

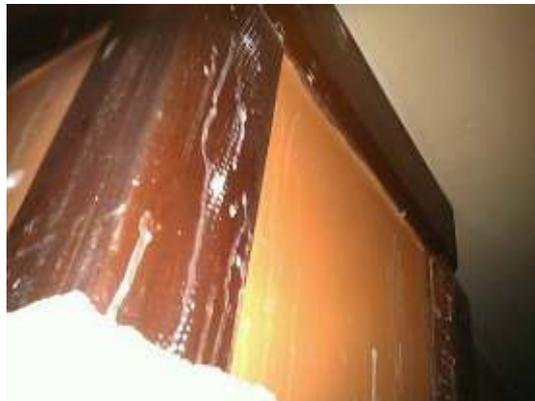
<b>Sample Number</b>	28	<b>Condition</b>	High damage
<b>Extent</b>	40m x 40m x 5mm	<b>Surface Treatment</b>	Unsealed
<b>Debris Present</b>	Yes	<b>HSE Licensable Material</b>	<b>Yes</b>
<b>Asbestos Type</b>	Chrysotile

**Recommendations** This material is defined as Licensable and Notifiable and if it is to be removed, it should only be done using an HSE Licensed removal contractor.

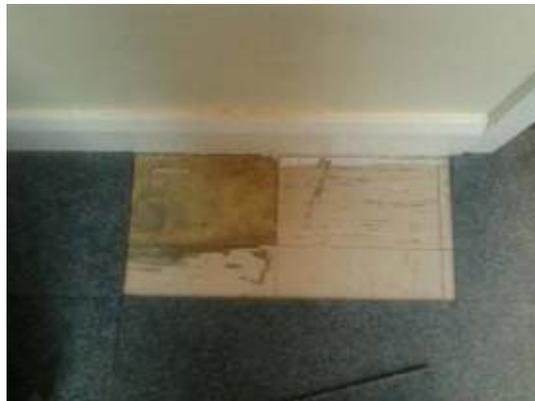
<b>Sample Number</b>	31	<b>Condition</b>	Good
<b>Extent</b>	6.5x7m	<b>Surface Treatment</b>	Composite Material
<b>Debris Present</b>	No	<b>HSE Licensable Material</b>	<b>No</b>
<b>Asbestos Type</b>	<b>Chrysotile</b>

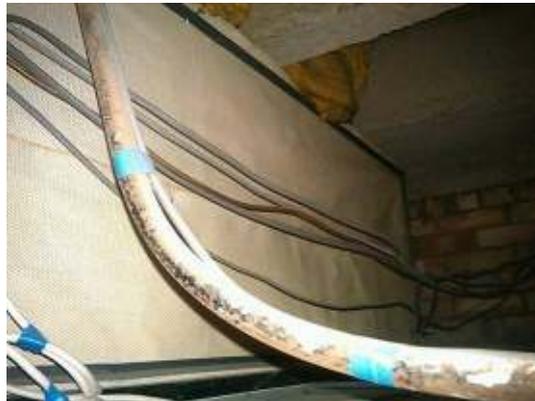
<b>Sample Number</b>	37	<b>Condition</b>	Medium damage
<b>Extent</b>	3M X 1M X 5MM	<b>Surface Treatment</b>	Unsealed
<b>Debris Present</b>	No	<b>HSE Licensable Material</b>	<b>Yes</b>
<b>Asbestos Type</b>	Chrysotile

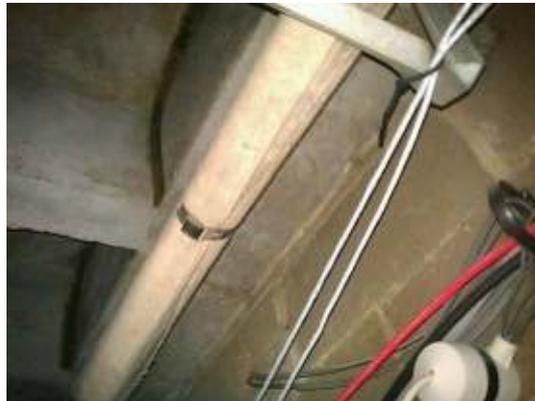
<b>Sample Number</b>	38	<b>Condition</b>	Medium damage
<b>Extent</b>	10m x 1m x 5mm	<b>Surface Treatment</b>	Unsealed
<b>Debris Present</b>	No	<b>HSE Licensable Material</b>	<b>Yes</b>
<b>Asbestos Type</b>	Chrysotile

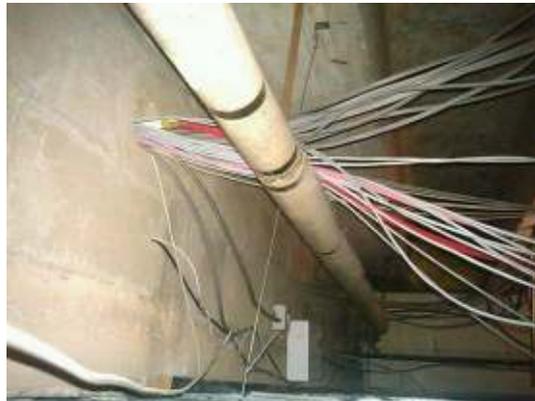
<b>Sample Number</b>	40	<b>Condition</b>	Medium damage
<b>Extent</b>	10m x 1m x 5mm	<b>Surface Treatment</b>	Unsealed
<b>Debris Present</b>	No	<b>HSE Licensable Material</b>	<b>Yes</b>
<b>Asbestos Type</b>	Chrysotile

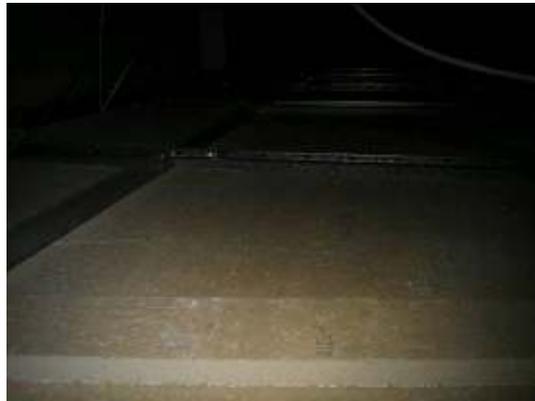
<b>Sample Number</b>	41	<b>Condition</b>	Medium damage
<b>Extent</b>	10m x 1m x 5mm	<b>Surface Treatment</b>	Unsealed
<b>Debris Present</b>	Yes	<b>HSE Licensable Material</b>	<b>Yes</b>
<b>Asbestos Type</b>	Chrysotile

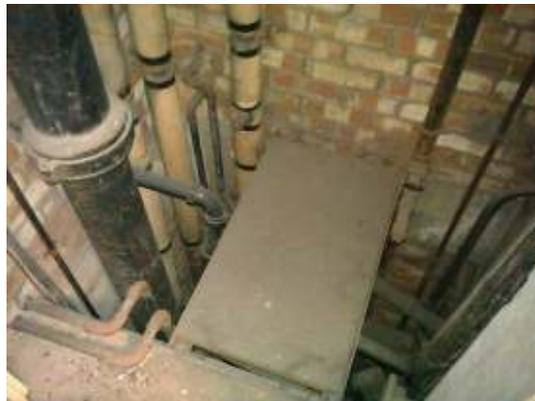
<b>Sample Number</b>	42	<b>Condition</b>	High damage
<b>Extent</b>	20m x 5mm x 5mm	<b>Surface Treatment</b>	Unsealed
<b>Debris Present</b>	Yes	<b>HSE Licensable Material</b>	<b>Yes</b>
<b>Asbestos Type</b>	Chrysotile

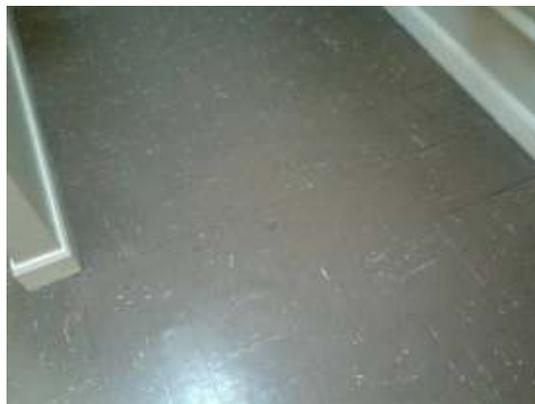
<b>Sample Number</b>	43	<b>Condition</b>	Good
<b>Extent</b>	Throughout	<b>Surface Treatment</b>	Composite Material
<b>Debris Present</b>	No	<b>HSE Licensable Material</b>	<b>No</b>
<b>Asbestos Type</b>	<b>Chrysotile</b>

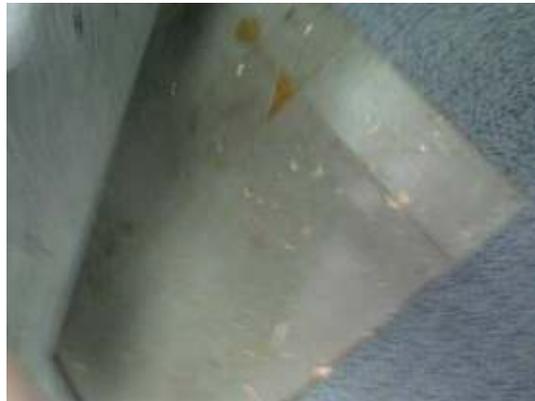
<b>Sample Number</b>	44	<b>Condition</b>	Good
<b>Extent</b>	6x4m & 4x2.5 x2	<b>Surface Treatment</b>	Composite Material
<b>Debris Present</b>	No	<b>HSE Licensable Material</b>	<b>No</b>
<b>Asbestos Type</b>	<b>Chrysotile</b>

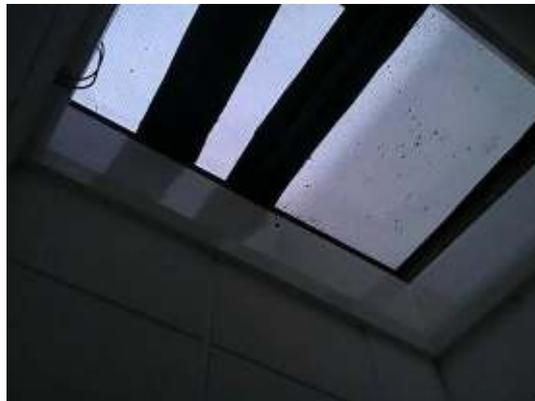
<b>Sample Number</b>	45	<b>Condition</b>	Low damage
<b>Extent</b>	5m x 10mm x 5mm	<b>Surface Treatment</b>	Composite Material
<b>Debris Present</b>	No	<b>HSE Licensable Material</b>	<b>No</b>
<b>Asbestos Type</b>	<b>Chrysotile</b>

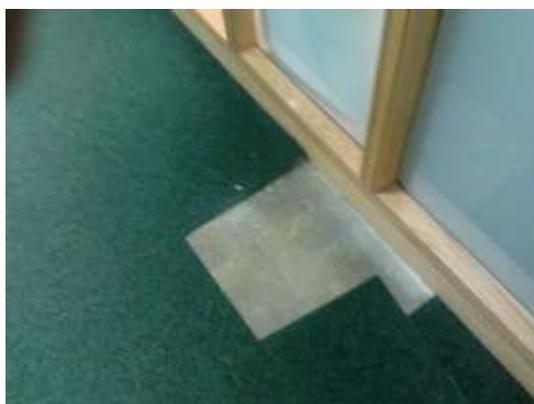
**Comments** Floor tiles under screed

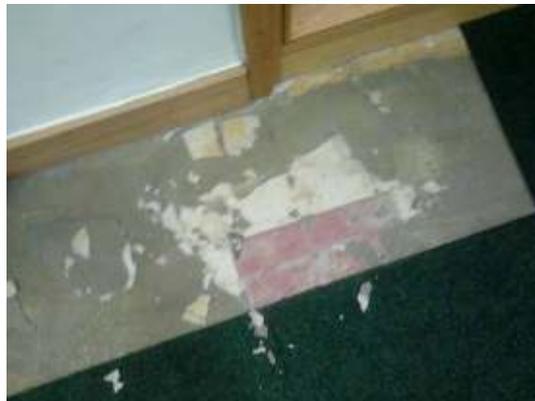
**Comments** Floor tiles under screed

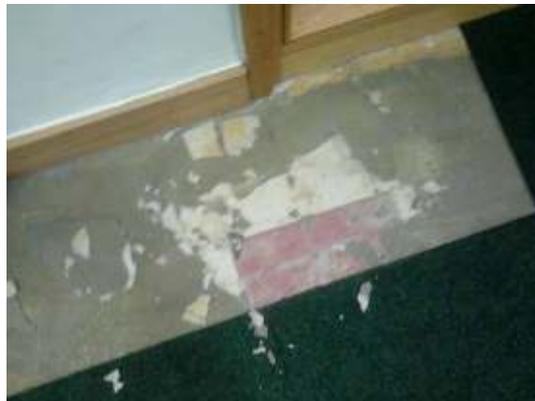
**Comments** Floor tiles under screed

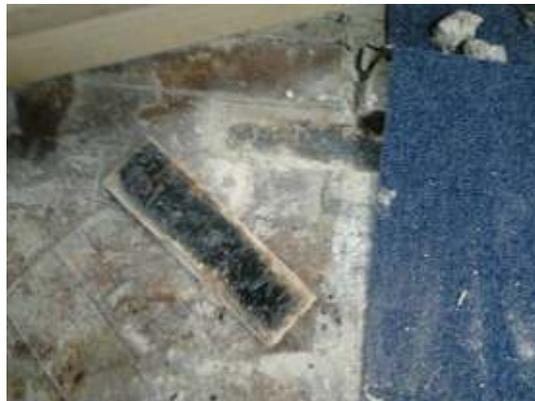
**Comments** In all refurbished offices under carpets

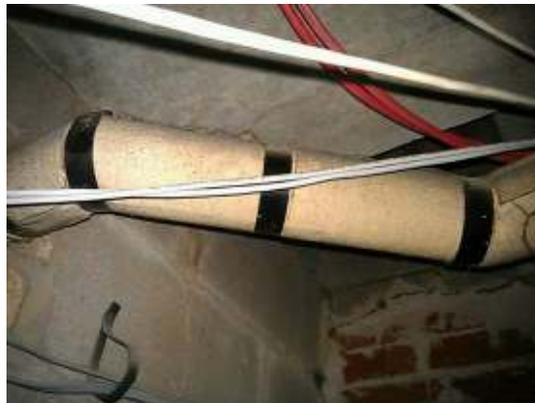
**Comments** Pipe work runs through into adjacent classrooms

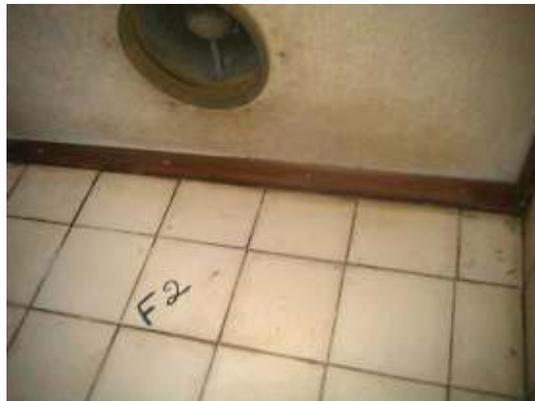
**Comments** Sample #8 cement pipe runs from the 4F riser down into Fume cupboard F2

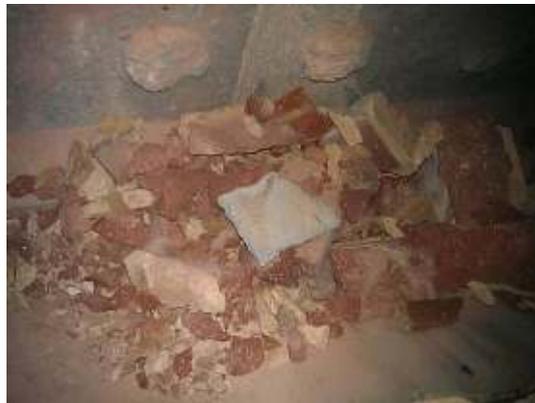
**Comments** There was only one piece of insulating board present within the void and it was not possible to identify where it had come from.

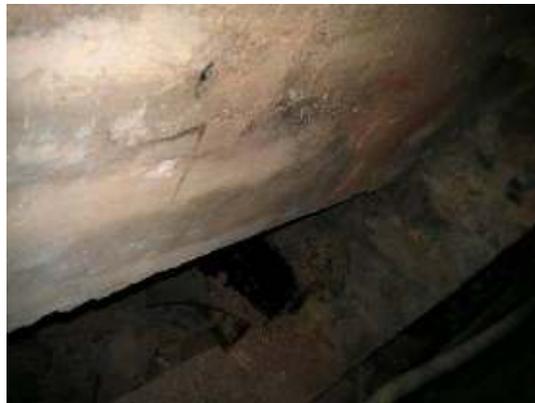
**Comments** Bitumen DPC is believed to be present throughout the building in all perimeter wall voids and within joints of external concrete wall cladding.

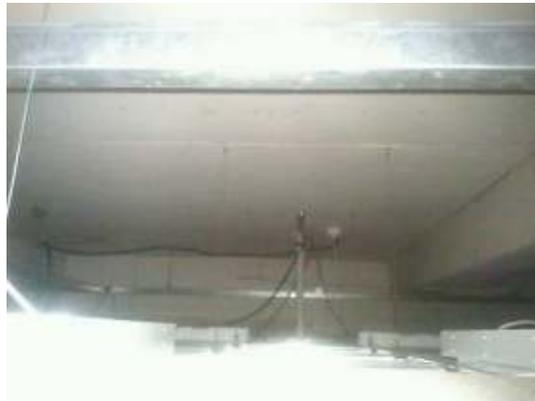
**Comments** Boarding is present to main ceiling and ceiling beams
