## Annual Inspection

West Swindon Parish Council

Middleleaze

Inspection Ref: 524050

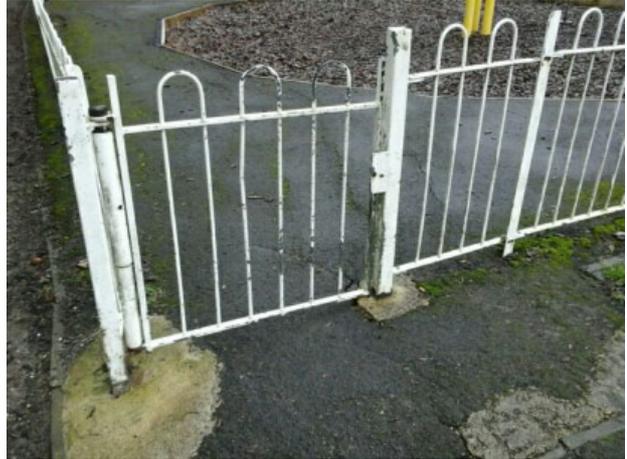
**Item:** Ancillary Items - Gate - Self Closing  
**Manufacturer:** Owner/Operator  
**Surface Type:** N/A  
**Equipment Compliance:** N/A  
**Surface Area Compliance:** N/A  
**Ref/Part Number:**  
**Total Findings:** 4

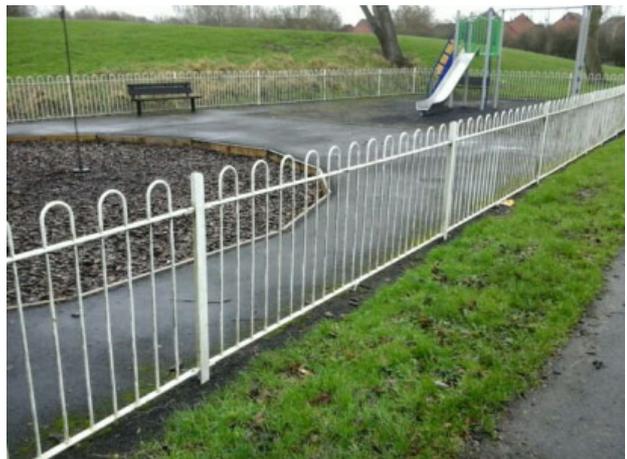
**Item:** Ancillary Items - Fence - Bow Top  
**Manufacturer:** Owner/Operator  
**Surface Type:** N/A  
**Equipment Compliance:** N/A  
**Surface Area Compliance:** N/A  
**Ref/Part Number:**  
**Total Findings:** 2

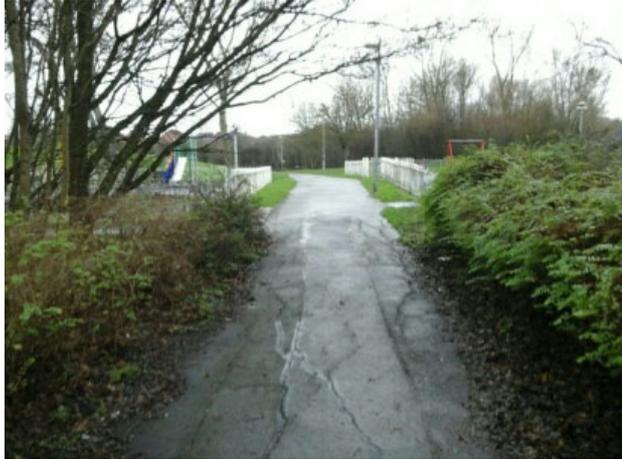
**Item:** Ancillary Items - Site General  
**Manufacturer:** Owner/Operator  
**Surface Type:** N/A  
**Equipment Compliance:** N/A  
**Surface Area Compliance:** N/A  
**Ref/Part Number:**  
**Total Findings:** 5

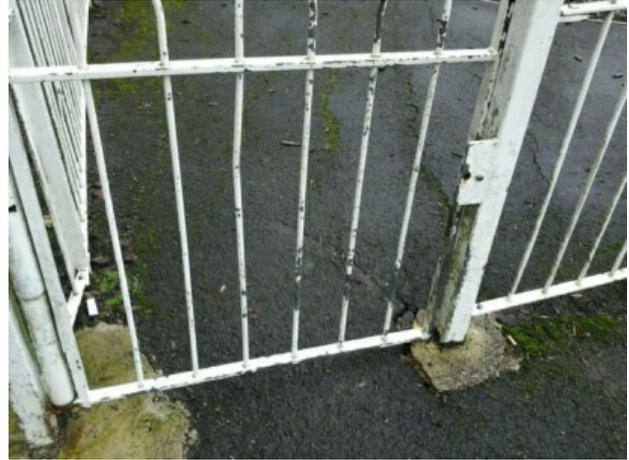
**Finding:** There is some minor damage to the gate

**Action:** Monitor for any further deterioration and repair as required

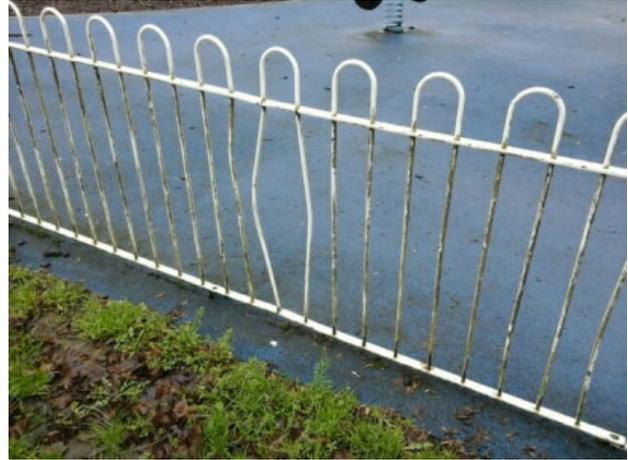
**Finding:** The fence is damaged in places

**Action:** Repair or replace all affected sections

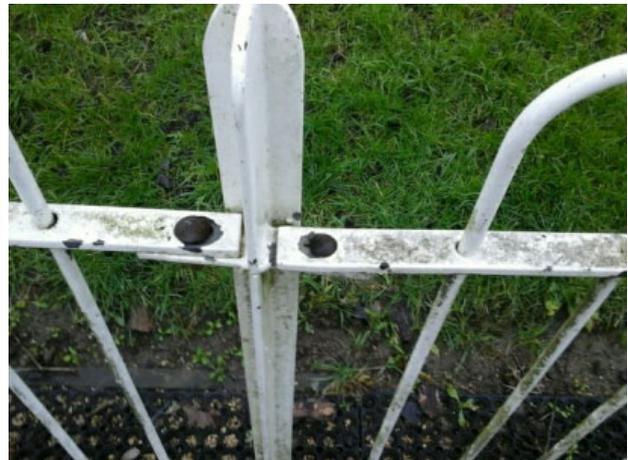
**Finding:** A number of fixings have worked loose around the fencing

**Action:** Secure all loose fixings

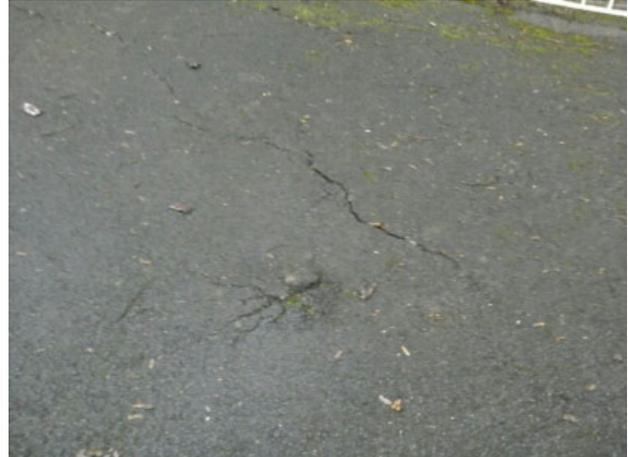
**Finding:** The tarmac surfacing is showing signs of wear / damage

**Action:** Monitor for any further deterioration and repair as required

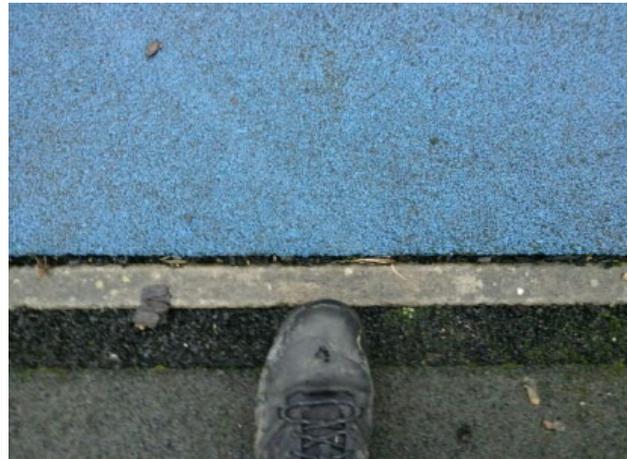
**Finding:** There are gaps opening between the wet pour surfacing and the edging surround or between the joints in the surfacing

**Action:** Monitor for any further deterioration and repair as required

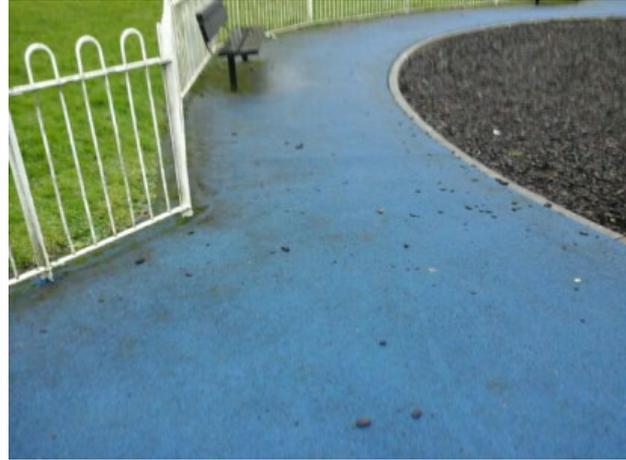
**Finding:** There is algae or moss growth on the wet pour surfacing resulting in slippery conditions

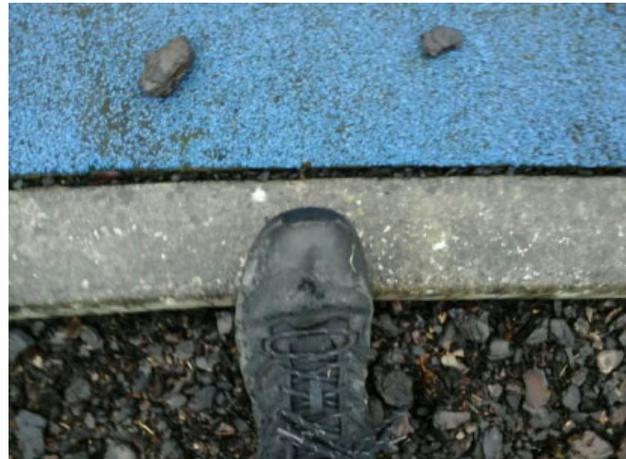
**Finding:** The wet pour surfacing is lifting at the edges and creating trip points

**Action:** Repair perimeter of surfacing to remove trip points

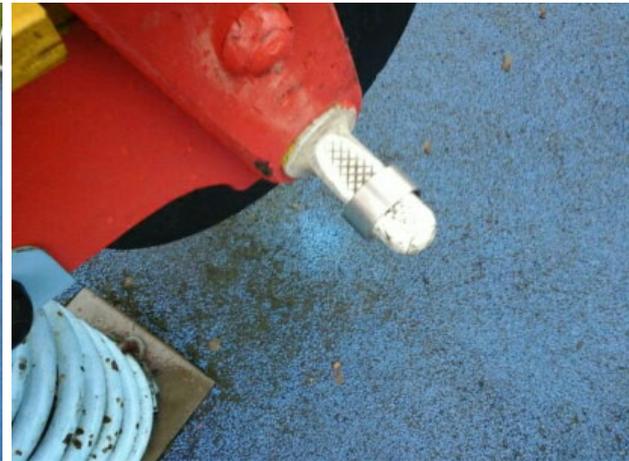
**Finding:** The end of handgrips and/or footrests have a cross section of less than 15cm<sup>2</sup> and fail to meet the requirements of BS EN 1176:2008 Part 6

**Action:** This is a relatively low risk failure and no remedial action is recommended

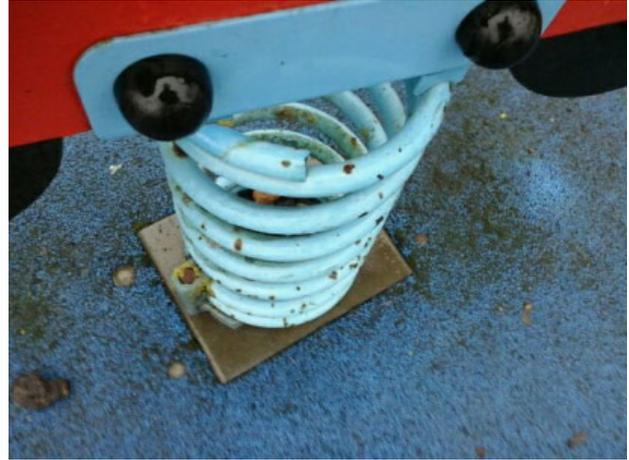
**Finding:** The paintwork on this item has been damaged or worn exposing the metal underneath which is rusting

**Action:** Treat any rusting components and repaint

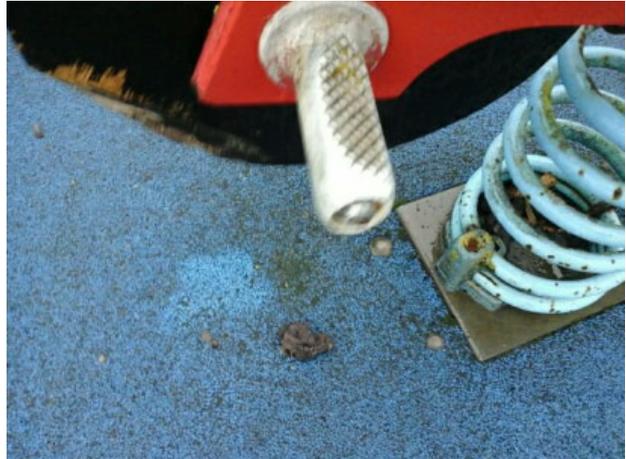
**Finding:** The end caps are missing on the Handgrips/Footrests

**Action:** Replace missing end caps

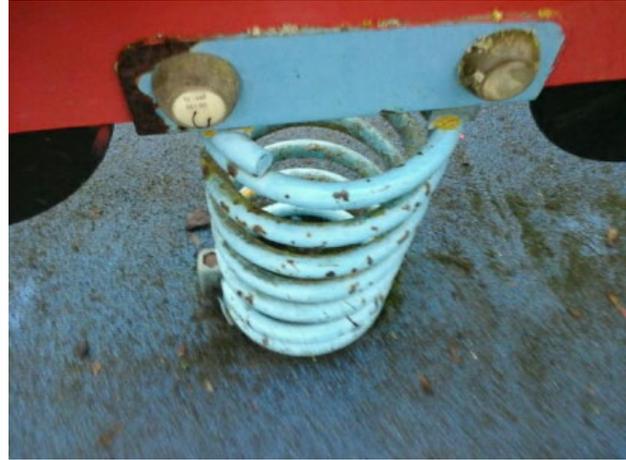
**Finding:** The paintwork on this item has been damaged or worn exposing the metal underneath which is rusting

**Action:** Treat any rusting components and repaint

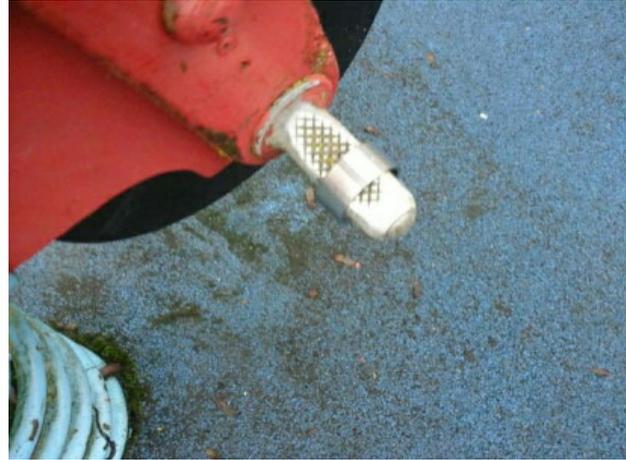
**Finding:** The end of handgrips and/or footrests have a cross section of less than 15cm<sup>2</sup> and fail to meet the requirements of BS EN 1176:2008 Part 6

**Action:** This is a relatively low risk failure and no remedial action is recommended

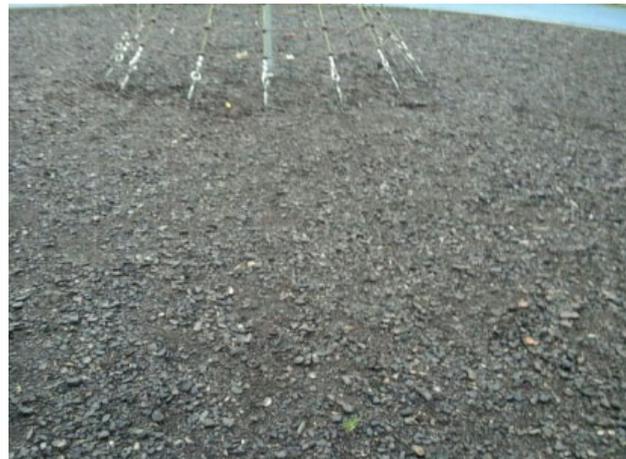
**Finding:** The level of loose fill surfacing has fallen significantly below the minimum 200mm recommended by BS EN 1176 Part 1

**Action:** Top up loose fill surfacing to recommended levels.

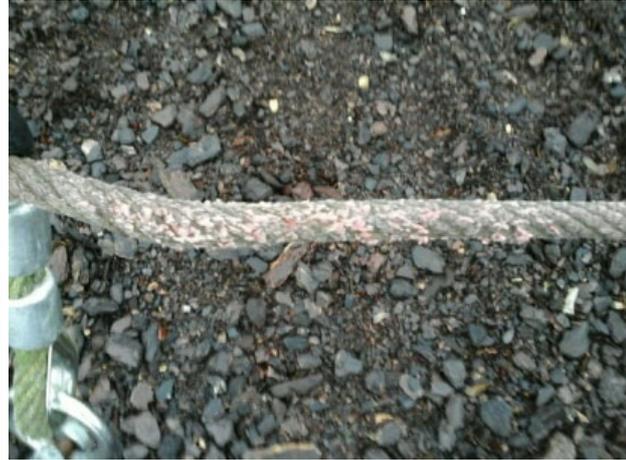
**Finding:** The ropes/nets are worn/damaged in places

**Action:** Monitor for any further deterioration and repair or replace as required

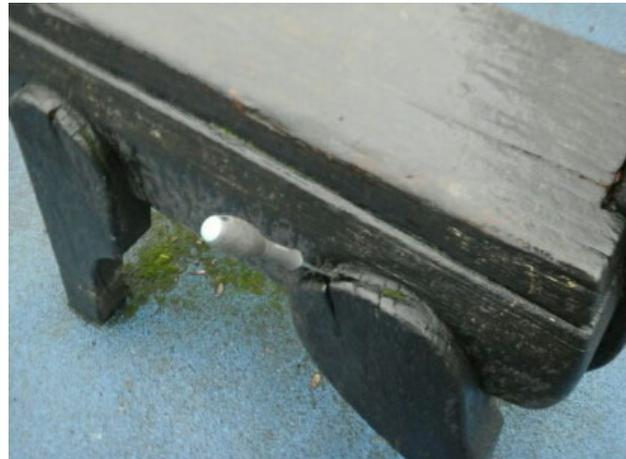
**Finding:** There is some evidence of rot in the timber

**Action:** Monitor for any further deterioration and replace as required

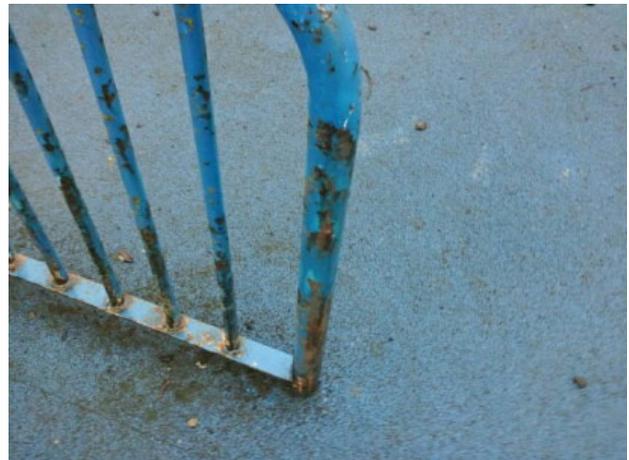
**Finding:** The paintwork on this item has been damaged or worn exposing the metal underneath which is rusting

**Action:** Treat any rusting components and repaint

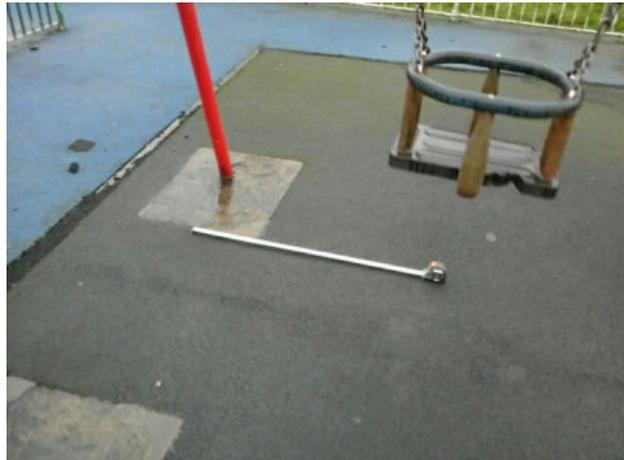
**Finding:** The surfacing width under each seat is less than 1.75 metres and fails the requirements of BS EN 1176 Part 2 - the concrete patches form hard objects in the impact area

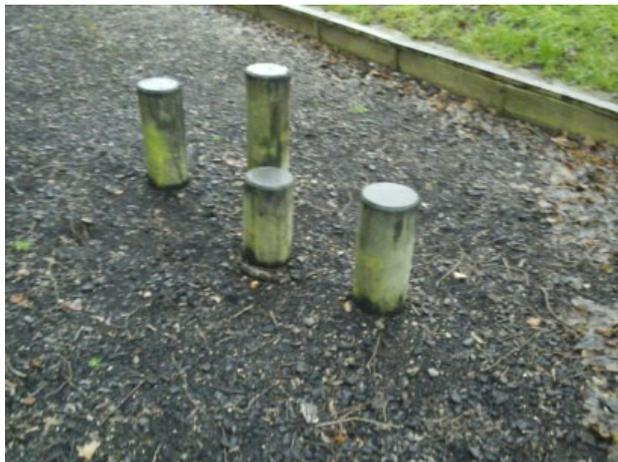
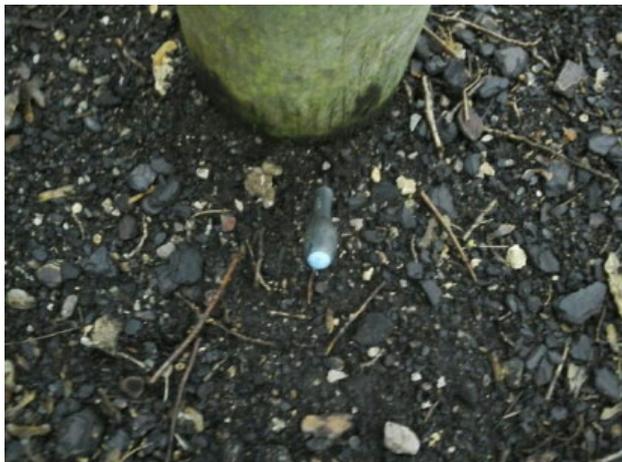
**Finding:** There is some evidence of rot in the timber

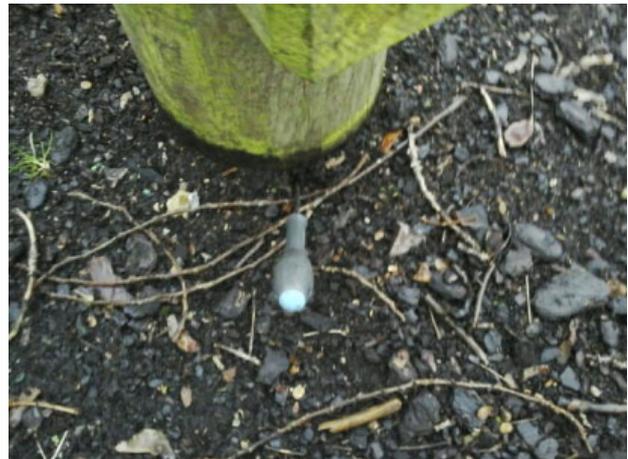
**Finding:** There is some evidence of rot in the timber

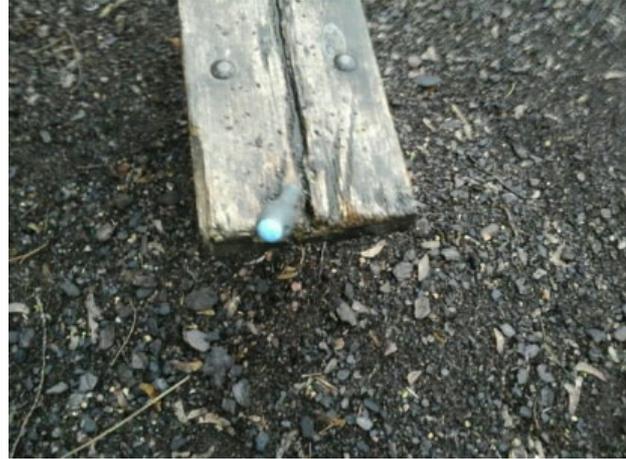
**Finding:** There is some evidence of rot in the timber

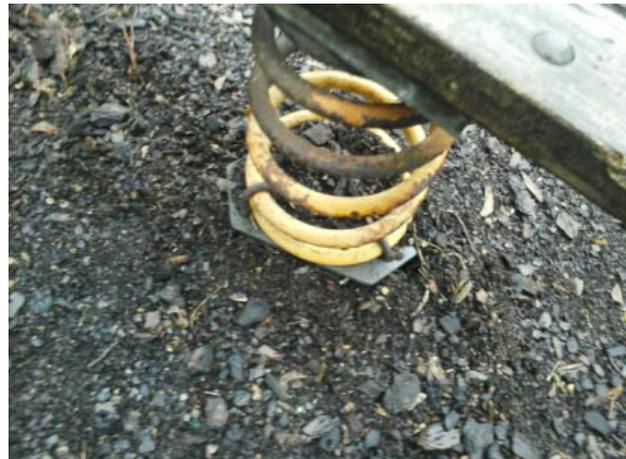
**Finding:** The paintwork on the spring has been damaged or worn exposing the metal underneath which is rusting

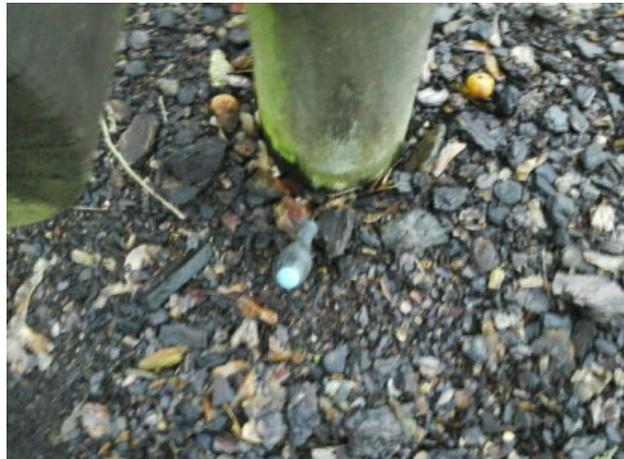
**Finding:** There is some evidence of rot in the timber

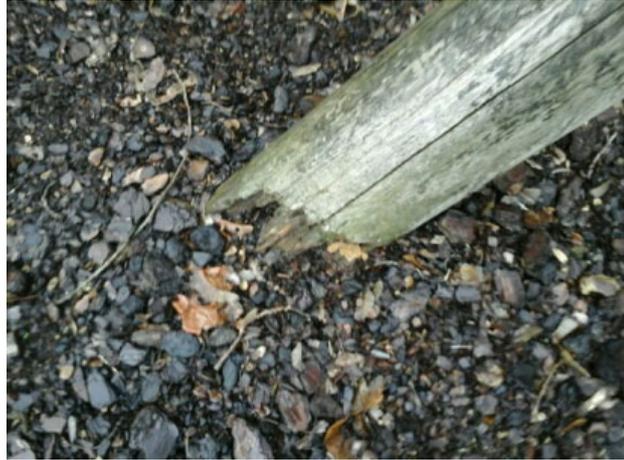
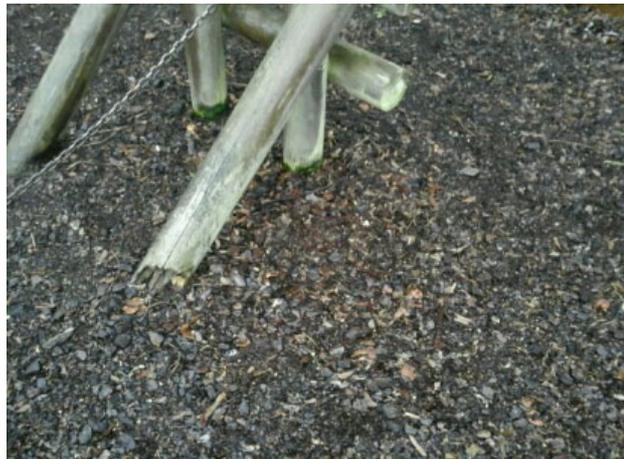
**Finding:** There are areas or parts of angled timber supports x2 on the structure that have rotted

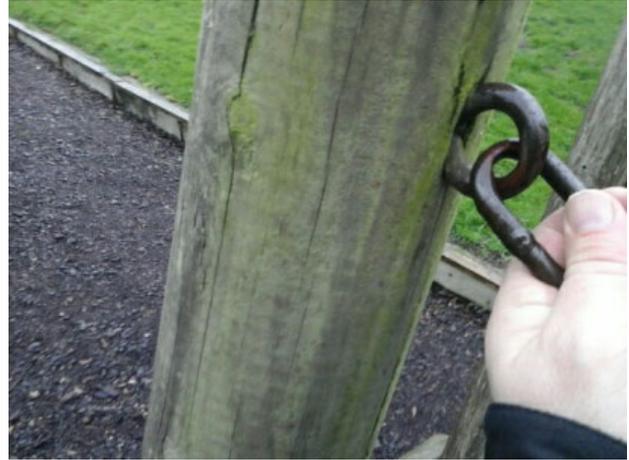
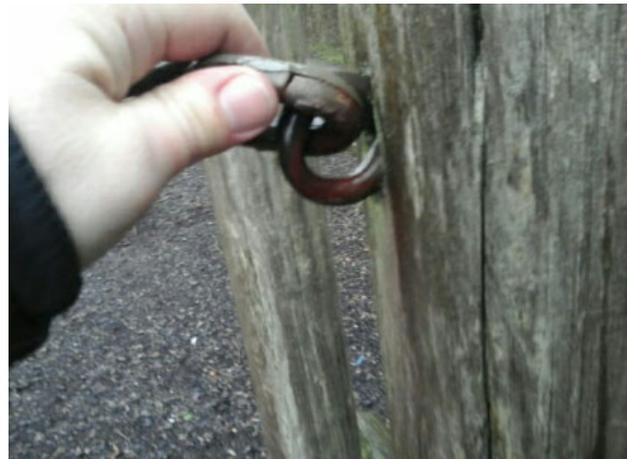
**Finding:** There is some chain and eye bolt wear

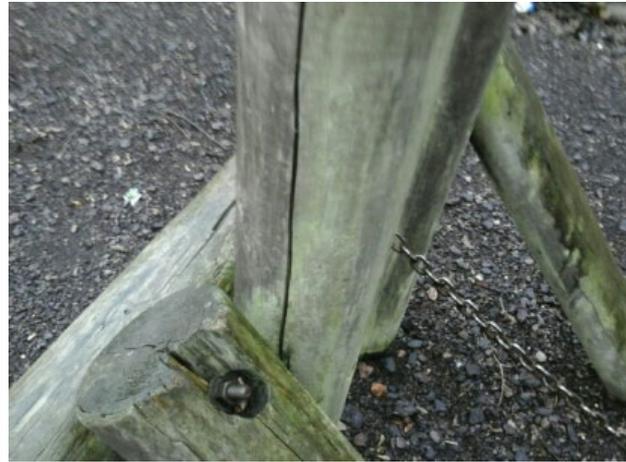
**Finding:** The timber has a number of air cracks apparent, the splits will have penetrated the preservative applied to the timber and allow water ingress to the unprotected areas

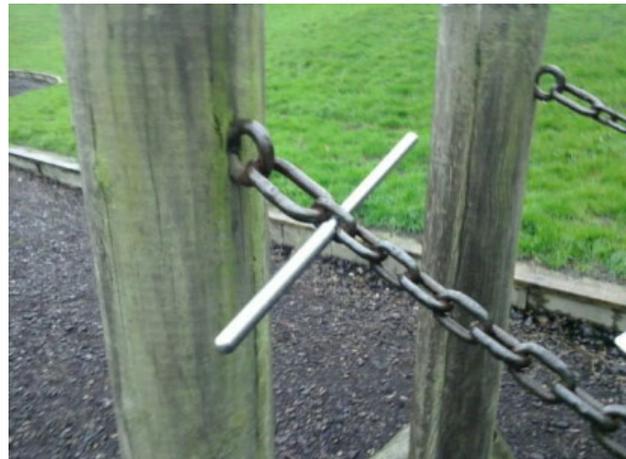
**Finding:** The chain openings are in excess of the 8.6mm as recommended by BS EN 1176

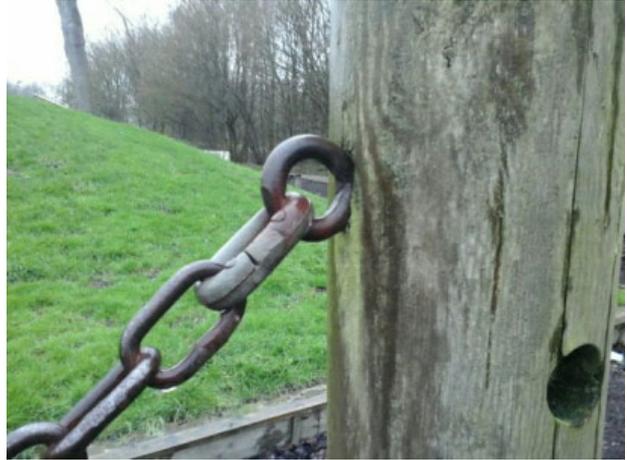
**Finding:** A number of eye bolt fixing(s) have worked loose

**Action:** Secure all loose fixings

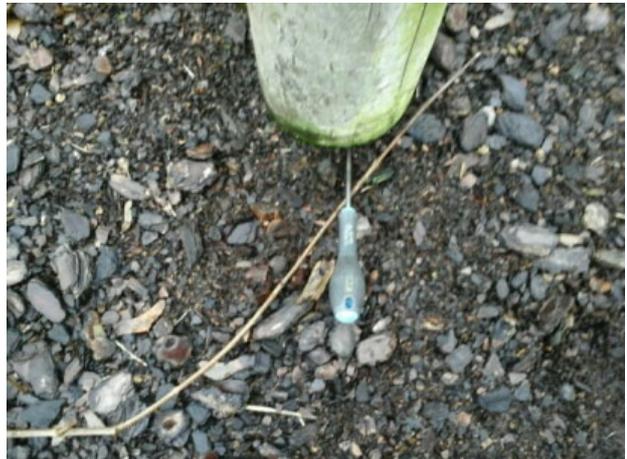
**Finding:** There is some evidence of rot in the timber

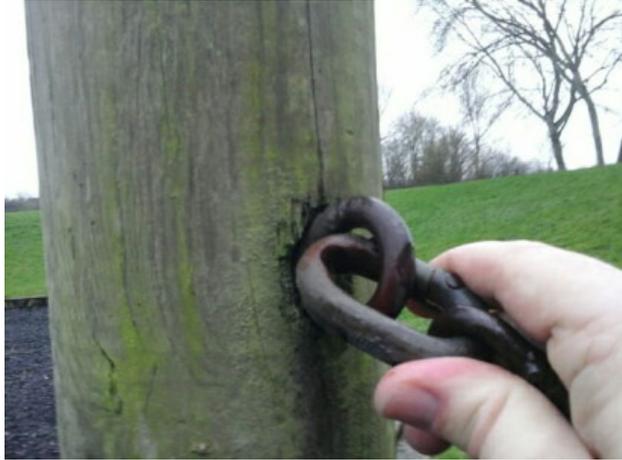
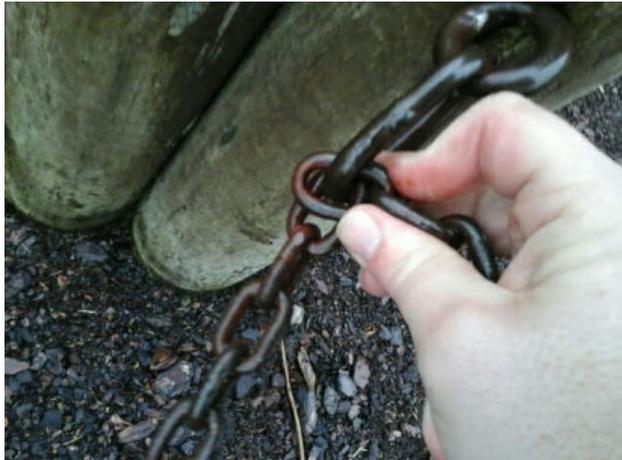
**Finding:** There is some chain and connecting link wear  
**Action:** Monitor for any further deterioration and replace when 40% worn

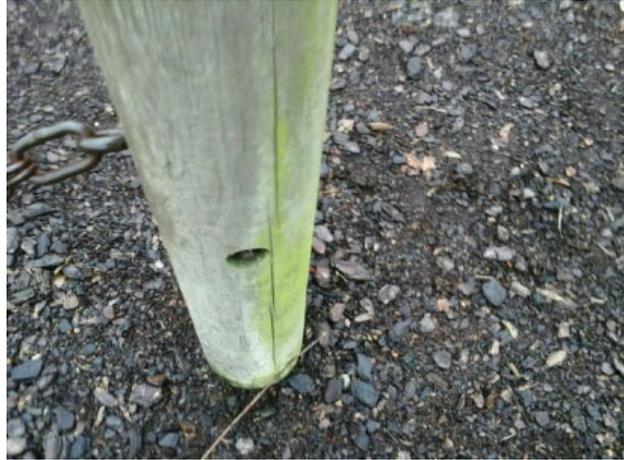
**Finding:** The timber has a number of air cracks apparent, the splits will have penetrated the preservative applied to the timber and allow water ingress to the unprotected areas

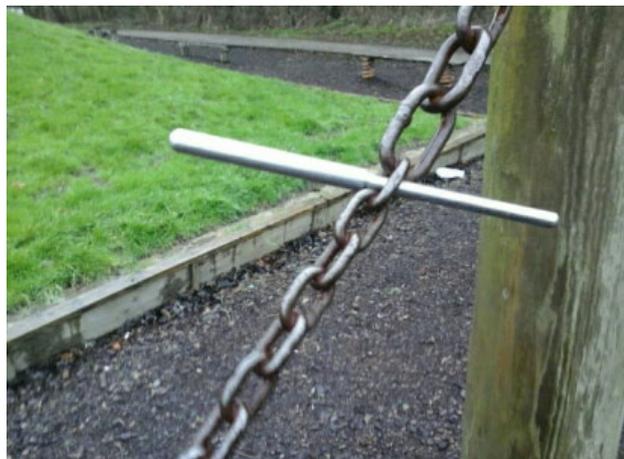
**Finding:** The chain openings are in excess of the 8.6mm as recommended by BS EN 1176

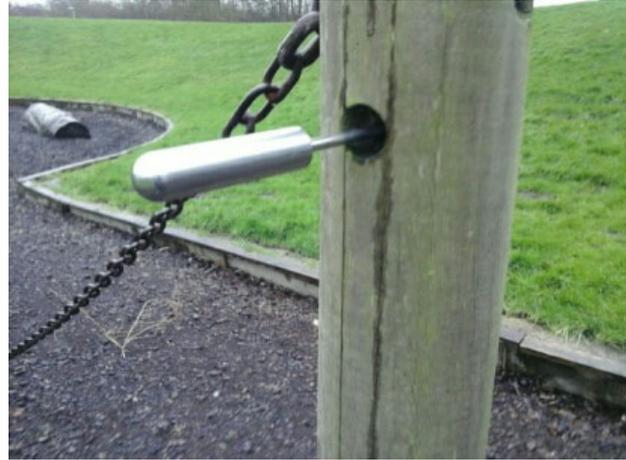
**Finding:** There is/are finger entrapment/s in the posts and the item fails to meet the requirements of BS EN 1176:2008 Part 1 4.2.7.6 Entrapment of fingers

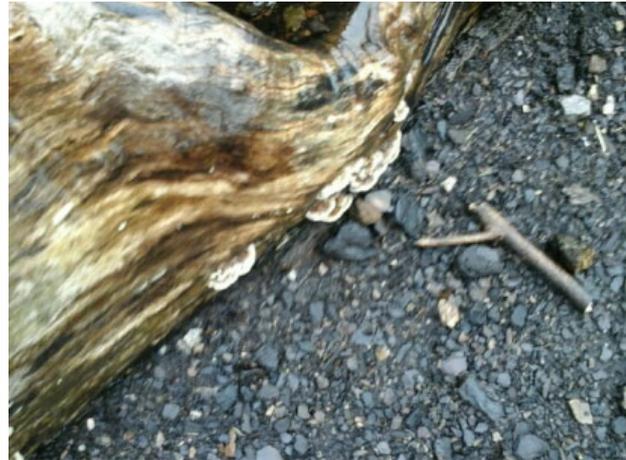
**Finding:** Fungus or algae was found on the logs

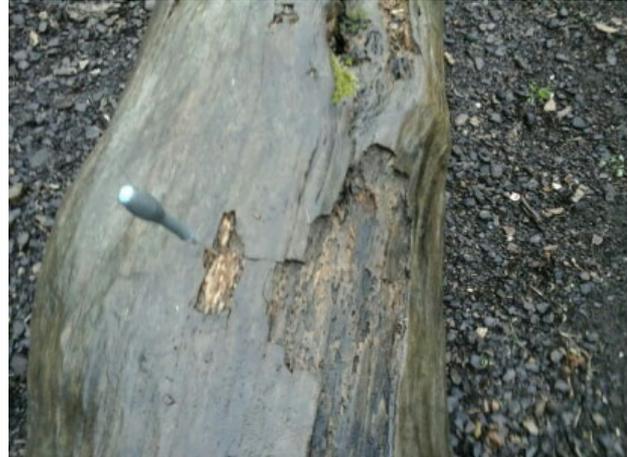
**Finding:** There is some evidence of rot in the timber

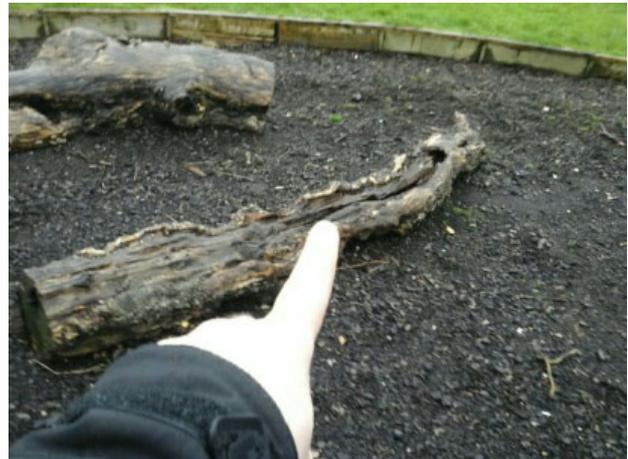
**Finding:** There are areas or parts of a log that have rotted extensively

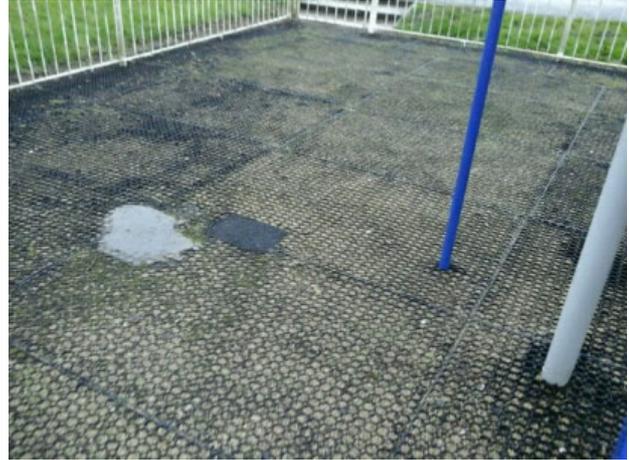
**Finding:** The resin patch repair to the surfacing forms a hard object within the impact area of the equipment in contravention of the requirements of BS EN 1176 Part 1

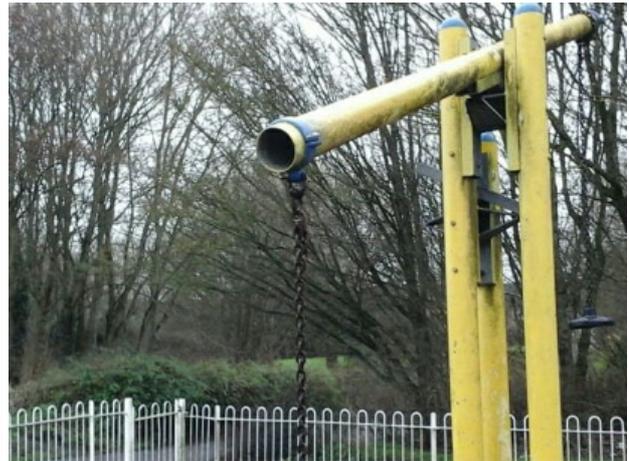
**Finding:** There are post caps missing from the item

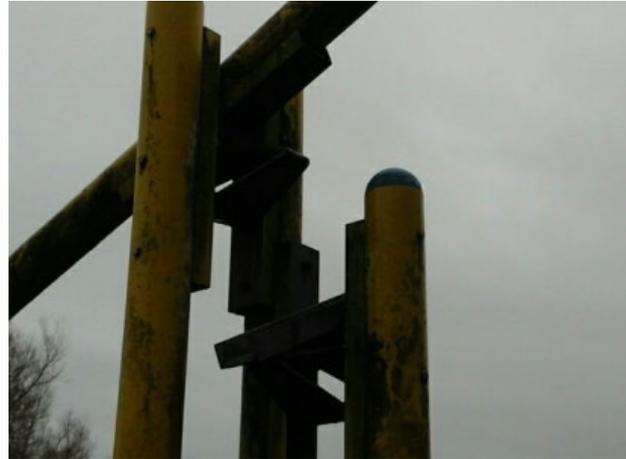
**Finding:** The rubber buffers are worn

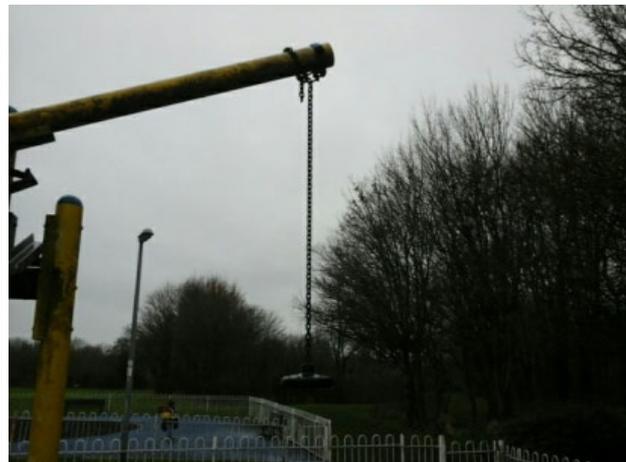
**Finding:** The chain on one seat was wrapped around the cross bar at the time of inspection and the inspector has been unable to fully assess their condition

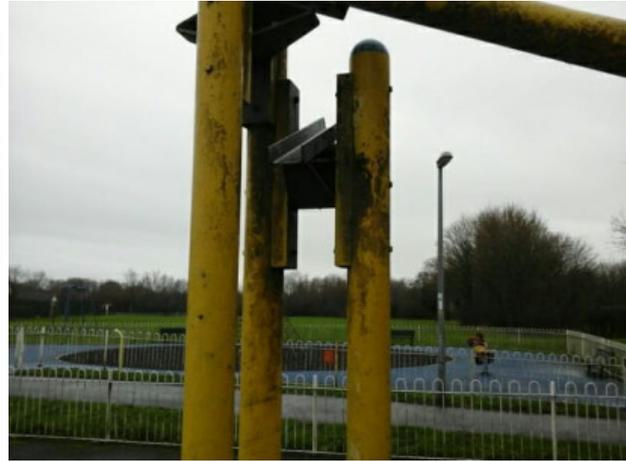
**Finding:** The item has missing component(s)

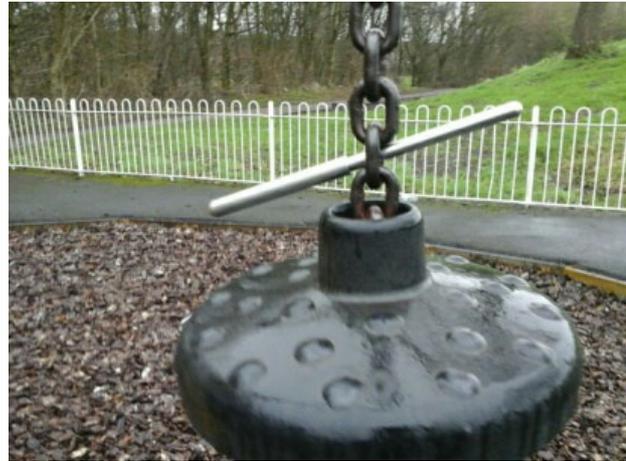
**Finding:** The chain openings are in excess of 8.6mm as recommended by BS EN 1176

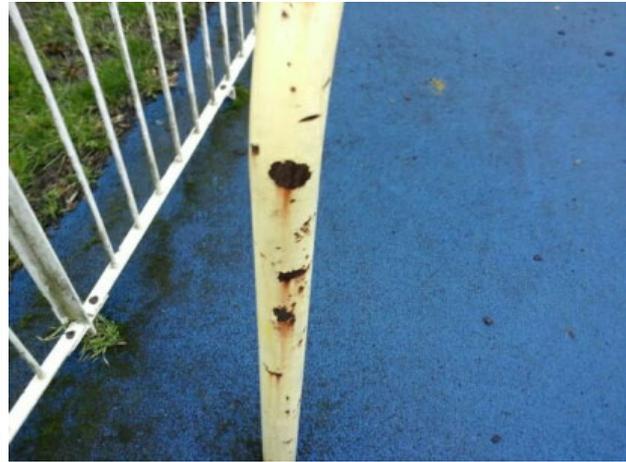
**Finding:** The paintwork on this item has been damaged or worn exposing the metal underneath which is rusting

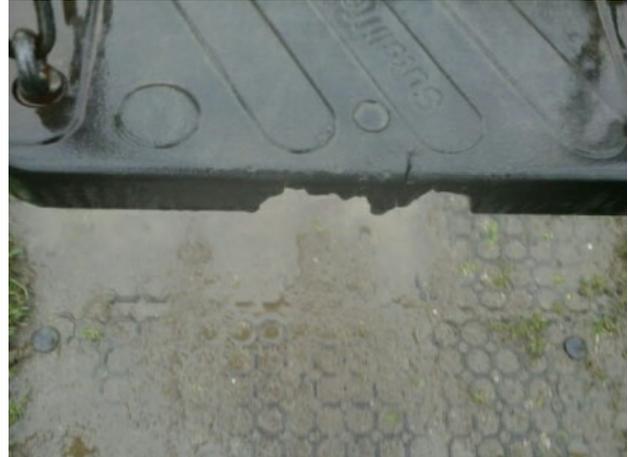
**Finding:** The seat is severely damaged and requires replacing

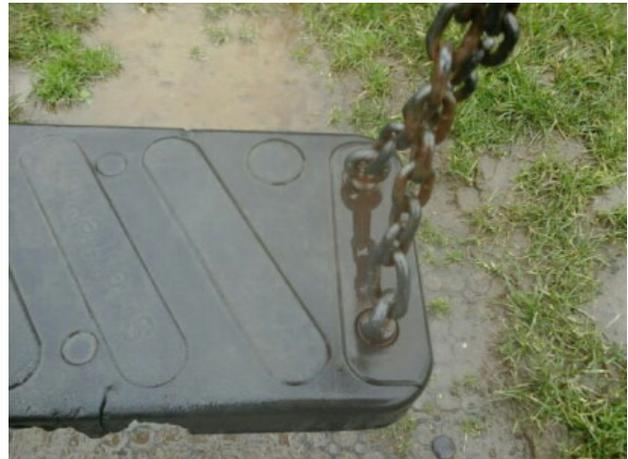
**Finding:** The swing seat connectors are loose

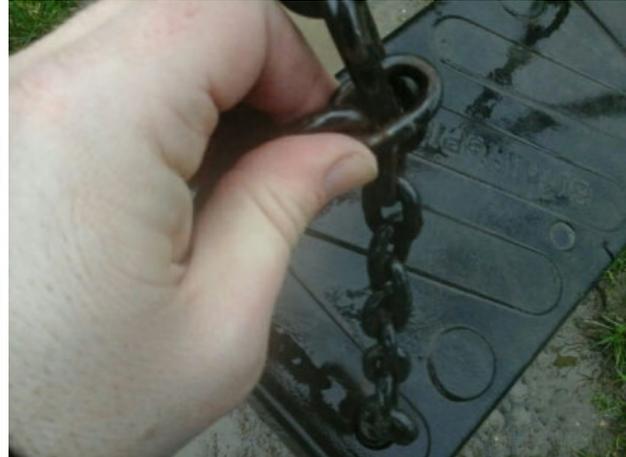
**Finding:** There is some chain wear

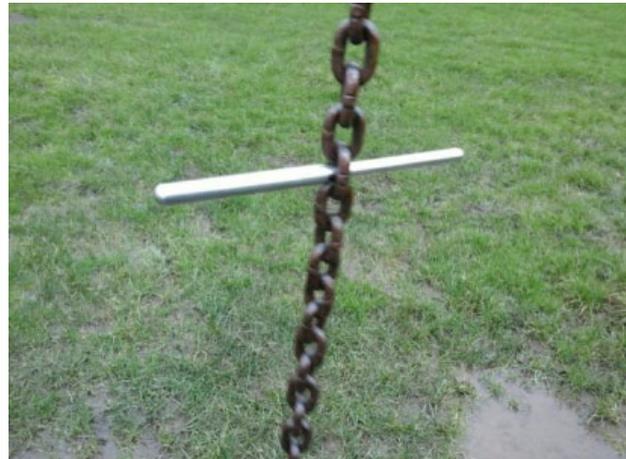
**Finding:** The chain openings are in excess of the 8.6mm as recommended by BS EN 1176

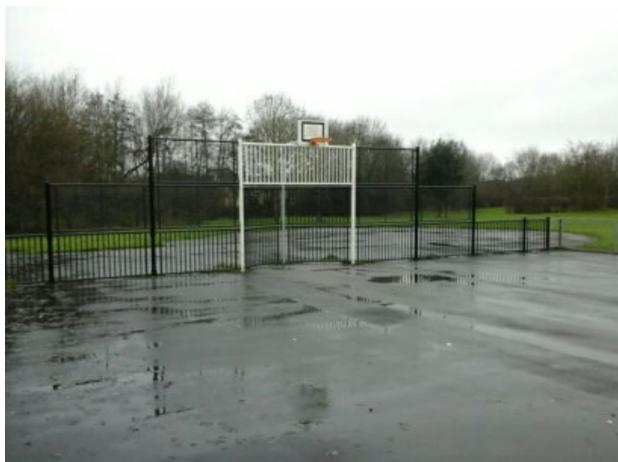
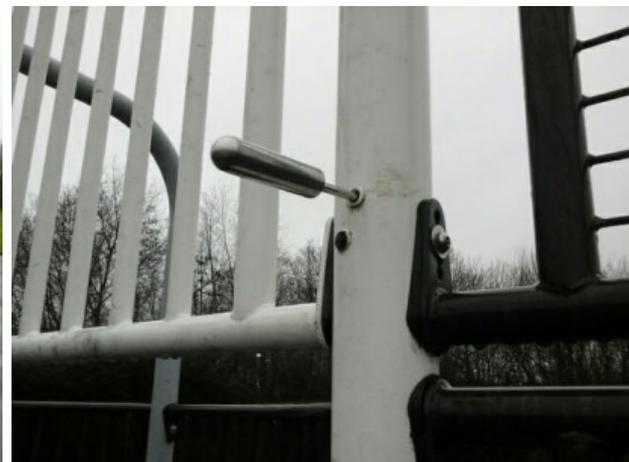
**Finding:** There is/are finger entrapments in the framework due to missing inserts and the item fails to meet the requirements of BS EN 15312 Clause 4.4.2.2 Entrapment of fingers

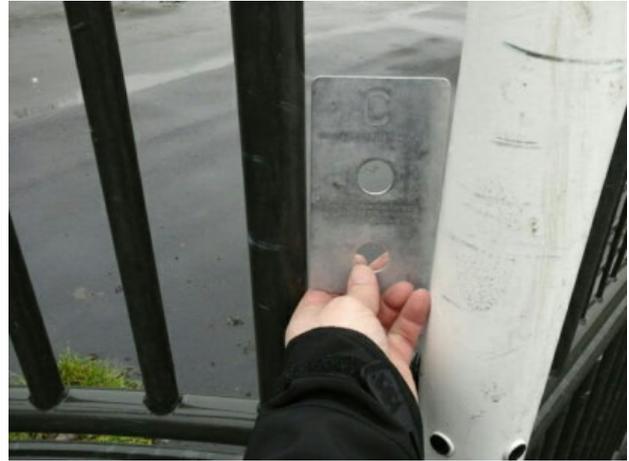
**Finding:** The item fails to meet the requirements of BS EN 15312 4.4.2.1 head and neck entrapment between the framework

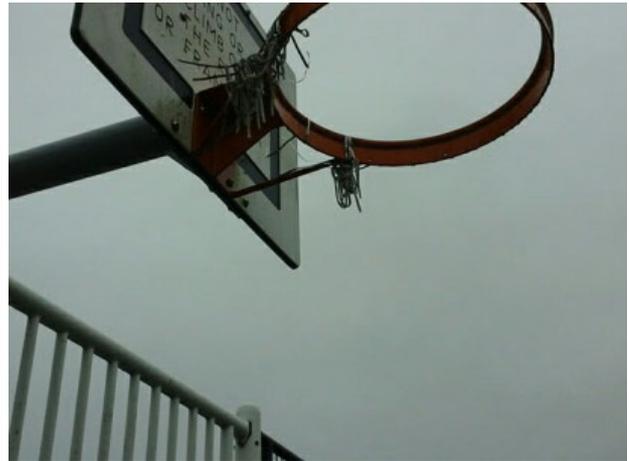
**Finding:** The nets are damaged

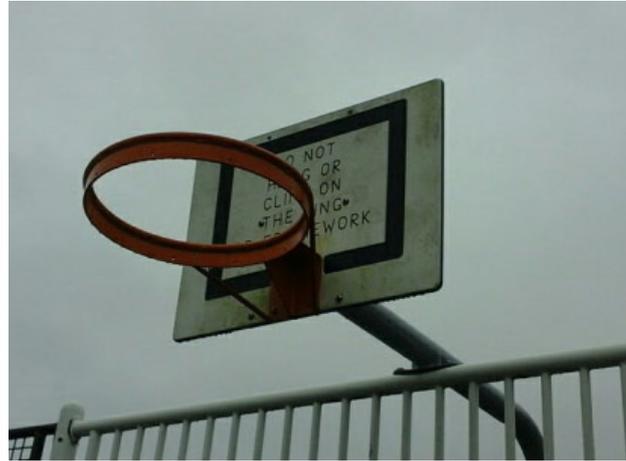
**Finding:** There is or are fixings missing on the item
