ASBESTOS MANAGEMENT SURVEY

GLOSSOP FIRE STATION

JUNE 2014

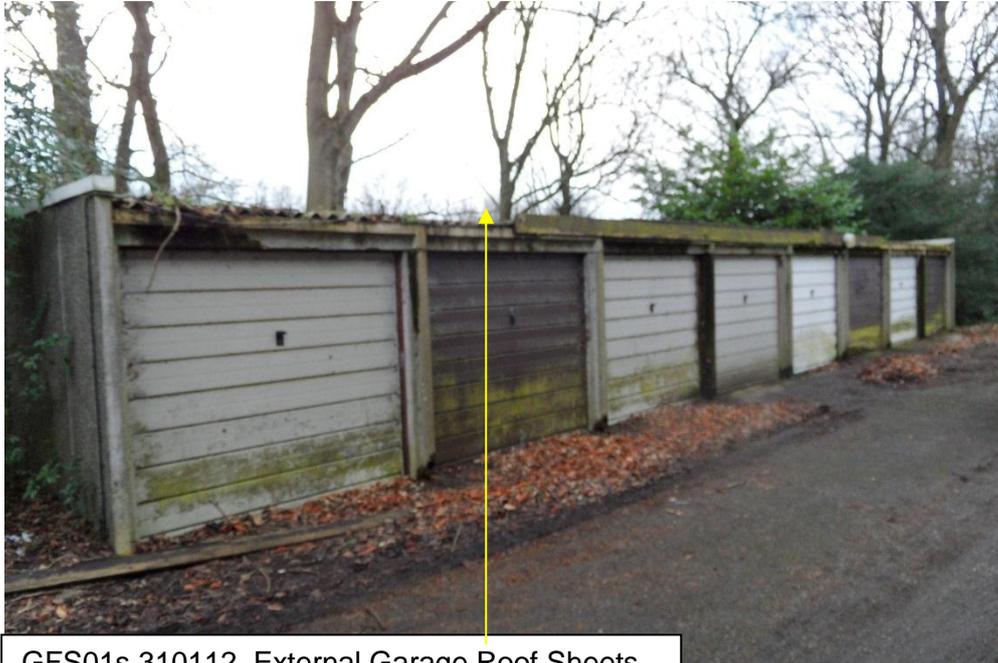
GFS01s 310112, External Garage Roof Sheets,
Asbestos Detected

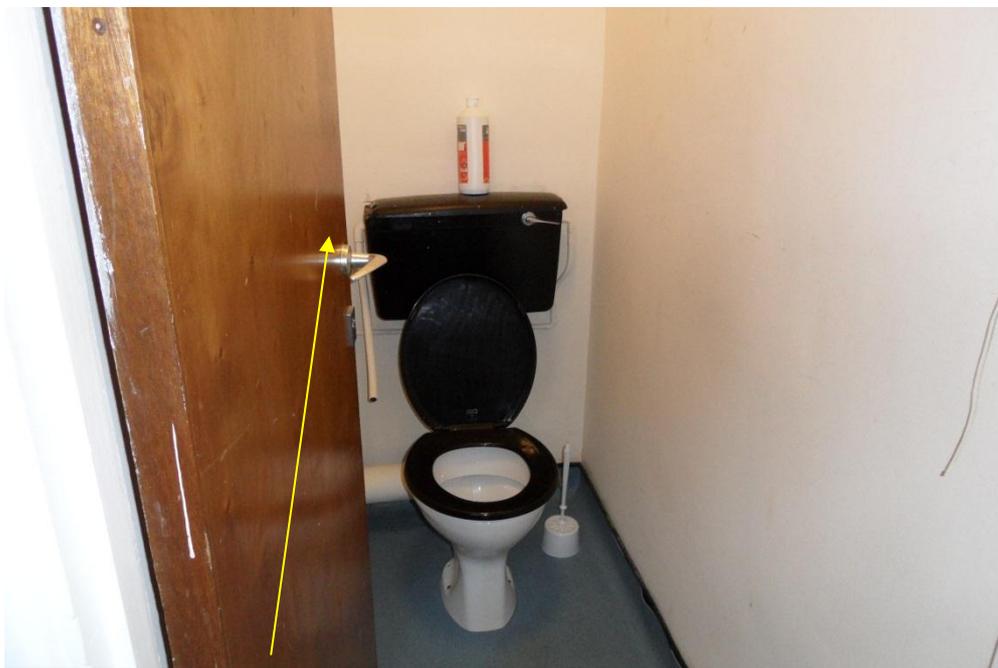
GFS02s 310112, First Floor Toilet Cistern
No Asbestos Detected

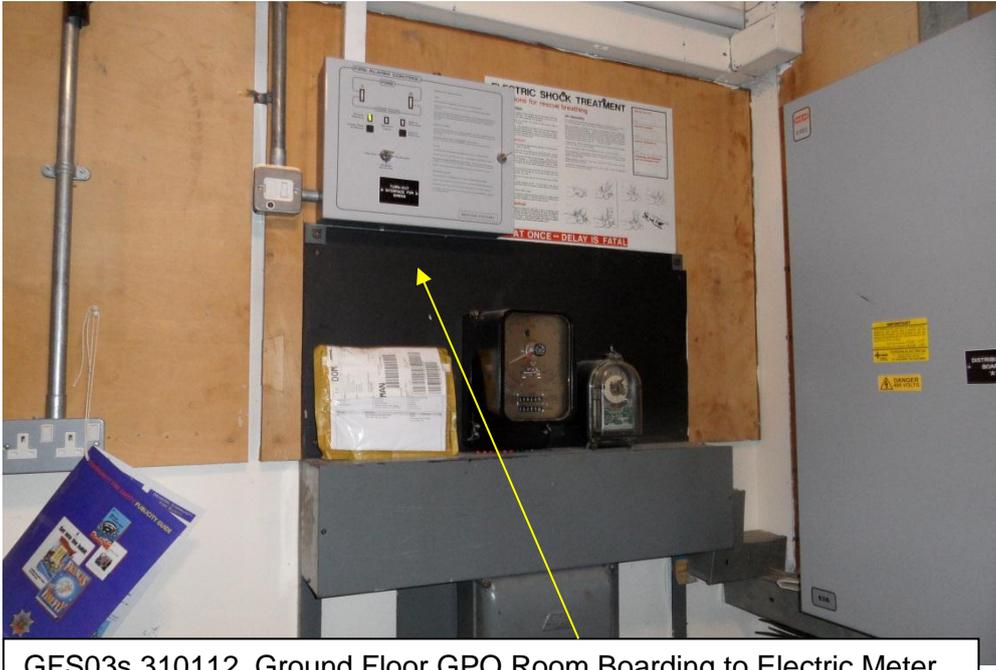
GFS03s 310112, Ground Floor GPO Room Boarding to Electric Meter
Asbestos Detected

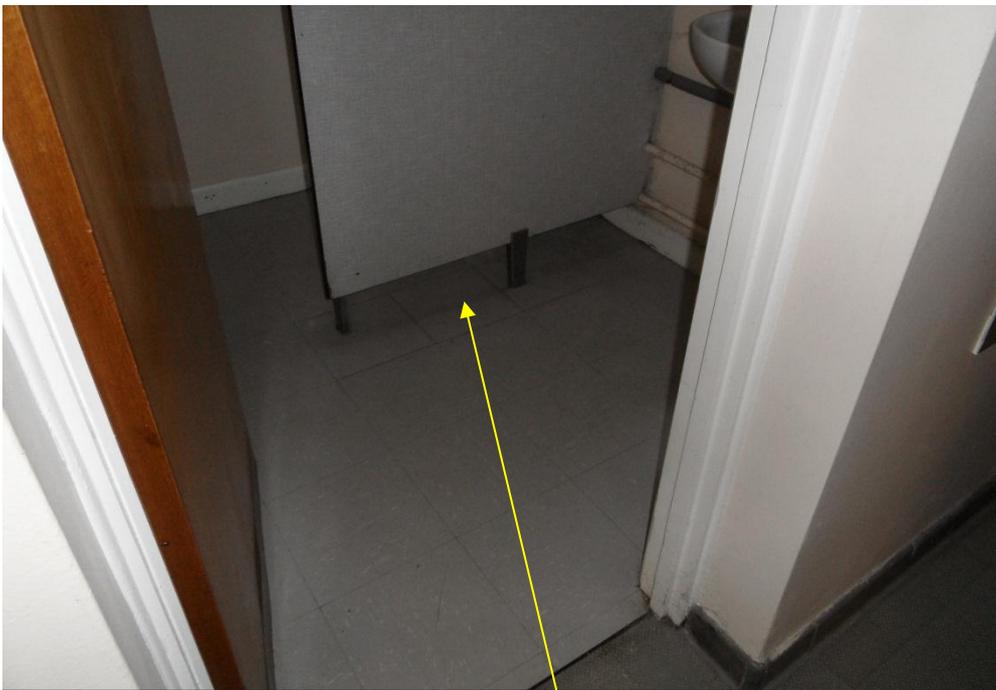
GFS04s 310112, Ground Floor Toilet Floor Tiles
No Asbestos Detected

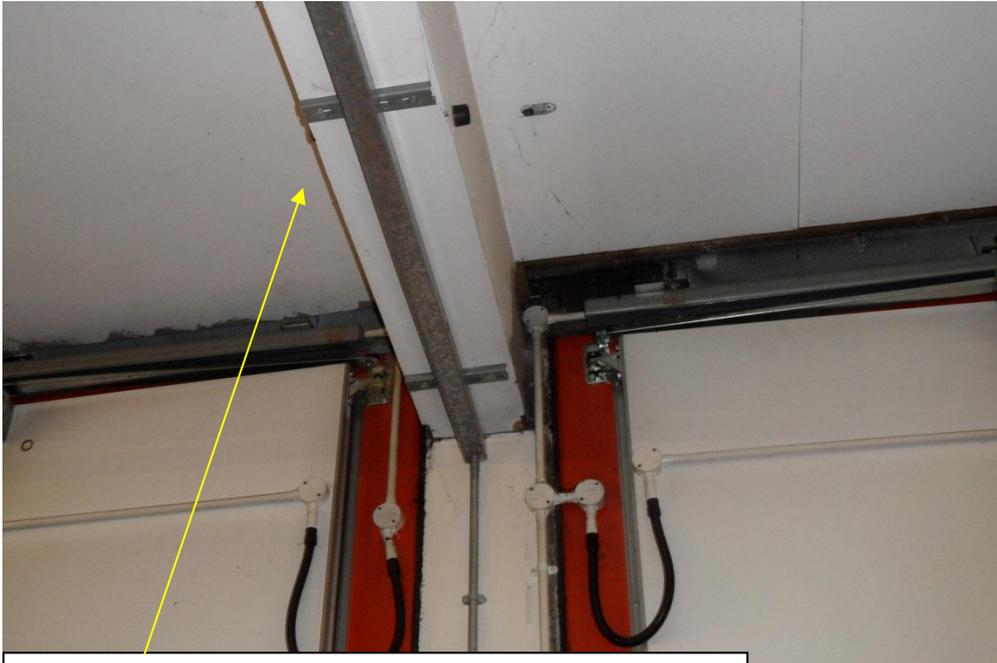
GFS05s 310112, Boarding to Beams (Appliance Bay)
No Asbestos Detected.

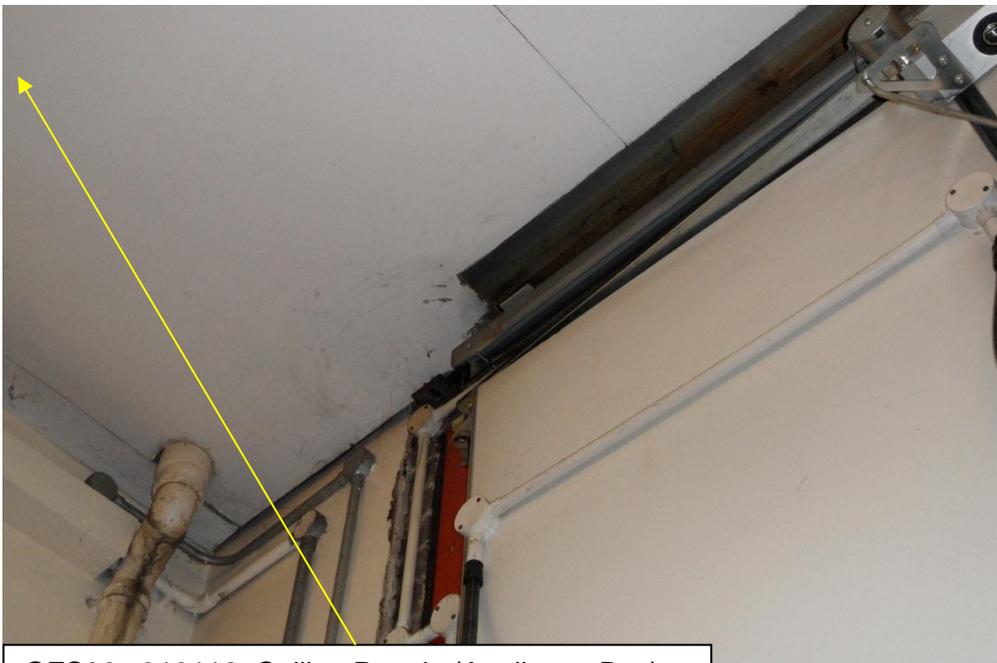
GFS06s 310112, Ceiling Panels (Appliance Bay)
No Asbestos Detected

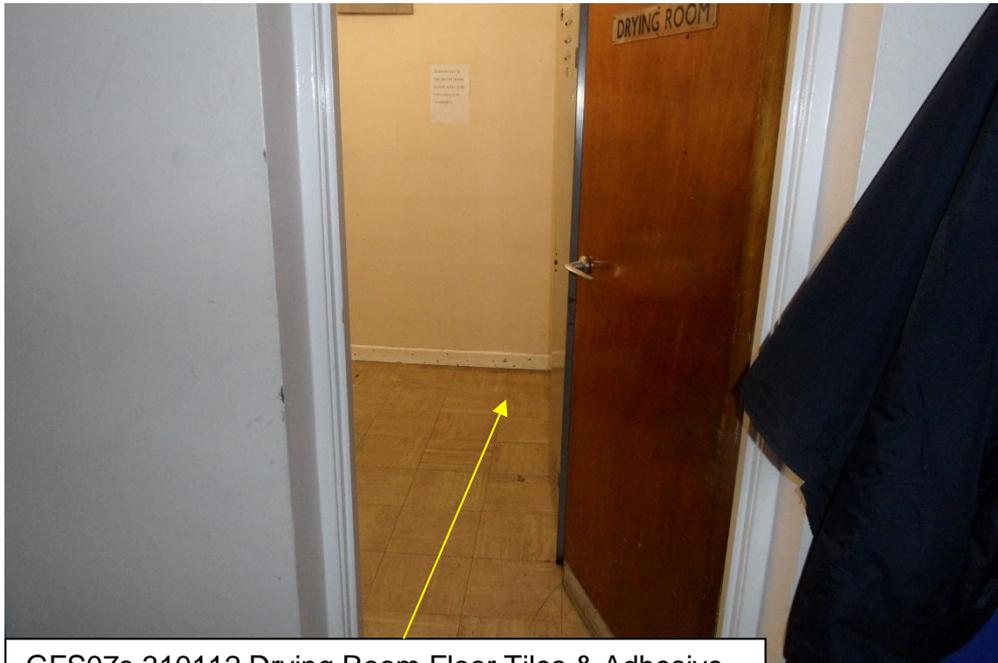
GFS07s 310112 Drying Room Floor Tiles & Adhesive
Asbestos Detected

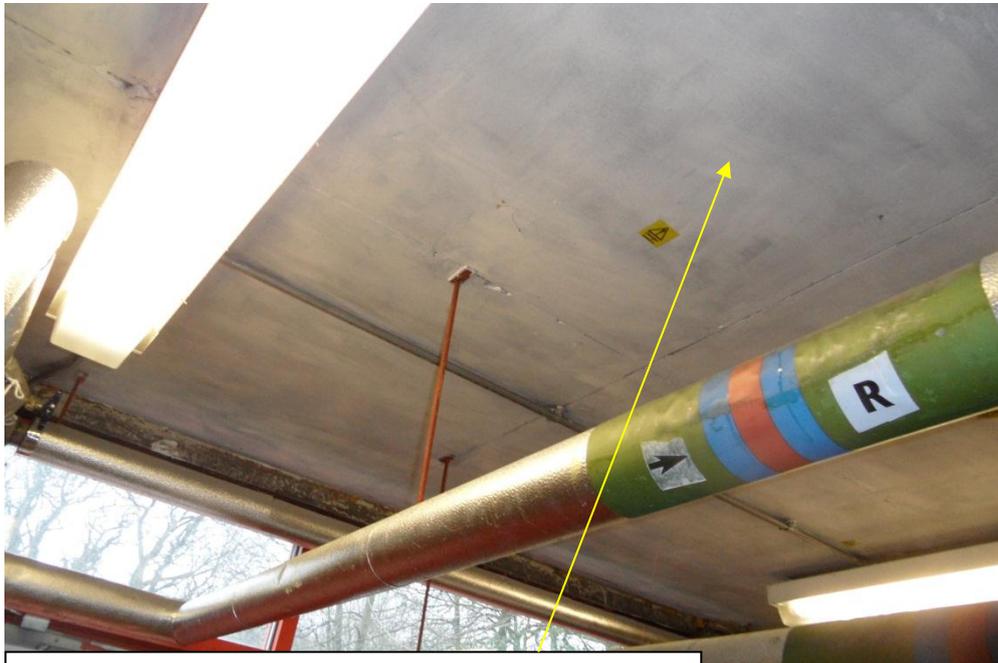
GFS08s 310112 Boiler Room Ceiling Panels
Asbestos Detected

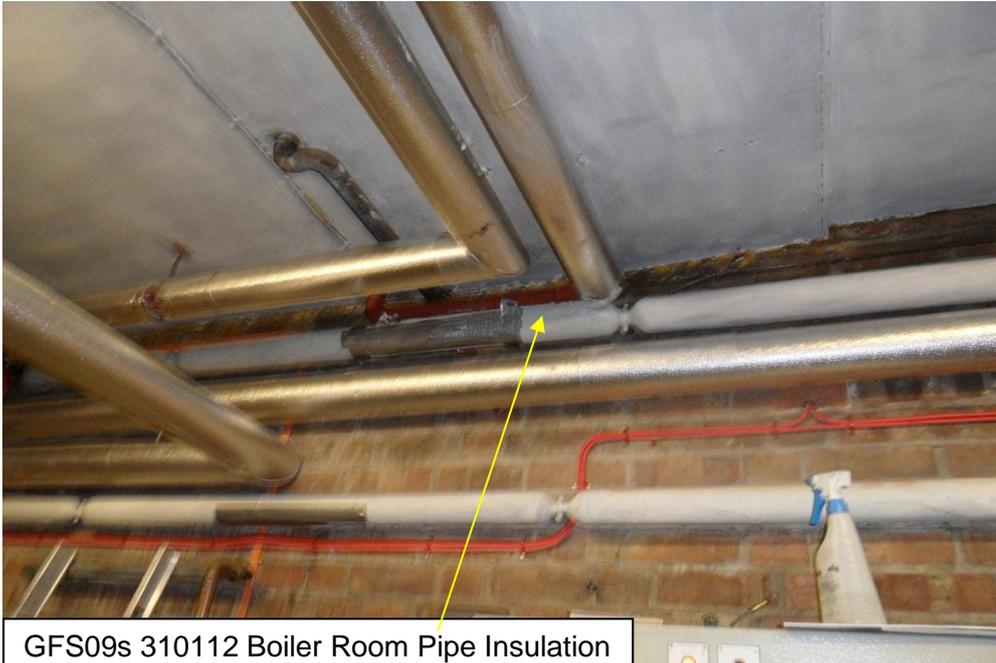
GFS09s 310112 Boiler Room Pipe Insulation
No Asbestos Detected

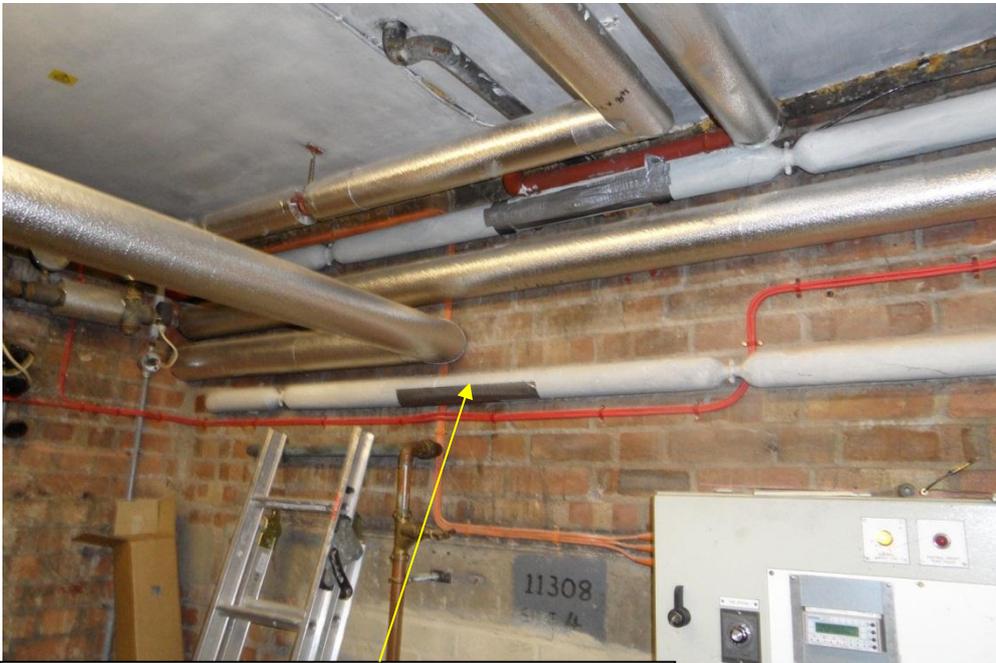
GFS10s 310112 Boiler Room Pipe Insulation
No Asbestos Detected

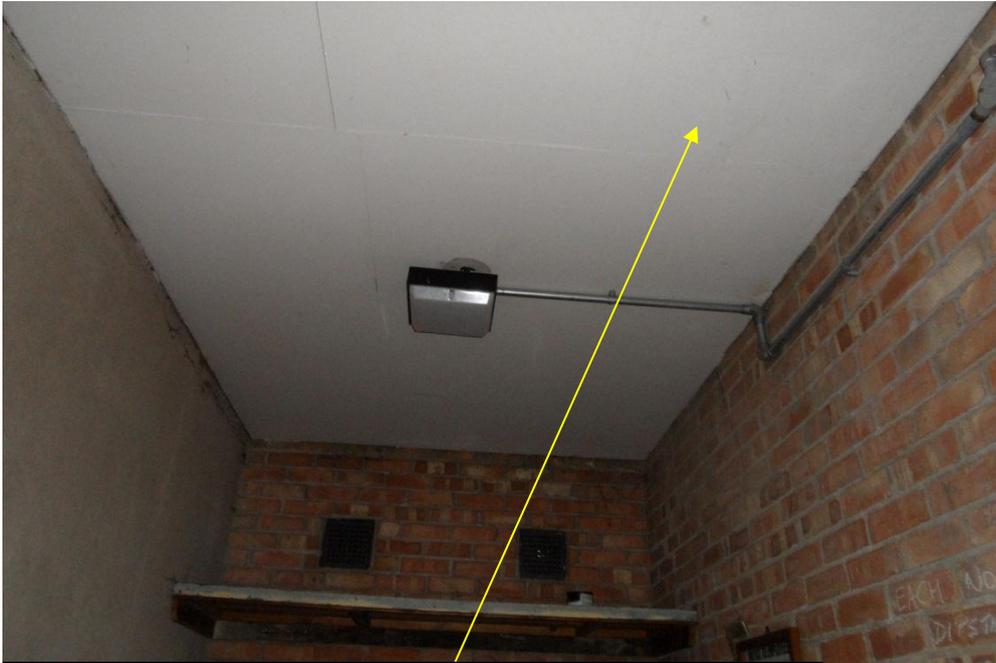
GFS11s 310112 Oil Store Ceiling Panels (Tower Block)
Asbestos Detected

GFS11s 310112	Ceiling	Board	Outbuilding Oil Store	Amosite (brown) Chrysotile (white)

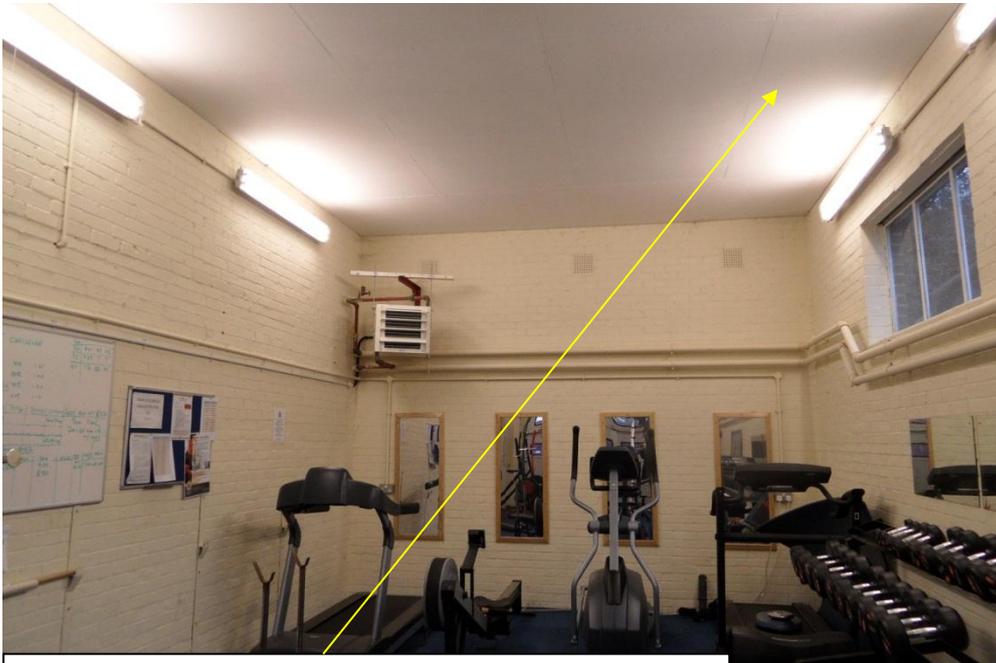
GFS12s 310112 Gym Ceiling Boards (Tower Block)
Asbestos Detected

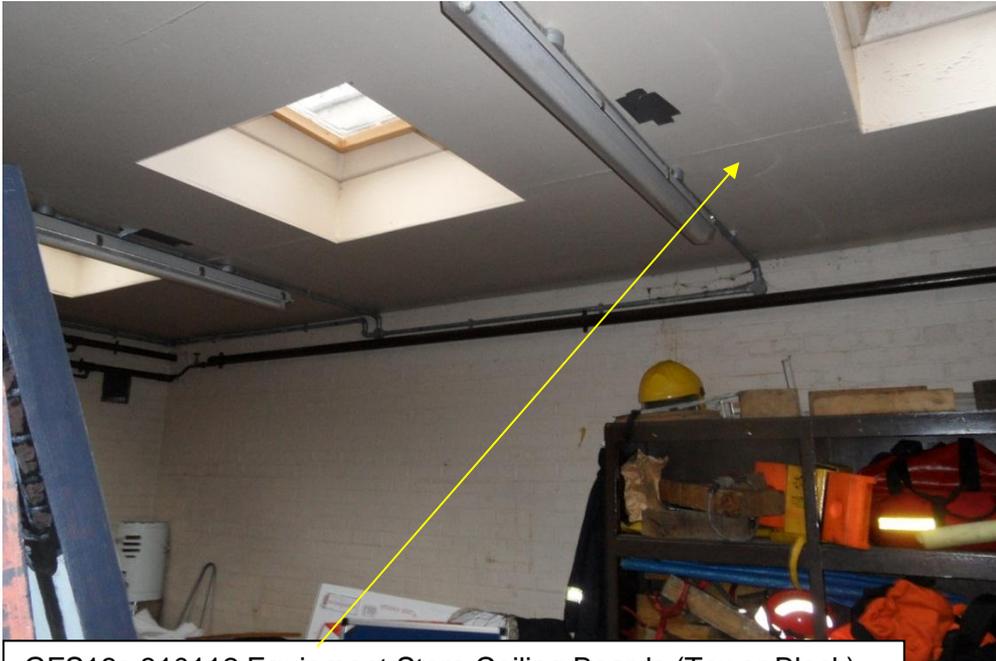
GFS13s 310112 Equipment Store Ceiling Boards (Tower Block)
Asbestos Detected

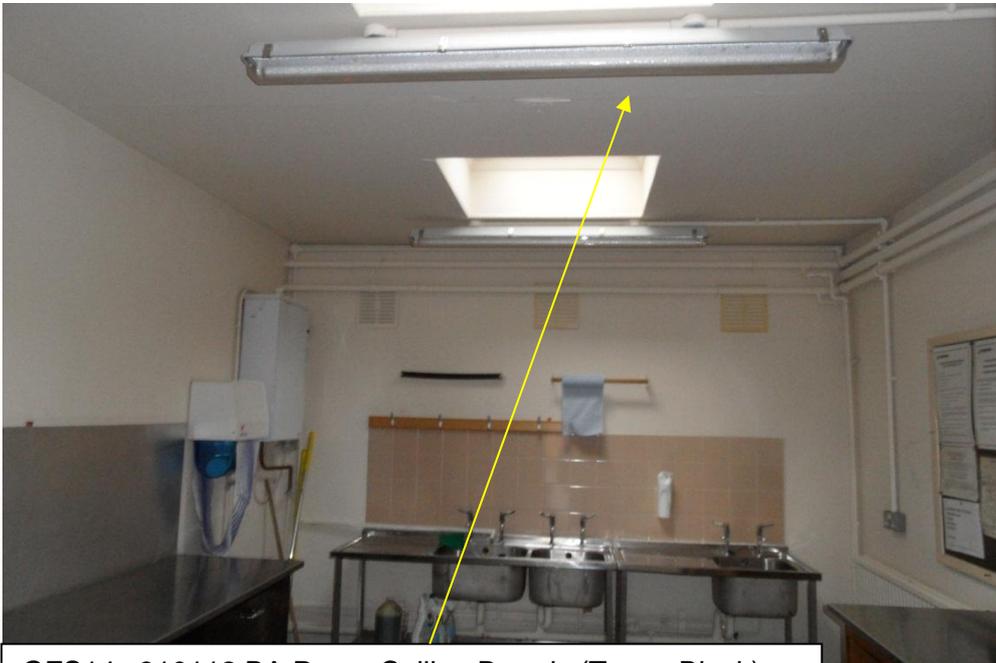
GFS14s 310112 BA Room Ceiling Boards (Tower Block)
Asbestos Detected
