# **RICHARD AYERS LTD**

## **MTB 71 MOTOR TORPEDO BOAT**

## **CONDITION SURVEY REPORT**

## **THE IMPERIAL WAR MUSEUM, DUXFORD**

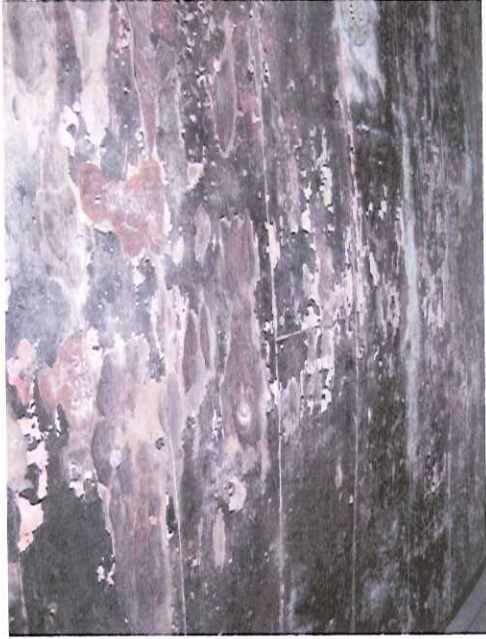
There are varying degrees of plank deterioration through the under body, but there are very few planks that have not been seriously degraded, with material missing between an 1/8" depth, to the full thickness of the planking (1/2"). The timber is in most placed de-lignified; lacking in strength and pliability.

Typical deterioration on underside planking

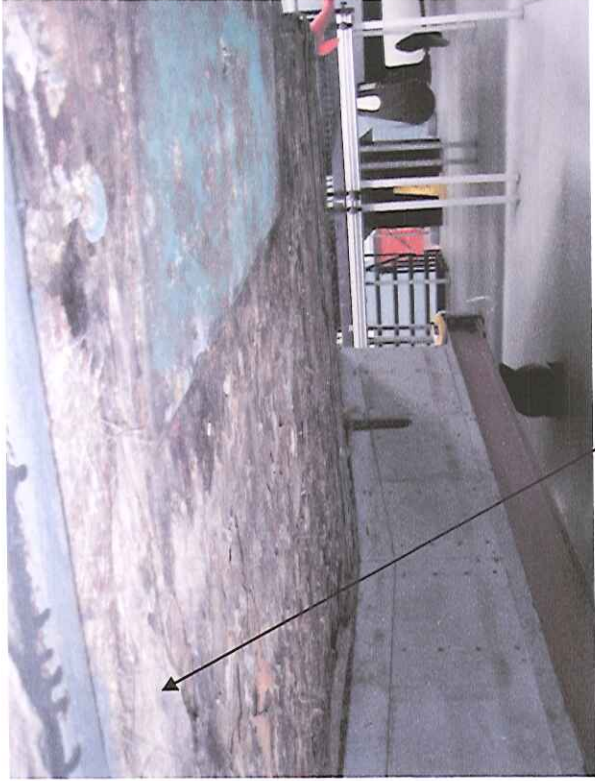
The below section of the hull was faired with hard filler at some stage and sheathed with a fairly heavy layup of glass fibre chopped strand matt bonded with polyester resin. There is little of this remaining and those sections still in place indicate that the level of bond between the filler and GRP with the original hull timber was poor.

Remnants of GRP sheathing

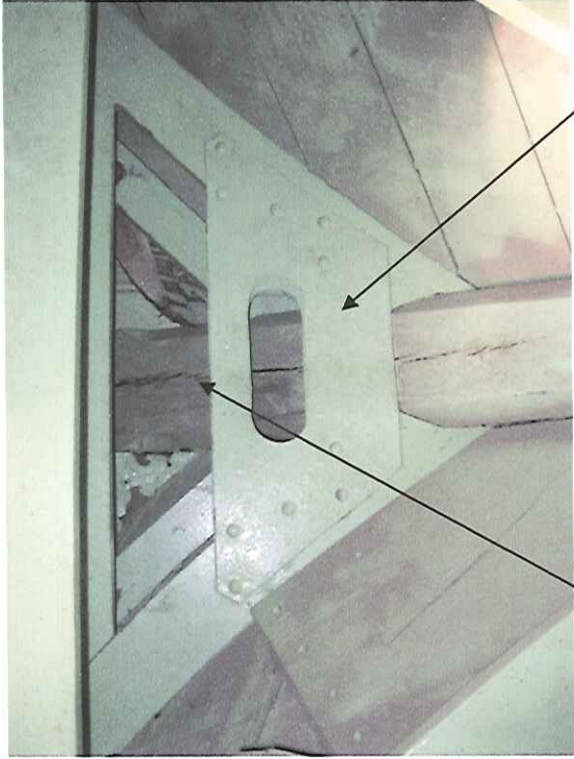
The inner stem is split from the top down, approximately 3' 6", with minor local decay. There are thin original design steel-plate floors on 1, 2 and 3 frames.

Crack inside stem

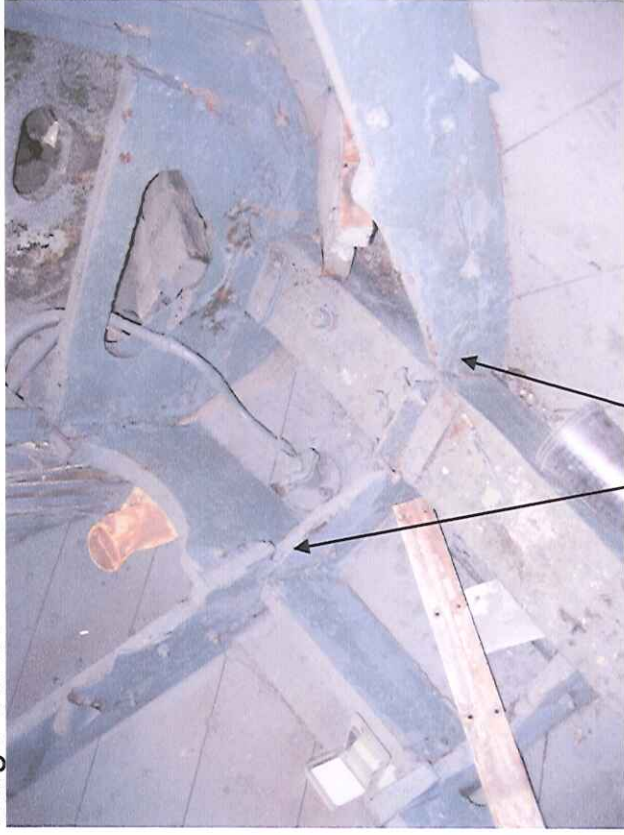
*Note*, the metal plate floors through this section extended approximately 2' up the hull sides, either side of the centreline and that there is considerable deterioration and decay, on the frames through the centreline areas and at the majority of positions where the floor and chine knee fastenings were positioned. The majority of the hanging knees at the deck beam to frame connection remain in position and material around these has not deteriorated badly.

Typical deterioration of frame bottoms with structural floor missing

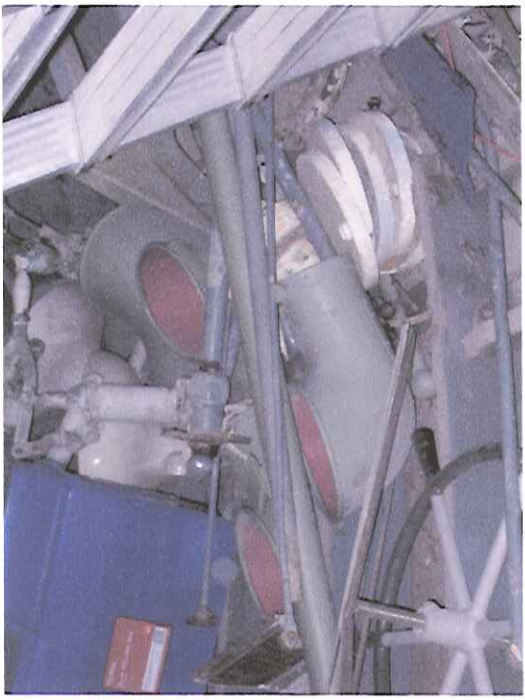
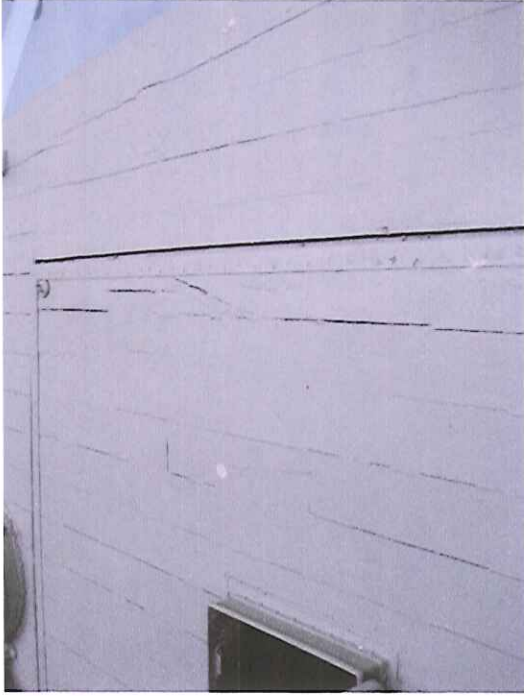
All of these soft patches show signs of deterioration and there has been some repair and replacement of planking on all of them.

Multiple repairs in aft deck removable hatches
