ASBESTOS REFURBISHMENT SURVEY REPORT
FOR
SWANAGE TOURIST INFORMATION CENTRE
AUGUST 2016

Address:	Swanage Tourist Information Centre, Shore Road, Swanage, Dorset
Property Description	
A detached stone build two storey historic building. Stone roof slabs/slates. Modern building materials within. (Suspected historic refurbishments over the years from original construction)	
Block A:	Tourist Information Centre

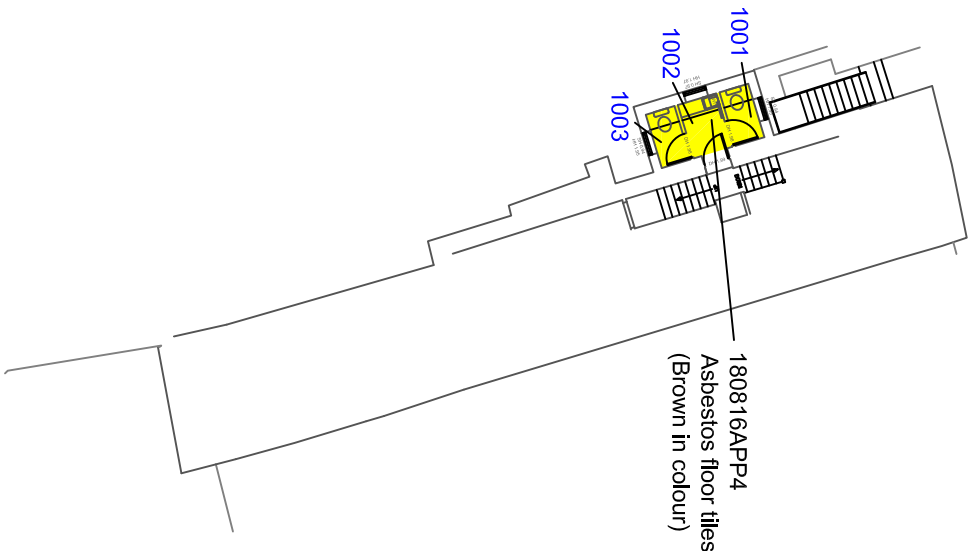
MEZZANINE FLOOR

Block Name	Asbestos Materials	High Risk items
Block A	Floor tiles within first/mezzanine Wc's and kitchenette	None detected
Non asbestos Items noted during the survey (to assist in management i.e. not to be confused with ACM's)		
Block A	<ul style="list-style-type: none"> ▪ Man made mineral fibre (glass fibre) insulation above ceilings/attic ▪ Plasterboard wall panels/partitions between rooms and cupboards ▪ Wooden windowsills/cupboard installations ▪ Modern floor coverings including carpets ▪ Artex coatings are negative for asbestos content including all past samples taken ▪ Modern sanitary ware ▪ Modern bitumen roof felt area (sampled negative) ▪ Roof slates/slabs are natural stone (with some wooden replacement slates)

1	If the areas of asbestos floor tiles within WC's/kitchenette are disturbed then these will need to be removed and disposed as contaminated waste. Furthermore, although unlikely at this property care should be taken on removal of door architrave or random concealed asbestos materials. All suspected material not highlighted in this report should be reported and investigated before recommencing.
---	---
