# Kennington Park Skatebowl London, SE11 4BE

Structural Engineering Development Outlines Report

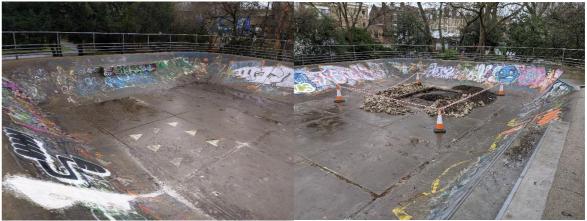
Figure 2 - Left: Southern end of skatepark Right: Northern end of skatebowl with Trial pit at broken out flat panel location In both cases trees visible in Foreground

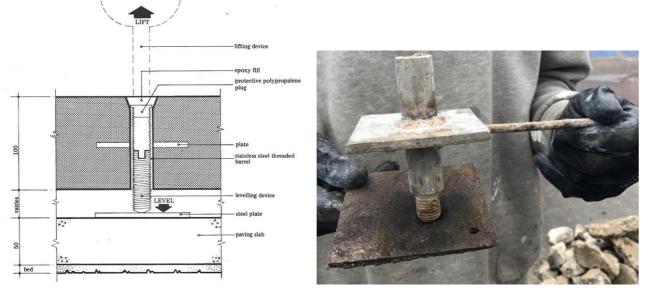
Of note is that the system uses a levelling device for the support of all units (Figure 4 – Left: Levelling device detail from Radical Banking catalogue). These are embedded plates cast-in with a stainless-steel threaded barrel bolt. This threaded bolt bears onto a steel plate which then sits on top of the proposed foundation (in the case of the catalogue a 'paving slab'). This acts as both the fixing for any lifting eyes during construction and as the levelling device on the bearing pad.

Figure 4 – Left: Levelling device detail from Radical Banking catalogue Right: Levelling device broken out from removed flat panel unit

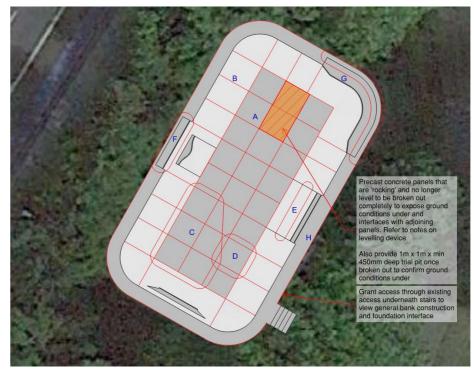
The site was visited on 16<sup>th</sup> February to view opening-up works and a trial pit dug by contractors on behalf of Lambeth Council. The purpose was to expose a typical foundation junction between a flat section with the banked units, the general high-level geology of the site and to visually assess the current condition of the skatepark. The units identified to be removed were the rocking flat panel units at the Northern end of the skatepark (Figure 6).

Figure 6 - Excerpt from P&M investigations mark-up outlining removed panel units

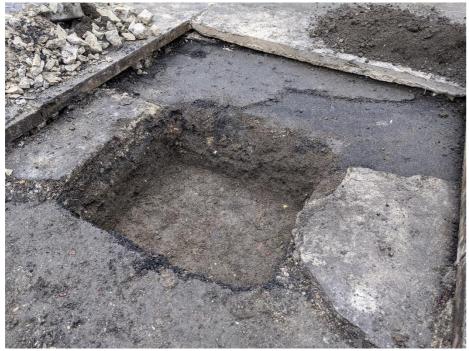
It was found that the typical foundation for the units was that of a nominal mass concrete pad varying in thickness from 20-75mm (Figure 7). Each pad was sized such that the meeting corners of four units sat directly on top via the levelling device in Figure 4. The trial pit found that the concrete bases were sat either directly on topsoil or the tarmac from the previous tennis courts. Below this Clay was found, with some parts appearing to be Made Ground (notable brick rubble, Figure 8). Site findings are detailed in Appendix A.

Figure 7 - Exposed trial pit and slab junction at northern end of skatepark. Existing tarmac on topsoil visible at top of picture with nominal mass concrete pads in foreground

Given the shallow skatebowl foundations it is understandable that the construction has seen considerable movement over the last 43 years. The differential movement of the precast units is likely caused by the seasonal water demand of the trees surrounding the skatepark combined with the high shrinkability of the clay strata. Similarly, the shallow mass concrete pads being part cast on historic tarmac and part on

topsoil would have had an effect, particularly given that this is above the 450mm zone that is susceptible to frost-heave in winter months.

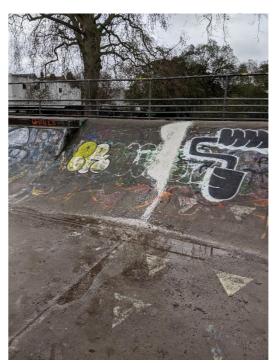
Typical best practice would have seen the skatepark founded on footings that are not susceptible to significant ground movement. If these were traditional mass concrete strip or pad footings NHBC 'Building Near Trees' guidance would put the foundations at a required depth of minimum 1.5 meters below ground level. Alternatively, a piled solution could also have been adopted. This is not to say that ground movement could have been completely avoided, though a deeper foundation solution when first built would have significantly limited the differential movement of the individual precast units and likely left the bowl skateable. Therefore, it is also understandable that the works in 2012 to refurbish the skateparks were hastily executed. Rather than address the engineering challenge of re-levelling the skatepark an unreinforced concrete skim was applied to temporarily mask this. Eventually the top surface cracked with seasonal movement, mirroring the seams between precast units and continuing to spall further to bring the park to its unusable state.

Figure 9 - Typical mirror crack in 2012 Concrete skim over top of units (white material is a DIY infill from local skateboarders)

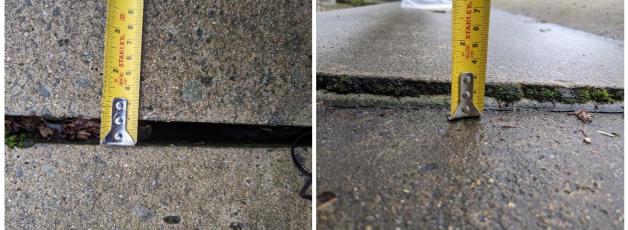
Measurements were taken along the top standing deck of the skatebowl, specifically looking at the gaps to the top of the banked units. This was to ascertain the approximate magnitude of deviation between units, both vertically and horizontally. If it is assumed that all panels were installed to the 3mm gap that the original radical banking catalogue denotes, then this can serve as a benchmark for the current deviation. Appendix B contains a log of the horizontal and vertical deviation between panels. Ultimately the vertical gap averaged around 5mm, however the Northwestern corner of the park showed the most significant movement ranging from 10-20mm vertically (Figure 12). The horizontal deviation was noted to be of a similar magnitude. In some areas the gasket strip appeared to have either fallen out, been removed with wear, or in some cases compressed and squeezed out (Figure 11). It however appeared that these strips

may not be of the original construction and possibly applied as part of the 2012 works. Due to the concrete skim over the main skateboarding surface, no measurements were able to be taken for the flat-bottom section. Therefore, this information should be taken as a window into the anticipated movement and any future works should seek to expose the precast construction to ascertain the full extent of movement.

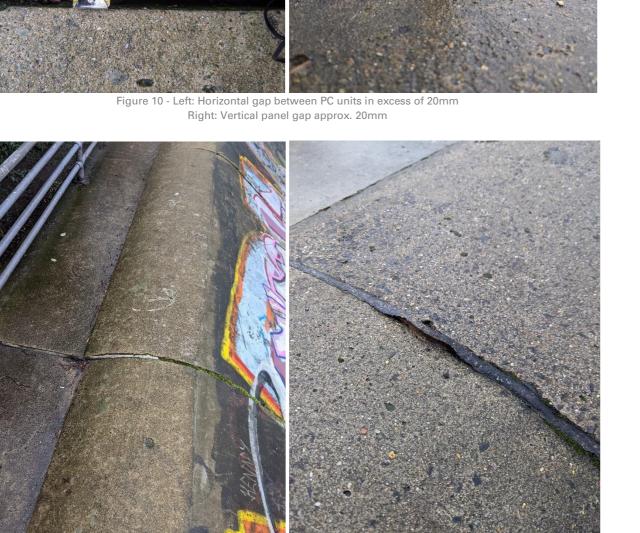
Figure 11 - Areas of gasket strips between units. Left: Partially removed sections with moss growth in between Right: compressed strips bulging out

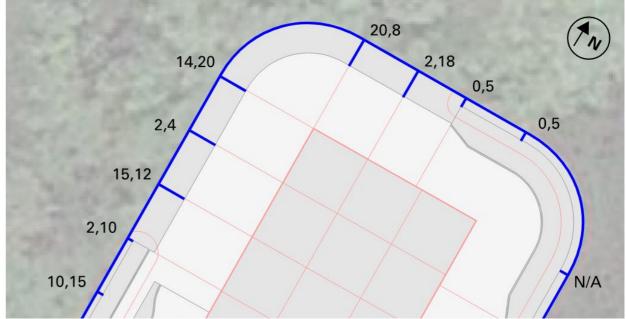
Figure 12 – North Western corner showing significant panel movement. Refer to Appendix B for further information

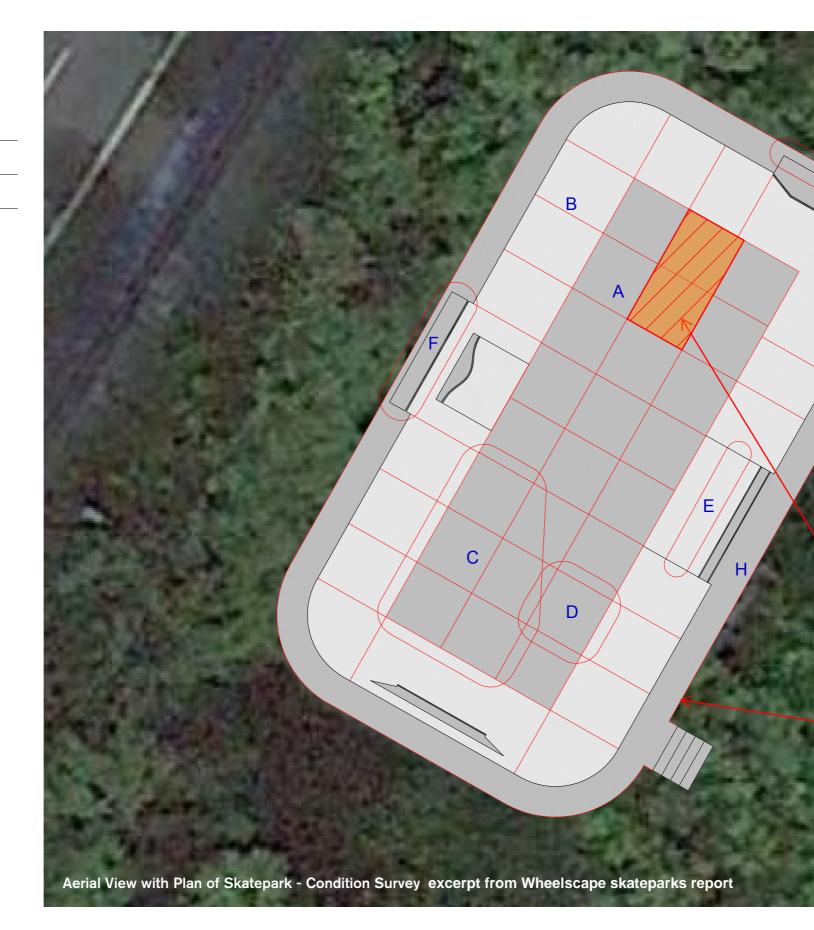
Job No.	29471	Page	SK 100	Rev 1	
Date	04/02/21	Eng	BB	Chd	
Job	Kennington	Skate	epark

Precast concrete panels that are 'rocking' and no longer level to be broken out completely to expose ground conditions under and interfaces with adjoining panels. Refer to notes on levelling device

Care to be taken no to affect anticipated leveling device at boundaries of precast panel units that support adjoining panels.

Also provide 1m x 1m x min 450mm deep trial pit once broken out to confirm ground conditions under

Grant access through existing access underneath stairs to view general bank construction and foundation interface

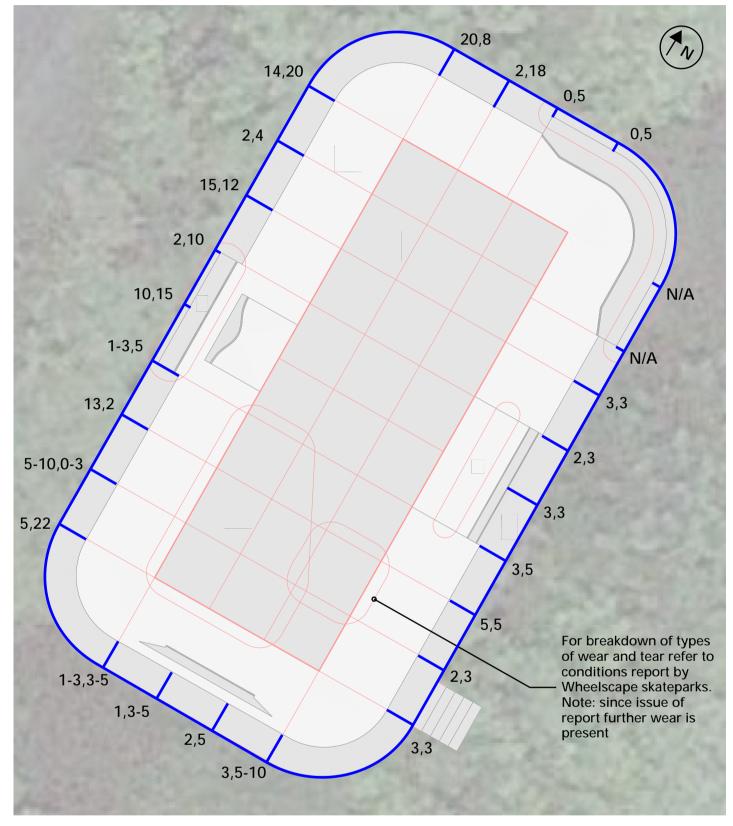
The deviations in seams between banked units were measured approximately at top junctions only at the top standing platform of the skatebowl. These are magnitude values of typical variation and should not be taken as detailed survey values.

Aerial view of Skatebowl showing movement / unit deviation among top standing area
