**PROFESSIONAL STRUCTURAL CONDITION ASSESSMENT -
(STRUCT – PROF)**

THE TUNNEL UNDER MRCC DOVER

LANGDON BATTERY, DOVER

OCTOBER 2015

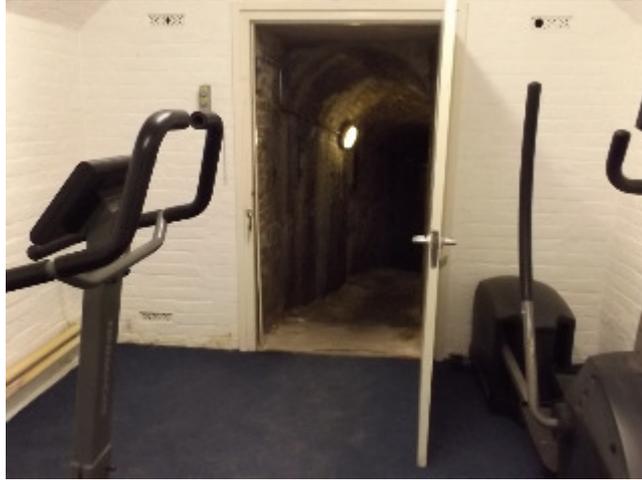
Photograph 1 – Entrance Door to Tunnel

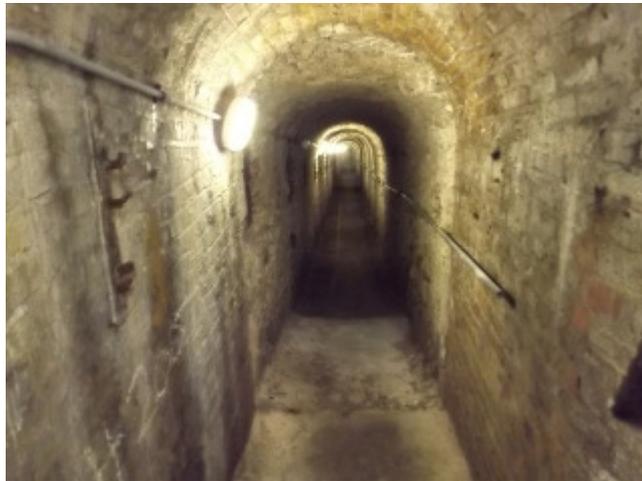
Photograph 2 – View of Tunnel length from Approach

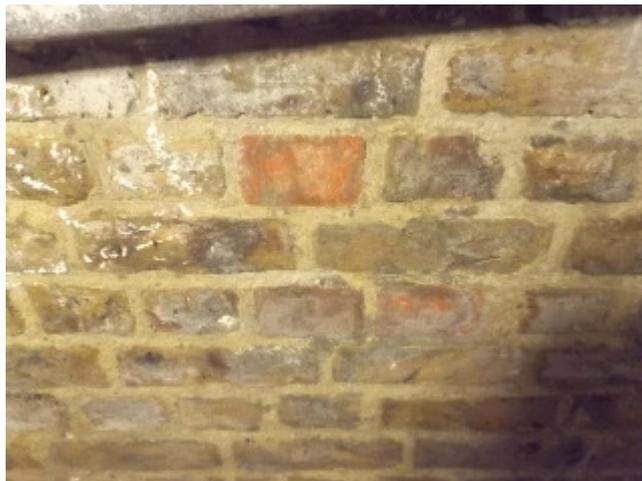
- 3.2 The brickwork side walls are of English bond and constructed with clay bricks and lime mortar pointing to the joints. The side walls are generally in satisfactory condition with no evidence of significant cracking or movement.
- 3.3 The barrel has been constructed in stretcher bond and pointed with sand and cement. The joints of the barrel are saturated with calcite deposits evident which imply that the water ingress has been occurring over a long period. The brickwork of the barrel remains stable.
- 3.4 The lighting conduit is corroding at the interface with the wall.

Photograph 3 – Brickwork with Lime Mortar Pointing

- 3.5 The sand and cement pointing to the joints of the barrel appear to be replacement mortar which was presumably placed to prevent the water ingress however this would not be effective and will contribute to the degradation of the brick arrises over time. The pointing should be replaced with a lime based mix which will not prevent water ingress but will assist with preferential evaporation through the joints and reduce the degradation of the brickwork.
This work should be undertaken within 2 years of the date of this report at an estimated cost of £1,500.00 excluding V.A.T.

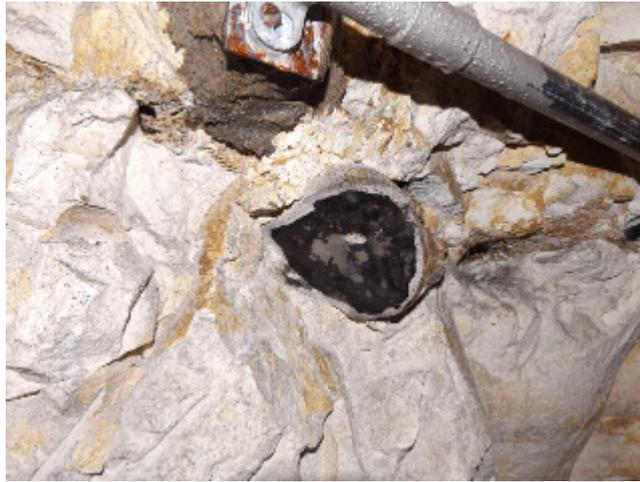
- 3.6 The tunnel face is of exposed chalk with layers of flint which appears to contain high levels of iron that is evident by its colour. The tooling marks are also evident in the chalk at some locations.
- 3.7 The surface of the chalk is stable but loose in some locations of the formed barrel, which is evident by the small fallen fragments of chalk.
- 3.8 There are embedded steel or iron support plates and conduit clips that have been mortared in position which are corroding but appear to have no impact on the surface condition of the chalk tunnel.

Photograph 4 – Chalk with Flint

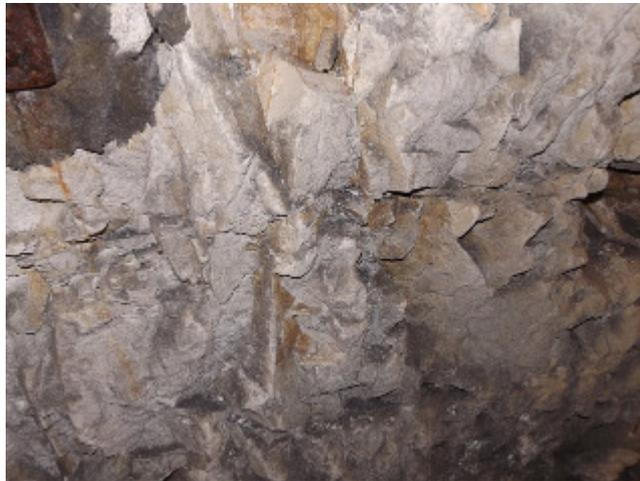
Photograph 5 – Tool Marks In Chalk

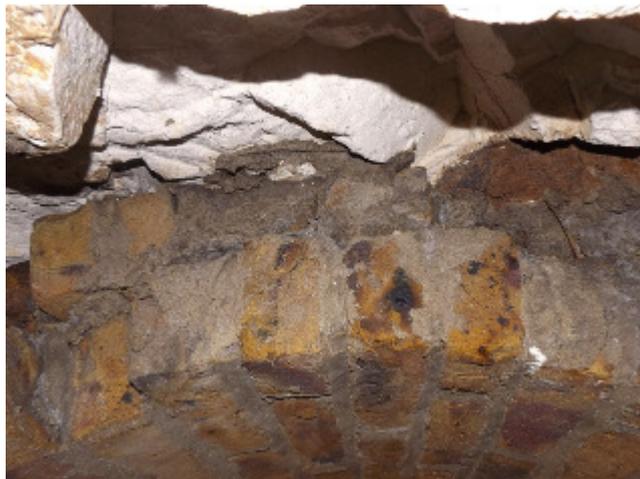
- 2.7 There are two intermediate sections of brickwork lining along the length of the tunnel which are of similar construction as the approach however these appear to have been constructed around the late 1930's with sand and cement mortar and pointing and have been referenced Lining Section 1 and Lining Section 2 for the purposes of this report. There is one lining section at 17,000mm which is 6,000mm long and a further lining section at 38,000mm which is 20,000mm long and are assumed to have been constructed to provide safe and stable areas under what may have been fissured or weak layers of chalk. The remaining lengths of the tunnel between are of exposed chalk and flint layers.

Photograph 6 – 2 Ring Arch Construction Forming Intermediate Brick lining Sections

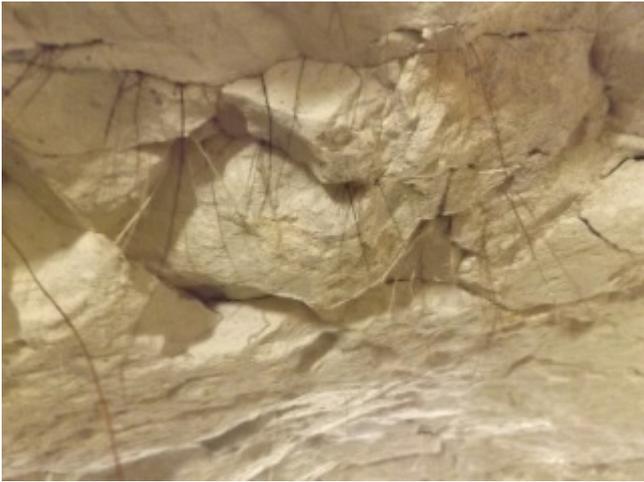
- 3.12 The tunnel face is of exposed chalk with layers of flint and the tooling marks are also evident in the chalk at some locations.
- 3.13 The surface of the chalk is stable but loose in some locations of the formed barrel, which is evident by the small fallen fragments of chalk. There are also roots from vegetation above which are penetrating the barrel and should be treated to prevent further detachment of the chalk
- 3.14 There are embedded conduit clips that have been mortared in position which are corroding but appear to have no impact on the surface condition of the chalk tunnel.

Photograph 7 – Roots from Vegetation Above Growing Though Barrel of Chalk

- 3.15 The surface of the chalk barrel should be carefully and lightly de-scaled to remove all loose and detached chalk. The vegetation over should be treated to prevent further root growth.
This work should be undertaken within 1 year of the date of this report and supervised by a Chartered Professional Engineer or Geologist at an estimated cost of £2,500.00 to £3,500.00 excluding V.A.T.

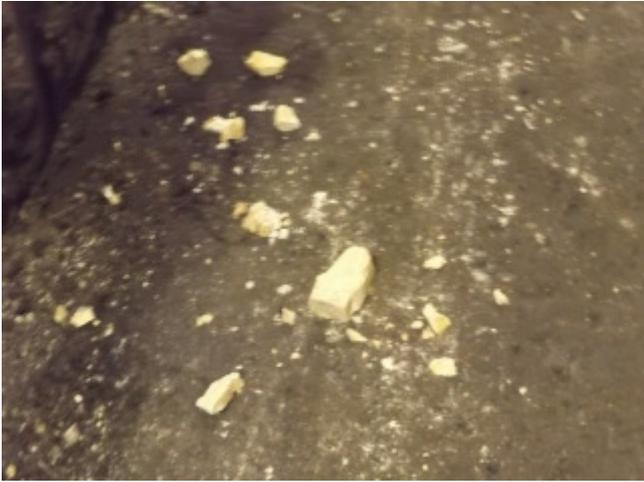
- 3.19 The tunnel face is of exposed chalk with layers of flint.
- 3.20 The surface of the chalk is stable but loose in some locations of the formed barrel, which is evident by the small fallen fragments of chalk.

Photograph 8 – Fallen Chalk form Barrel

- 3.21 The surface of the chalk barrel should be carefully and lightly de-scaled to remove all loose and detached chalk.
This work should be undertaken within 3 years of the date of this report and supervised by a Chartered Professional Engineer or Geologist at an estimated cost of £1,500.00 to £2,000.00 excluding V.A.T.

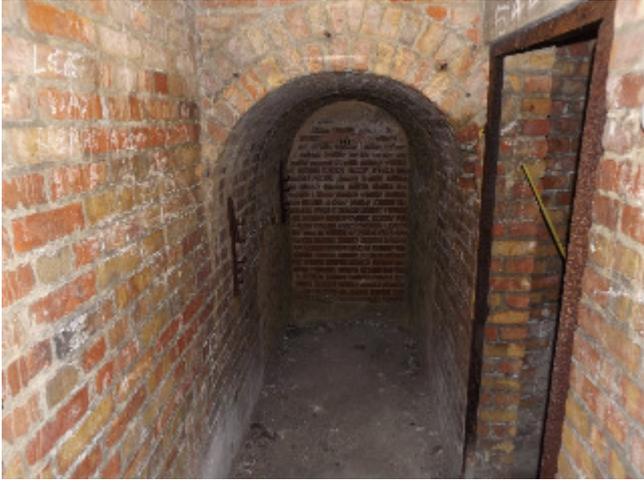
- 3.22 The tunnel end and escape chamber is of English bond and is constructed with clay bricks and sand / cement pointing to the joints. The roof has been formed by cast insitu reinforced concrete which incorporates two flights of reinforced concrete steps leading to the steel escape hatch which has been cast into a reinforced concrete surround. The walls are generally in reasonable condition however there is evidence of spalling above the concrete steps.
- 3.23 The steel door frame leading to the escape chamber is severely corroded.
- 3.24 There is significant corrosion to the underside of the escape hatch which is inoperable.
- 3.25 There are considerable amounts of condensation on the underside of the reinforced concrete slab which is likely to be due to the effects of cold bridging.

Photograph 9 – End Wall and Escape Chamber

- 3.26 The brickwork and sand cement joints appear to be in reasonable condition but the area is generally damp and would benefit from ventilation being provided in the end wall and the corroding steel door frame should be removed.
This work should be undertaken within 3 years of the date of this report at an estimate cost of £750.00 excluding V.A.T.

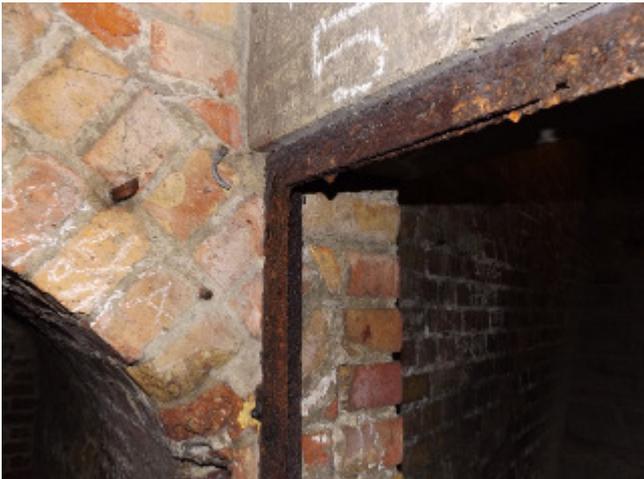
Photograph 10 – Corroding Steel Door Frame

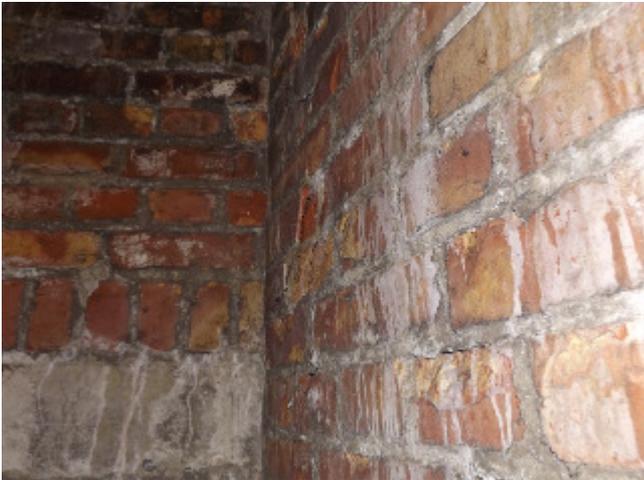
Photograph 11 – Spalling Brickwork Above Concrete Steps

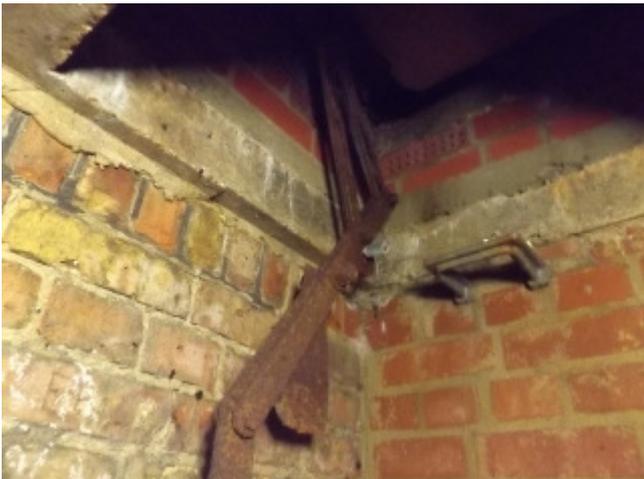
- 3.27 The escape hatch is inoperable due to the effects of corrosion but provided the only alternative means of escape in the event of a tunnel collapse.

Photograph 12 – Corroded Escape Hatch Mechanism

- 3.28 The escape hatch should be regularly maintained and no person should enter the tunnels for maintenance purposes or any other reason unless the hatch can be demonstrated as being operable and should be kept open for the period the tunnel is occupied.
This work should be undertaken as soon as possible at an estimated cost of £1,000.00 excluding V.A.T.

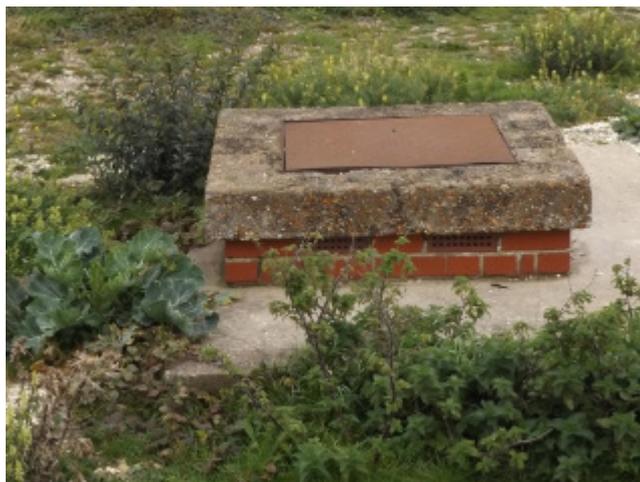
Photograph 13 – Escape Hatch - External
