# **ASBESTOS SURVEY REPORT**

**SURVEY REPORT NO: CAS/RD/RL/00294**

**System Town Sports Pavilion  
Necton Street  
System  
Leicestershire  
LE7 1HF**

**DATE:** 09/02/2016

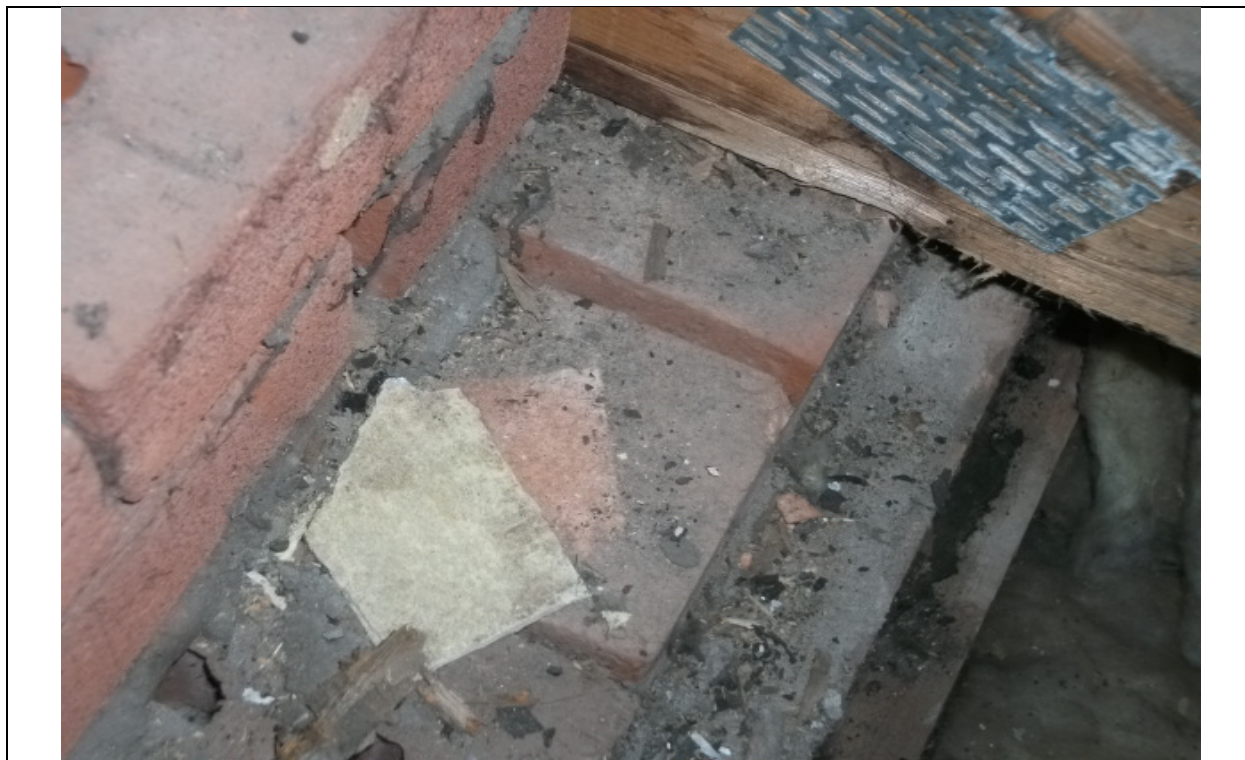
### Photo Ref: 001

| Sample No. | BN/19164 | Analysis | Chrysotile |

The packers are good condition they are unlikely to be disturbed as they are not easily accessible so may be left in situ.

Asbestos cement packers are unlikely to give rise to airborne fibre release as the Chrysotile fibres are bound into a hard cement matrix, however subjecting the packers to mechanical damage i.e. drilling, sanding or breaking is liable to give rise to significant airborne fibre release and should be avoided.

If future repair/maintenance works will lead to the disturbance of the packers the Control of Asbestos Regs 2012 do not require the use of a licensed asbestos removal contractor for the removal of asbestos cement products of this type, however the packers should be removed in a controlled manner and disposed of as asbestos waste.

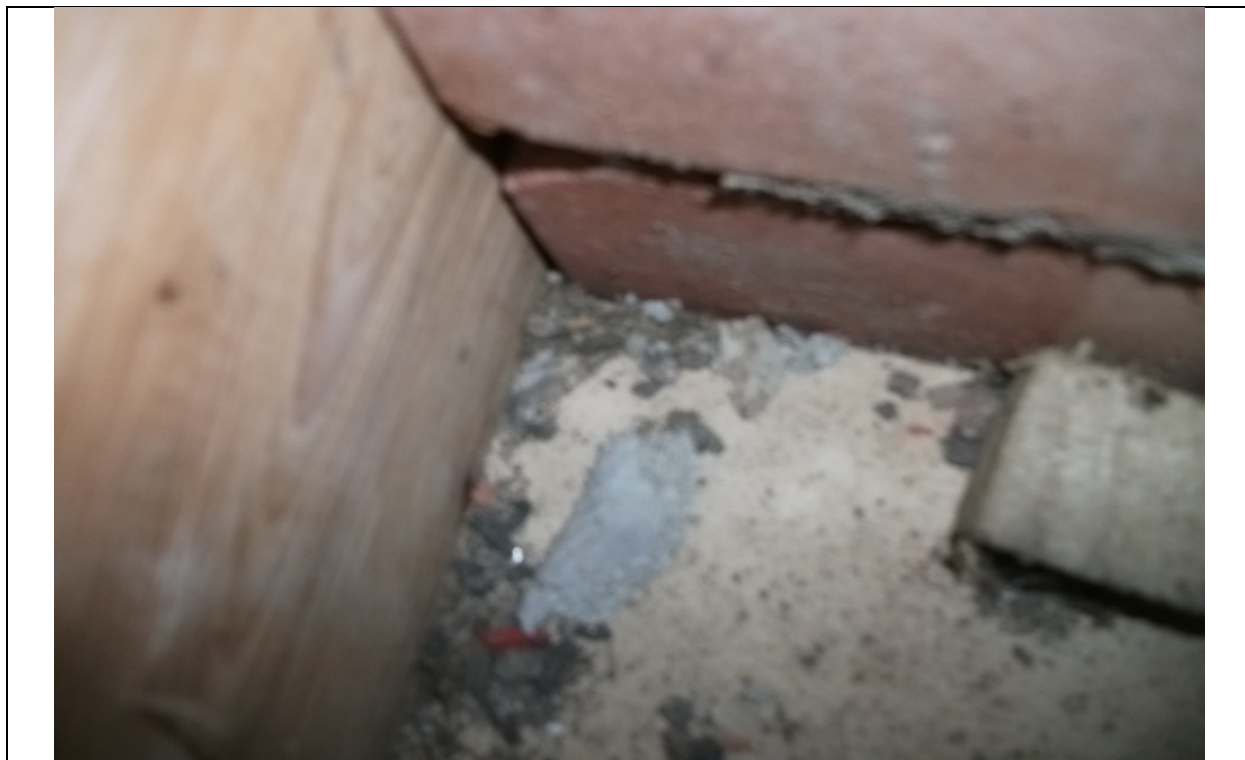
### Photo Ref: 002

| Sample No. | BN/19165 | Analysis | Chrysotile |

The debris is in very poor condition although it is unlikely to give rise to airborne fibre release as the Chrysotile fibres are bound into a hard cement matrix. However as the debris contains asbestos it would be prudent to remove.

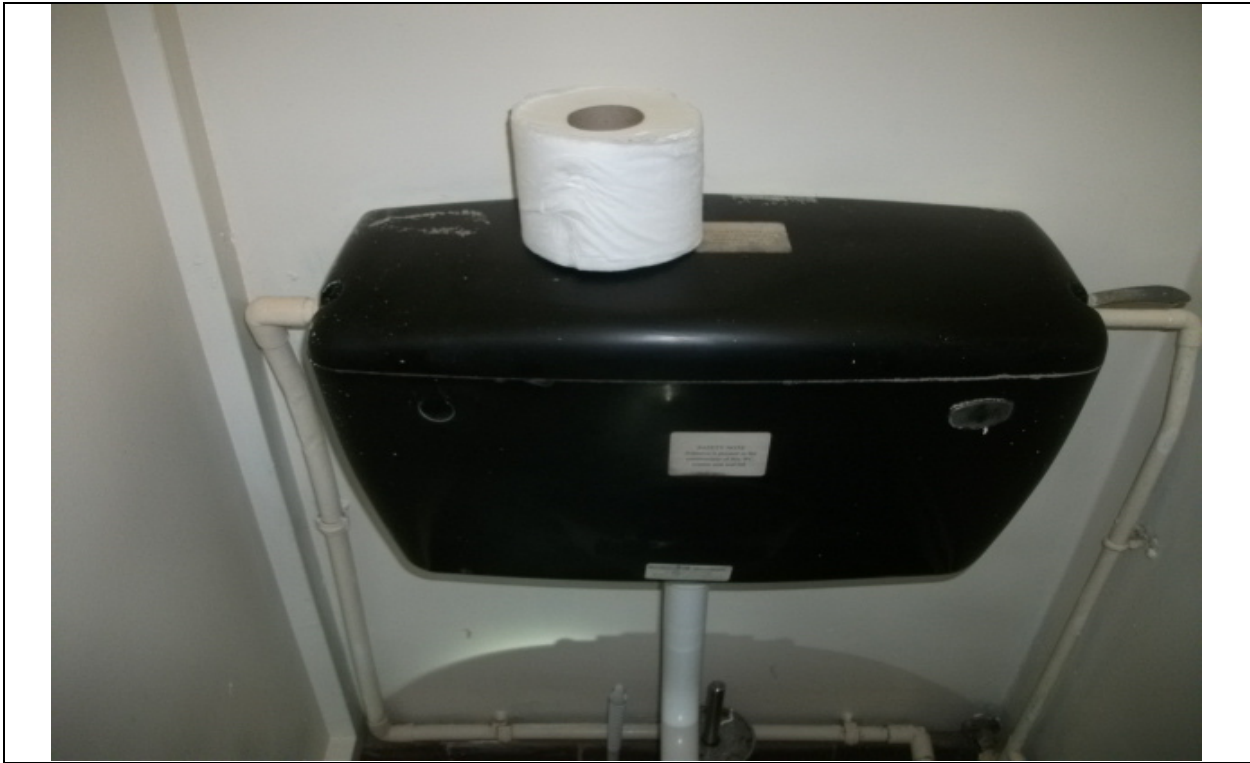
### Photo Ref: 003

| Sample No. | BN/19166 | Analysis | Amosite |

Due to the hard nature of the reinforced resin matrix the Amosite fibres are bound into, airborne fibre release is unlikely so they may be left in situ. However subjecting the cistern to mechanical damage i.e. drilling, sanding or breaking may give rise to an airborne fibre release and should be avoided.

If future repair/refurbishment works will lead to the disturbance of the cistern the Control of Asbestos Regs 2012 do not require the use of a licensed asbestos removal contractor for the removal of materials of this type, however it should be removed under controlled conditions and disposed of as asbestos waste.

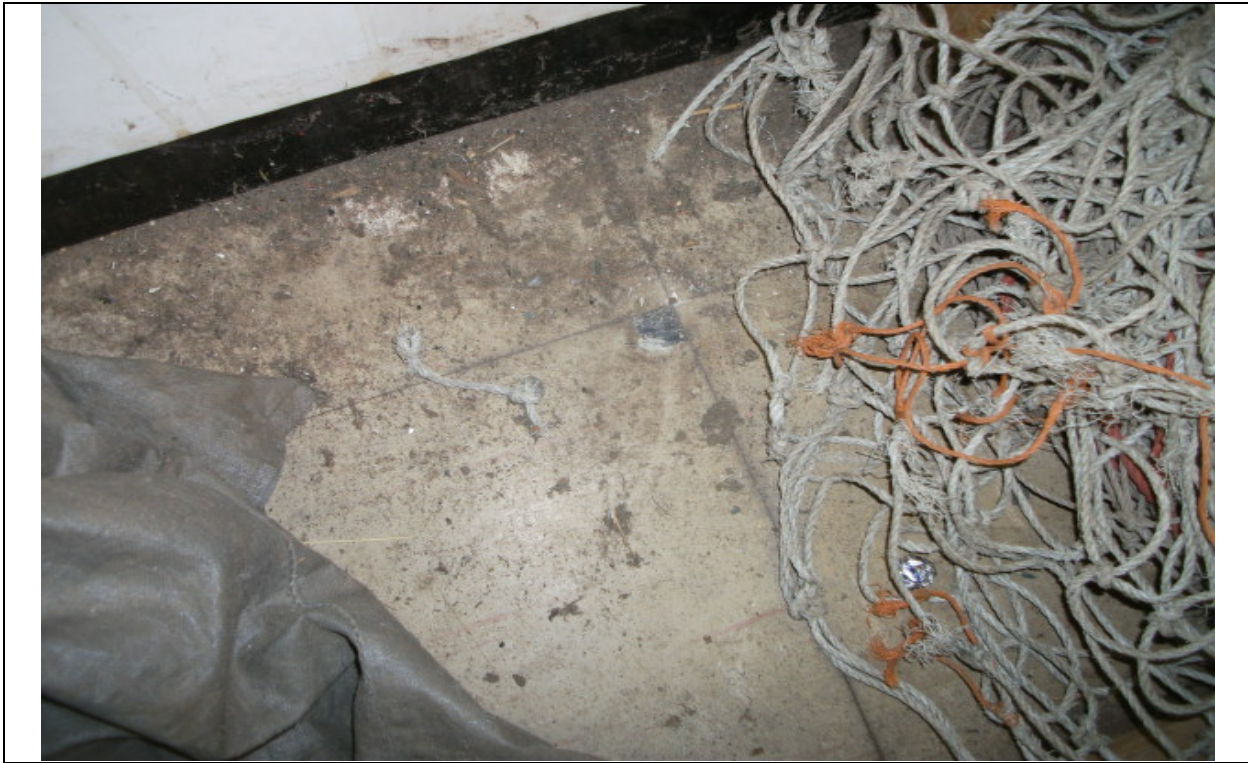
### **Photo Ref: 004**

| Sample No. | BN/19167 | Analysis | Chrysotile |

The beige floor tiles in the locations listed above contain Chrysotile (white asbestos). It should be noted that in the changing room – ref. 10/3 the tiles & adhesive are only present within the low level boxing area.

If future repair/refurbishment works will lead to the disturbance/removal of the floor tiles and adhesive the Control of Asbestos Regs 2012 not require the use of a licensed asbestos removal contractor for the removal of asbestos products of this type, but the works should be carried out in a controlled manner and any tiles removed should be disposed of as asbestos waste.

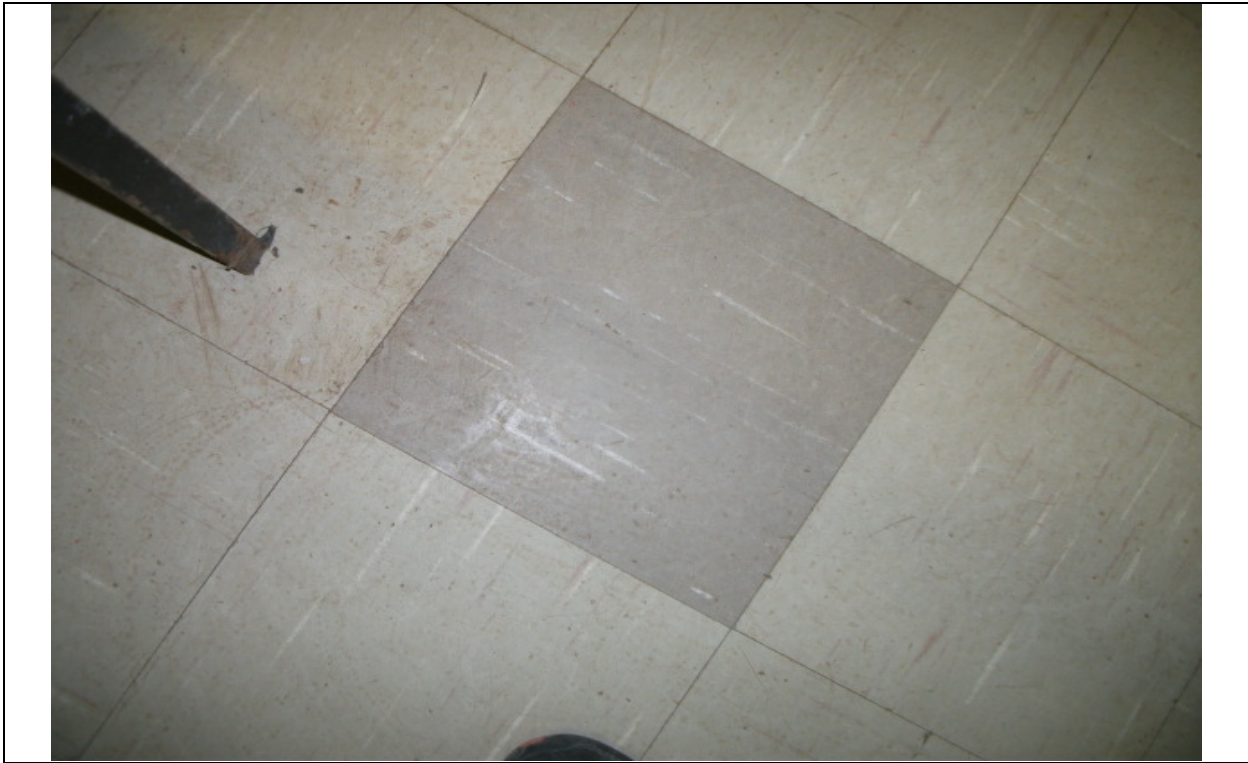
### Photo Ref: 004

| Sample No. | BN/19168 | Analysis | Chrysotile |

If future repair/refurbishment works will lead to the disturbance/removal of the floor tiles and adhesive the Control of Asbestos Regs 2012 not require the use of a licensed asbestos removal contractor for the removal of asbestos products of this type, but the works should be carried out in a controlled manner and any tiles removed should be disposed of as asbestos waste.

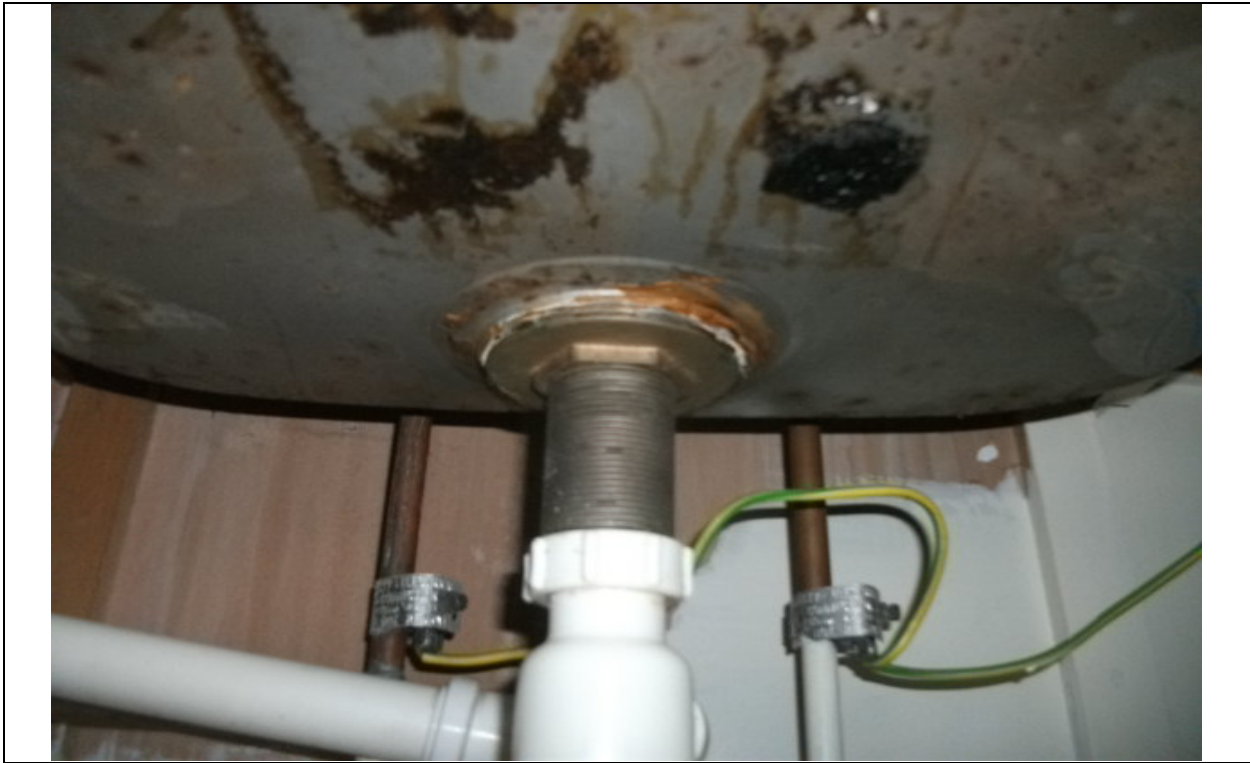
### Photo Ref: 005

| Sample No. | BN/19169 | Analysis | Chrysotile |

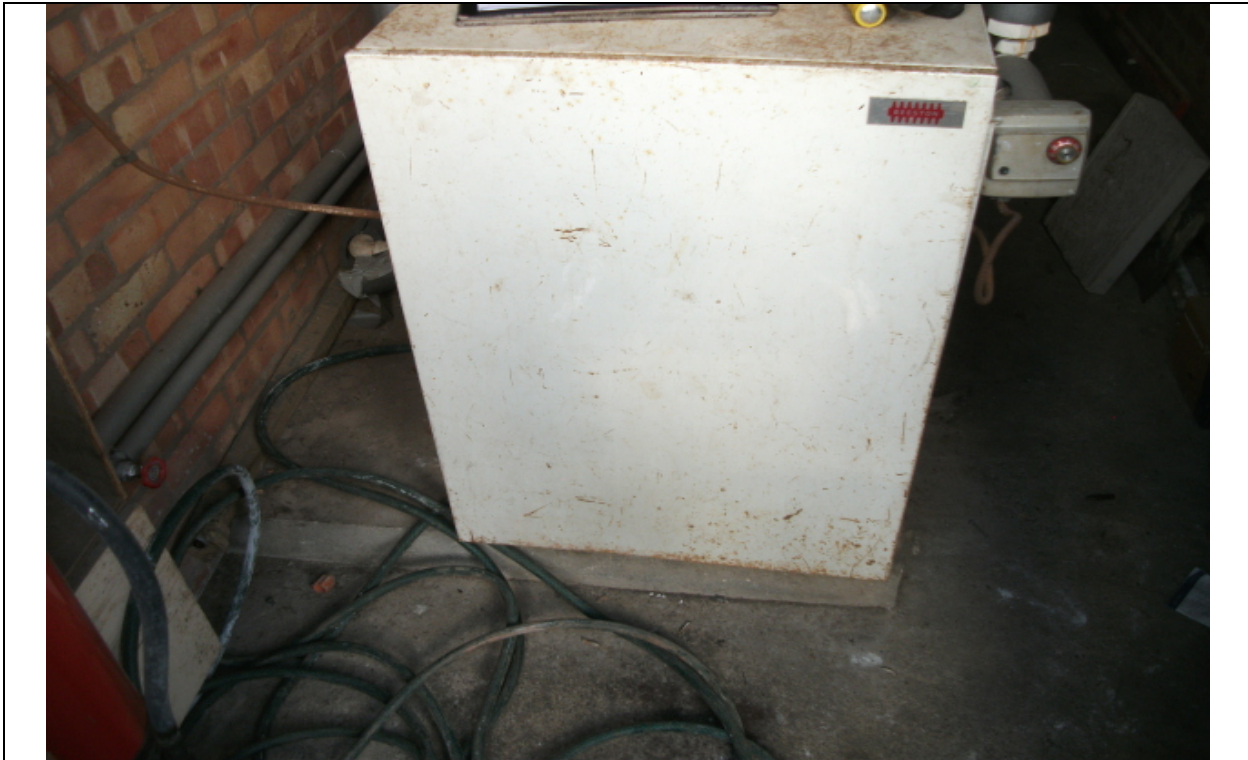
### Photo Ref: 006

| Sample No. | N/A | Analysis | Presumed Chrysotile |

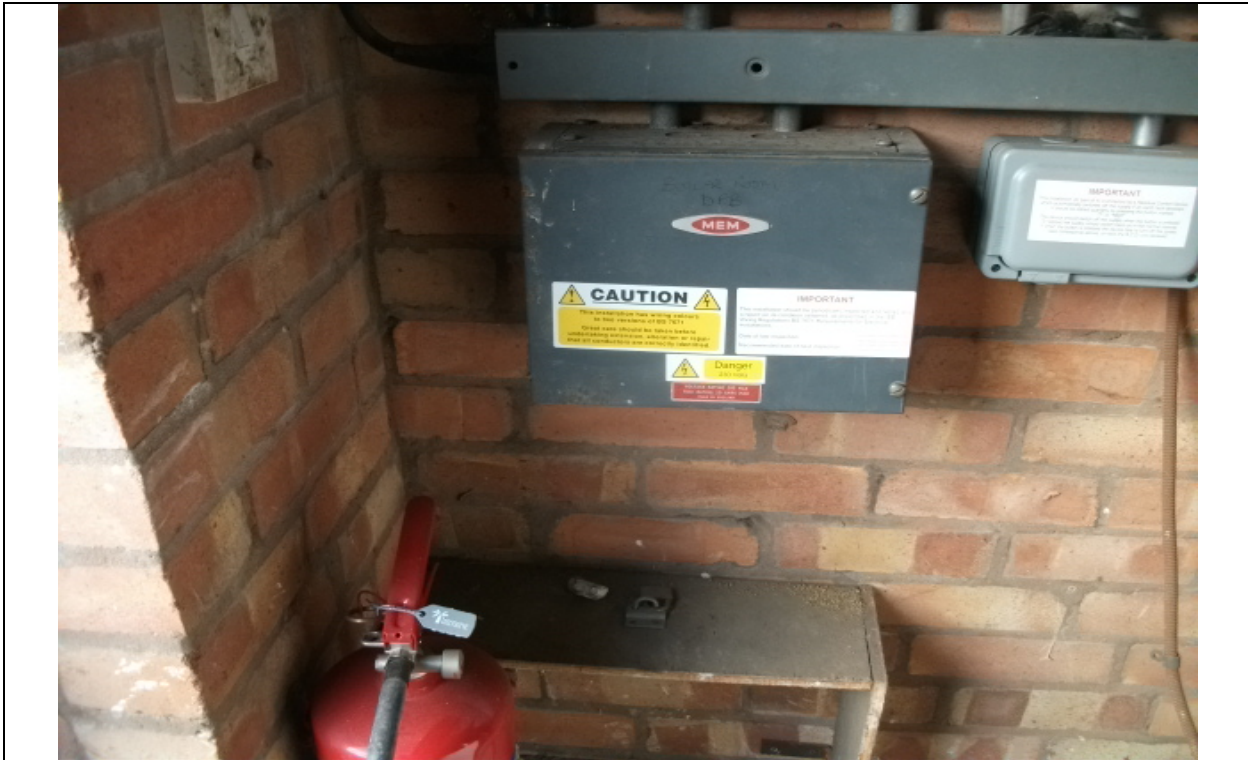
### Photo Ref: 007

| Sample No. | N/A | Analysis | Presumed Crocidolite |

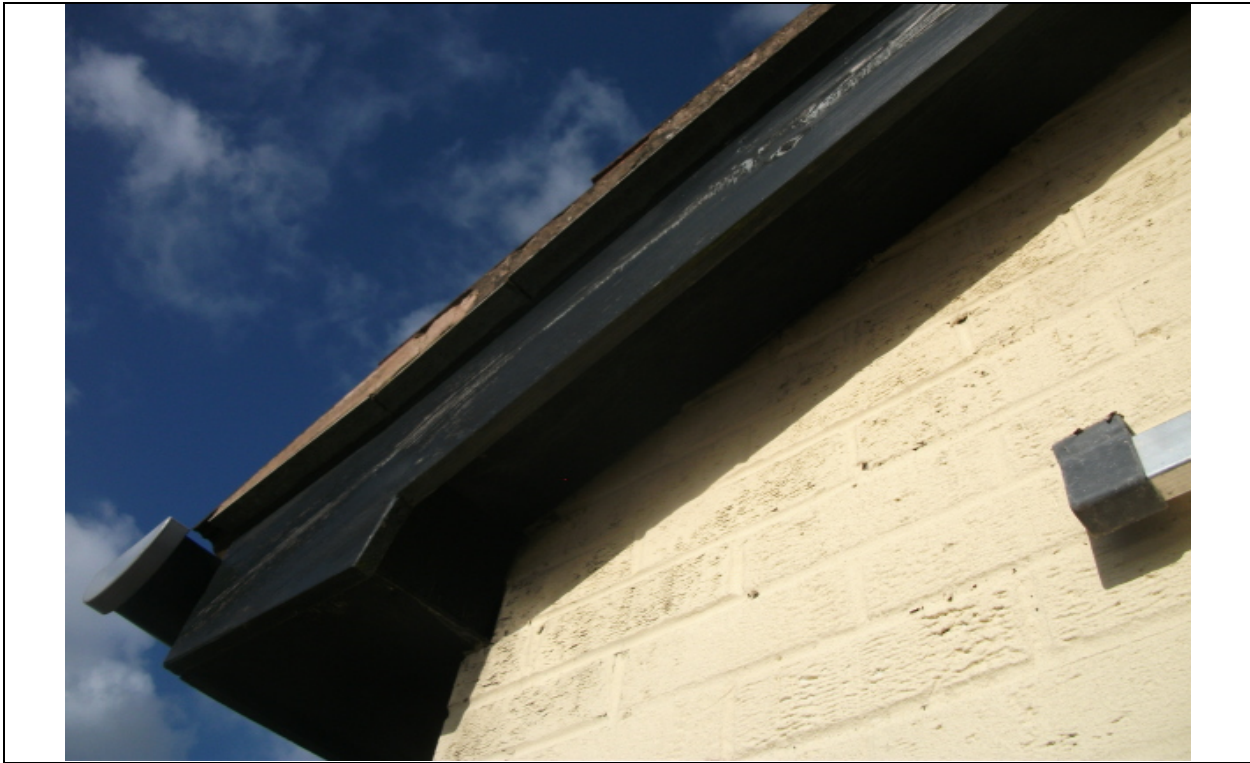
### Photo Ref: 007

| Sample No. | N/A | Analysis | Chrysotile |

Asbestos cement undercloaking to the pitched roof at the sides of the building contains Chrysotile (white asbestos). The undercloaking is in good condition and unlikely to be disturbed so may be left in situ.

Asbestos cement undercloaking is unlikely to give rise to airborne fibre release as the Chrysotile fibres are bound into a hard cement matrix, however subjecting the undercloaking to mechanical damage i.e. drilling, sanding or breaking is liable to give rise to significant airborne fibre release and should be avoided.

If future repair/maintenance works will lead to the disturbance of the undercloaking the Control of Asbestos Regs 2012 do not require the use of a licensed asbestos removal contractor for the removal of asbestos cement products of this type, however the undercloaking should be removed in a controlled manner and disposed of as asbestos waste.
