Management Survey

Site: Battle Sports Pavillion, North Trade Road, Battle, East Sussex, TN33 0HB
Client: Battle Town Council
Report No: J031391
Survey Date: 27th February 2025
Report Date: 27th February 2025
Surveyors: Colin Van Son
Report Produced By: **Report Authorised By:**

Asbestos Survey of Battle Sports Pavillion, North Trade Road, Battle, East Sussex

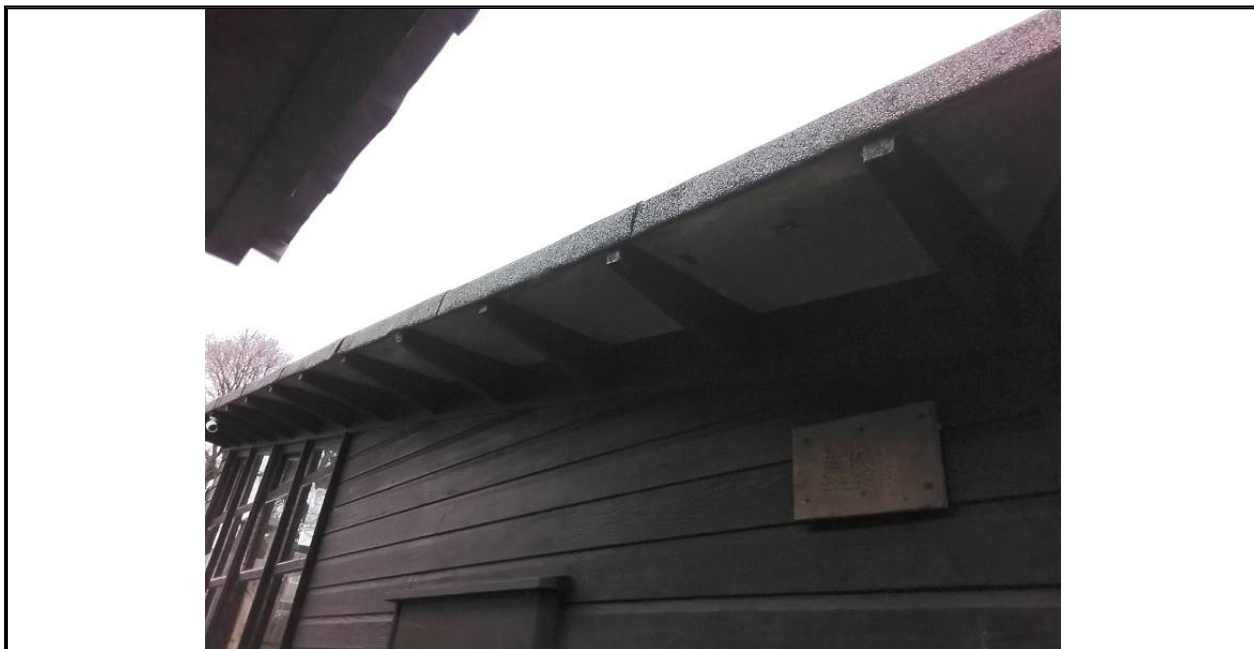
Sample No:	DN000200
Item No:	16
Survey Date:	27/02/25
Building:	Battle Sports Pavillion, North Trade Rd. Battle
Floor:	External
Room No:	External Elements
Position:	Soffits - Cement
Extent:	50lm
Substrate:	Nailed, Timber
Material:	(1) Asbestos Cement
Accessibility:	(0) Usually inaccessible or unlikely to be disturbed
Asbestos Type:	Chrysotile
Risk Category:	D
Recommended Action:	Low risk ACM (Bound in matrix). Where appropriate label with warning signs. Undertake routine inspections for damage and deterioration. Work on this material does not require a license. Work on this material may be notifiable to the appropriate enforcing authority. Disposal of asbestos waste by a licensed contractor only. All work must conform to the 'Control of Asbestos Regulations 2012'.

<p>Picture 16</p>
DN000200	Battle Sports Pavillion, North Trade Rd. Battle	External	Cement	External Elements, Soffits	50lm	Nailed	Timber	Chrysotile	
Recommendations					Assessment Scores			Risk Code	
					Material	Priority	Total		
Low risk ACM (Bound in matrix). Where appropriate label with warning signs. Undertake routine inspections for damage and deterioration. Work on this material does not require a license. Work on this material may be notifiable to the appropriate enforcing authority. Disposal of asbestos waste by a licensed contractor only. All work must conform to the 'Control of Asbestos Regulations 2012'.					4	-	4	D	
Reinspection Due		12 months	Actions Taken	N/A	Time Scale			Action Completed Sign & Date

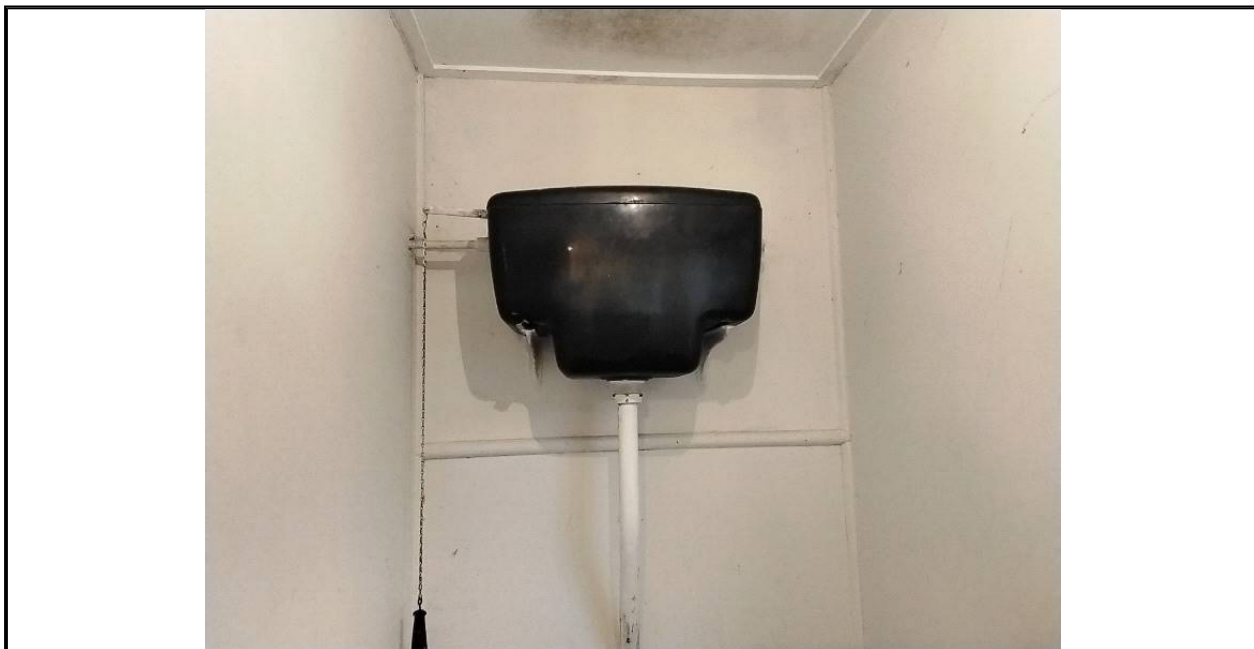
Sample No:	DN000199
Item No:	11
Survey Date:	27/02/25
Building:	Battle Sports Pavillion, North Trade Rd. Battle
Floor:	Ground Floor
Room No:	Toilets
Position:	Toilet cistern - Reinforced Composite
Extent:	1no.
Substrate:	Bolted, Timber
Material:	(1) Reinforced Composite
Accessibility:	(1) Occasionally likely to be disturbed
Asbestos Type:	Amosite
Risk Category:	D
Recommended Action:	Low risk ACM (Bound in matrix). Where appropriate label with warning signs. Undertake routine inspections for damage and deterioration. Work on this material does not require a license. Work on this material may be notifiable to the appropriate enforcing authority. Disposal of asbestos waste by a licensed contractor only. All work must conform to the 'Control of Asbestos Regulations 2012'.

<p>Picture 11</p>
DN000199	Battle Sports Pavillion, North Trade Rd. Battle	Ground Floor	Reinforced Composite	Toilets, Toilet cistern	1no.	Bolted	Timber	Amosite	
Recommendations					Assessment Scores			Risk Code	
					Material	Priority	Total		
Low risk ACM (Bound in matrix). Where appropriate label with warning signs. Undertake routine inspections for damage and deterioration. Work on this material does not require a license. Work on this material may be notifiable to the appropriate enforcing authority. Disposal of asbestos waste by a licensed contractor only. All work must conform to the 'Control of Asbestos Regulations 2012'.					4	-	4	D	
Reinspection Due		12 months	Actions Taken	N/A	Time Scale			Action Completed Sign & Date

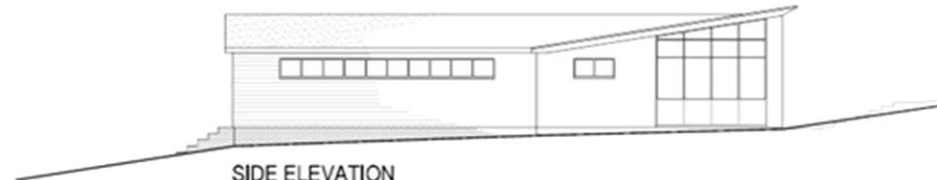
DN000200

Cement

Soffits To

Front & Side

Elevations
