Annual Inspection

Central Swindon North Parish Council

Barnum Court

Inspection Ref: 2249510

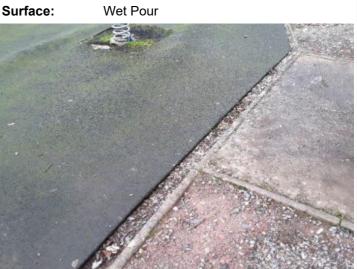
Finding: There are significant gaps (over 30mm) between the surface and the edging or between the joints in the surface; these are large enough for a small foot to enter

Action: Repair surfacing

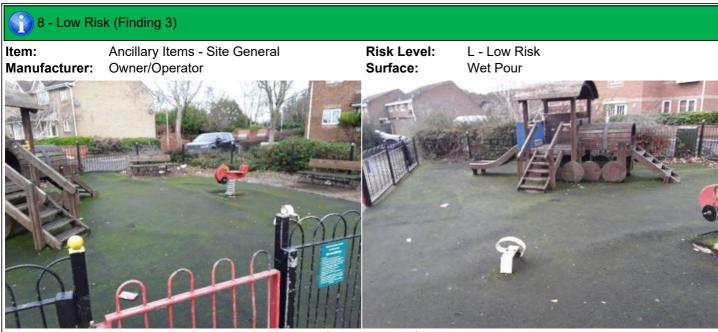
Finding: There is algae, silt or moss growth on the surface Action: Clean and treat appropriately resulting in slippery conditions

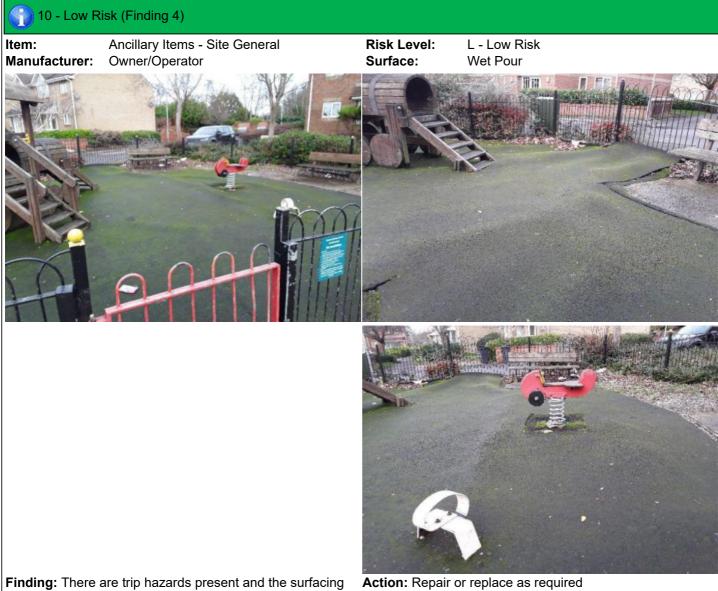
Finding: There are trip hazards present and the surfacing has subsided or has been pushed up due to tree roots

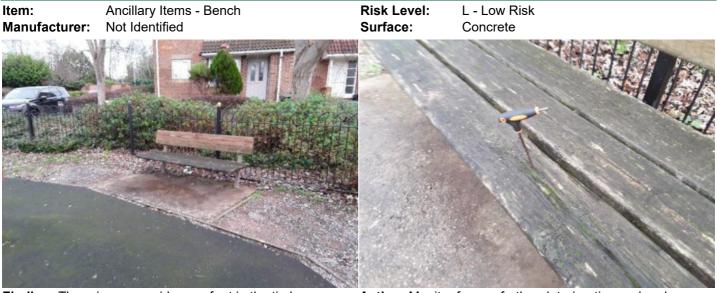
6 - Low Risk (Finding 2)

Finding: There is some evidence of rot in the timber

Action: Monitor for any further deterioration and replace as required

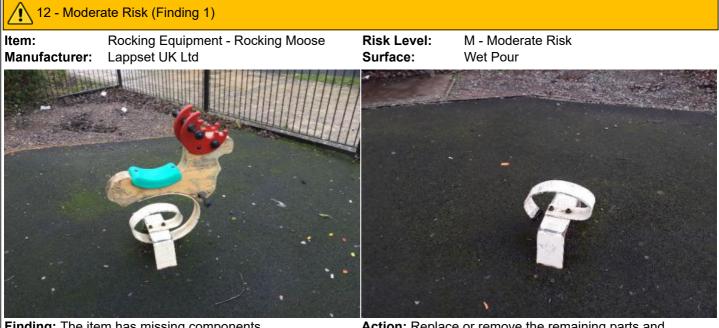
Finding: The item has missing components

Action: Replace or remove the remaining parts and reinstate the surface

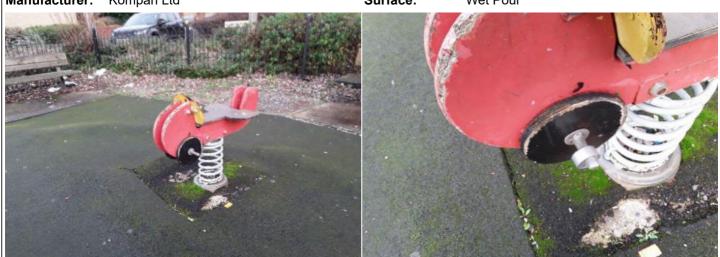
6 - Low Risk (Finding 2)

Finding: The end of handgrips and/or footrests have a cross **Action:** Monitor - No remedial work recommended section of less than 15cm2 and fail to meet the requirements of BS EN 1176 Part 6

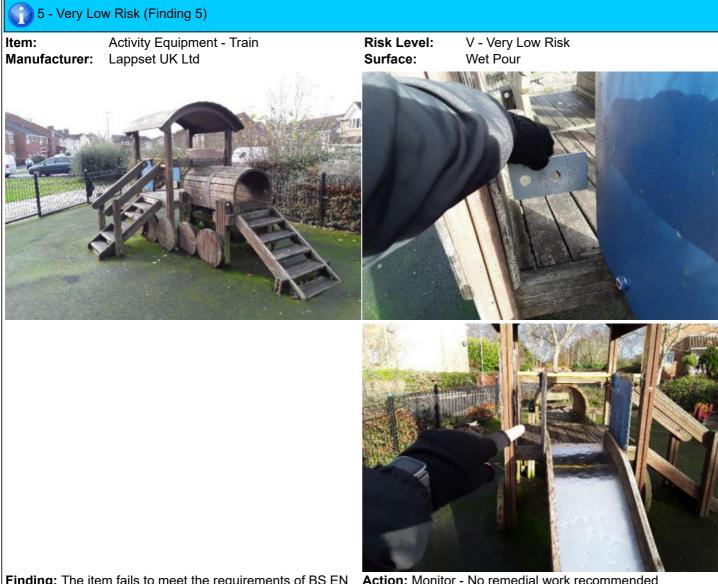
Finding: The item fails to meet the requirements of BS EN **Action:** Monitor - No remedial work recommended 1176 Part 1 4.2.7.2 head and neck entrapment in the barriers and/or steps

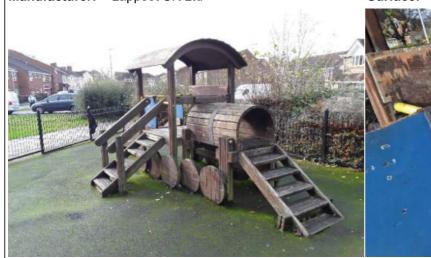
6 - Low Risk (Finding 6)

Finding: The paintwork on this item has been damaged or Action: Treat affected areas and repaint worn exposing the metal underneath which is rusting / corroding

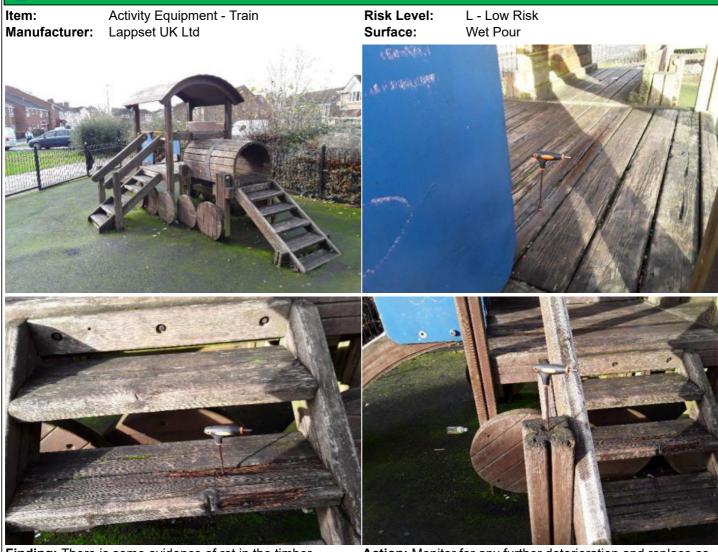
8 - Low Risk (Finding 8)

Finding: There is some evidence of rot in the timber throughout

Action: Monitor for any further deterioration and replace as required
