HA MONITORING RECORD SHEET

SCHEME: A30 Rawridge Hill 242/9 EB (Zone B)		Grid Reference:	Start E319772, N104895 End E319844, N104979
Earthwork ID	6543		
Earthwork Type	Embankment		
Max slope Height (m)	3.1		
Max Slope Angle (°)	39°		
Drainage	Top		
	Slope	N/A	
	Base	N/A	
Site Instructions	TM required: Traffic Lights	Monitoring Frequency	Initial: Quarterly Current: Quarterly

CURRENT OBSERVATIONS

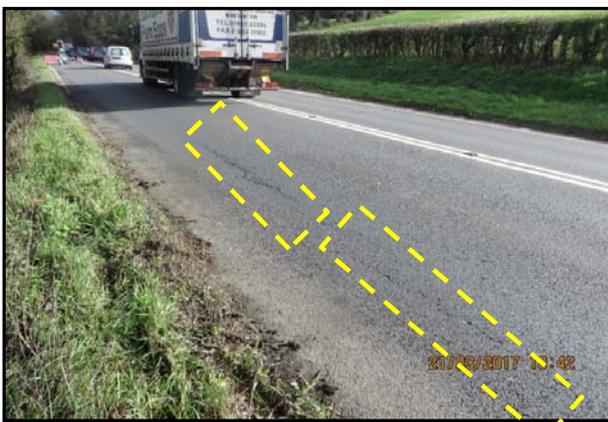
Photographs - 21/03/2017 - visual inspection

Linear pavement cracking 1.0m from kerb EB NS wheel track has widened. Second linear crack has developed west of existing linear feature subsequent to the 19/10/2016 monitoring visit

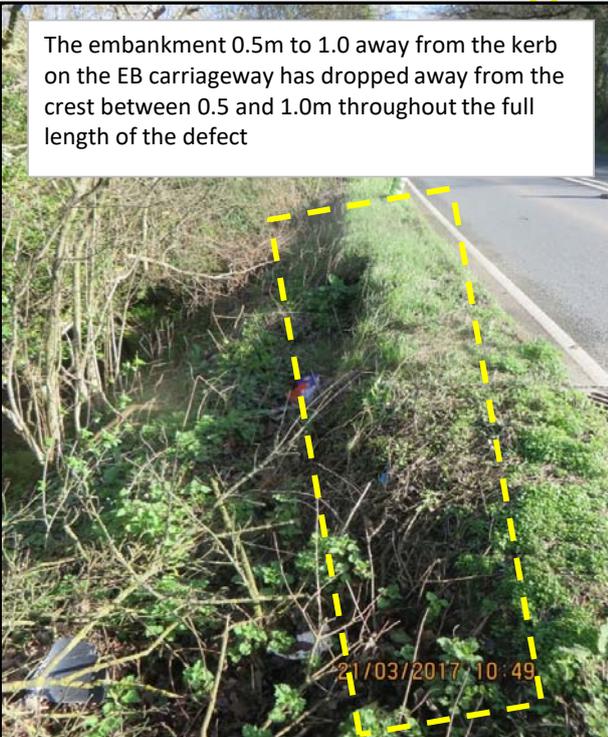
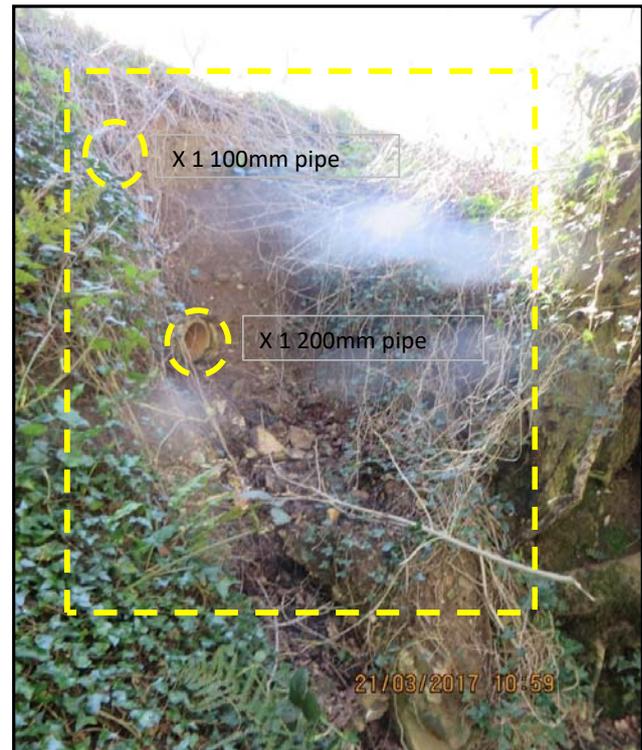
The embankment has been eroded away below the carriageway (shown at the top of the picture) there are two clay vitreous pipes daylighting in the face of the eroded earthwork, x 1, 100mm diameter and x 1, 250mm diameter. The area at the base of the erosion is saturated and a new connection to the two pipes is required as a temporary repair.

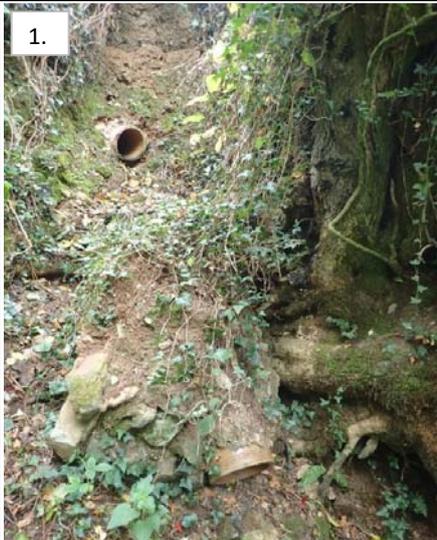
1.

Photo 1: view of embankment below carriageway, supporting A30 EB carriageway. Cross carriageway drainage sheared and caused embankment failure. Steady flow of water observed to be entering the catchpit on the WB which should feed into this cross carriageway drainage, but no water is flowing out of the pipe where it

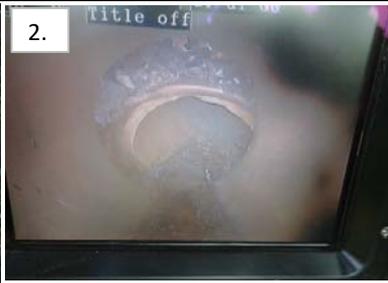
2.

Photo 2: CCTV camera probed cross carriageway drainage from both EB and WB access. EB access identified a blockage which the camera could not penetrate. WB access identified numerous pipe fractures and areas of collapse.

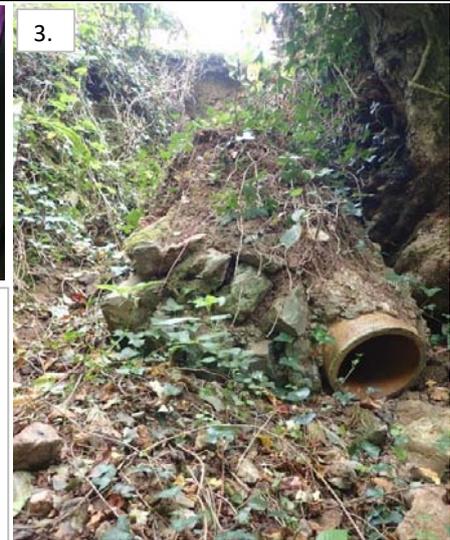
3.

Photo 3: view of embankment below carriageway showing sheared section of pipe and soil failure.

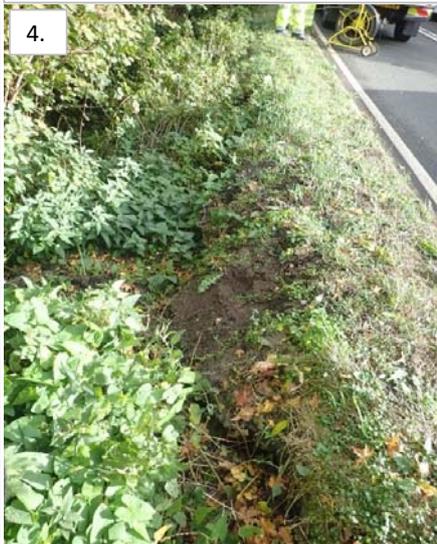
4.

Photo 4: Significant settlement in verge behind kerb line, forming separation cracking and exposes kerb haunching.

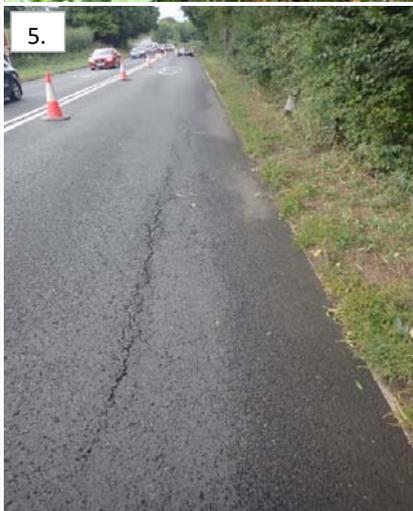
5.

Photo 5: Cracking evident in carriageway, potentially slightly worse than previous visit. However, this is hard to tell without quantitative monitoring in place.

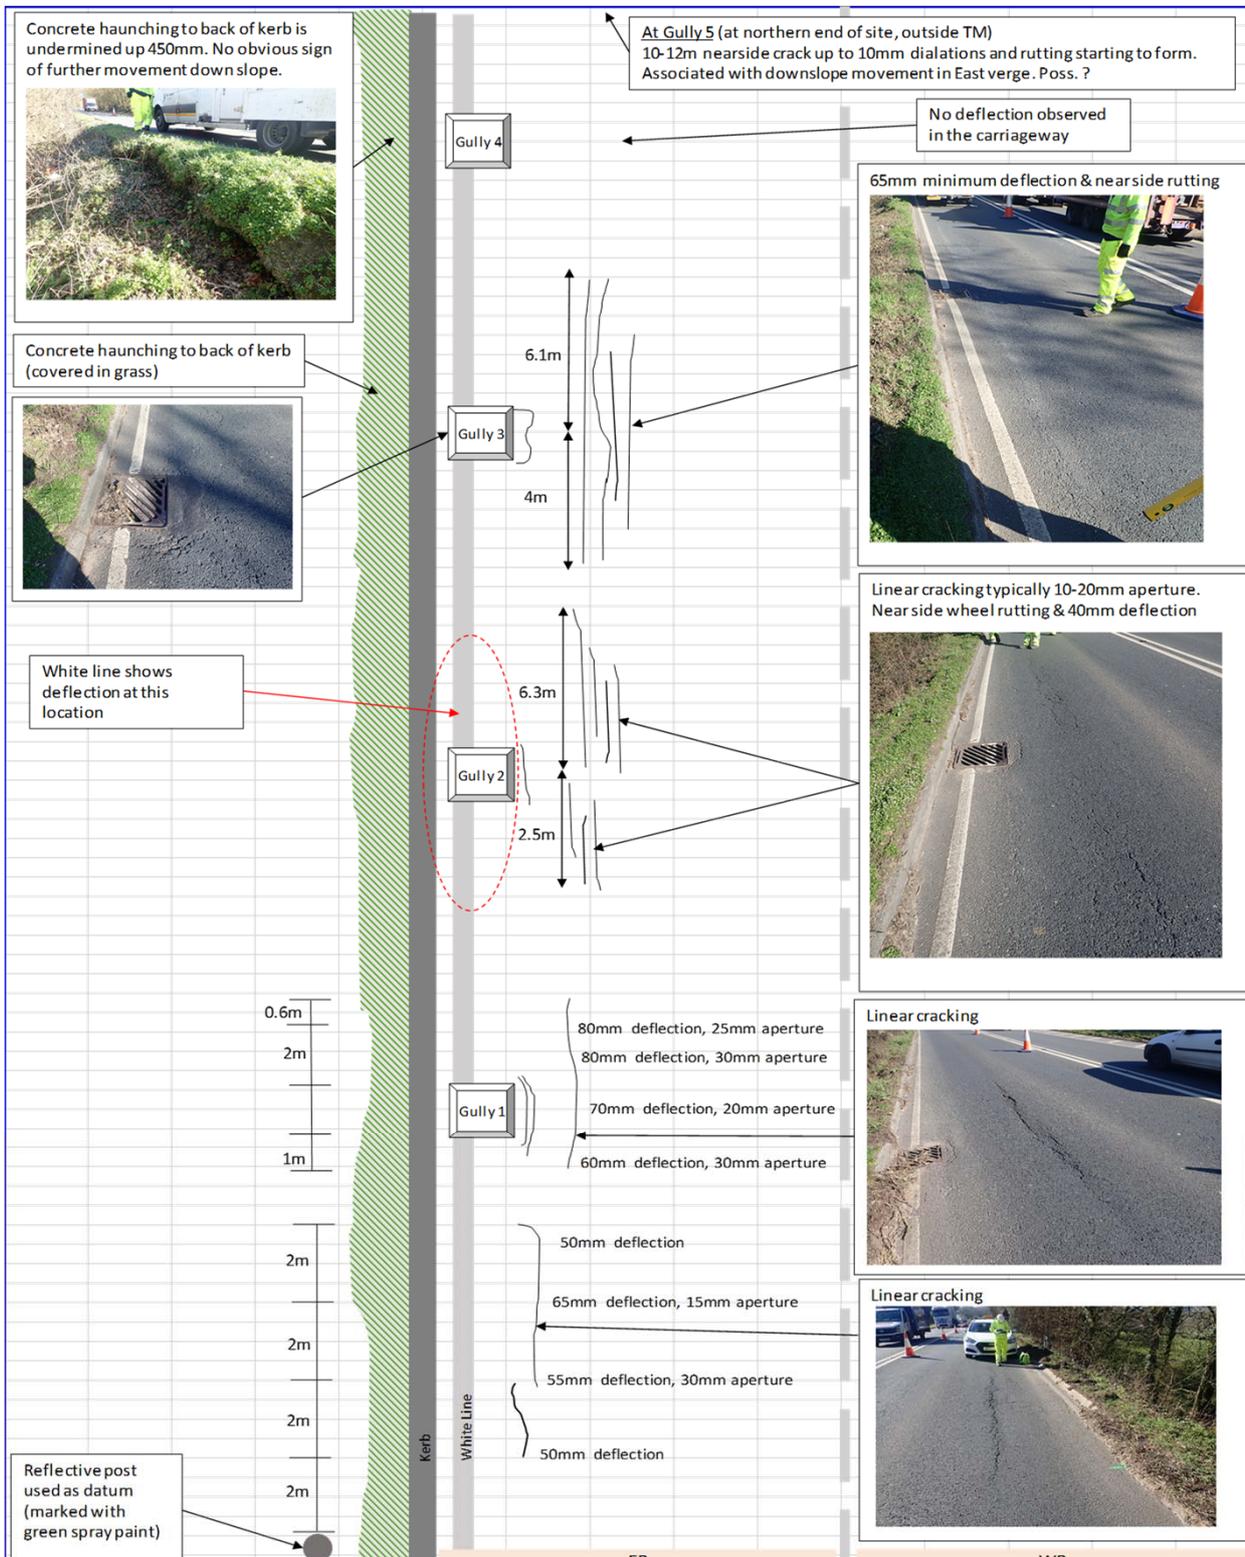
Site plan: 26th February 2019

26/02/2019	608281	MI	MM/PL/RB	Site inspection undertaken with TM in place. Linear cracking and near side wheel rutting observed in the carriageway. Site plan created showing deflection and aperture measurements (see below). The concrete haunching to the back of the kerb is undermined by up to 450mm in places. There are no obvious signs of further movement down slope. Drainage gullies blocked.	1A/A	5

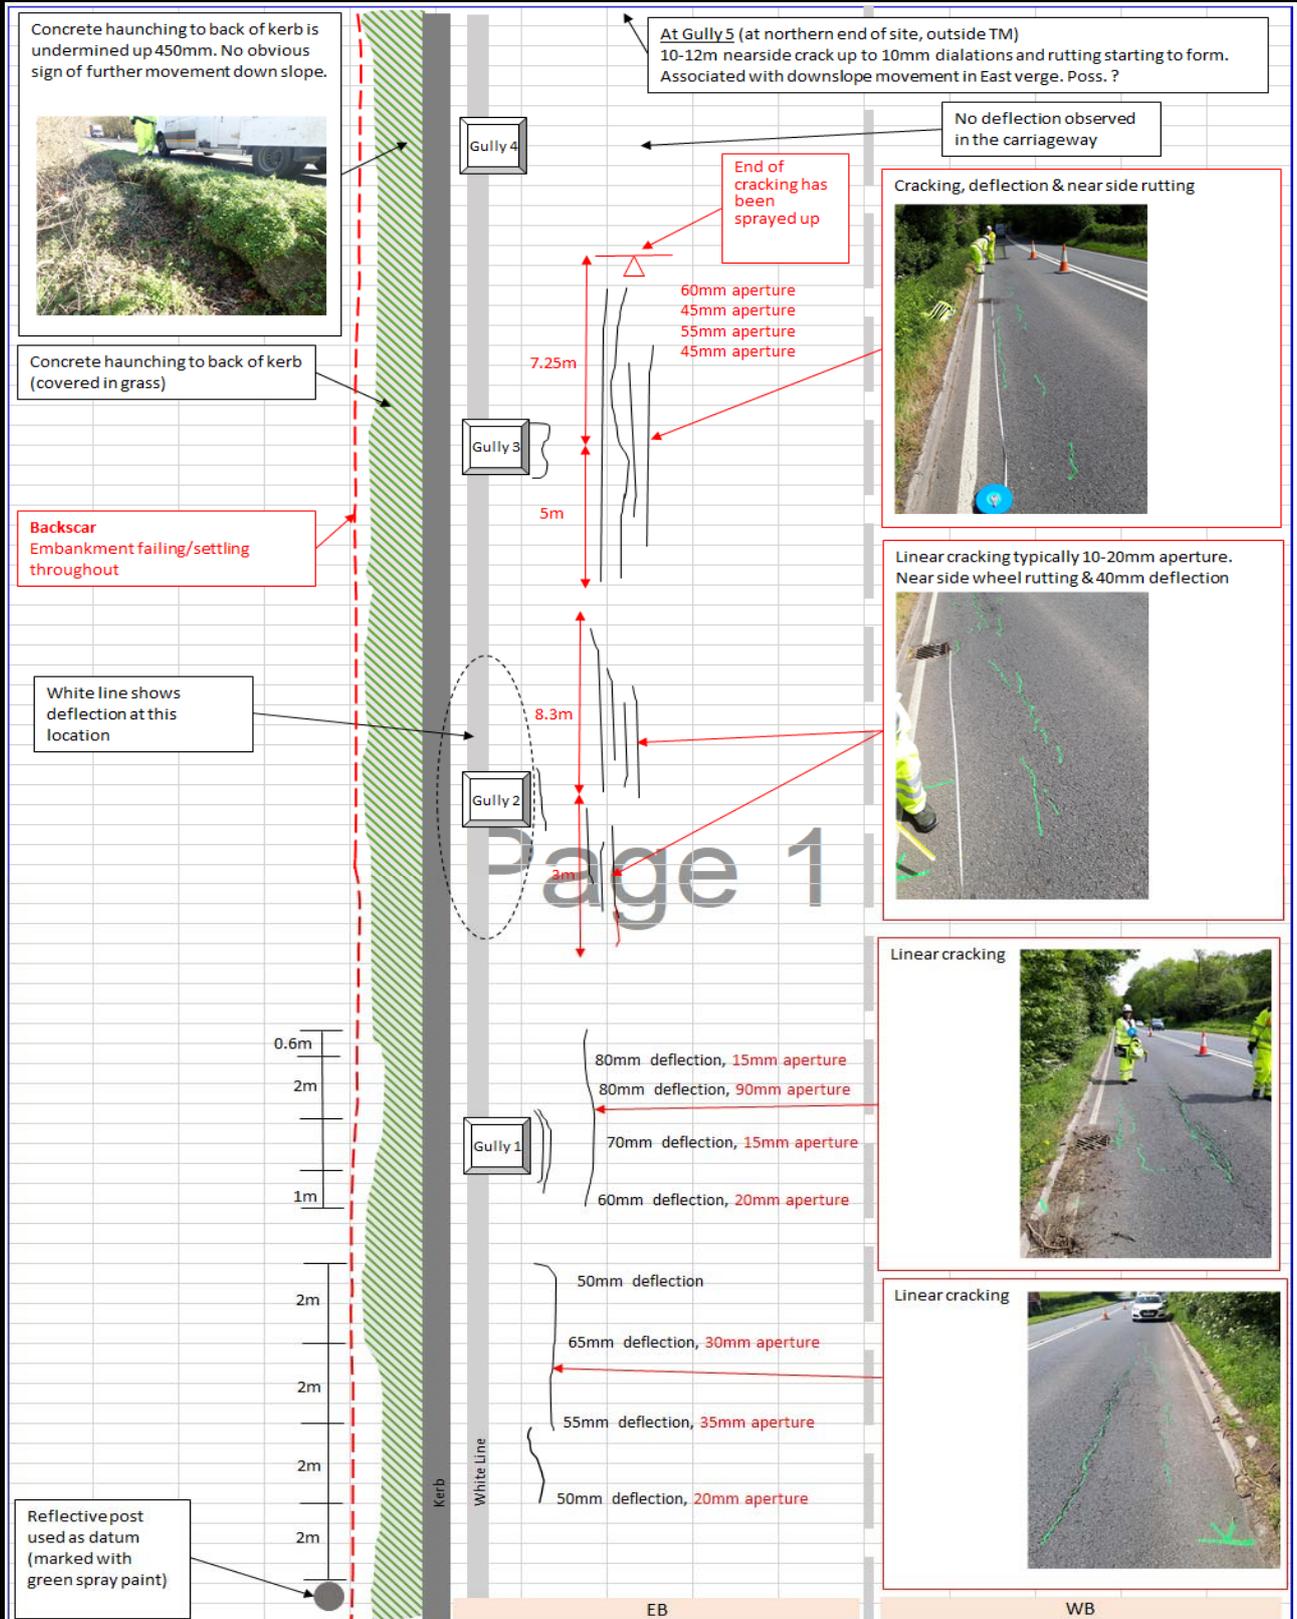
Site Plan: 22 May 2019

22/05/2019	615210	MI	PL/MM	<p>Slight increase in some aperture measurements (+5mm to +60mm).</p> <p>Cracking has increased in length and severity at Gully 2 and 3 (see site plan attached).</p> <p>Slope was difficult to observe due to dense vegetation but did not show signs of further movement.</p> <p>Extents of cracking has been sprayed up in order to visually assess change from last inspection.</p>	1A/A	5
07/08/2019	616262	MI	RB/MM	<p>Due to our availability and TM restrictions an inspection on foot in August was not possible. A drive-by was carried out instead. The defects do not seem to have worsened. The toe of the slope could not be observed from the carriageway.</p>	1A/A	5

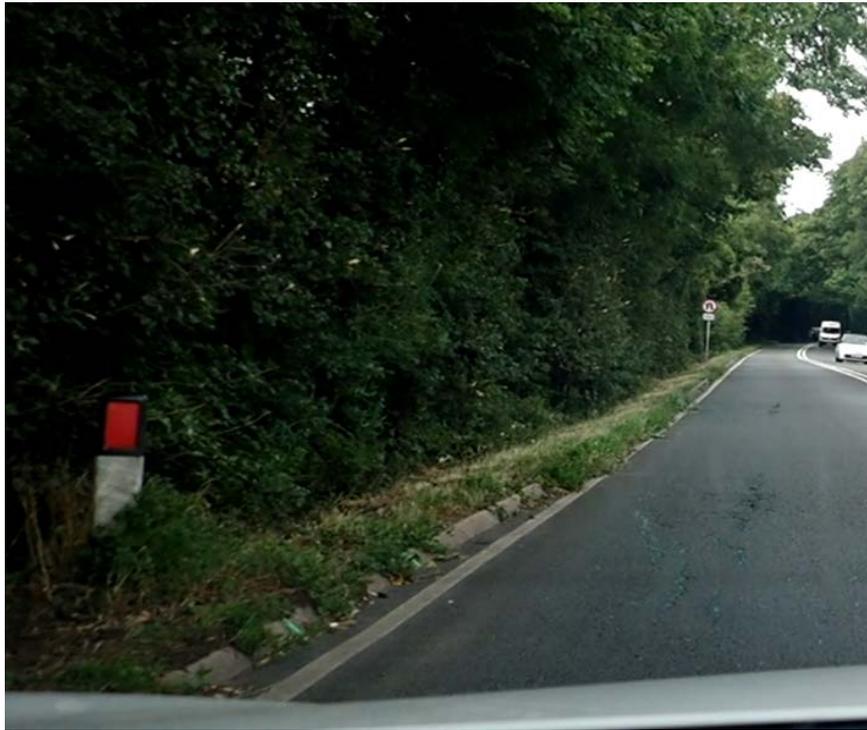
Site Photos: 07/08/19

This drive-by photograph was taken from the end of the defect at MP 242.9 looking East.

The defect does not seem to have worsened since the last visit.

Another inspection is planned for November 2019.
