NCM05

National Coal Mining Museum, Caphouse Colliery, WF4 4RH

Small works contract Nov 2025

REFERENCE PHOTOS:

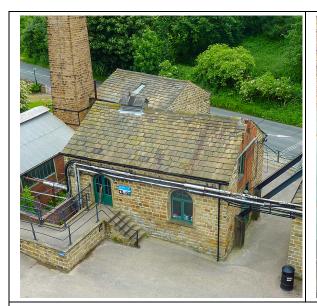
Roof: General views from North

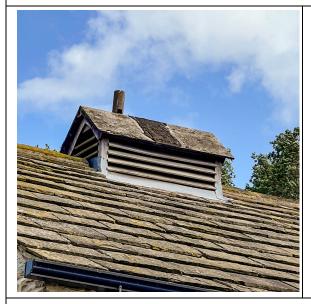
Roof: Ridge dormer has lost its covering leaving just decaying plywood

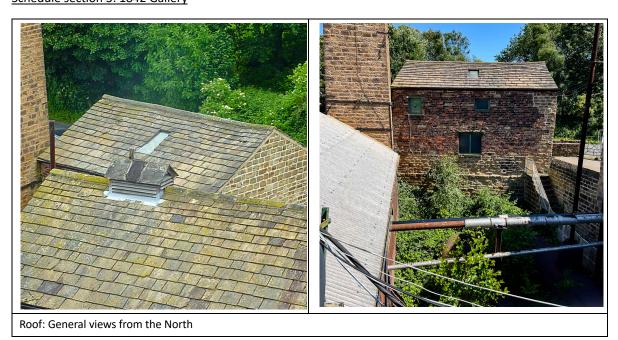
Roof: North side crudely detailed roof light

Roof: North side damaged roof slates

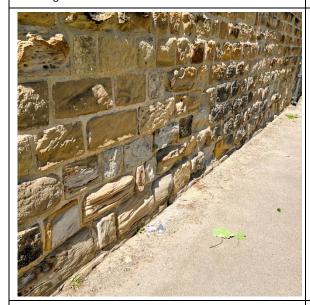
South. Further stone replacement would be desirable to lower wall.

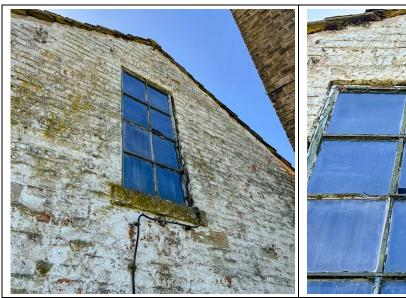
East. Window in poor order. Elevation needs limewashing

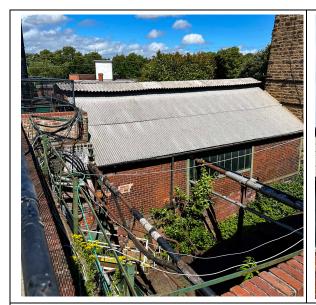
Lancashire boilers. Replace eaves gutters

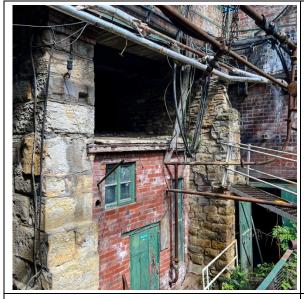
Lancashire boiler - Switch room general view

Lancashire boiler - Switch room door to replace

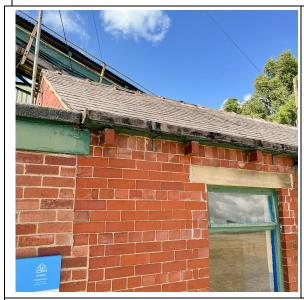
Control room: Front rainwater goods are still the old timber gutters and a poorly fixed plastic downpipe.

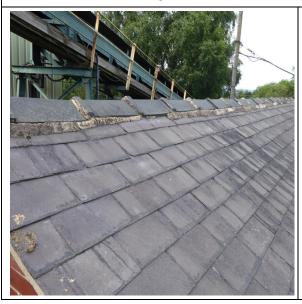
Control room: mortar loss from ridge

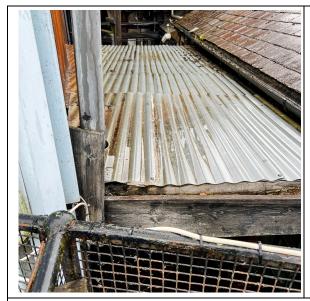
Screens: Roof over lamp room waiting area is very badly made. The sheets do not extend to the edge and the RWP from the upper roof soaks the gap

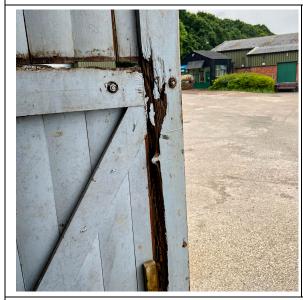
Door of north garage in poor order.

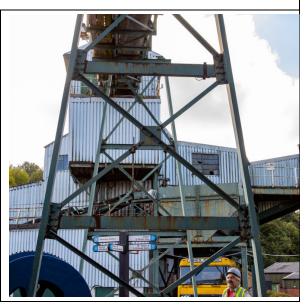
Screens: high level window by the top of the gantry in poor order.

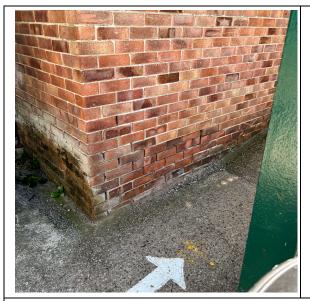
Modern Workshop / entrance to underground tour: Brickwork on north face almost complete loss of mortar

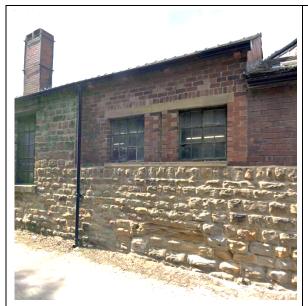
Lamp room south – 2no small square windows need replacing

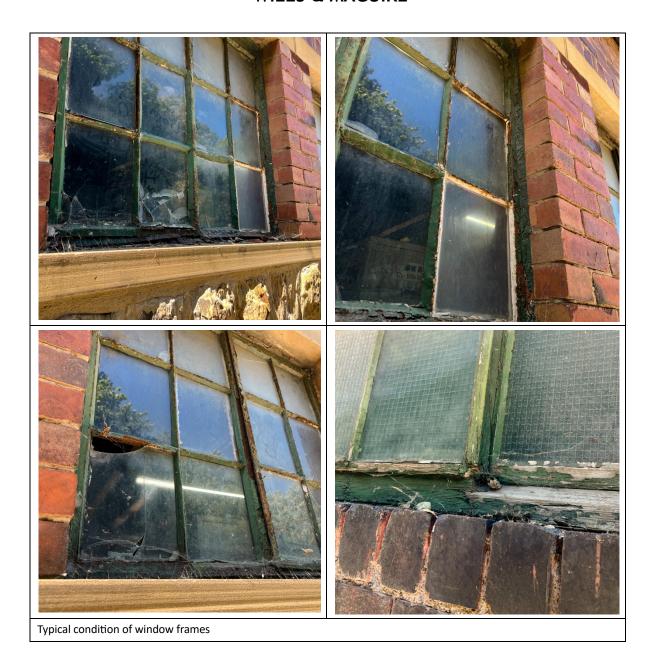
Lamp room south – 2no long windows need replacing
