Market House Refurbishment and Associated  
Works

# BUILDING INSPECTION REPORT

# THE MARKET HOUSE, ST IVES

**As inspected 2<sup>nd</sup> February 2023**  
**CGH/8187**

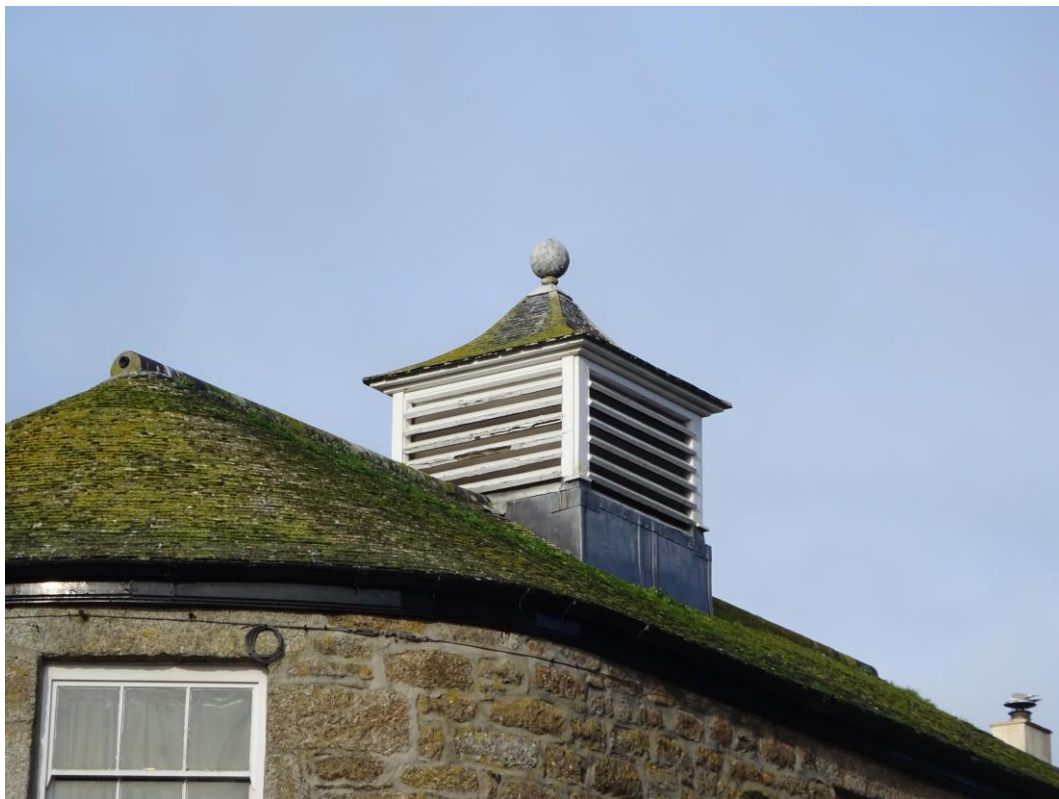
There are some areas where mortar has been lost from below the slates, particularly at the eaves. There are also a number of loose and slipped slates evident.

Due to the excessive covering of moss it is difficult to fully gauge the condition of the roof covering but from what is visible it appears generally competent.

2. View along east roof from southeast end.

It is recommended that the vegetation and moss is sprayed to carefully remove it from all areas. Scraping is not recommended due to the fragile nature of the mortar bedding.

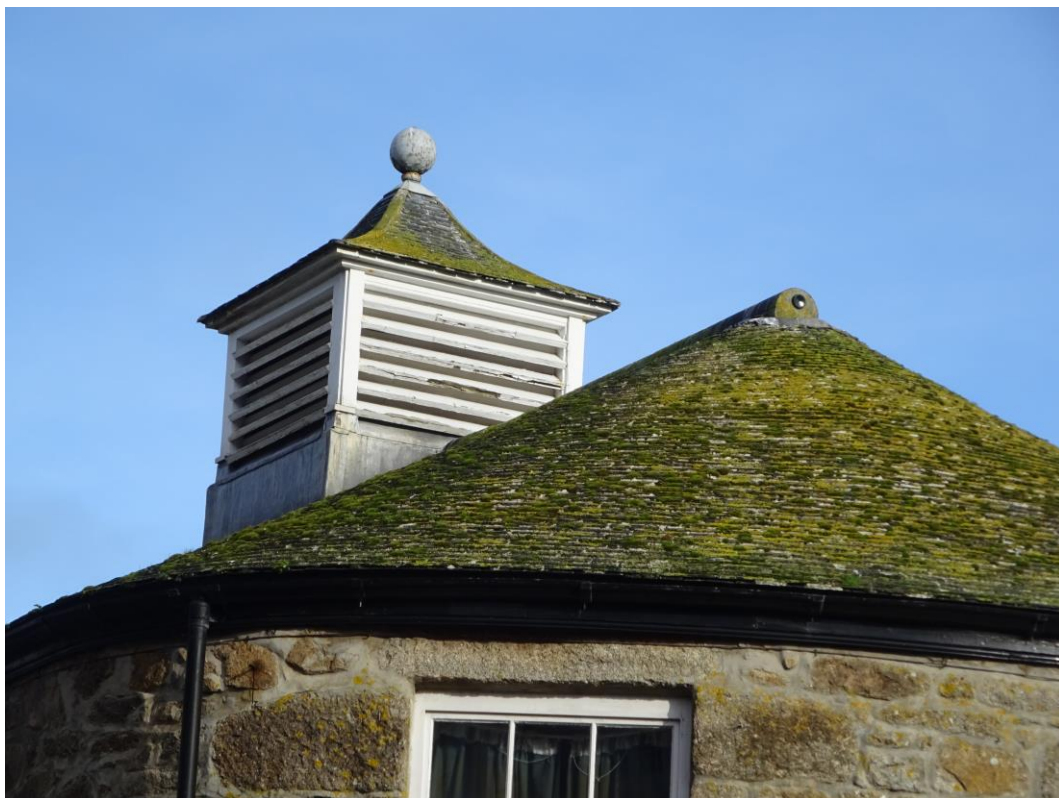
3. South roof

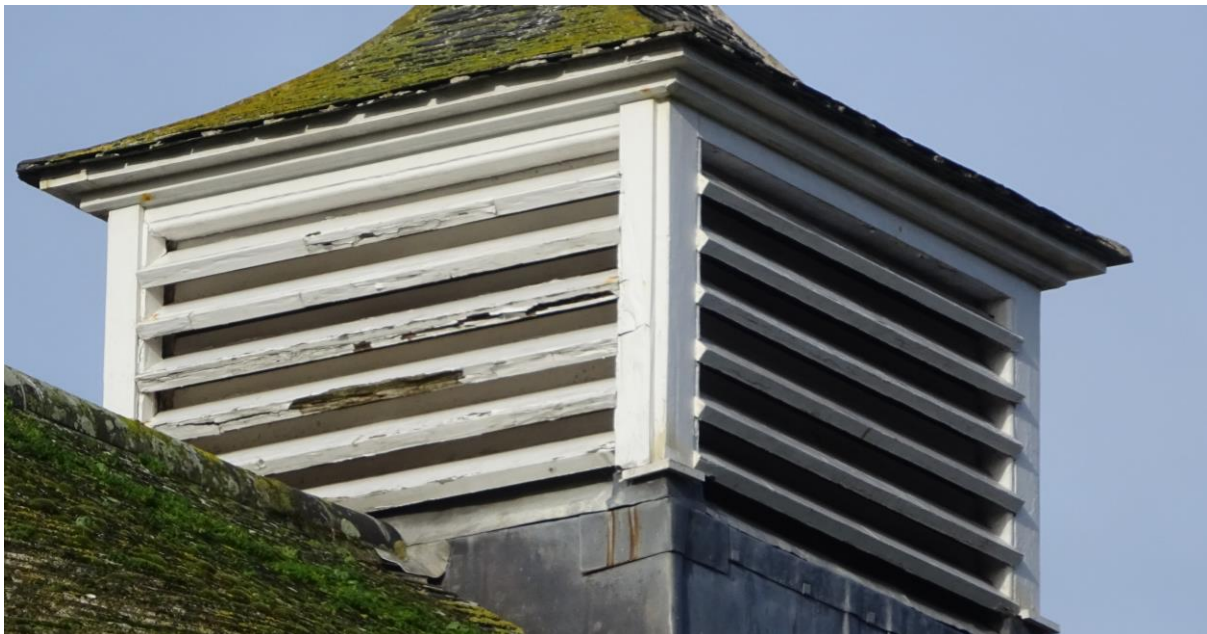
There are signs of deterioration to the louvres and corner posts with wet rot clearly visible on the sound side in particular. It appears as if this has been formed with a softwood timber. This needs regular decoration and in a coastal location such as this 3 years would be the recommended time frame for re-decoration.

4. Close up of southern louvres showing wet rot to the timbers.

Access and further assessment to the condition of the timber work is required and we would certainly recommend investigating replacing the existing timber with a more durable iroko hardwood or similar. This can be painted to the same standard but would be much more durable long term.

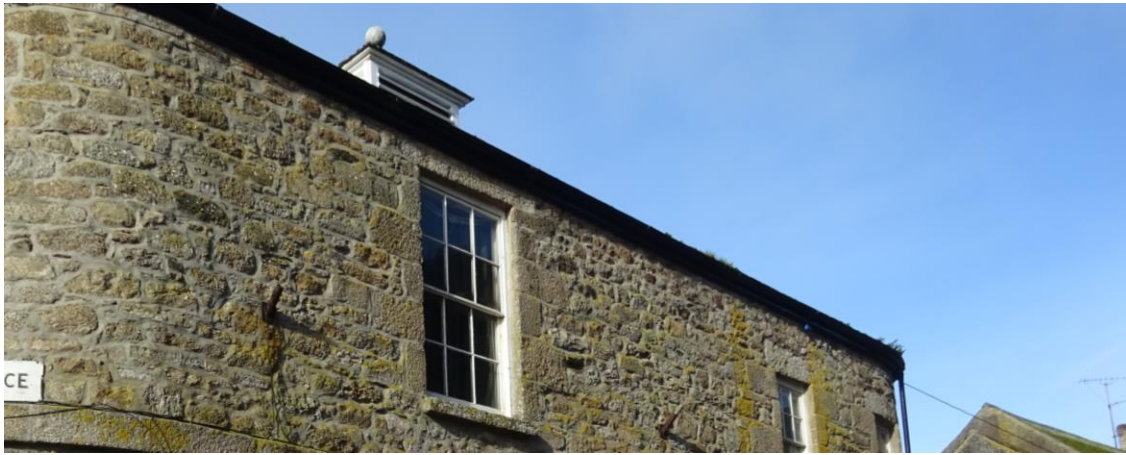
There is some evidence of rust to the rainwater goods largely due needing re-decoration with appropriate metal paint. The back of the gutters are not visible but generally these areas can be badly affected by rust which can cause the gutter sections to fail.

5. View along east gutter showing vegetation showing over the gutter line.

We would recommend accessing and assessing the gutters when fully cleared to ascertain if more extensive repairs are necessary beyond generally re-decoration.

The provision of further downpipes would be beneficial and this will avoid long runs where blockages can build up.

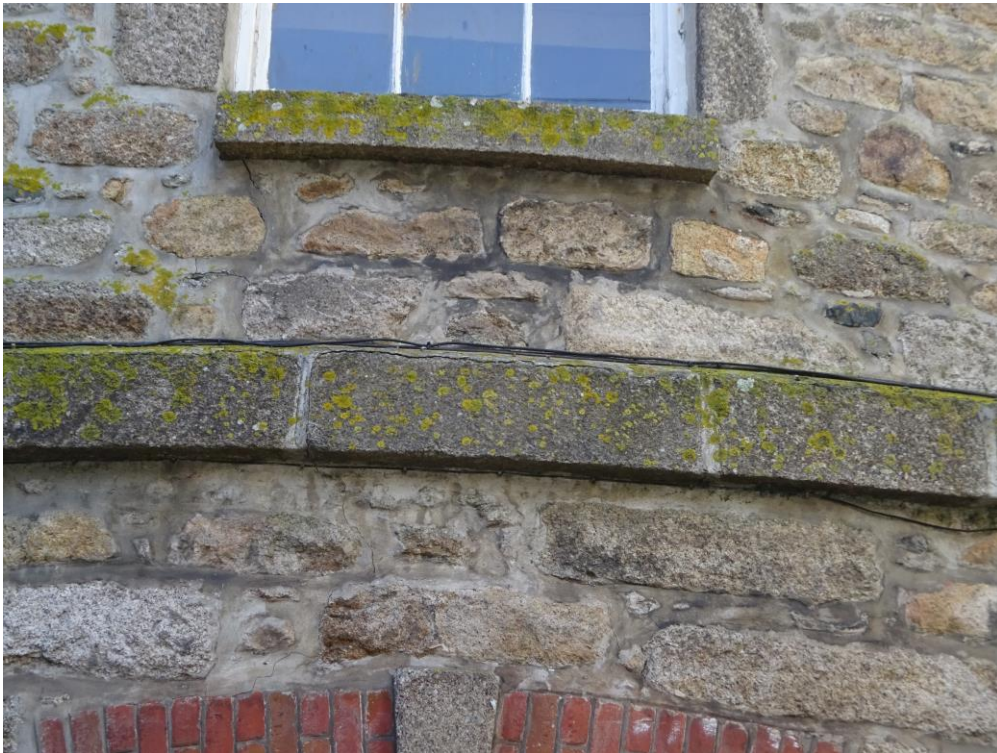
6. View of string course.

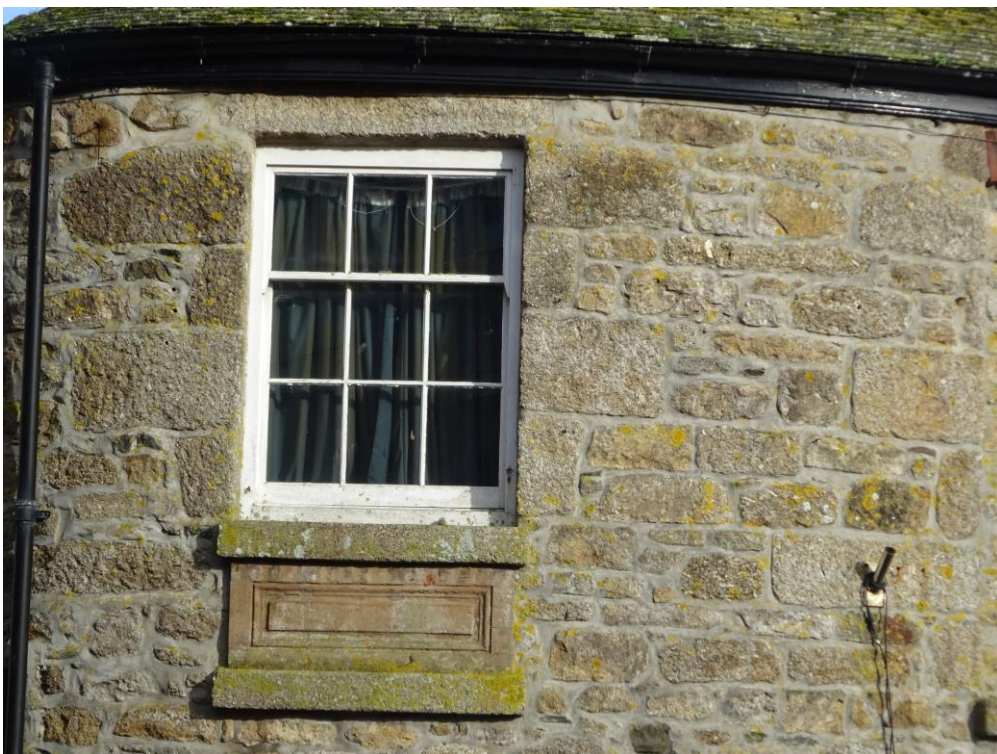
The building has been re-pointed in cement. This is impermeable and does not allow the masonry to breathe. This leads to trapped moisture within the core of the wall which can track internally. There is evidence on the first floor of penetration as a result of a lack of evaporation within the core of the wall. The granite is relatively robust but in time the harder cement can lead to excessive erosion of the stone surface, which leads to ledges forming and therefore further routes for moisture to penetrate. With sufficient weathering and erosion the mortar will drop off.

7. Close up view of masonry.

repointing here given the costs and potential for damage to the stone, but the masonry should be regularly checked as erosion can accelerate. Any loose or missing mortar should be repointed in breathable lime based mortar.

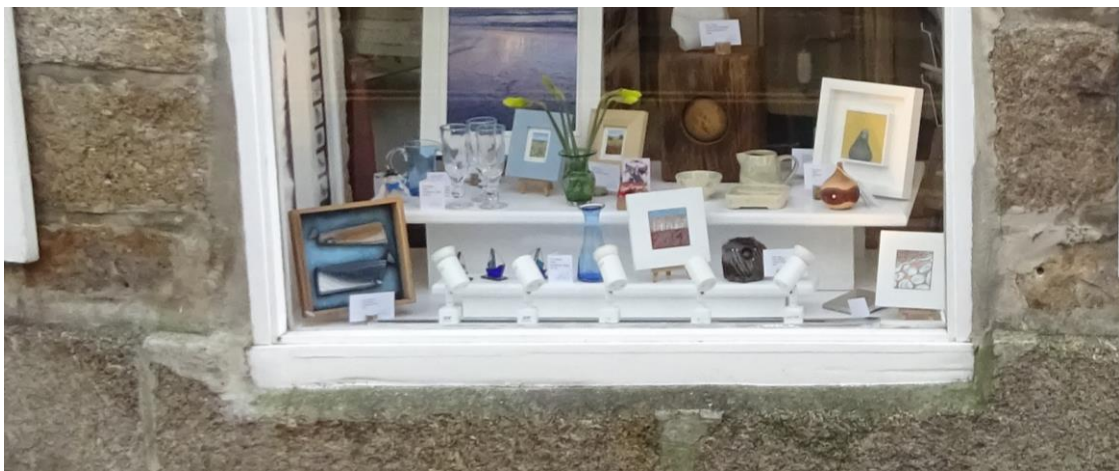
As per W1. Rot evident to cill and jambs to sides of frame. The paint will need fully stripping back to assess extent and repairs undertaken to the timberwork as required. This can be achieved in-situ using scarf joints to insert new sections of joinery.

8. Rot evident to cill of W4

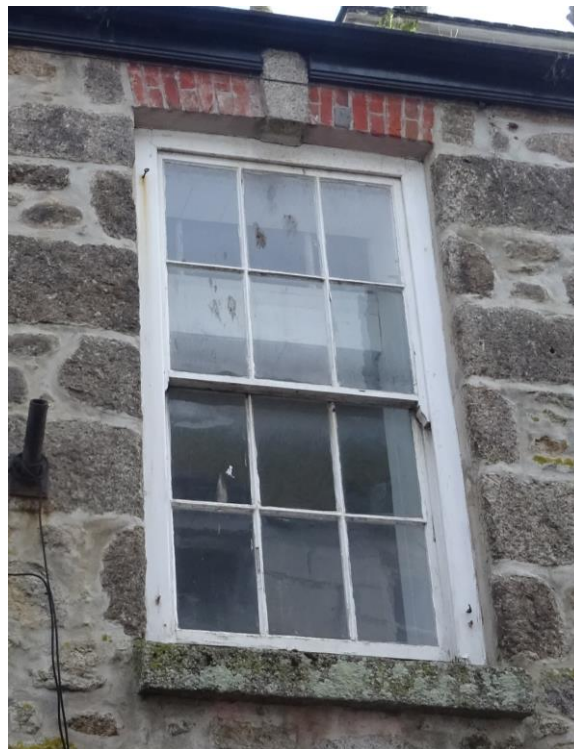
Timber frame sliding sash single glazed 12 pane horned window – possible replacement to standard un-horned sash. Horned sashes not used until 1850. Rot to cill evident. Window will need stripping back and timber repairs undertaken. Cracked pane to lower right as looking from outside will require replacement. Re-putty and redecorate.

9. View of 1W3.

Ease and ensure fully operational.

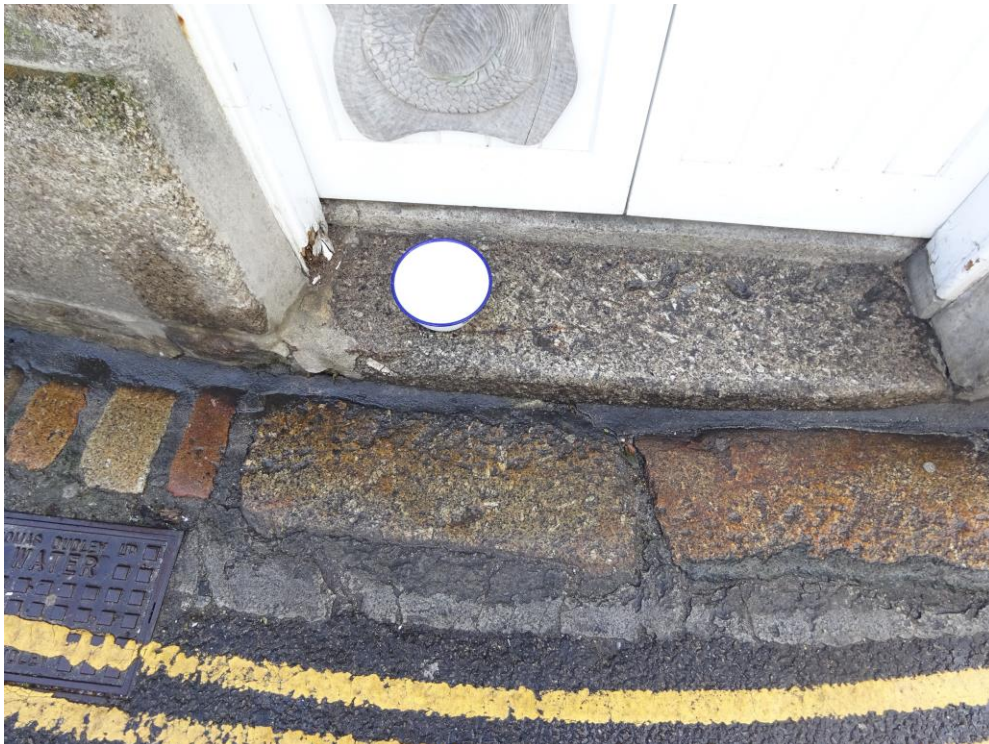
Timber frame single glazed 'french' doors into retail unit. Glazed upper and solid lower panel. Rot to base of frame on left side as viewed from outside. Base of frame on right side already cut short with render used to infill where frame base rotted. Scarf repairs required following assessment having removed all paintwork. Allow for re-decoration following repairs.

10. View of rotten frame to base of D4.

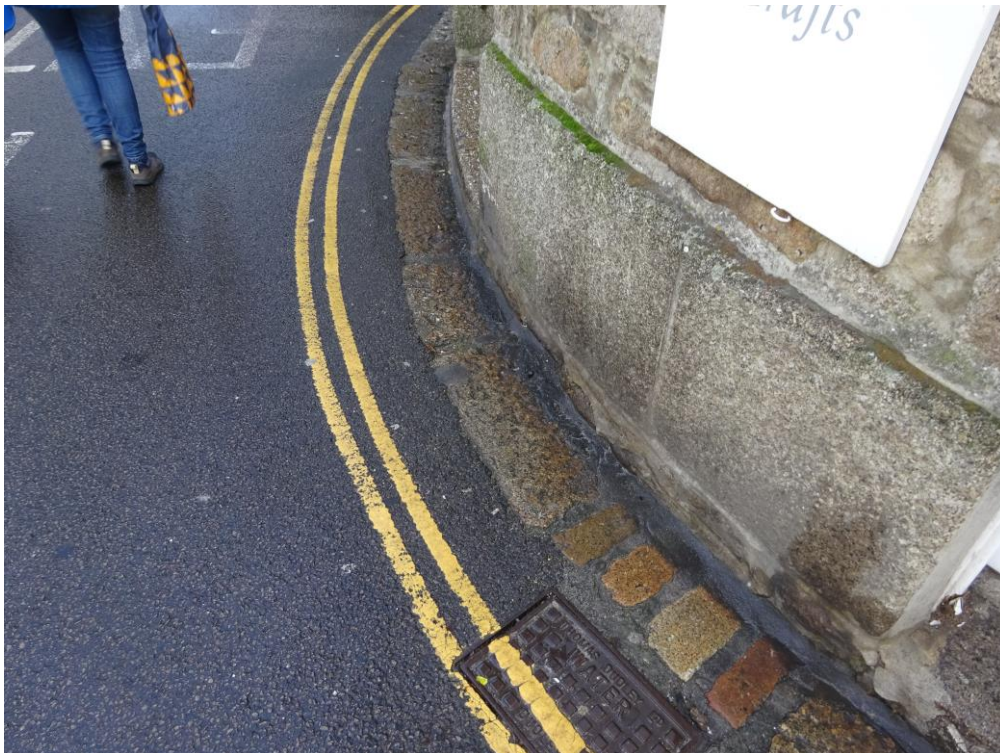
The building has no grounds surrounding beyond a strip of granite slabs that formed the original kerb to the road. These are part of the street. On the east side the original granite cobbles remain and these are listed separately (see listing in appendix). To the south, north and west the street is tarmac abutting the granite kerb, which is unfortunately. Care needs to be taken when working on or near the listed cobbles.

11. View of granite kerb stones that surround the building.

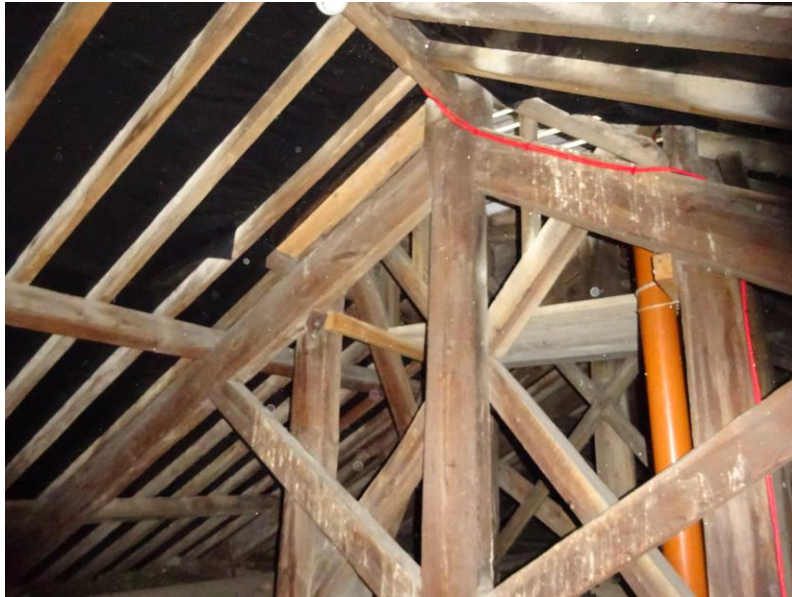
The roof is dry and the timbers are in good condition. We could not see any evidence of active rot or worm.

12. View of roof timbers towards vent tower framework

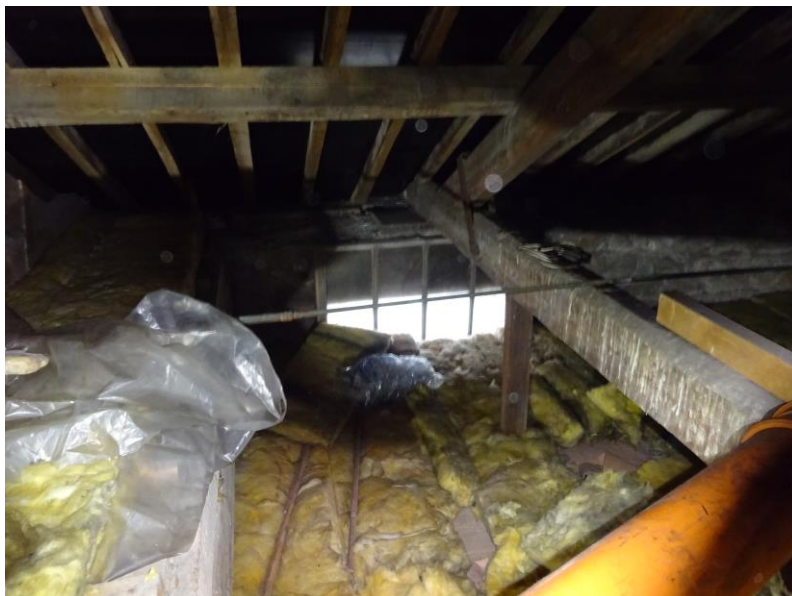
13. View towards window within roof void.

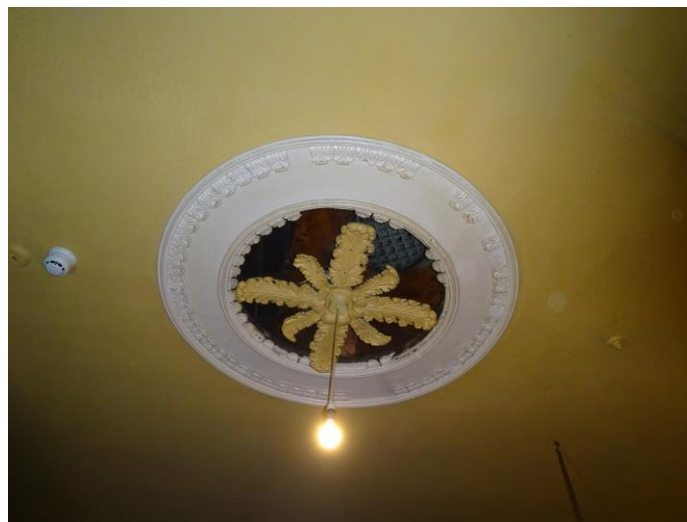
Lath and plaster with central plaster rose. Main ceiling shows no signs of damage or cracking, but plaster key and laths (as described above) should be checked from above when the roof void is cleared. Rose has lost some edge details that will need to be reinstated. This can be repaired.

14. View of ceiling rose

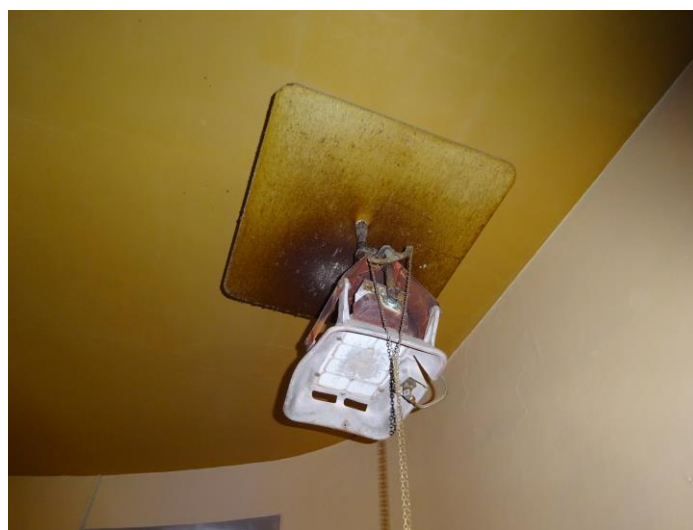
4 gas heaters hang from the ceiling. These are historic and would benefit from restoring and painting as a feature (not to be made operational). These have a metal plate just above to direct heat downwards. Large lights above the snooker tables are supported from timbers within the roof void. The supports in the roof void need checking when cleared out to assess condition.

15. Gas heaters to main hall.

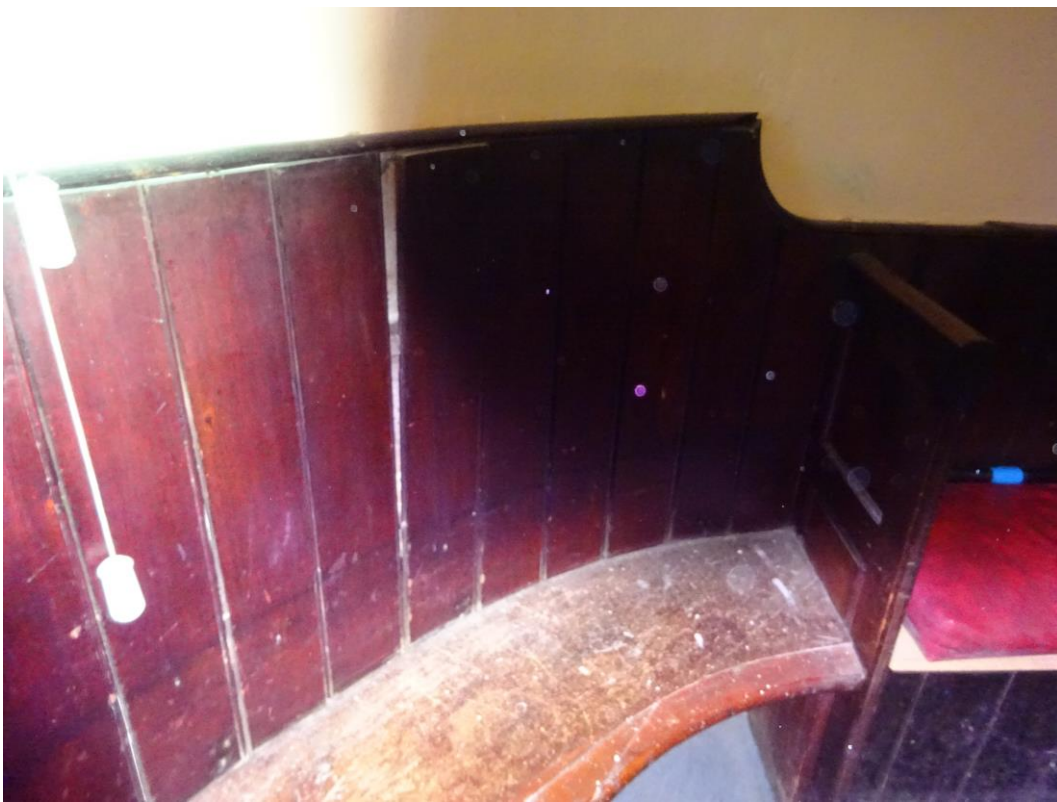
Timber wainscot to lower section with plaster on solid above. There is significant damage to the wainscot with many loose sections both between the timber sections and a loss of fixing to the walls. Missing section on north wall. Allow for repairing the wainscot to reinstated missing / loose elements and re-secure back to the walling having undertaken any repairs to surfaces behind.

16. Damaged wainscot boarding to northeast corner of main hall.

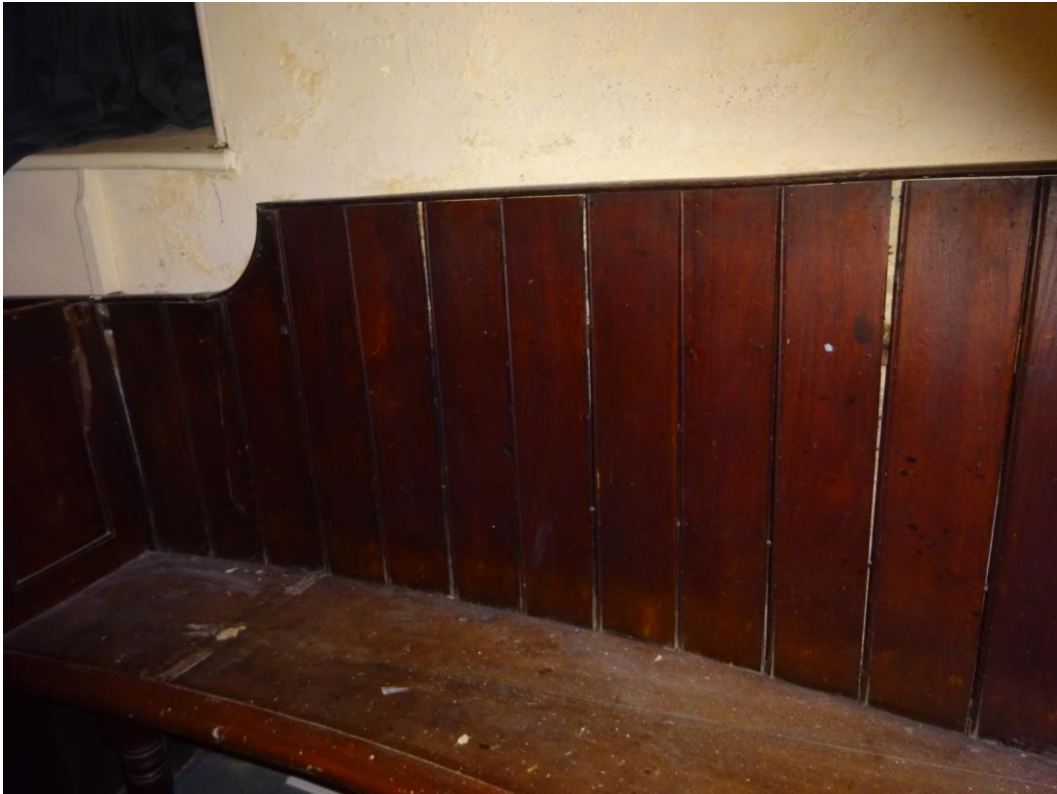
The plaster has blown in areas. There is an extensive area over the Mayor's seat. Clearly the wall has been affected by water penetration likely as a combination of historic roof leaks, water spilling over the back of blocked gutters or penetration through the blocked window openings externally. Emulsion paint has trapped moisture further. Areas of re-plastering required and the whole room requires decoration.

17. Damaged wainscot – note blown plaster above (just to left of mayor's seat).

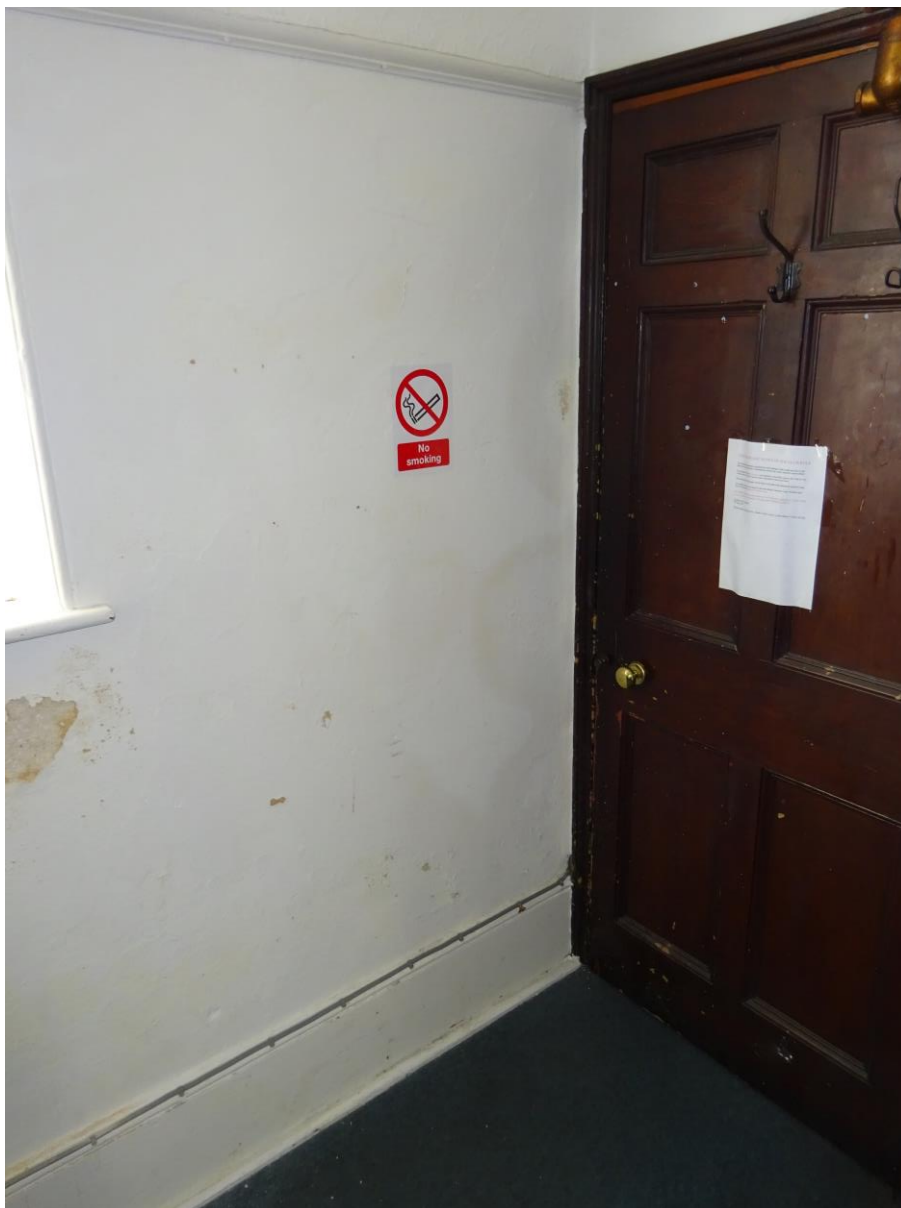
Wall to east (external) plaster on solid below picture rail – papered above. Plaster has blown in areas potentially due to historic water ingress. Patch repairs will be required in lime.

18. Historic damp and damaged plaster

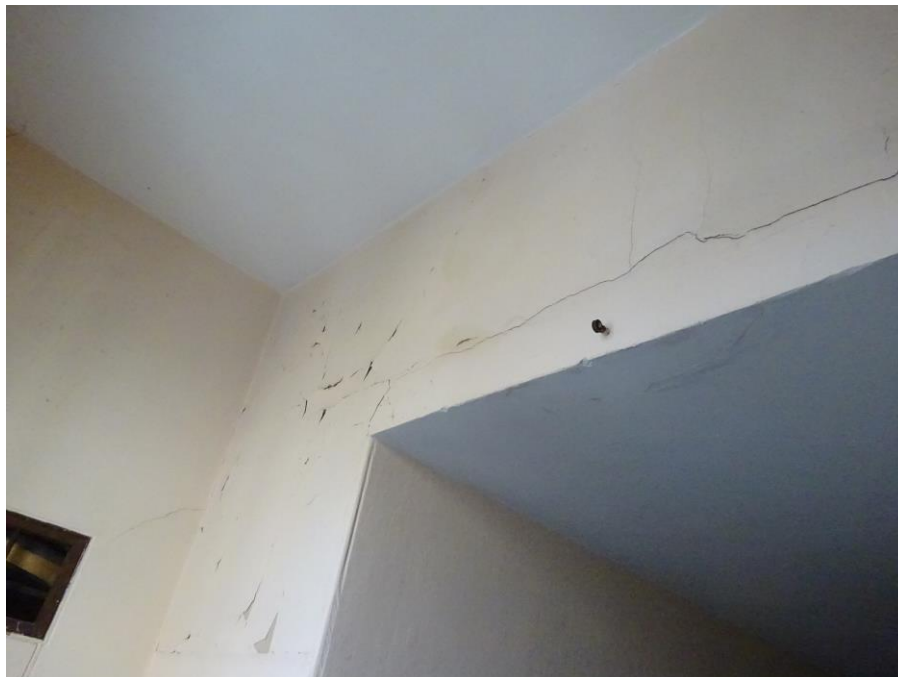
Wall to roof void opposite window where ceiling steps is cracking with peeling of paint work. This looks historic and potentially relates to an earlier leak that pre-dated the re-roofing project. This area should be scraped back for further assessment. It is likely that replastering is required to this area.

19. Cracking to wall opposite window to landing.

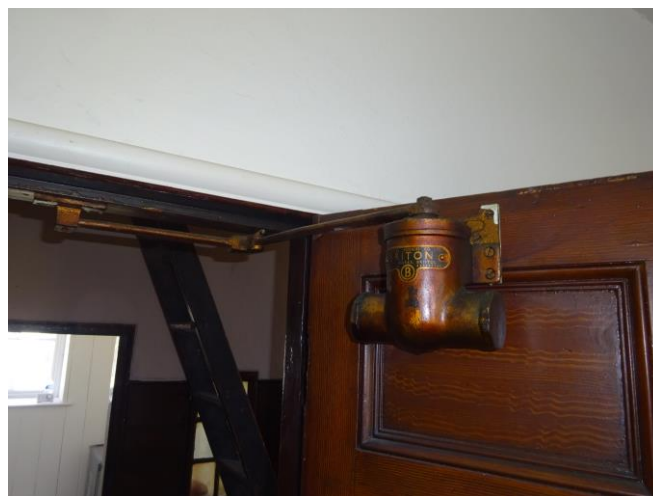
Historic Briton door closer on door to office. Still in operation. This should be retained and conserved.

20. Historic Briton door closer

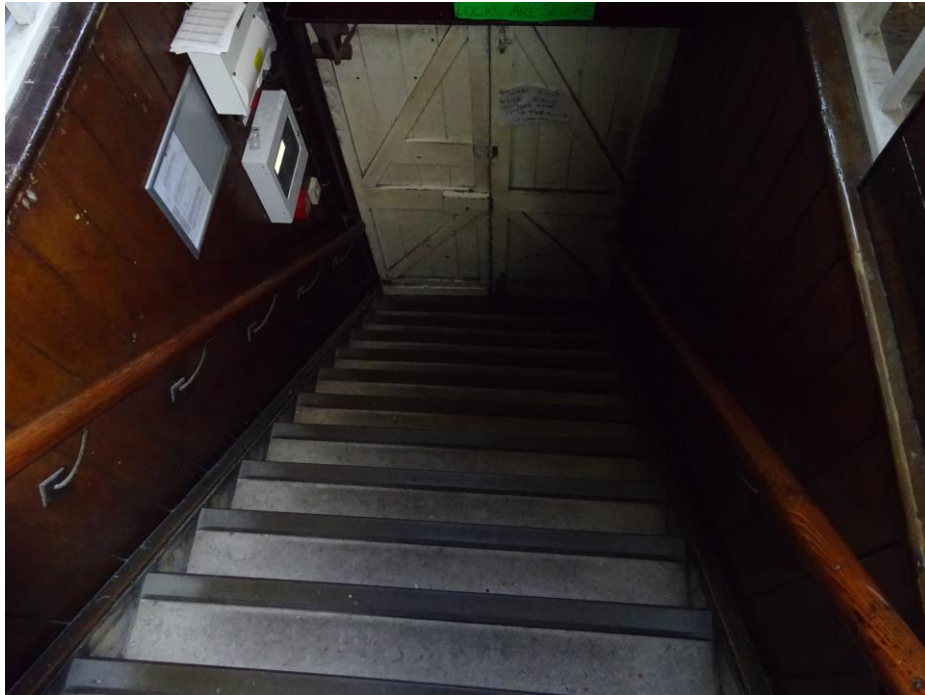
The stairs are formed from timber and lined with vinyl with rubber nosings. The stairs is generally in sound condition. They rise almost immediately from the doors onto the street. This is dangerous and causes access issues. They are also very steep and well beyond the recommended pitch for public access stairs. Unfortunately given the tight space within the landing and the historic features on either side, reformatting the stairs will be a challenge and alternative additional access such as a passenger lift may be the best way to ensure accessibility to the upper floor.

21. View of stairs

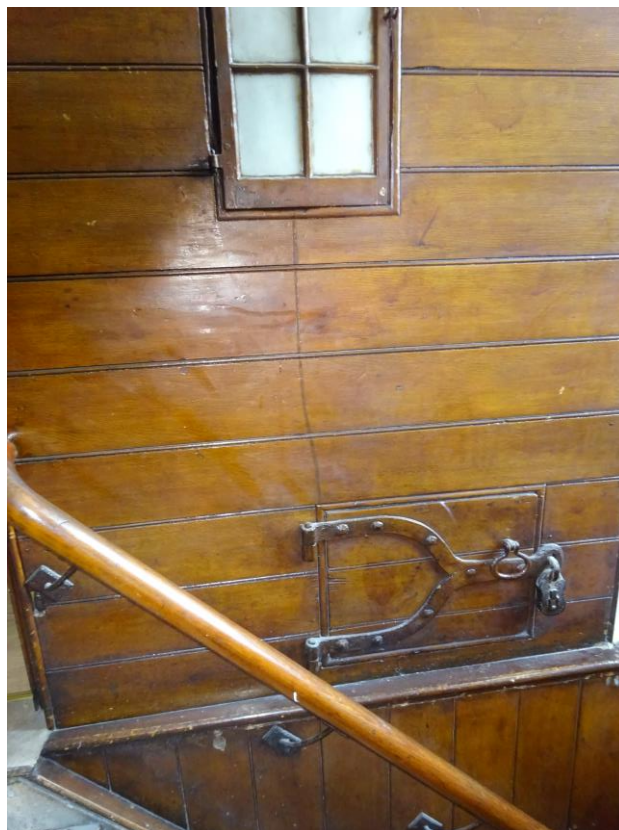
22. Historic gaol fittings

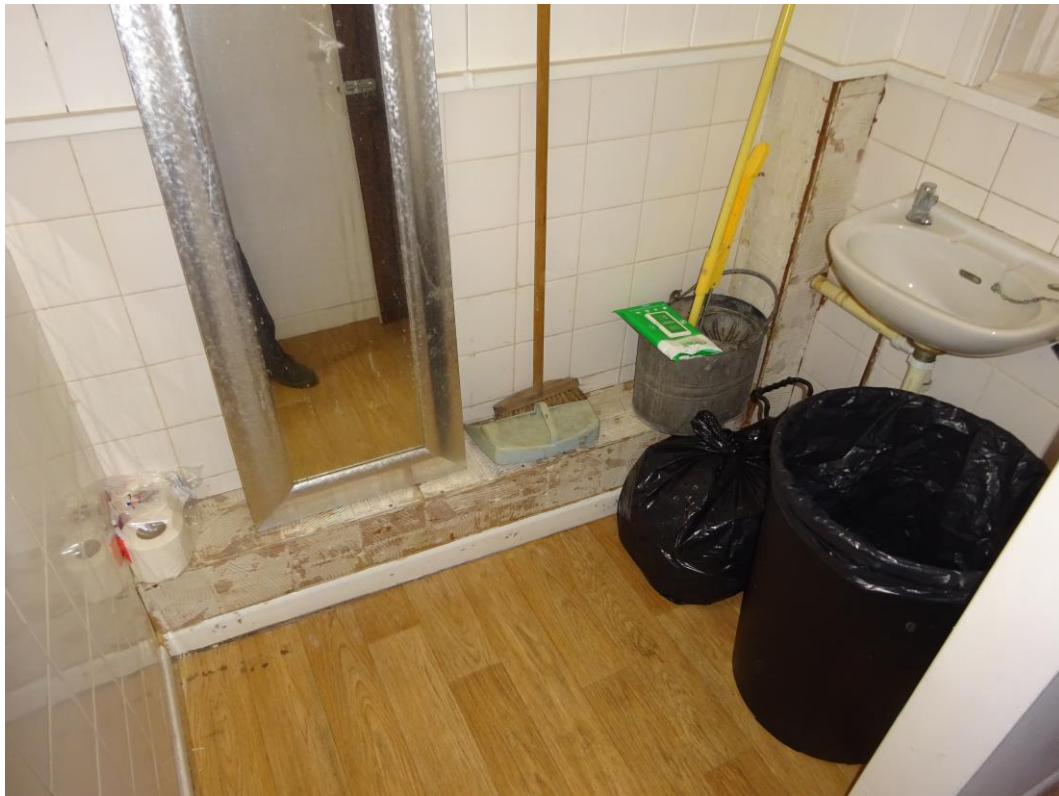
Mix traditional wide vertical boarding and plasterboard with tiling. Tiling to boxing beside the basin have come away (possibly to access the pipes historically). This will need reinstating or capping with a timber cover with improved access. There is cut to the boarding near the lavatory which looks to be from a former fitting. This will need to be repaired to ensure the covering is continuous. Tiles are tired – consider new tiling to improve appearance. Decoration required.

23. Removed tiles to boxing

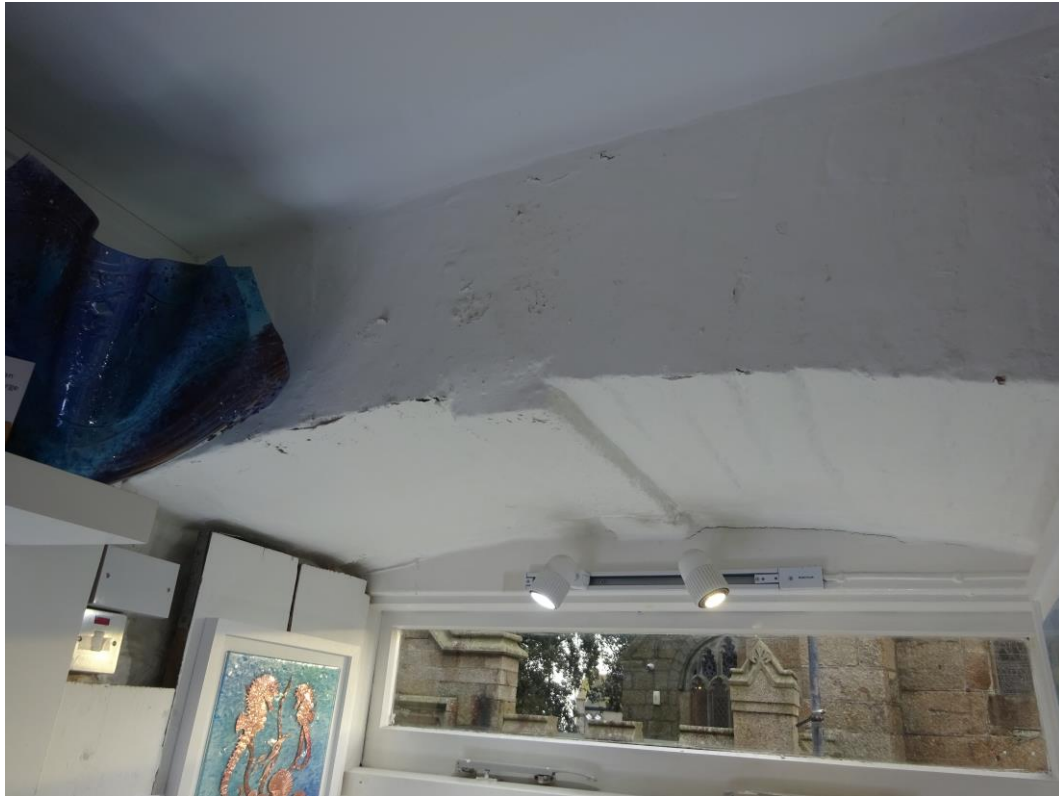
Painted stonework over external openings. Emulsion paint has been used and this is peeling in places. Consider redecoration with breathable mineral based paint.

24. Peeling paint to masonry elements
