Refurbishment & Demolition Survey

Building 6
Imperial War Museum Duxford
Cambridge
CB224QR

SURVEY ISSUE DATE: 23.03.2017

SURVEY NUMBER: SAS 4580

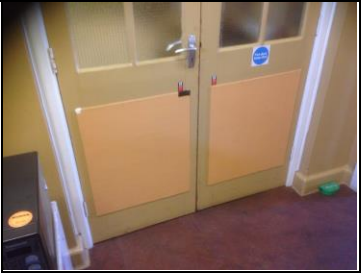
| Location | 001 - Lobby | | Extent | 2m2 | | | | |

| Building | Building 6 | | Comments | No comments. | | | E | |
| Floor | Ground Floor | | Item Description | Panel to wall | | | | |

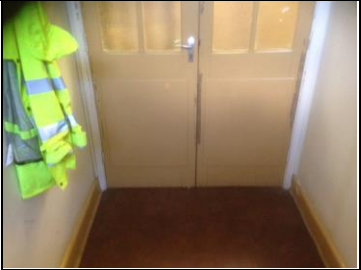
| Location | 004 - Lobby | | Extent | N/A | | | | |

| Building | Building 6 | | Comments | No comments. | | | E | |
| Floor | Ground Floor | | Item Description | Panel to wall | | | | |

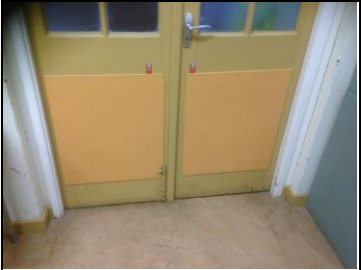
| Location | 006 - Stores | | Extent | N/A | | | | |

| Building | Building 6 | | Comments | No comments. | | | E | |
| Floor | Ground Floor | | Item Description | Panel to wall | | | | |

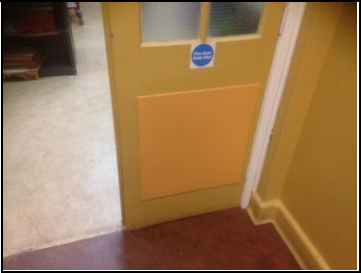
| Location | 007 - Lobby | | Extent | 2m2 | | | |

| Building | Building 6 | | Comments | No comments. | | | |
| Floor | Ground Floor | | Item Description | Panel to wall | | Recommendations | |

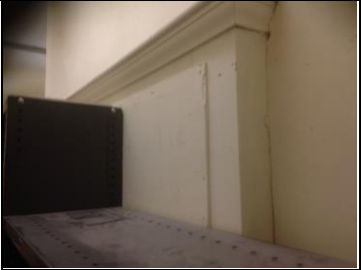
| Location | 015 - Stores | | Extent | 6m2 | | | |

| Building | Building 6 | | Comments | No comments. | | | |
| Floor | Ground Floor | | Item Description | Wall panel | | Recommendations | |

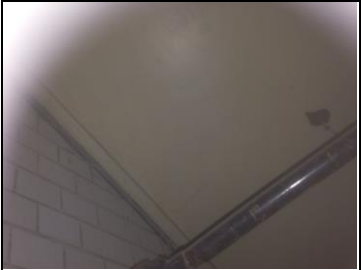
| Floor | Ground Floor | | Item Description | Ceiling panels | | Recommendations | |
| Location | 022 - Stores | | Extent | 40m2 | | Remove | |
| Condition | 1 | Low damage | Potential for exposure | 0 | Very low | | |

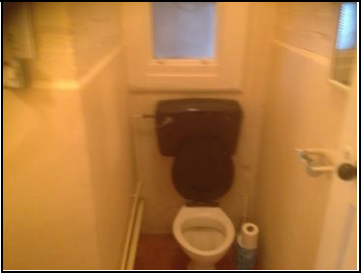
| Location | 029 - Toilet | | Extent | 1m2 | | | |

| Building | Building 6 | | Comments | No comments. | | | |
| Floor | Ground Floor | | Item Description | Toilet cistern | | | |

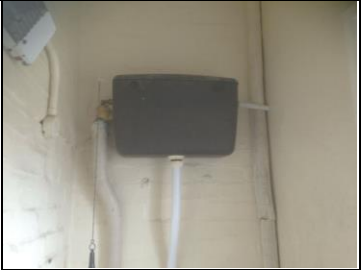
| Location | 030 - Toilet | | Extent | 1m2 | | | |

| Building | Building 6 | | Comments | No comments. | | | |
| Floor | Ground Floor | | Item Description | Toilet cistern | | | |

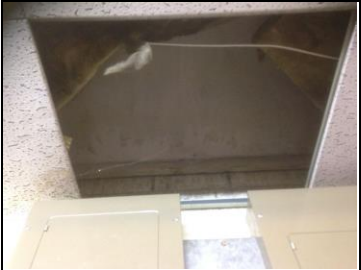
| Location | 031 - Stores | | Extent | 40m2 | | | |

| Building | Building 6 | | Comments | No comments. | | | |
| Floor | Ground Floor | | Item Description | Ceiling panels | | | |
| Condition | 1 | Low damage | Potential for exposure | 0 | Very low | | |

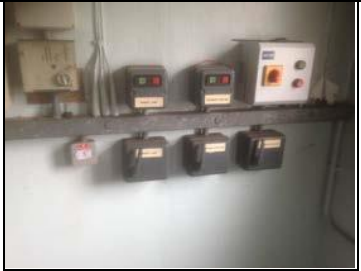
| Location | 038 - Plant room | | Extent | 2m2 | | | |

| Floor | Ground Floor | | Item Description | Electrics | | | |
| Condition | 1 | Low damage | Potential for exposure | 0 | Very low | | |

| | | | | | | Remove | |

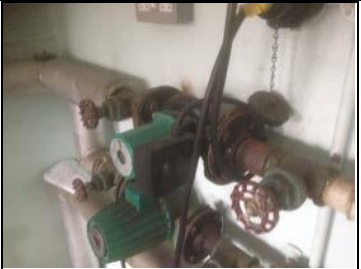
| Location | 038 - Plant room | | Extent | Throughout | | | |

| Floor | Ground Floor | | Item Description | Gaskets | | | |
| Condition | 1 | Low damage | Potential for exposure | 0 | Very low | | |

| | | | | | | Remove | |

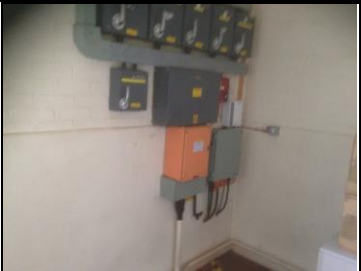
| Location | 043 - Stores | | Extent | 2m2 | | | |

| Floor | Ground Floor | | Item Description | Electrics | | | |
| Condition | 1 | Low damage | Potential for exposure | 0 | Very low | | |

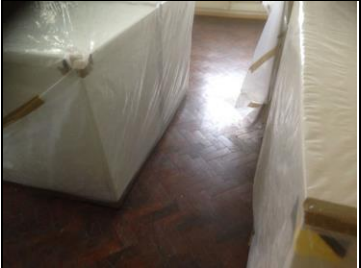
| Location | 003 - Stores | | Item Description | Bitumen to floor | | Recommendations | |
| Sample No. | As 007 | | Extent | N/A | | <div style="font-size: 2em; font-weight: bold; margin-top: 20px;">E</div> | |

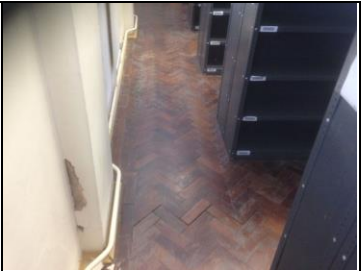
| Location | 004 - Stores | | Item Description | Bitumen to floor | | Recommendations | |
| Sample No. | As 007 | | Extent | N/A | | <div style="font-size: 2em; font-weight: bold; margin-top: 20px;">E</div> | |

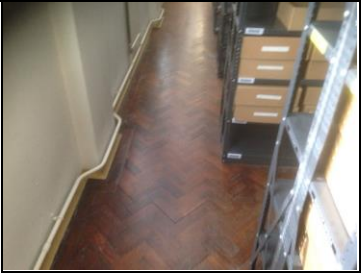
| Location | 005 - Stores | | Extent | N/A | | | |

| Building | Building 6 | | Comments | No comments. | | E | |
| Floor | First Floor | | Item Description | Bitumen to floor | | | |

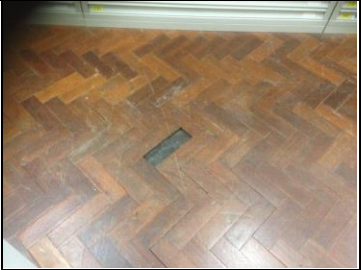
| Location | 006 - Stores | | Extent | 50m2 | | | |

| Building | Building 6 | | Comments | No comments. | | E | |
| Floor | First Floor | | Item Description | Bitumen to floor | | | |

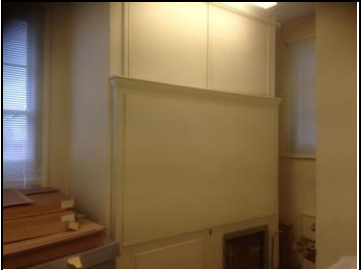
| Location | 006 - Stores | | Extent | 8m2 | | | |

| Building | Building 6 | | Comments | No comments. | | E | |
| Floor | First Floor | | Item Description | Wall panels | | | |

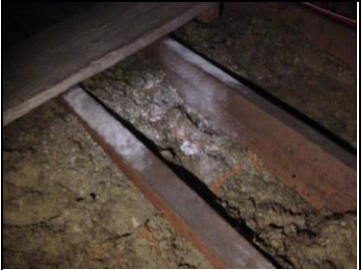
| Location | 013 - Loft | | Item Description | debris to floor | | Recommendations | |
| Sample No. | 015 | | Extent | N/A | | <div style="background-color: white; color: black; font-size: 2em; width: 40px; height: 40px; margin: 0 auto; display: flex; align-items: center; justify-content: center;">E</div> | |
| Condition | N/A | N/A | Accessibility | N/A | N/A | | E |

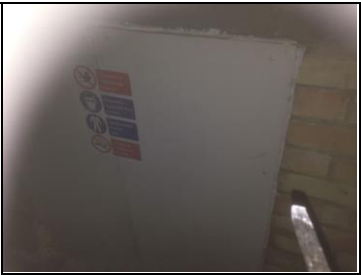
| Location | 001 - Loft | | Extent | 2m2 | | <p align="center">E</p> | |

| Building | Building 6 | | Comments | No comments. | | | |
| Floor | Second Floor | | Item Description | Panel to wall | | Recommendations | |

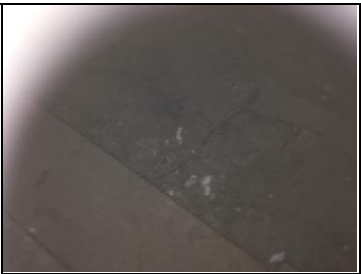
| Floor | Second Floor | | Item Description | Residue to floor | | Recommendations | |
| Location | 002 - Loft | | Extent | Throughout | | <p align="center">C</p> | |
| Product Type | 3 | Thermal insulation, sprayed asbestos, loose asbestos etc. | Accessibility | 0 | Usually inaccessible | | |
| Condition | 3 | High damage | Potential for exposure | 0 | Very low | | |
| Surface Treatment | 3 | Unsealed lagging and sprays | Maintenance Activity | 0 | Minor Disturbance | | |
| Asbestos Type | 3 | Crocidolite | | | | | |

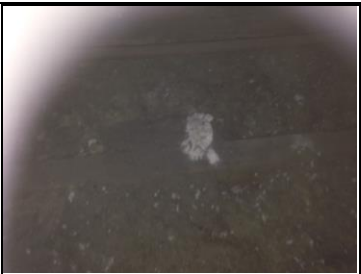
| Floor | Second Floor | | Item Description | Residue to floor | | Recommendations | |
| Location | 002 - Loft | | Extent | Throughout | | <p align="center">C</p> | |
| Product Type | 3 | Thermal insulation, sprayed asbestos, loose asbestos etc. | Accessibility | 0 | Usually inaccessible | | |
| Condition | 3 | High damage | Potential for exposure | 0 | Very low | | |

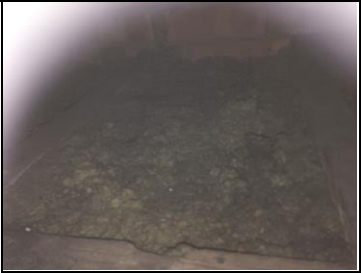
| Location | 003 - Loft | | Item Description | Debris to floor | | Recommendations |
| Condition | 0 | N/A | Accessibility | 0 | N/A | |
| E | | | | | | |
