## ***ASBESTOS SURVEY REPORT***

***REPORT ID NO: AAS101105DXT-D***

***SITE NAME: Yew Tree Court***

***CLIENT: Broxstowe Council***

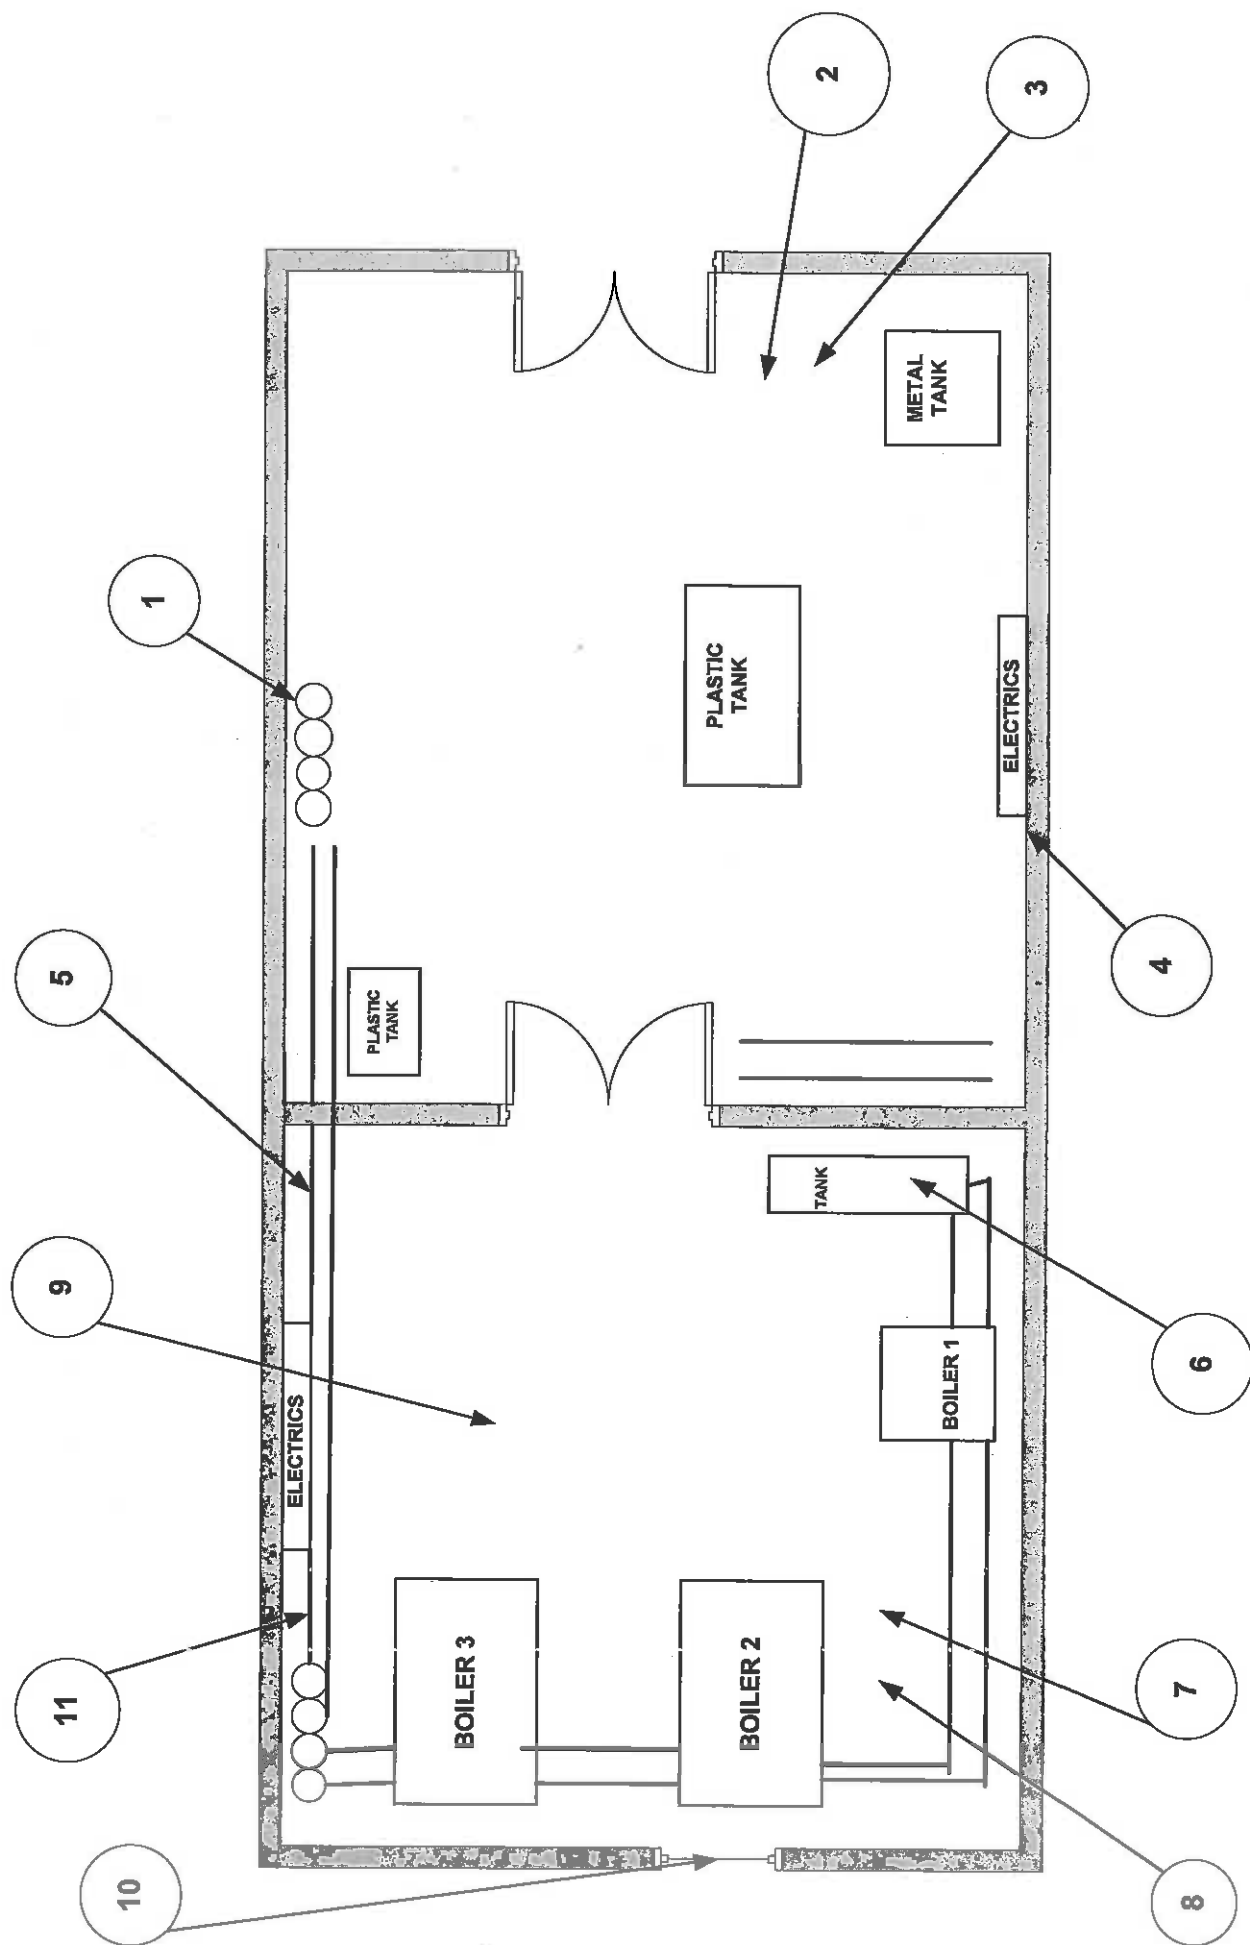
# BOILERHOUSE TO YEW TREE COURT

*Sample 11 - Boiler Room Gasket To Pipework*
