Asbestos Refurbishment Survey

The Town Hall

Shaftesbury

Survey Date: 30th June 2023
Job Number: CAS 1620-1

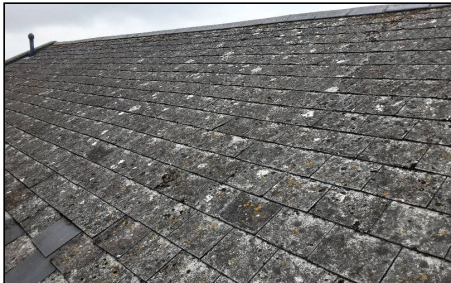
| Building | Floor | Location /Room No. | Item | S,P,SP,AS Sample No | Product Type | Condition | Surface Treatment | Asbestos Type | Quantity | Accessibility | Material Score |
|---|---|---|---|---|---|---|---|---|---|--|---|
| Shaftesbury Town Hall | External | External / E01 | Cement Slates - Roof . | S CA001506 | Asbestos Cement | Low Damage | Surface Sealed | Chrysotile | 200m ² | Usually inaccessible or unlikely to be disturbed | 4 |

| | Survey Date: | Lead Surveyor | Survey Type | Floor | Analysis |
| | 30 Jun 2023 | Aaron Silvester | Refurbishment Survey | External | Chrysotile (1) |
| | CA001506 (S) | Asbestos Cement (1) | Surface Sealed (1) | Low Damage (1) | Usually inaccessible or unlikely to be disturbed |

| | Survey Date: | Lead Surveyor | Survey Type | Floor | Analysis |
|--|---|---|---|---|--|
| Recommended action | Removal | | | | |
| Surveyor comments | Remove If Affected By Proposed Works | | | | |

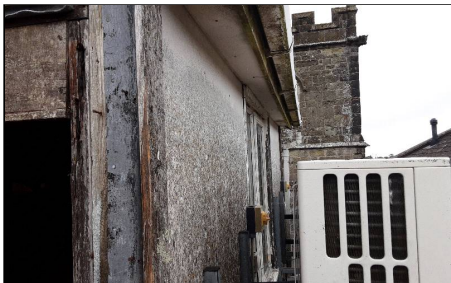
| | Survey Date: | Lead Surveyor | Survey Type | Floor | Analysis |
| | 30 Jun 2023 | Aaron Silvester | Refurbishment Survey | External | No Asbestos Detected |

| | Survey Date: | Lead Surveyor | Survey Type | Floor | Analysis |
|---|---|---|---|---|---|
| Recommended action | No Further Action Required | | | | |

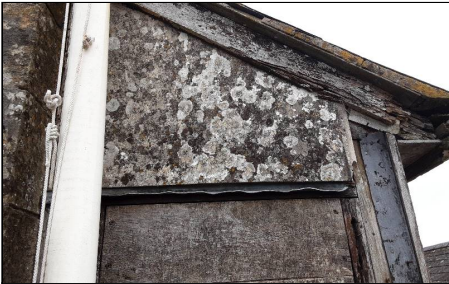
| Building | Floor | Location /Room No. | Item | S,P,SP,AS Sample No | Product Type | Condition | Surface Treatment | Asbestos Type | Quantity | Accessibility | Material Score |
|---|---|---|---|---|---|---|---|---|---|--|---|
| Shaftesbury Town Hall | External | External / E01 | Cement Panels - Fascias & Undercloaking . | S CA001508 | Asbestos Cement | Low Damage | Surface Sealed | Chrysotile | 1m ² | Usually inaccessible or unlikely to be disturbed | 4 |

| | Survey Date: | Lead Surveyor | Survey Type | Floor | Analysis |
| | 30 Jun 2023 | Aaron Silvester | Refurbishment Survey | External | Chrysotile (1) |
| | CA001508 (S) | Asbestos Cement (1) | Surface Sealed (1) | Low Damage (1) | Usually inaccessible or unlikely to be disturbed |

| | Survey Date: | Lead Surveyor | Survey Type | Floor | Analysis |
|--|---|---|---|---|--|
| Recommended action | | Removal | | | |

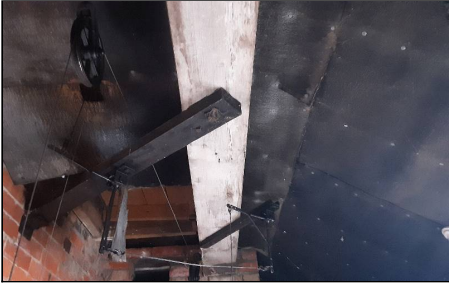
| | Survey Date: | Lead Surveyor | Survey Type | Floor | Analysis |
| | 30 Jun 2023 | Aaron Silvester | Refurbishment Survey | External | No Asbestos Detected |

| | Survey Date: | Lead Surveyor | Survey Type | Floor | Analysis |
|---|---|---|---|---|---|
| Recommended action | | No Further Action Required | | | |

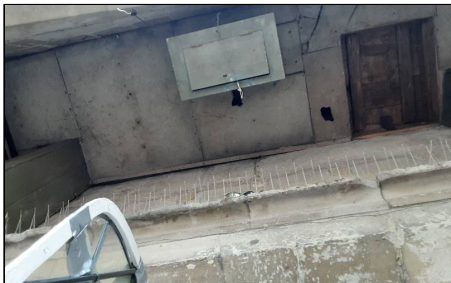
| Building | Floor | Location /Room No. | Item | S,P,SP,AS Sample No | Product Type | Condition | Surface Treatment | Asbestos Type | Quantity | Accessibility | Material Score |
|---|---|---|---|---|---|---|---|---|---|--|---|
| Shaftesbury Town Hall | External | External / E01 | Cement Panels - Underside Of Clock Rm . | SP As CA001508 | Asbestos Cement | Low Damage | Surface Sealed | Chrysotile | 2.5m ² | Usually inaccessible or unlikely to be disturbed | 4 |

| | Survey Date: | Lead Surveyor | Survey Type | Floor | Analysis |
| | 30 Jun 2023 | Aaron Silvester | Refurbishment Survey | External | Chrysotile (1) |
| | As CA001508 (SP) | Asbestos Cement (1) | Surface Sealed (1) | Low Damage (1) | Usually inaccessible or unlikely to be disturbed |

| | Survey Date: | Lead Surveyor | Survey Type | Floor | Analysis |
|--|---|---|---|---|--|
| Recommended action | Removal | | | | |
