TARGETED PRE-REFURBISHMENT SURVEY

APEX HOUSE
3 EMBASSY DRIVE
EDGBASTON
BIRMINGHAM
B15 1TR

15.06.2016

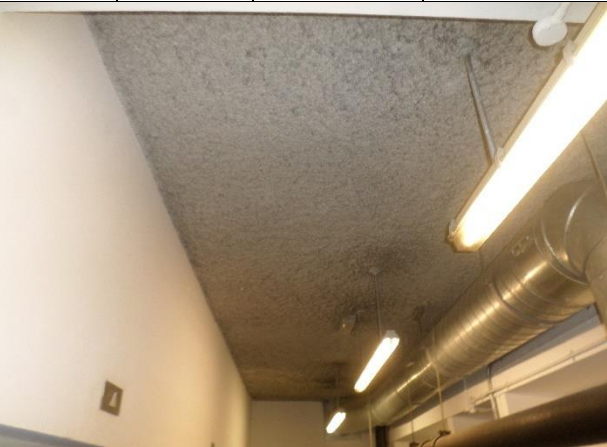
| ITEM | Sample Number | Exterior/ Interior | Level | Location/ Room | Position | Quantity (Approx) |
|---|---|---|---|--|---|---|
| 00 | 002 | Interior | Basement | Lift lobby | Ceiling | Throughout |

| ITEM | Sample Number | Exterior/ Interior | Level | Location/ Room | Position | Quantity (Approx) |
|---|---|---|---|--|---|---|
| | | | | Fibreglass insulation (non-asbestos) | | |

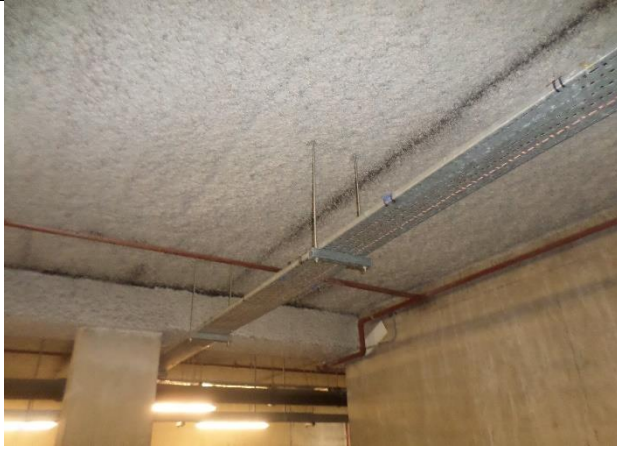
| ITEM | Sample Number | Exterior/ Interior | Level | Location/ Room | Position | Quantity (Approx) |
|---|---|---|---|--|---|---|
| 00 | 003 | Interior | Basement | Car park | Ceiling | Throughout |

| ITEM | Sample Number | Exterior/ Interior | Level | Location/ Room | Position | Quantity (Approx) |
|---|---|---|---|--|---|---|
| | | | | Fibreglass insulation (non-asbestos) | | |

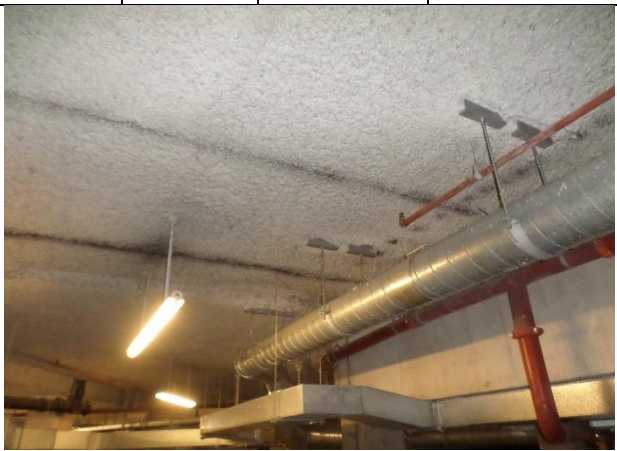
| ITEM | Sample Number | Exterior/ Interior | Level | Location/ Room | Position | Quantity (Approx) |
|---|---|---|---|--|---|---|
| 00 | 004 | Interior | Basement | Car park | Ceiling | Throughout |

| ITEM | Sample Number | Exterior/ Interior | Level | Location/ Room | Position | Quantity (Approx) |
|---|---|---|---|--|---|---|
| | | | | Fibreglass insulation (non-asbestos) | | |

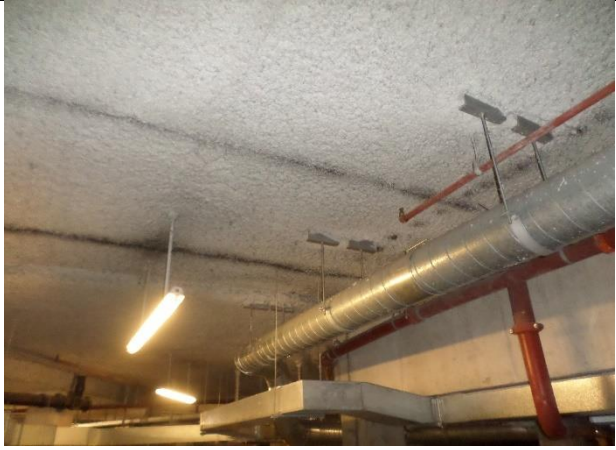
| ITEM | Sample Number | Exterior/ Interior | Level | Location/ Room | Position | Quantity (Approx) |
|---|---|---|---|--|---|---|
| 00 | 005 | Interior | Basement | Car park | Ceiling | Throughout |

| ITEM | Sample Number | Exterior/ Interior | Level | Location/ Room | Position | Quantity (Approx) |
|---|---|---|---|--|---|---|
| | | | | Fibreglass insulation (non-asbestos) | | |

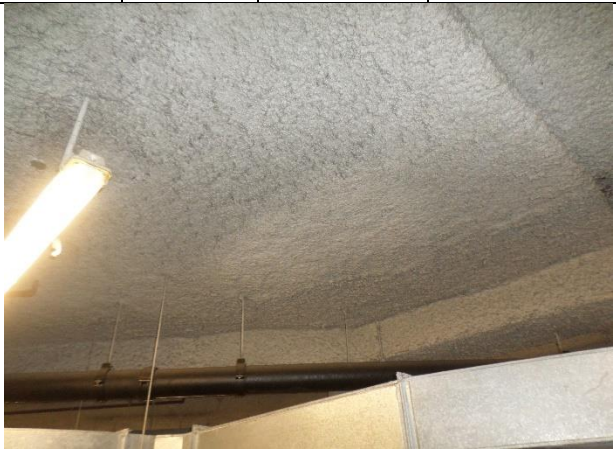
| ITEM | Sample Number | Exterior/ Interior | Level | Location/ Room | Position | Quantity (Approx) |
|---|---|---|---|--|---|---|
| 00 | 006 | Interior | Basement | Car park | Ceiling | Throughout |

| ITEM | Sample Number | Exterior/ Interior | Level | Location/ Room | Position | Quantity (Approx) |
|---|---|---|---|--|---|---|
| | | | | Fibreglass insulation (non-asbestos) | | |
