Asbestos Refurbishment and Demolition Survey Report

Site Address: High Cross
Madingley Road
Cambridge,
CB3 0ET

Survey Reference: J178267
Survey Date: 11 Dec 2019 to 18 Feb 2020

Client: British Antarctic Survey
Client Address: High Cross
Madingley Road
Cambridge

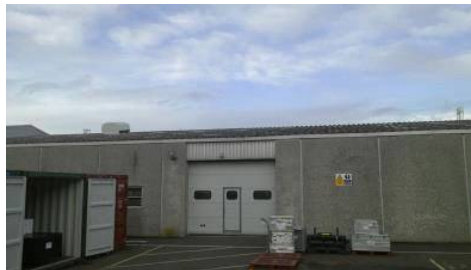
Asbestos Content: **Contains (1) Chrysotile asbestos fibres.**

Material Score	1	Extent of Damage Score	1
Surface Treatment Score	1	Asbestos Type Score	1

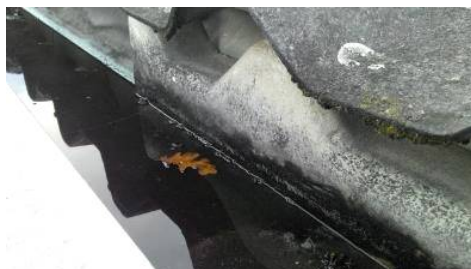
Asbestos Content: **Contains (1) Chrysotile asbestos fibres.**

Material Score	1	Extent of Damage Score	0
Surface Treatment Score	1	Asbestos Type Score	1

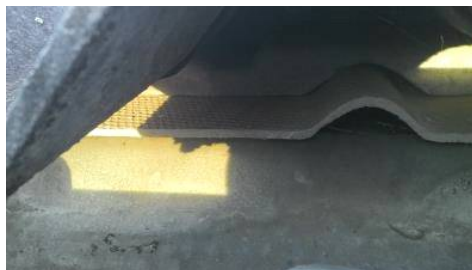
Asbestos Content: **Contains (1) Chrysotile asbestos fibres.**

Material Score	1	Extent of Damage Score	1
Surface Treatment Score	1	Asbestos Type Score	1

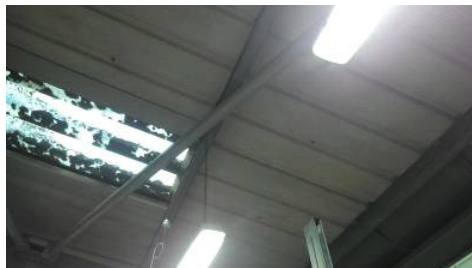
Profile ceiling - cement - rough edging with loose material at fixings (as sample CE003428)

Asbestos Content: **Strongly presumed to contain (1) Chrysotile asbestos fibres.**

Material Score	1	Extent of Damage Score	1
Surface Treatment Score	1	Asbestos Type Score	1

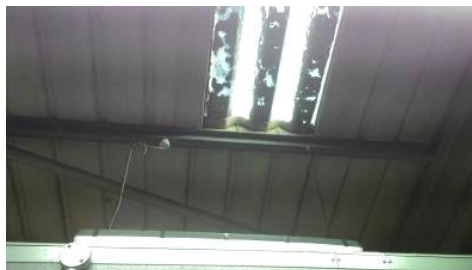
Asbestos Content: **Strongly presumed to contain (1) Chrysotile asbestos fibres.**

Material Score	1	Extent of Damage Score	1
Surface Treatment Score	1	Asbestos Type Score	1

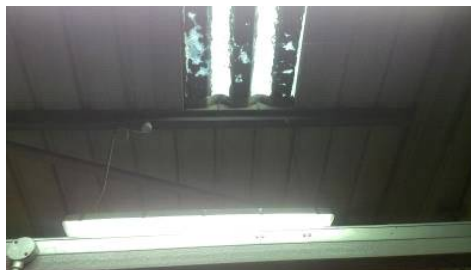
Asbestos Content: **Strongly presumed to contain (1) Chrysotile asbestos fibres.**

Material Score	1	Extent of Damage Score	0
Surface Treatment Score	1	Asbestos Type Score	1

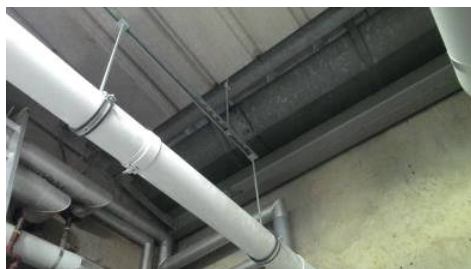
Asbestos Content: **Contains (1) Chrysotile asbestos fibres.**

Material Score	1	Extent of Damage Score	0
Surface Treatment Score	0	Asbestos Type Score	1

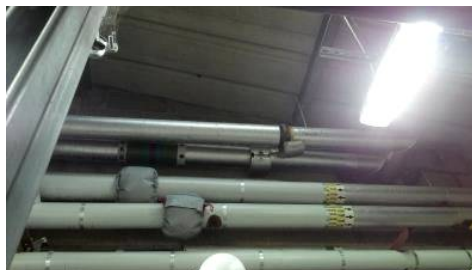
Asbestos Content: **Contains (1) Chrysotile asbestos fibres.**

Material Score	2	Extent of Damage Score	0
Surface Treatment Score	1	Asbestos Type Score	1

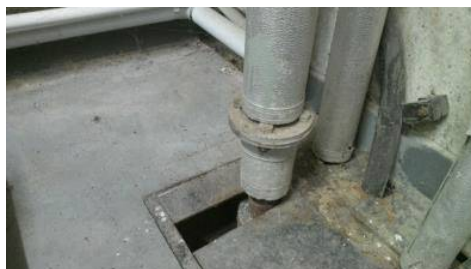
Asbestos Content: **Contains (1) Chrysotile asbestos fibres.**

Material Score	2	Extent of Damage Score	0
Surface Treatment Score	1	Asbestos Type Score	1

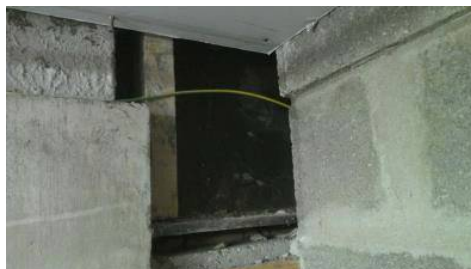
Inspection photograph showing structure of concrete clad steel columns, mezzanine steel joists and ground floor/mezzanine block walls

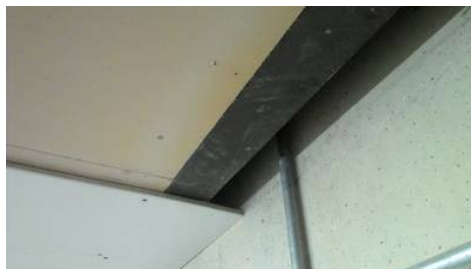
Inspection photograph showing structure of plasterboard ceiling/cladding to mezzanine steel joists with timber joists and timber flooring above

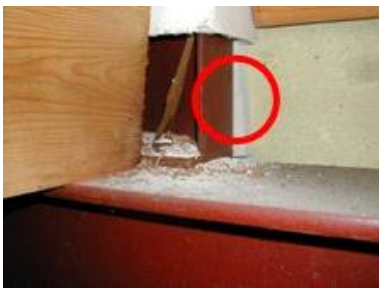
<p><i>Concealed within ceiling voids – Asbestos Insulation Board packing behind I-beams</i></p>

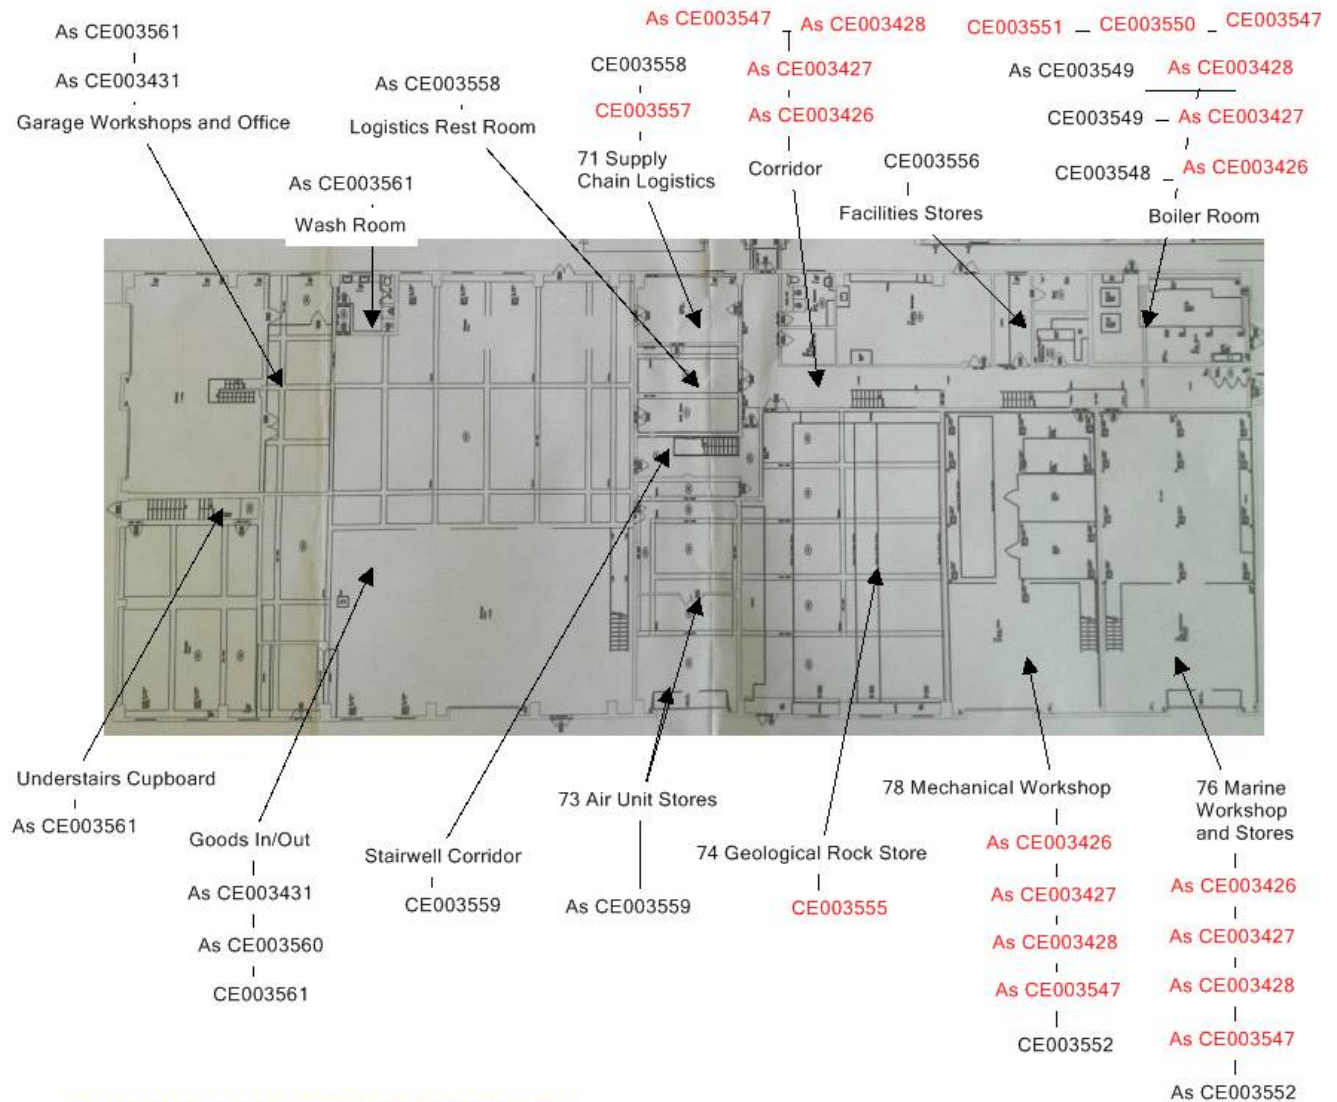
Block wall cavity in boiler room not inspected throughout

Flange gasket to live gas pipework in corridor gas meter cupboard not accessed
