WATER FOR GROWTH

Glynn Weir Photo Record

Pre-works/ Baseline Photos – Spring 2019

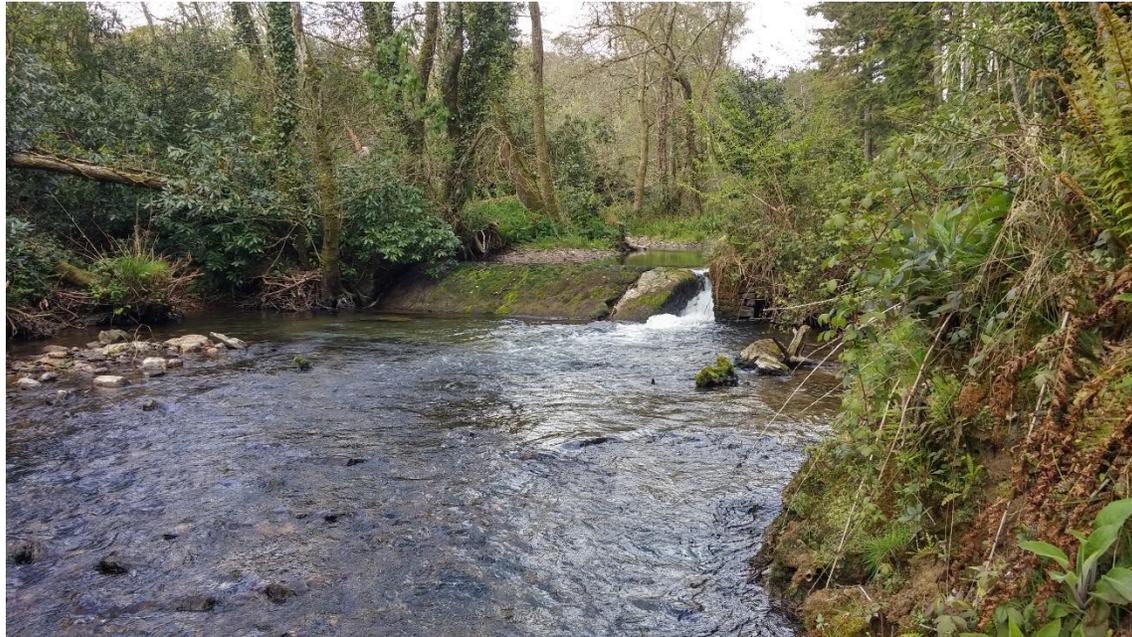
Photo 1: View upstream from left hand bank in low spring flow

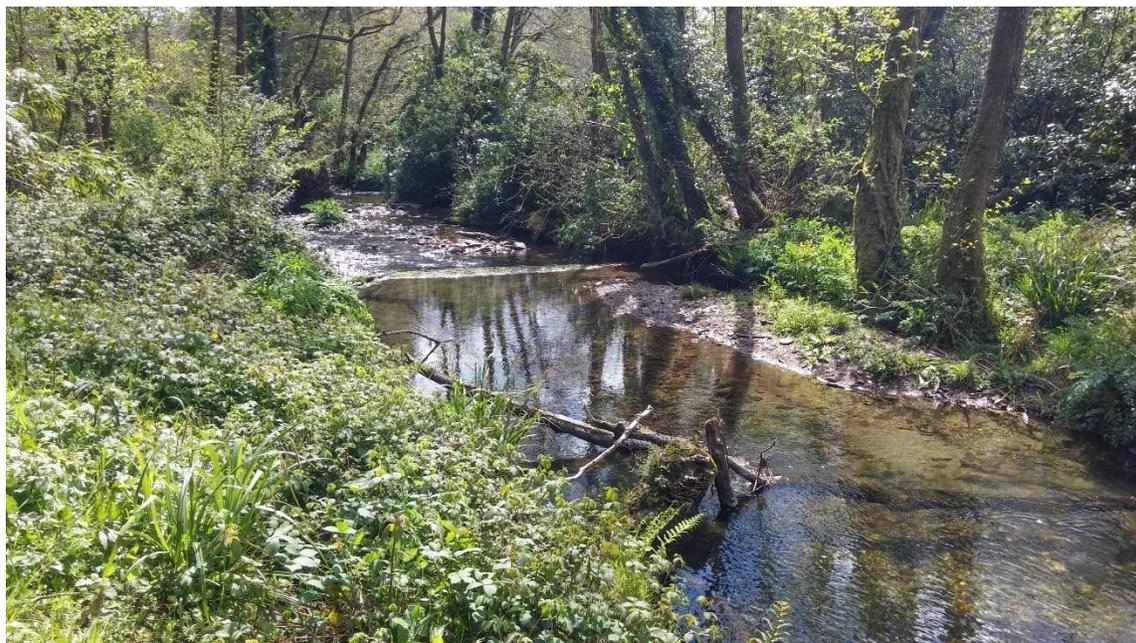
Photo 2: View downstream from left hand bank in low spring flows

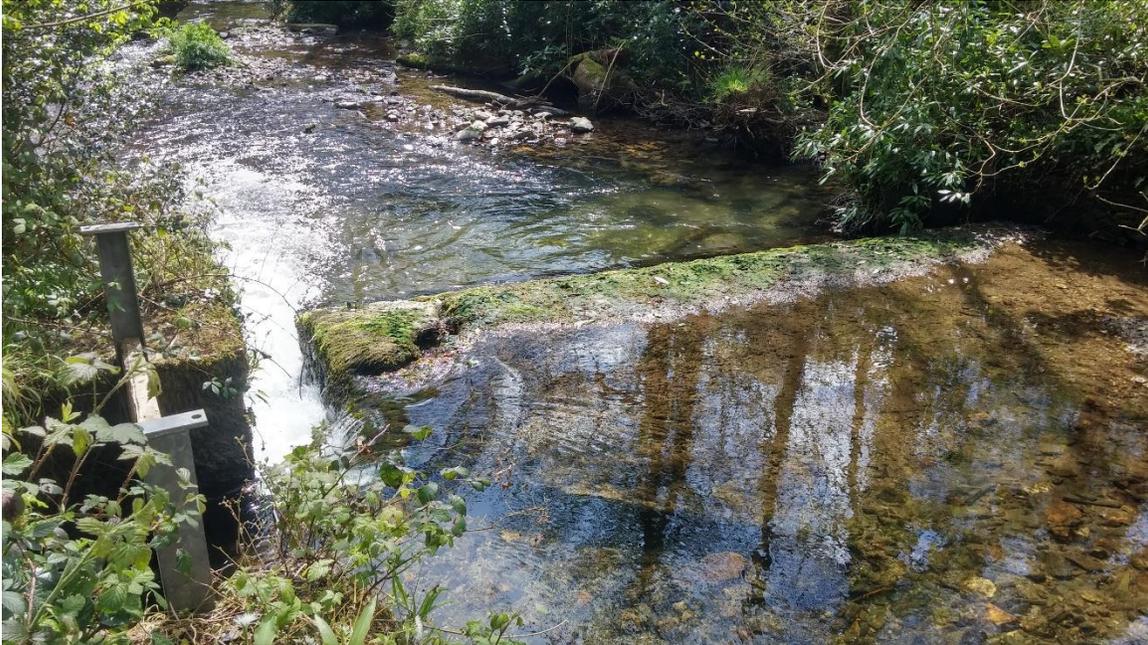
Photo 3: View downstream - weir crest, low flow notch with leaf control structure to left

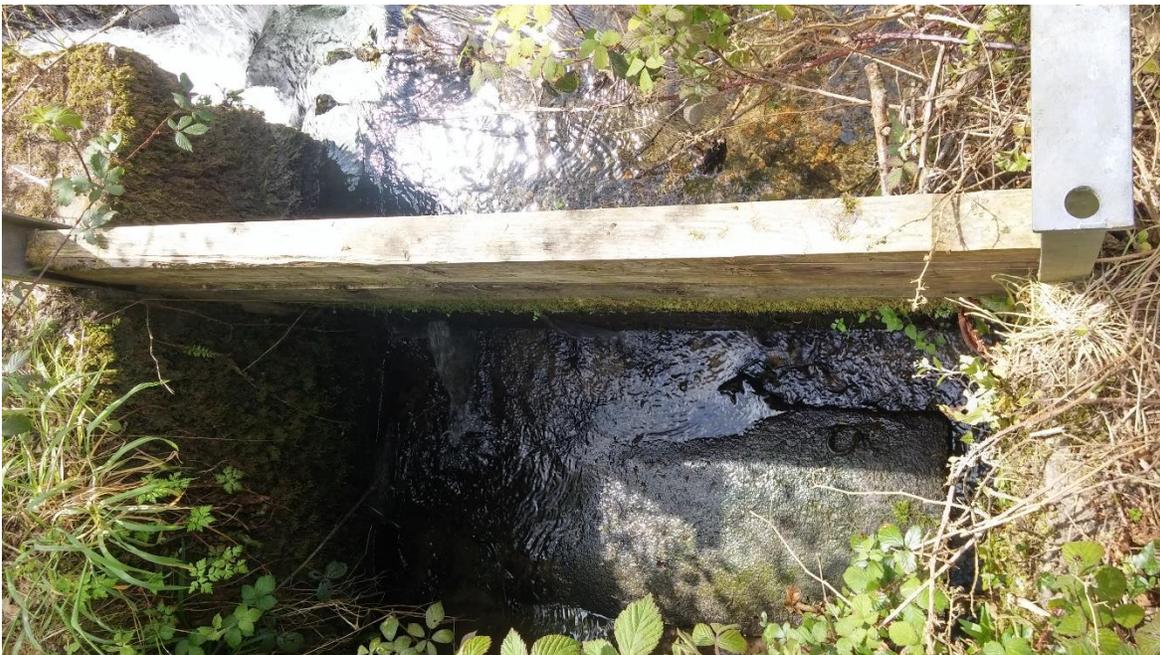
Photo 4: Aerial view of leaf control structure

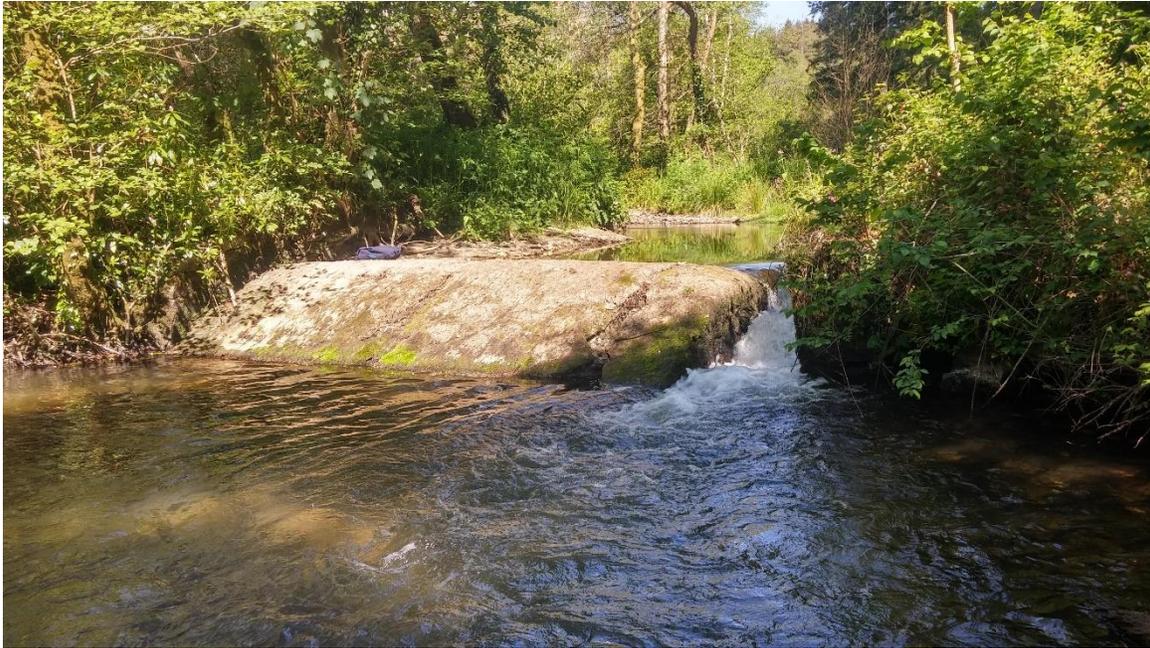
Photo 5: View upstream – weir glacia and low flow notch

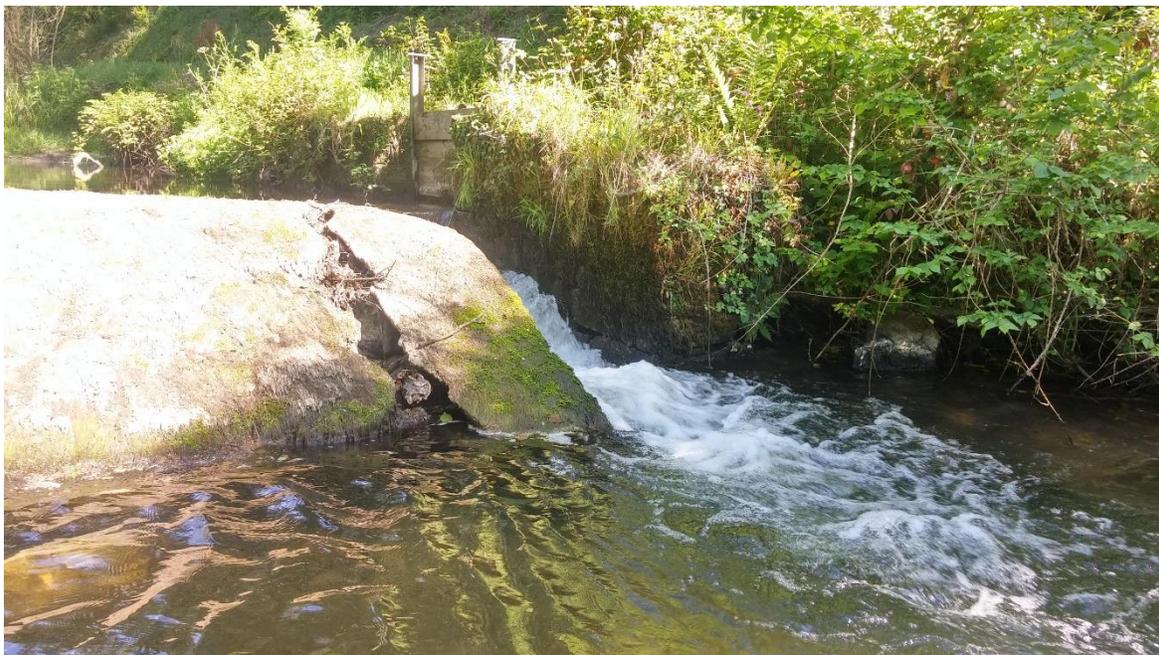
Photo 6: Upstream view – damage on weir glacia

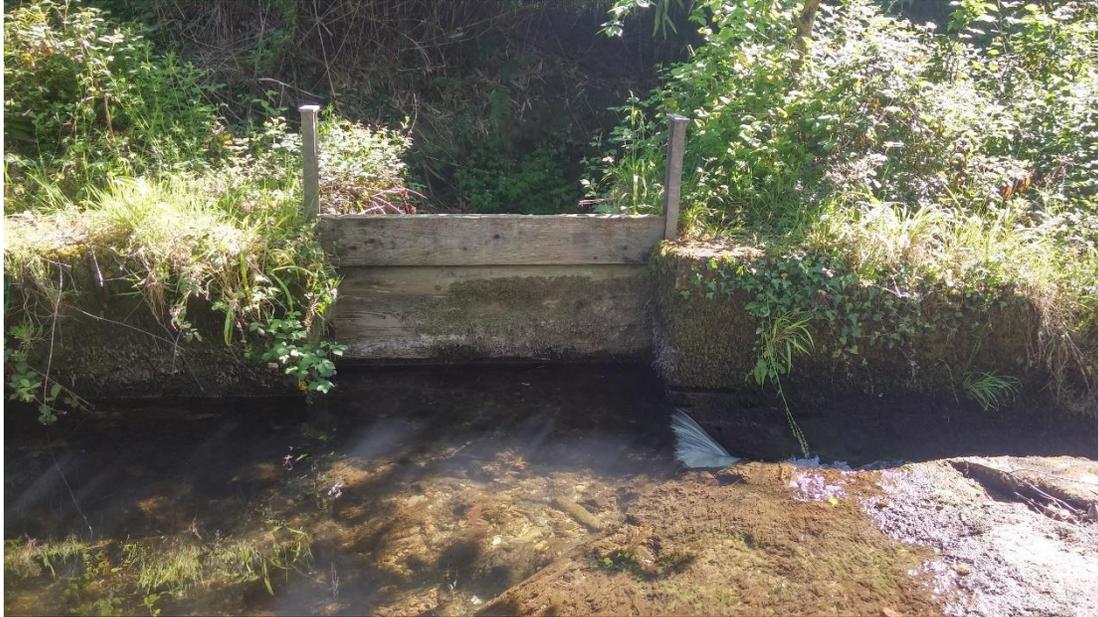
Photo 7: Leat control structure
