Asbestos Refurbishment & Demolition Survey Report

**Willett Hill Depot
Lydeard St Lawrence
Taunton
Somerset
TA4 3QB**

Report Status:		ISSUED 23 May 2017	
Report Reference:		9492	
Name		Signature	Date
Surveyor:	Henry Parkin & No Assistant surveyor

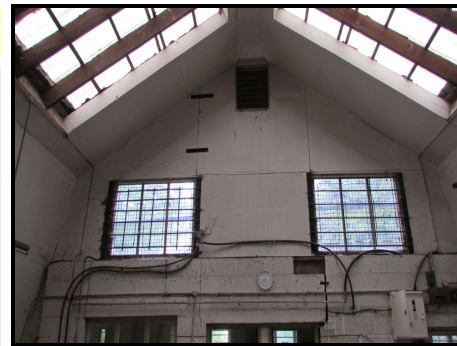
Sample No.	002	Building (Floor)	Willett Hill Depot (Ground Floor)	Comments The inner wall linings to the gable ends (both ends) and the triangular partition at high level between Areas A & B of the workshop are asbestos insulation board (AIB)

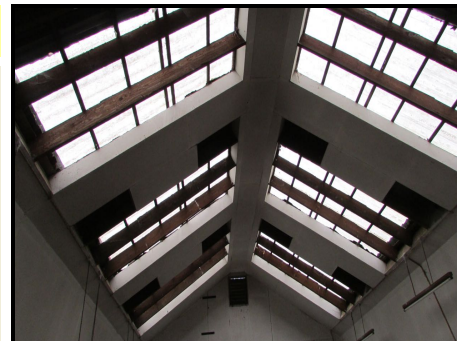
Room Area	Area B	Description of Location	Wall lining		
Product Description	Insulation Board	Asbestos Type	Amosite		
Approx Quantity	85.00m2	HSE Notifiable	Yes		
Sample No.	003	Building (Floor)	Willett Hill Depot (Ground Floor)	Comments The inner roof lining to Area B of the workshop is asbestos insulation board (AIB). The inner wall linings to this area and the linings to the gable ends are also AIB.

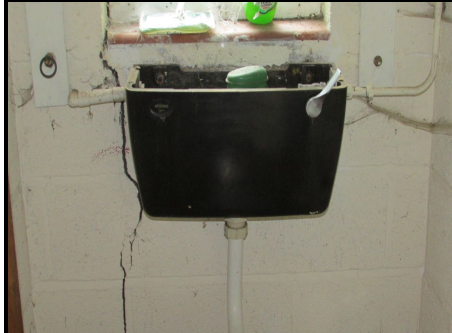
Room Area	WC	Description of Location	Toilet Cistern	The lavatory cistern is is asbestos containing.	
Product Description	Toilet Cistern	Asbestos Type	Amosite		
Approx Quantity	N/A	HSE Notifiable	No

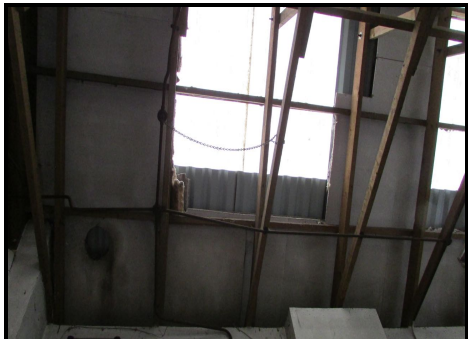
Sample No.	004	Building (Floor)	Willett Hill Depot (Ground Floor)	<div>Comments</div> <div>The inner roof lining to Area A of the Workshop is asbestos free . However the inner wall lining to the gable end and the partition triangle at high level between Areas A & B is also AIB.</div>

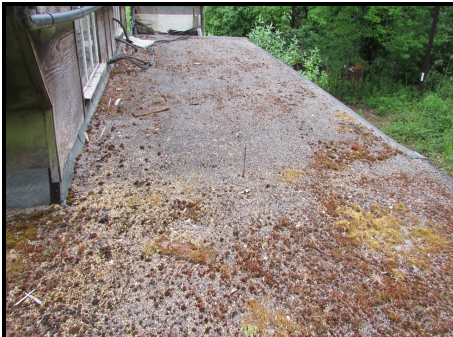
Sample No.	013	Building (Floor)	Willett Hill Depot (External)	Comments The roofing felt on the flat roof to the rear of the property is asbestos free.

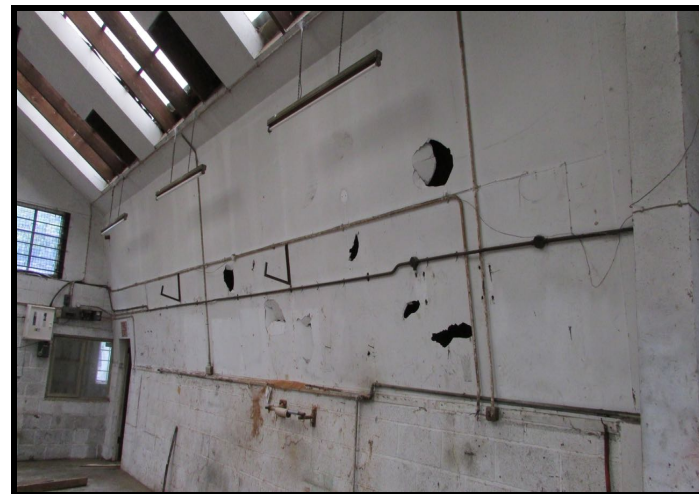
SAMPLE REFERENCE 001

Building	Floor	Room	Location			
Willett Hill Depot	Ground Floor	Area B	Wall lining			
Description						
MATERIAL ASSESSMENT				SCORE		
Product Type	Insulation Board	Extent of Damage	Low Damage		7	
Asbestos Type	Amosite	Surface Treatment	Sealed Board (Painted)			
PRIORITY ASSESSMENT				SCORE		
Occupant Activity	Not Applicable	Extent / Amount	200.00 m2		1	
Accessibility	Not Applicable	Location	Not Applicable			
Avg Time in Use	Not Applicable	Frequency of Use	Not Applicable			
No. of Occupants	Not Applicable	Secondary Activity	Not Applicable			
Maintenance	Not Applicable	Maintenance Frequency	Not Applicable			
MANAGEMENT ACTION				SCORE		
Recommendation	REMOVE IF PART OF DEMOLITION OR REFURBISHMENT			8		
Recommendation Due		Next Inspection	None			
Apply Labels	No	Permit to Work Required	No			
Survey Type	Demolition	Lead Surveyor	Henry Parkin			
Survey Date	23 May 2017	UKAS Laboratory	REC Asbestos South West / [J-07476]

The inner wall linings to Area B of the Workshop is asbestos insulation board (AIB). The inner roof linings and gable ends are also AIB.

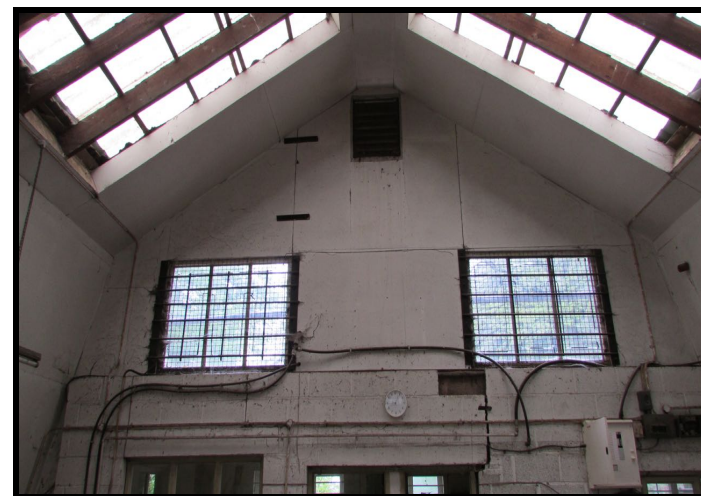
SAMPLE REFERENCE 002

Building	Floor	Room	Location
Willett Hill Depot	Ground Floor	Area B	Wall lining
Description			
MATERIAL ASSESSMENT			
Product Type	Insulation Board	Extent of Damage	Good Condition
Asbestos Type	Amosite	Surface Treatment	Asbestos cement sheets etc
PRIORITY ASSESSMENT			
Occupant Activity	Not Applicable	Extent / Amount	85.00 m2
Accessibility	Not Applicable	Location	Not Applicable
Avg Time in Use	Not Applicable	Frequency of Use	Not Applicable
No. of Occupants	Not Applicable	Secondary Activity	Not Applicable
Maintenance	Not Applicable	Maintenance Frequency	Not Applicable
MANAGEMENT ACTION			
Recommendation	REMOVE IF PART OF DEMOLITION OR REFURBISHMENT		
Recommendation Due		Next Inspection	None
Apply Labels	No	Permit to Work Required	No
Survey Type	Demolition	Lead Surveyor	Henry Parkin
Survey Date	23 May 2017	UKAS Laboratory	NOT SAMPLED (Cross Referenced)
Site Reference	9492	Licensed Material	Yes
		Notifiable Non Licensed Work	No

The inner wall linings to the gable ends (both ends) and the triangular partition at high level between Areas A & B of the workshop are asbestos insulation board (AIB)

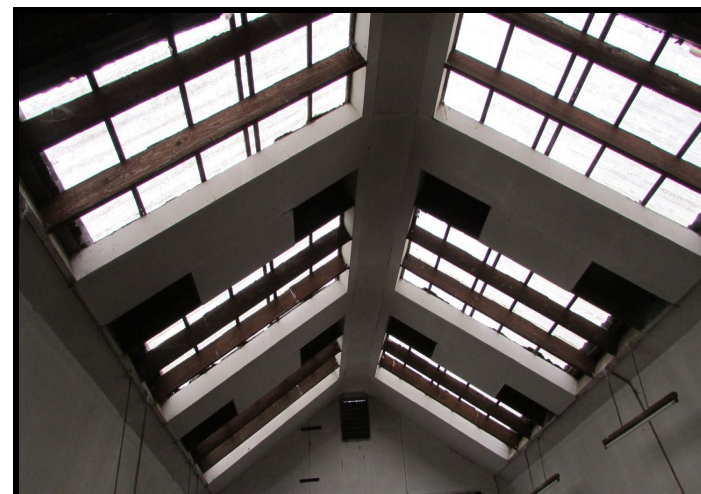
SAMPLE REFERENCE 003

Building	Floor	Room	Location
Willett Hill Depot	Ground Floor	Area B	Roof lining
Description			
MATERIAL ASSESSMENT			
Product Type	Insulation Board	Extent of Damage	Not Applicable
Asbestos Type	Amosite	Surface Treatment	Sealed Board (Painted)
PRIORITY ASSESSMENT			
Occupant Activity	Not Applicable	Extent / Amount	90.00 m2
Accessibility	Not Applicable	Location	Not Applicable
Avg Time in Use	Not Applicable	Frequency of Use	Not Applicable
No. of Occupants	Not Applicable	Secondary Activity	Not Applicable
Maintenance	Not Applicable	Maintenance Frequency	Not Applicable
MANAGEMENT ACTION			
Recommendation	REMOVE IF PART OF DEMOLITION OR REFURBISHMENT		
Recommendation Due		Next Inspection	None
Apply Labels	No	Permit to Work Required	No
Survey Type	Demolition	Lead Surveyor	Henry Parkin
Survey Date	23 May 2017	UKAS Laboratory	NOT SAMPLED (Cross Referenced)
Site Reference	9492	Licensed Material	Yes
		Notifiable Non Licensed Work	No

The inner roof lining to Area B of the workshop is asbestos insulation board (AIB). The inner wall linings to this area and the linings to the gable ends are also AIB.

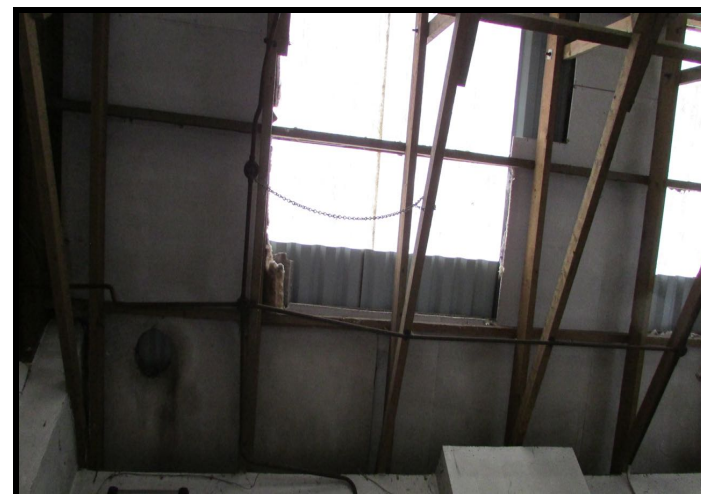
SAMPLE REFERENCE 004

The inner roof lining to Area A of the Workshop is asbestos free . However the inner wall lining to the gable end and the partition triangle at high level between Areas A & B is also AIB.

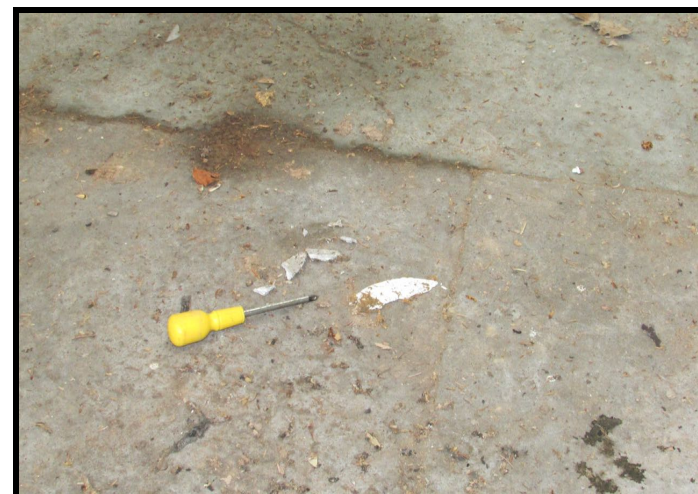
SAMPLE REFERENCE 005

Building	Floor	Room	Location
Willett Hill Depot	Ground Floor	Area A	Dust/debris
Description			
MATERIAL ASSESSMENT			
Product Type	Insulation Board	Extent of Damage	Low Damage
Asbestos Type	Amosite	Surface Treatment	Sealed Board (Painted)
PRIORITY ASSESSMENT			
Occupant Activity	Not Applicable	Extent / Amount	N/A
Accessibility	Not Applicable	Location	Not Applicable
Avg Time in Use	Not Applicable	Frequency of Use	Not Applicable
No. of Occupants	Not Applicable	Secondary Activity	Not Applicable
Maintenance	Not Applicable	Maintenance Frequency	Not Applicable
MANAGEMENT ACTION			
Recommendation	REMOVE IF PART OF DEMOLITION OR REFURBISHMENT		
Recommendation Due		Next Inspection	None
Apply Labels	No	Permit to Work Required	No
Survey Type	Demolition	Lead Surveyor	Henry Parkin
Survey Date	23 May 2017	UKAS Laboratory	NOT SAMPLED (Cross Referenced)
Site Reference	9492	Licensed Material	Yes
		Notifiable Non Licensed Work	No

There are small amounts of AIB and asbestos cement debris on the floor of Area A of the workshop.

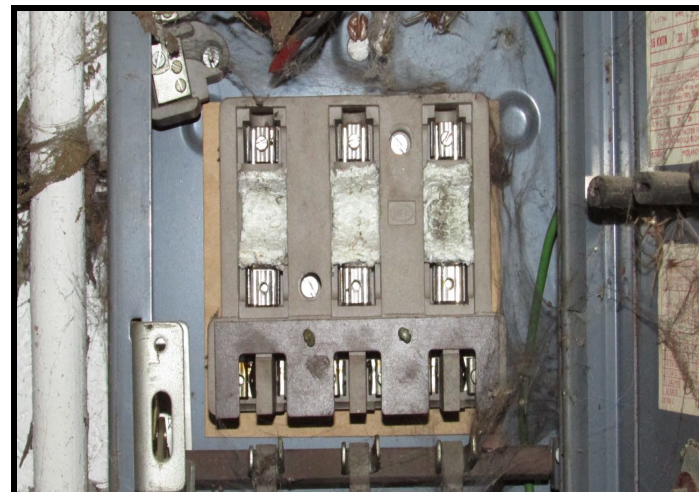
SAMPLE REFERENCE 006

Building	Floor	Room	Location
Willett Hill Depot	Ground Floor	Area B	Flash Guard
Description			
MATERIAL ASSESSMENT			
Product Type	Woven textile	Extent of Damage	Not Applicable
Asbestos Type	Chrysotile	Surface Treatment	Textile
PRIORITY ASSESSMENT			
Occupant Activity	Not Applicable	Extent / Amount	N/A
Accessibility	Not Applicable	Location	Not Applicable
Avg Time in Use	Not Applicable	Frequency of Use	Not Applicable
No. of Occupants	Not Applicable	Secondary Activity	Not Applicable
Maintenance	Not Applicable	Maintenance Frequency	Not Applicable
MANAGEMENT ACTION			
Recommendation	REMOVE IF PART OF DEMOLITION OR REFURBISHMENT		
Recommendation Due		Next Inspection	None
Apply Labels	No	Permit to Work Required	No
Survey Type	Demolition	Lead Surveyor	Henry Parkin
Survey Date	23 May 2017	UKAS Laboratory	NOT SAMPLED
Site Reference	9492	Licensed Material	No
		Notifiable Non Licensed Work	No

There are asbestos woven flash guards in four fuse boxes. Three of the fuse boxes are on the rear wall of Area B in the workshop. Please see drawing for all four locations.

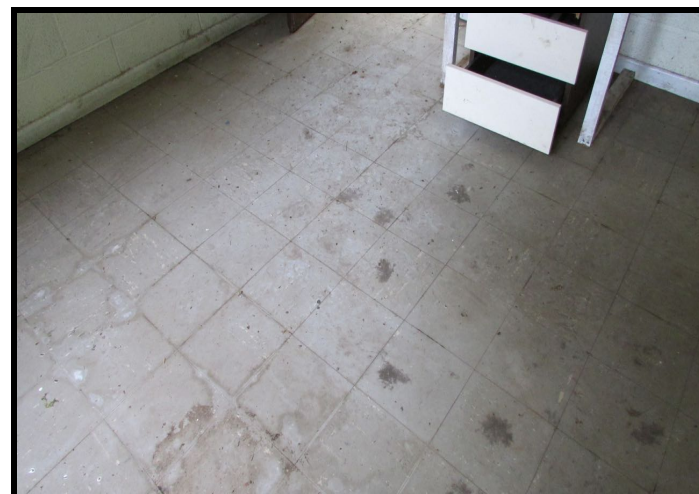
SAMPLE REFERENCE 007

The grey floor tiles are asbestos free.

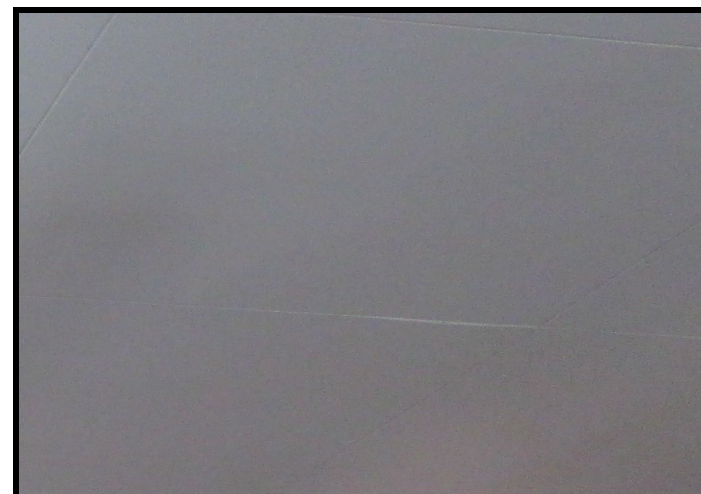
SAMPLE REFERENCE 008

The ceiling in the office and adjoining toilet is asbestos free. The same board ceiling is also in the lean-to store area to the side of the building.

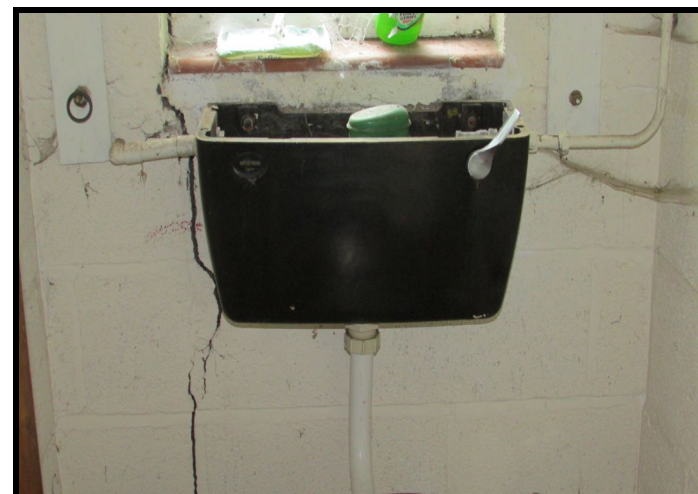
SAMPLE REFERENCE 009

Building	Floor	Room	Location
Willett Hill Depot	Ground Floor	WC	Toilet Cistern
Description			
MATERIAL ASSESSMENT			
Product Type	Toilet Cistern	Extent of Damage	Not Applicable
Asbestos Type	Amosite	Surface Treatment	Composite materials
PRIORITY ASSESSMENT			
Occupant Activity	Not Applicable	Extent / Amount	N/A
Accessibility	Not Applicable	Location	Not Applicable
Avg Time in Use	Not Applicable	Frequency of Use	Not Applicable
No. of Occupants	Not Applicable	Secondary Activity	Not Applicable
Maintenance	Not Applicable	Maintenance Frequency	Not Applicable
MANAGEMENT ACTION			
Recommendation	REMOVE IF PART OF DEMOLITION OR REFURBISHMENT		
Recommendation Due		Next Inspection	None
Apply Labels	No	Permit to Work Required	No
Survey Type	Demolition	Lead Surveyor	Henry Parkin
Survey Date	23 May 2017	UKAS Laboratory	NOT SAMPLED
Site Reference	9492	Licensed Material	No
		Notifiable Non Licensed Work	No

The lavatory cistern is is asbestos containing.

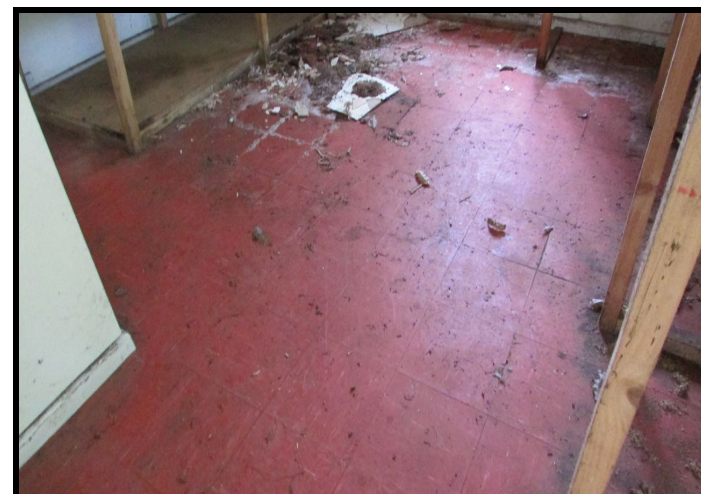
SAMPLE REFERENCE 010

The red floor tiles in Store E are asbestos free. The same floor tiles are also in the cubicle are only of WC D

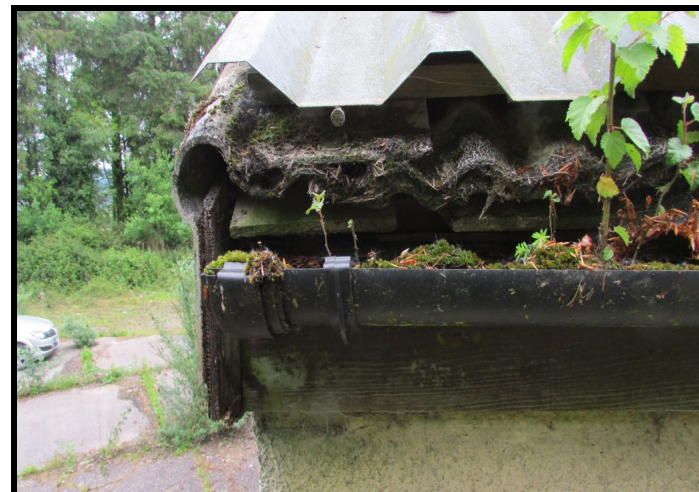
SAMPLE REFERENCE 011

Building	Floor	Room	Location			
Willett Hill Depot	External	Roof Area A	Roof			
Description						
MATERIAL ASSESSMENT				SCORE		
Product Type	Roof Sheet	Extent of Damage	Medium Damage		5	
Asbestos Type	Chrysotile	Surface Treatment	Asbestos cement sheets etc			
PRIORITY ASSESSMENT				SCORE		
Occupant Activity	Not Applicable	Extent / Amount	75.00 m2		1	
Accessibility	Not Applicable	Location	Not Applicable			
Avg Time in Use	Not Applicable	Frequency of Use	Not Applicable			
No. of Occupants	Not Applicable	Secondary Activity	Not Applicable			
Maintenance	Not Applicable	Maintenance Frequency	Not Applicable			
MANAGEMENT ACTION				SCORE		
Recommendation	REMOVE IF PART OF DEMOLITION OR REFURBISHMENT			6		
Recommendation Due		Next Inspection	None			
Apply Labels	No	Permit to Work Required	No			
Survey Type	Demolition	Lead Surveyor	Henry Parkin			
Survey Date	23 May 2017	UKAS Laboratory	REC Asbestos South West / [J-07476]

The roof sheets over Area A of the workshop are asbestos cement. The sheets have been overlaid with profiled metal sheeting. There are the original asbestos cement capping sections on the front of the building.

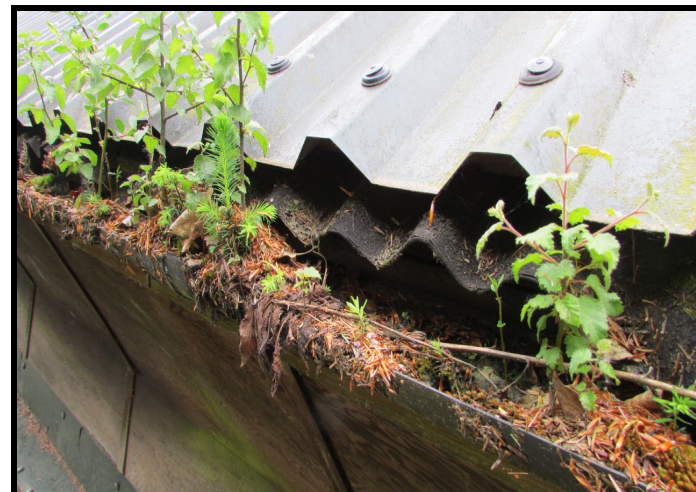
SAMPLE REFERENCE 012

The original roof sheets over Area B of the roof are asbestos free. They have been overclad with profiled metal sheeting.

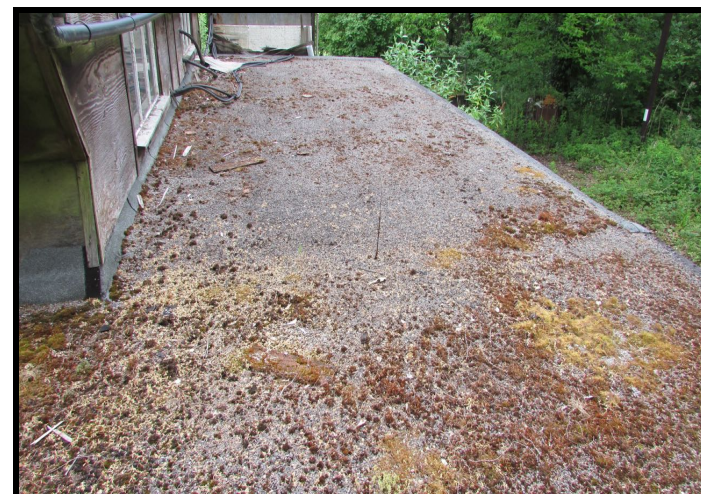
SAMPLE REFERENCE 013

The roofing felt on the flat roof to the rear of the property is asbestos free.
