# Pre-Refurbishment & Demolition Asbestos Survey for Witney Town Council

West Witney Sports and Social Club  
Burford Road  
Witney  
OX29 0NB

**Amiantus Environmental Consultants Ltd.**

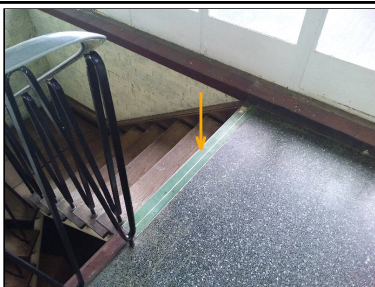
Survey Date:	Lead Surveyor	Survey Type	Floor	Analysis
	12 Jun 2025	Dudley Firkins	Refurbishment & Demolition survey	1st Floor	Chrysotile (1)
	Building	Room	Item	Quantity	
	West Witney Sports Club	Stair Landing 102	Nosing to step	1no.	
	Sample No (S,SP,P,As)	Product Type	Surface Treatment	Condition	Accessibility
	DF005674 (S)	Thermoplastic (1)	Completely Sealed (0)	Low Damage (1)	Easily disturbed
	Material Risk Score				
	3				
Recommended action	D - Manage and re-inspect				
Surveyor comments	Asbestos nosing to top step.

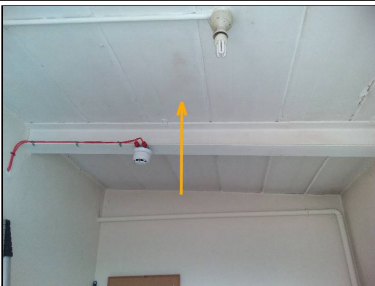
Survey Date:	Lead Surveyor	Survey Type	Floor	Analysis
	12 Jun 2025	Dudley Firkins	Refurbishment & Demolition survey	1st Floor	Chrysotile (1)
	Building	Room	Item	Quantity	
	West Witney Sports Club	Kitchen 111	Cement Sheets to ceiling	75m <sup>2</sup>	
	Sample No (S,SP,P,As)	Product Type	Surface Treatment	Condition	Accessibility
	DF005677 (S)	Cement (1)	Surface Sealed (1)	Low Damage (1)	Occasionally likely to be disturbed
	Material Risk Score				
Recommended action		D - Manage and re-inspect			
Surveyor comments		Asbestos cement sheets to ceiling (roof). Continues across ceilings to rooms 109 to 116 above ceilings in places.

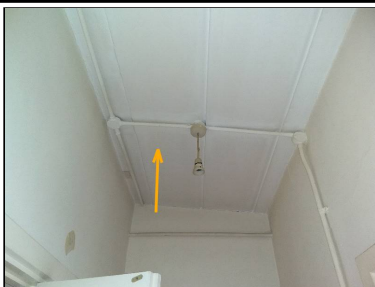
Survey Date:	Lead Surveyor	Survey Type	Floor	Analysis
	12 Jun 2025	Dudley Firkins	Refurbishment & Demolition survey	1st Floor	Chrysotile (1)
	Building	Room	Item	Quantity	
	West Witney Sports Club	Corridor and Cupboards 114	Cement Sheets to ceiling	See associated entry	
	Sample No (S,SP,P,As)	Product Type	Surface Treatment	Condition	Accessibility
	As DF005677 (SP)	Cement (1)	Surface Sealed (1)	Low Damage (1)	Occasionally likely to be disturbed
	Material Risk Score				
	4				
Recommended action	D - Manage and re-inspect				
Surveyor comments	Asbestos cement sheets to ceiling (roof).

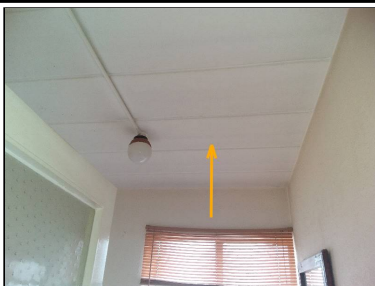
Survey Date:	Lead Surveyor	Survey Type	Floor	Analysis
	12 Jun 2025	Dudley Firkins	Refurbishment & Demolition survey	1st Floor	Chrysotile (1)
	Building	Room	Item	Quantity	
	West Witney Sports Club	Bathroom 115	Cement Sheets to ceiling	See associated entry	
	Sample No (S,SP,P,As)	Product Type	Surface Treatment	Condition	Accessibility
	As DF005677 (SP)	Cement (1)	Surface Sealed (1)	Low Damage (1)	Occasionally likely to be disturbed
	Material Risk Score				
4					
Recommended action	D - Manage and re-inspect				
Surveyor comments	Asbestos cement sheets to ceiling (roof).

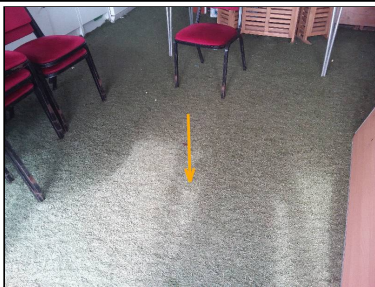
Survey Date:	Lead Surveyor	Survey Type	Floor	Analysis
	12 Jun 2025	Dudley Firkins	Refurbishment & Demolition survey	Ground Floor	Chrysotile (1)
	Building	Room	Item	Quantity	
	West Witney Sports Club	Cricket Store G01	Bitumen Adhesive to floor	30m²	
	Sample No (S,SP,P,As)	Product Type	Surface Treatment	Condition	Accessibility
	DF005668 (S)	Bituminous (1)	Completely Sealed (0)	Low Damage (1)	Occasionally likely to be disturbed
	Material Risk Score				
3					
Recommended action	D - Manage and re-inspect				
Surveyor comments	Asbestos bitumen adhesive to concrete below carpet.

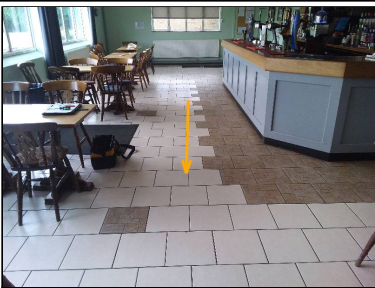
Survey Date:	Lead Surveyor	Survey Type	Floor	Analysis
	12 Jun 2025	Dudley Firkins	Refurbishment & Demolition survey	Ground Floor	Chrysotile (1)
	Building	Room	Item	Quantity	
	West Witney Sports Club	Bar Area G02	Bitumen Adhesive to floor	84m <sup>2</sup>	
	Sample No (S,SP,P,As)	Product Type	Surface Treatment	Condition	Accessibility
	DF005670 (S)	Bituminous (1)	Completely Sealed (0)	Low Damage (1)	Usually inaccessible or unlikely to be disturbed
	Material Risk Score				
Recommended action		D - Manage and re-inspect			
Surveyor comments		Asbestos bitumen adhesive to concrete below ceramic tiles.

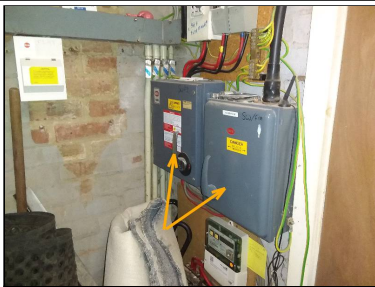
Survey Date:	Lead Surveyor	Survey Type	Floor	Analysis
	12 Jun 2025	Dudley Firkins	Refurbishment & Demolition survey	Ground Floor	Chrysotile (1)
	Building	Room	Item	Quantity	
	West Witney Sports Club	Cleaners Cupboard G12	Presumed Asbestos Flash Guards within electrical boxes	2no.	
	Sample No (S,SP,P,As)	Product Type	Surface Treatment	Condition	Accessibility
	Visual (P)	Asbestos Textiles/Paper (2)	Unsealed (2)	Low Damage (1)	Occasionally likely to be disturbed
	Material Risk Score				
6					
Recommended action	D - Manage and re-inspect				
Surveyor comments	Presumed Asbestos Flash Guards within live electrical boxes.

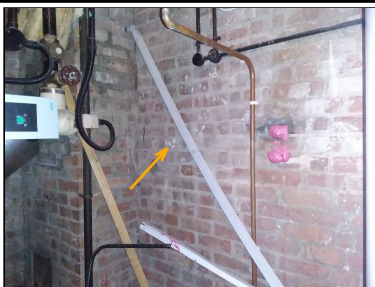
West Witney Sports Club	Ground	Boiler Room G16, Debris to walls	S DF005671	Dust/Debris	High Damage	Unsealed lagging and sprays	Chrysotile + Amosite	Small amounts	Easily disturbed	11	A - Restrict access/remove	Asbestos debris to all walls.
West Witney Sports Club	Ground	Boiler Room G16, Debris to floor	S DF005672	Preformed Lagging	High Damage	Unsealed lagging and sprays	Chrysotile + Amosite	Small amounts	Easily disturbed	11	A - Restrict access/remove	Asbestos debris to floor.
West Witney Sports Club	Ground	Boiler Room G16, Debris to pipes	SP As DF005672	Preformed Lagging	High Damage	Unsealed lagging and sprays	Chrysotile + Amosite	Small amounts	Easily disturbed	11	A - Restrict access/remove	Asbestos debris to pipes.

Survey Date:	Lead Surveyor	Survey Type	Floor	Analysis
	12 Jun 2025	Dudley Firkins	Refurbishment & Demolition survey	Ground Floor	Chrysotile + Amosite (2)
	Building	Room	Item	Quantity	
	West Witney Sports Club	Boiler Room G16	Debris to walls	Small amounts	
	Sample No (S,SP,P,As)	Product Type	Surface Treatment	Condition	Accessibility
	DF005671 (S)	Dust/Debris (3)	Unsealed lagging and sprays (3)	High Damage (3)	Easily disturbed
	Material Risk Score				
11					
Recommended action	A - Restrict access/remove				
Surveyor comments	Asbestos debris to all walls.

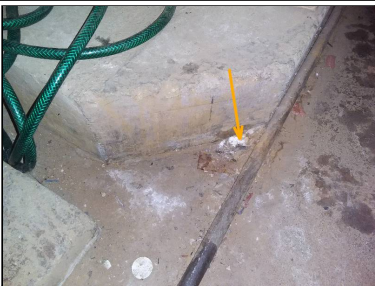
Survey Date:	Lead Surveyor	Survey Type	Floor	Analysis
	12 Jun 2025	Dudley Firkins	Refurbishment & Demolition survey	Ground Floor	Chrysotile + Amosite (2)
	Building	Room	Item	Quantity	
	West Witney Sports Club	Boiler Room G16	Debris to floor	Small amounts	
	Sample No (S,SP,P,As)	Product Type	Surface Treatment	Condition	Accessibility
	DF005672 (S)	Preformed Lagging (3)	Unsealed lagging and sprays (3)	High Damage (3)	Easily disturbed
<b>Material Risk Score</b>					
11					
<b>Recommended action</b>		A - Restrict access/remove			
<b>Surveyor comments</b>		Asbestos debris to floor.

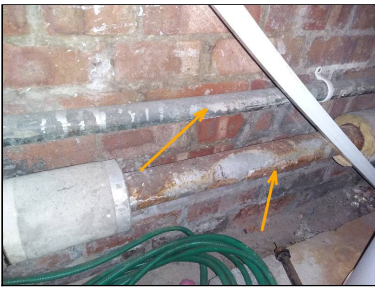
Survey Date:	Lead Surveyor	Survey Type	Floor	Analysis
	12 Jun 2025	Dudley Firkins	Refurbishment & Demolition survey	Ground Floor	Chrysotile + Amosite (2)
	Building	Room	Item	Quantity	
	West Witney Sports Club	Boiler Room G16	Debris to pipes	Small amounts	
	Sample No (S,SP,P,As)	Product Type	Surface Treatment	Condition	Accessibility
	As DF005672 (SP)	Preformed Lagging (3)	Unsealed lagging and sprays (3)	High Damage (3)	Easily disturbed
<b>Material Risk Score</b>					
11					
<b>Recommended action</b>		A - Restrict access/remove			
<b>Surveyor comments</b>		Asbestos debris to pipes.

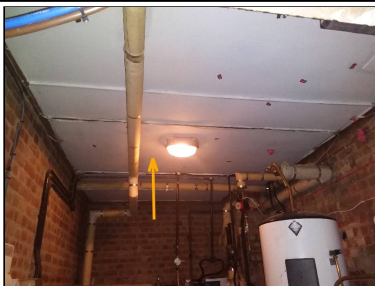
Survey Date:	Lead Surveyor	Survey Type	Floor	Analysis
	12 Jun 2025	Dudley Firkins	Refurbishment & Demolition survey	Ground Floor	Chrysotile + Amosite (2)
	Building	Room	Item	Quantity	
	West Witney Sports Club	Boiler Room G16	Board to ceiling	12m²	
	Sample No (S,SP,P,As)	Product Type	Surface Treatment	Condition	Accessibility
	DF005673 (S)	Asbestos Insulating Board (2)	Surface Sealed (1)	Low Damage (1)	Occasionally likely to be disturbed
	Material Risk Score				
6					
Recommended action	D - Manage and re-inspect				
Surveyor comments	Asbestos Insulating Board (AIB) to ceiling.

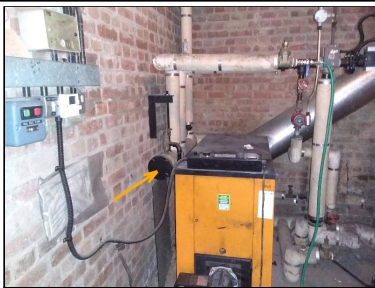
Survey Date:	Lead Surveyor	Survey Type	Floor	Analysis
	12 Jun 2025	Dudley Firkins	Refurbishment & Demolition survey	Ground Floor	Chrysotile (1)
	Building	Room	Item	Quantity	
	West Witney Sports Club	Boiler Room G16	Presumed Asbestos Gaskets to pipe flanges	Throughout	
	Sample No (S,SP,P,As)	Product Type	Surface Treatment	Condition	Accessibility
	Visual (P)	Asbestos Textiles/Paper (2)	Surface Sealed (1)	Low Damage (1)	Usually inaccessible or unlikely to be disturbed
	Material Risk Score				
5					
Recommended action	D - Manage and re-inspect				
Surveyor comments	Presumed Asbestos Gaskets to pipe flanges. Unable to obtain a sample.

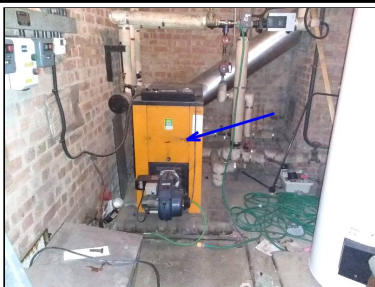
Survey Date:	Lead Surveyor	Survey Type	Floor	Analysis
	12 Jun 2025	Dudley Firkins	Refurbishment & Demolition survey	Ground Floor	N/A
	Building	Room	Item	Quantity	
	West Witney Sports Club	Boiler Room G16	No Access within boiler	N/A	Accessibility
	Sample No (S,SP,P,As)	Product Type	Surface Treatment	Condition	
	Visual (P)	N/A	N/A	N/A	
	Material Risk Score				
N/A					
Recommended action	Inspection required				
Surveyor comments	No access within boiler, still operational. Modern rope seal to front.

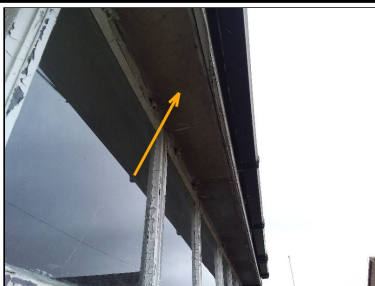
Survey Date:	Lead Surveyor	Survey Type	Floor	Analysis
	12 Jun 2025	Dudley Firkins	Refurbishment & Demolition survey	External	Chrysotile + Crocidolite (3)
	Building	Room	Item	Quantity	
	West Witney Sports Club	External Elevations E01	Board to soffits	5lm	
	Sample No (S,SP,P,As)	Product Type	Surface Treatment	Condition	Accessibility
	DF005679 (S)	Asbestos Insulating Board (2)	Unsealed (2)	Low Damage (1)	Occasionally likely to be disturbed
	Material Risk Score				
8					
Recommended action	C - Encapsulate or repair				
Surveyor comments	Asbestos Insulating Board (AIB) to soffits of room G01. Timber at front.

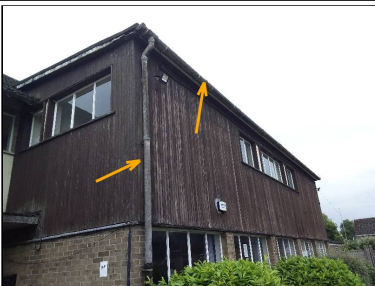
<b>Survey Date:</b>	<b>Lead Surveyor</b>	<b>Survey Type</b>	<b>Floor</b>	<b>Analysis</b>
	12 Jun 2025	Dudley Firkins	Refurbishment & Demolition survey	External	Chrysotile (1)
	<b>Building</b>	<b>Room</b>	<b>Item</b>	<b>Quantity</b>	
	West Witney Sports Club	External Elevations E01	Cement Rainwater Goods to walls/roof	65lm	
	<b>Sample No (S,SP,P,As)</b>	<b>Product Type</b>	<b>Surface Treatment</b>	<b>Condition</b>	<b>Accessibility</b>
	DF005681 (S)	Cement (1)	Surface Sealed (1)	Low Damage (1)	Occasionally likely to be disturbed
<b>Material Risk Score</b>					
4					
<b>Recommended action</b>	D - Manage and re-inspect				
<b>Surveyor comments</b>	Asbestos cement rainwater guttering and downpipes to walls/roof. Includes 5no downpipes.

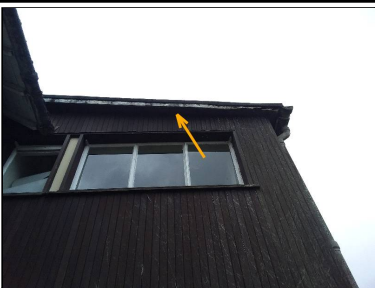
<b>Survey Date:</b>	<b>Lead Surveyor</b>	<b>Survey Type</b>	<b>Floor</b>	<b>Analysis</b>
	12 Jun 2025	Dudley Firkins	Refurbishment & Demolition survey	External	Chrysotile (1)
	<b>Building</b>	<b>Room</b>	<b>Item</b>	<b>Quantity</b>	
	West Witney Sports Club	External Elevations E01	Cement Sheets to soffit	See associated entry	
	<b>Sample No (S,SP,P,As)</b>	<b>Product Type</b>	<b>Surface Treatment</b>	<b>Condition</b>	<b>Accessibility</b>
	As DF005677 (SP)	Cement (1)	Surface Sealed (1)	Low Damage (1)	Occasionally likely to be disturbed
<b>Material Risk Score</b>					
4					
<b>Recommended action</b>	D - Manage and re-inspect				
<b>Surveyor comments</b>	Asbestos cement to part of roof. Sampled internally but visible below felt externally.

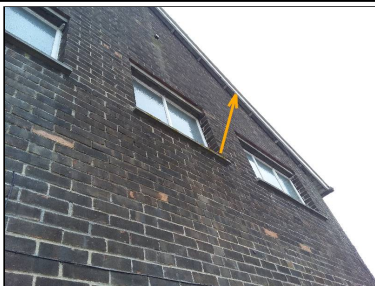
Survey Date:	Lead Surveyor	Survey Type	Floor	Analysis
	12 Jun 2025	Dudley Firkins	Refurbishment & Demolition survey	External	Crocidolite (or unknown) (3)
	Building	Room	Item	Quantity	
	West Witney Sports Club	External Elevations E01	Presumed Asbestos Cement Undercloaking to roof edges	24lm	
	Sample No (S,SP,P,As)	Product Type	Surface Treatment	Condition	Accessibility
	Visual (P)	Asbestos Cement (1)	Surface Sealed (1)	Low Damage (1)	Usually inaccessible or unlikely to be disturbed
	Material Risk Score				
6					
Recommended action	D - Manage and re-inspect				
Surveyor comments	Presumed Asbestos Cement Undercloaking to roof edges.
