# the play inspection company

# **Annual Inspection**

St Germans Parish Council

Tideford Play Park

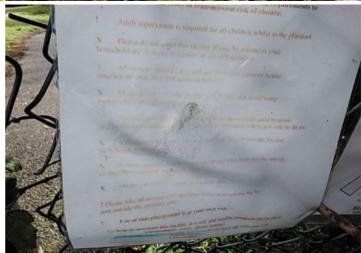
**Finding:** The main sign is concealed behind vegetation and the temporary signs are fading and difficult to read **Action:** Remove excess vegetation and replace temporary signs

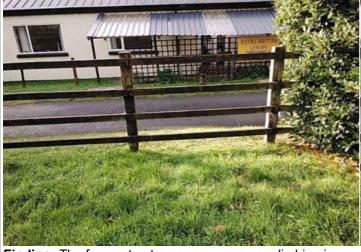
**Finding:** The fence structure may encourage climbing in places

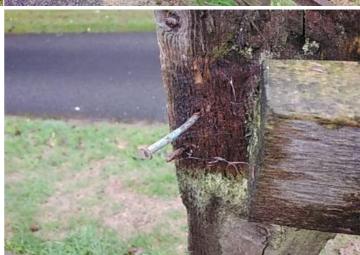
**Finding:** There is a timber slat missing from the fence leaving projecting fixings

Action: Remove projecting fixings and replace missing slat

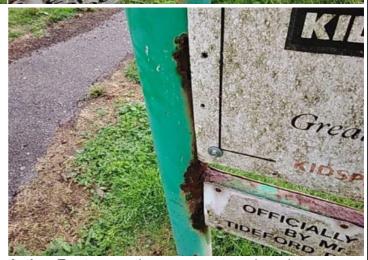
Finding: The paintwork on this item has been damaged or Action: Treat any rusting components and repaint worn exposing the metal underneath which is rusting

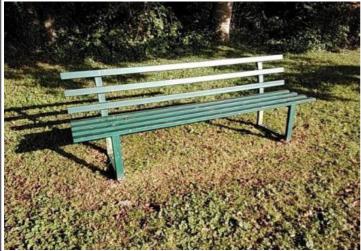
Finding: The paintwork on this item has been damaged or Action: Treat any rusting components and repaint worn exposing the metal underneath which is rusting

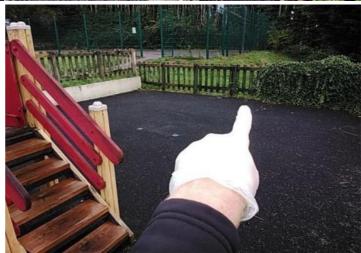
**Finding:** There are trip hazards present where the swing has been removed

**Action:** Reinstate surrounding surfaces to level to remove the trip points

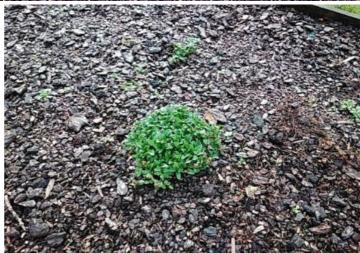
Finding: There is weed / vegetation growth throughout the Action: Remove weed / vegetation growth bark mulch surfacing

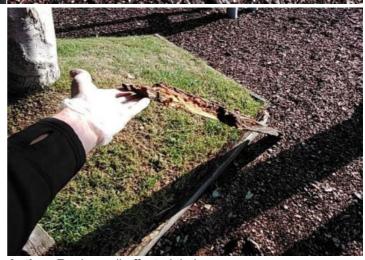
**Finding:** There are areas or parts of the timber edging around the bark pit that have rotted and a plank is unsecured

Action: Replace all affected timbers

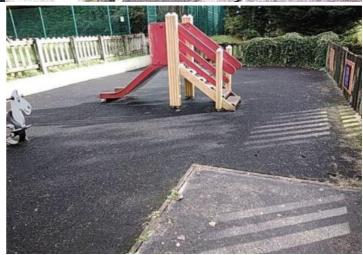
**Finding:** There is algae or moss growth on the wetpour surface in the fenced area resulting in slippery conditions

Action: Clean and treat appropriately

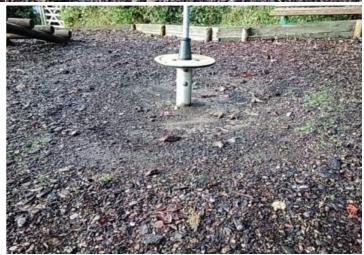
**Finding:** The bark surfacing has been displaced from under the unit and the sub-base is exposed **Action:** Rake the surface level across the area and ensure a minimum depth of 300mm of bark mulch. Top up bark

mulch if required

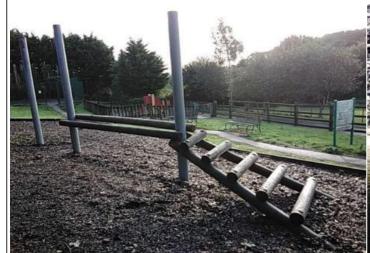
Finding: There is/are bolt cap covers missing or damaged Action: Replace missing or damaged bolt cap covers on the item

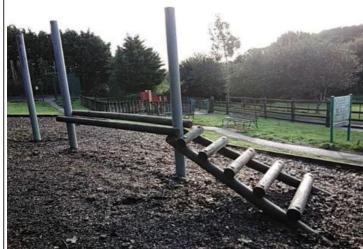
Finding: There is some evidence of rot in the timber

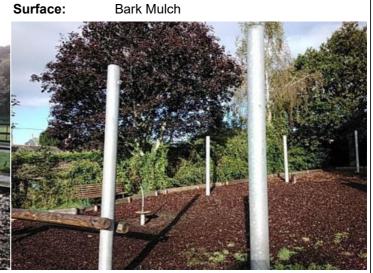
Finding: The item has missing component(s)

**Action:** Consider replacing missing components

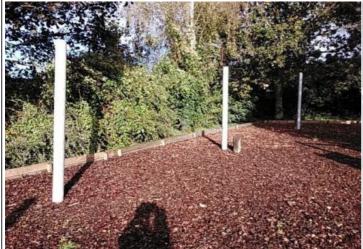
Finding: There is some notable evidence of eye bolt wear

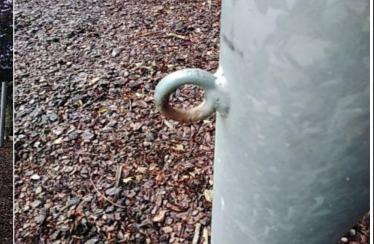
Finding: There is some notable evidence of eye bolt wear

**Action:** Monitor for any further deterioration and replace when 40% worn

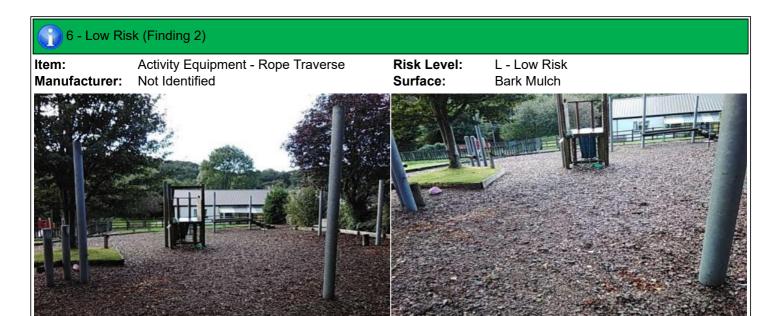
Finding: The item has missing component(s) - traverse rope Action: Consider replacing missing components

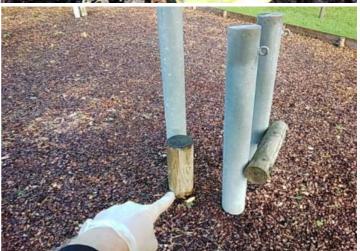
Finding: There are areas or parts of the timber post on the Action: Replace all affected timbers structure that have rotted

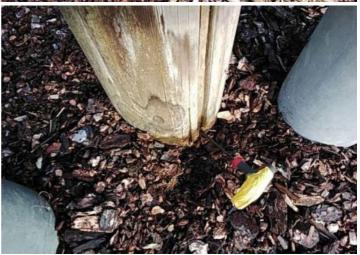
Finding: There is some evidence of rot in the timber

**Action:** Monitor for any further deterioration and replace as required

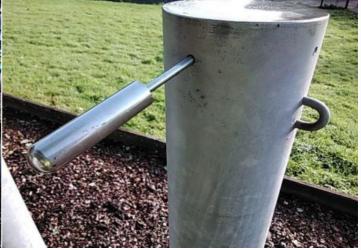
There is/are several inserts missing and the exposed holes create finger entrapments required contravention of the requirements of BS EN 1176 - Replace missing inserts to remove the entrapments

Action: Replace missing inserts to remove the entrapments

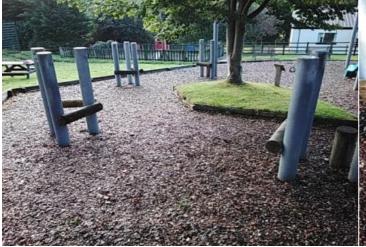
**Finding:** The edging forms a hard object within the falling space of the equipment in contravention of the requirements of BS EN 1176 Part 1

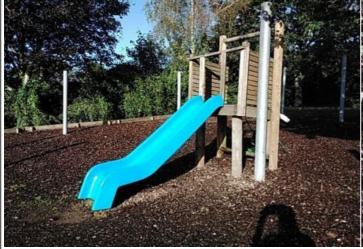
**Finding:** Bark mulch has been displaced from the end of the **Action:** Reinstate / top up mulch to ensure a minimum slide and the compacted, stoney sub-base is exposed depth of 300mm all around the unit

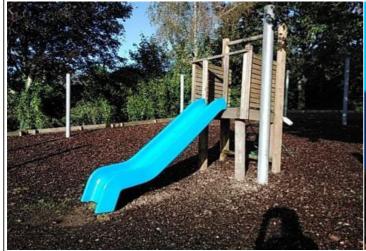
Finding: The paintwork on this item has been damaged or Action: Treat any rusting components and repaint worn exposing the metal underneath which is rusting

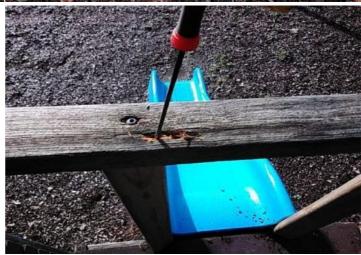
**Finding:** There is some evidence of rot in the timber

**Action:** Monitor for any further deterioration and replace as required

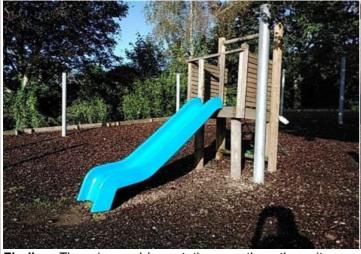
**Finding:** There is weed / vegetation growth on the unit

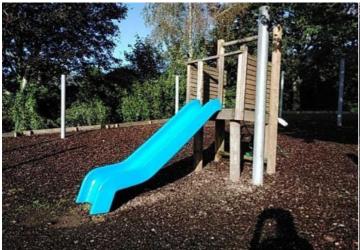
**Finding:** There is/are finger entrapment/s in the slide and the item fails to meet the requirements of BS EN 1176 Part 1

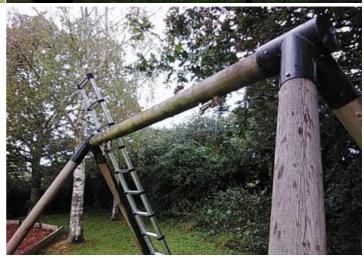
**Finding:** The inspector has some concerns about the internal condition of the timber crossbar due to discoloration and algal growth and was unable to verify the structural integrity without further testing. We recommend a Resi-PD survey to establish the condition of the timber at it's core.

**Action:** Contact the Play Inspection Company office for further information

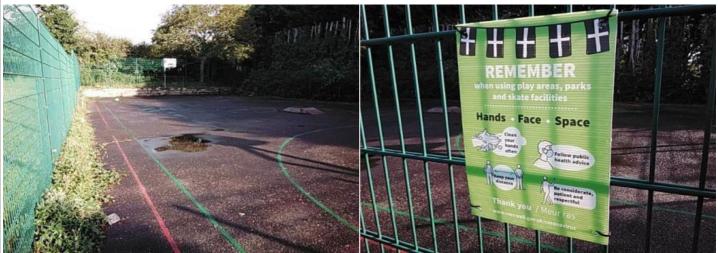
Finding: A clearly visible facility sign should be provided in Action: Provide signage to BS EN 15312 a prominent position with the wording as detailed BS EN 15312- the equipment is not intended for children less than 3 years old- the warning - Do not climb on the framework or nets- the warning - Do not hang on the ring (if provided)- the warning - Do not wear rings or other jewellery- name and telephone number of the administrator- number to call in case of accident

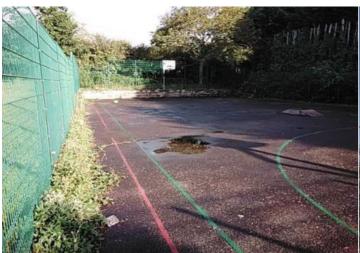
Finding: The backboard is damaged

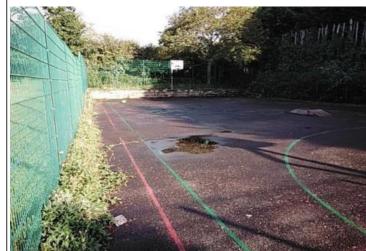
Finding: The basketball post is slightly loose in its mount

**Action:** Monitor for any further deterioration and repair as required

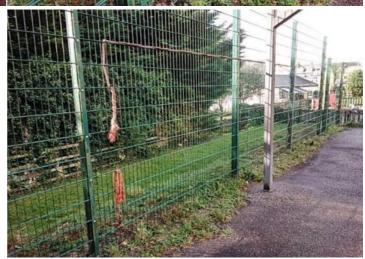
Finding: The rope is damaged

Action: Repair or remove

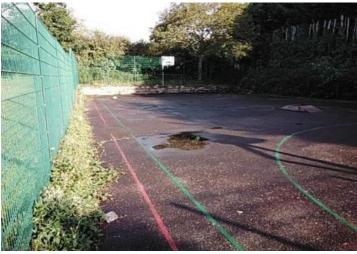
Finding: The net is severely damaged

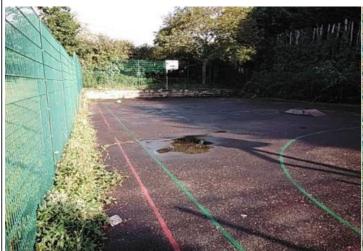
Finding: There is some minor damage to the surface

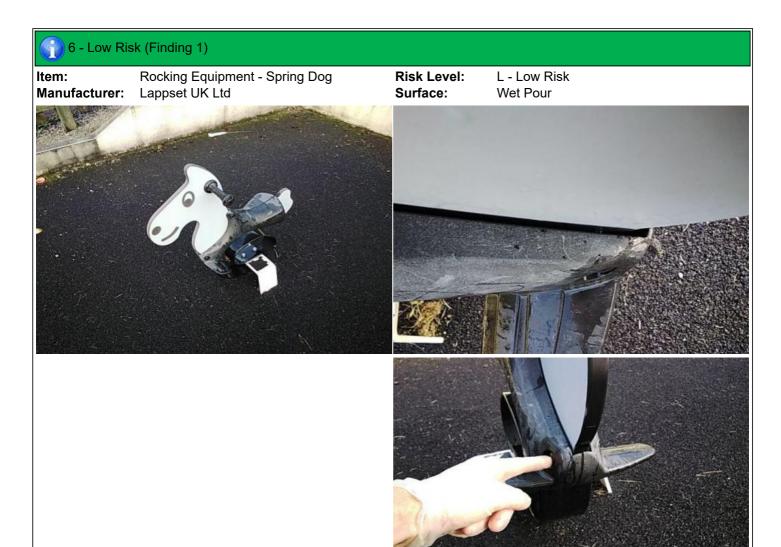
Finding: A number of fixing(s) have worked loose

Action: Secure all loose fixings

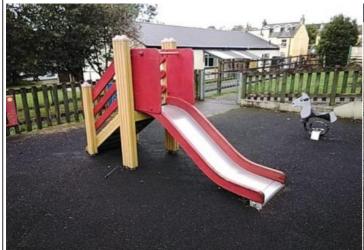
**Finding:** There is or are fixings missing on the item

**Action:** Replace all missing fixings

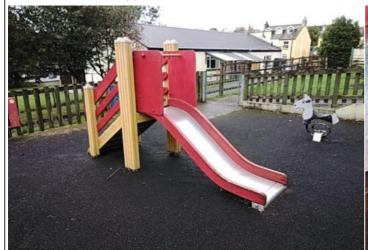
**Finding:** There is / are toggle entrapment/s present in contravention of the recommendations set out in BS EN 1176 Part 3
