Project Name: Mayfield House

Project Date: 26/08/2022

Inspection Standard: MSCC5 Sewers & Drainage GB (SRM5
Scoring)

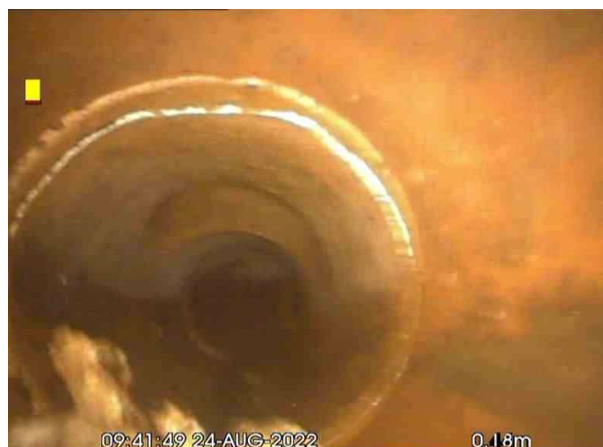
FMH3X_3c744aaa-f794-492d-8fe9-5964c65f8630_20220826_120929_486.jpg, 00:00:07, 0.18 m
Fracture, circumferential at joint from 9 o'clock to 3 o'clock

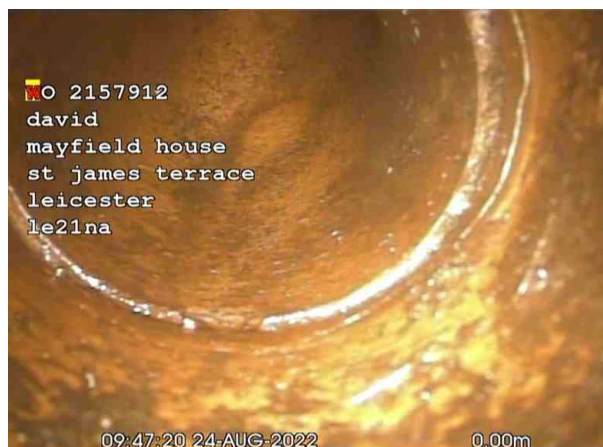
AX_fd924152-17b6-4146-839b-07471c5cded5_20220826_12
3831_736.jpg, 00:00:00, 0.00 m
Crack, circumferential at joint from 2 o'clock to 6 o'clock

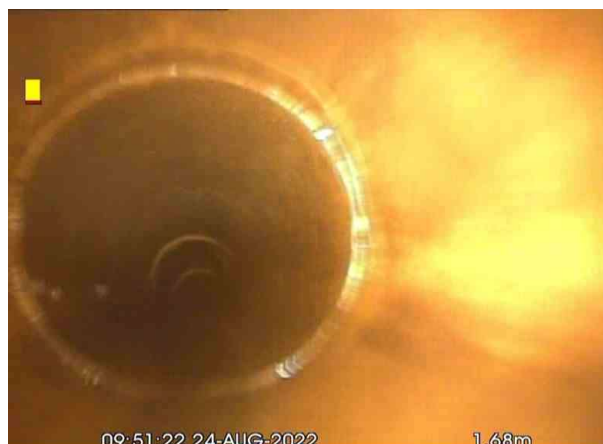
FMH5X_368cfac7-d831-4cc0-90fe-85dd2ab0d1e2_20220826_124459_799.jpg, 00:00:11, 1.68 m
Crack, circumferential at joint from 9 o'clock to 3 o'clock

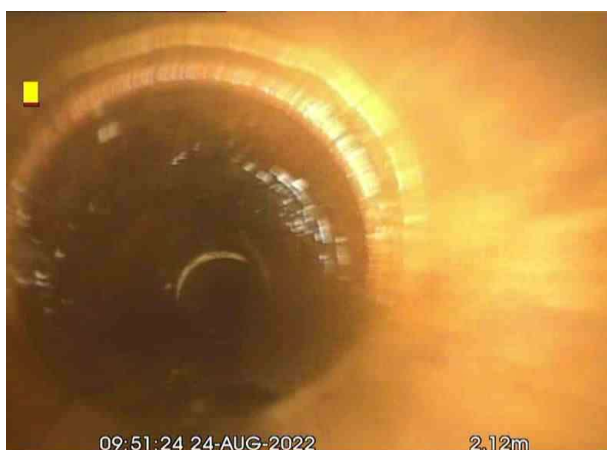
FMH5X_4abb7846-7c39-42a6-b2c0-81b8239ca69d_20220826_124518_178.jpg, 00:00:13, 2.12 m
Crack, circumferential at joint from 10 o'clock to 4 o'clock

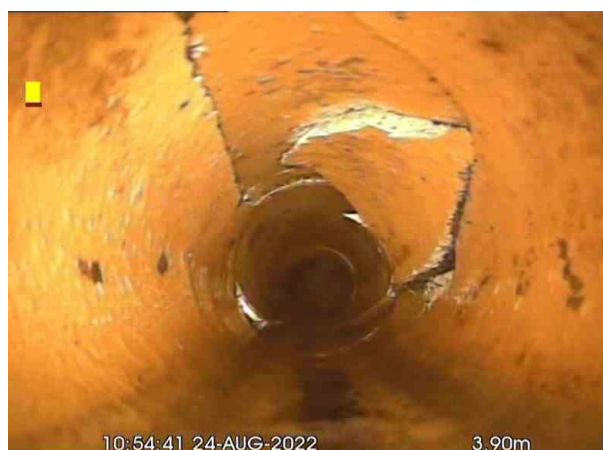
MH5aX_5680e134-a02a-4e76-8f4a-ba76ad208263_20220826_143019_247.jpg, 00:00:17, 3.90 m
Broken pipe from 10 o'clock to 4 o'clock

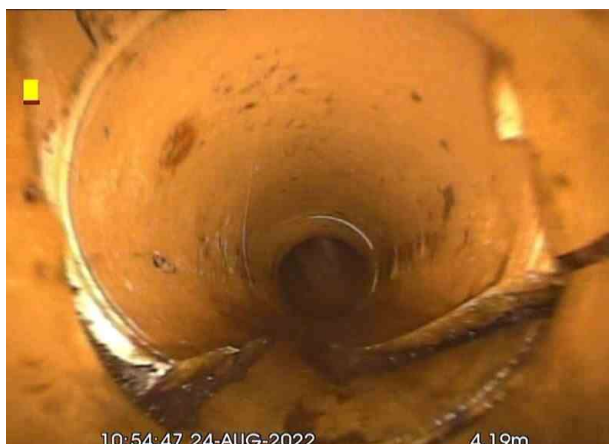
MH5aX_82e79a74-90eb-4154-ad14-19dc65b6d16f_20220826_143110_033.jpg, 00:00:21, 4.19 m
Broken pipe from 5 o'clock to 7 o'clock

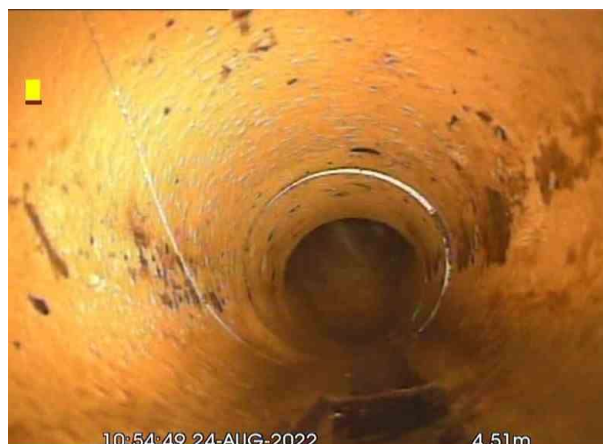
MH5aX_f90a0f58-68e0-404b-a191-e9604e2f41a0_20220826_143227_066.jpg, 00:00:23, 4.51 m
Cracks, spiral from 7 o'clock to 11 o'clock

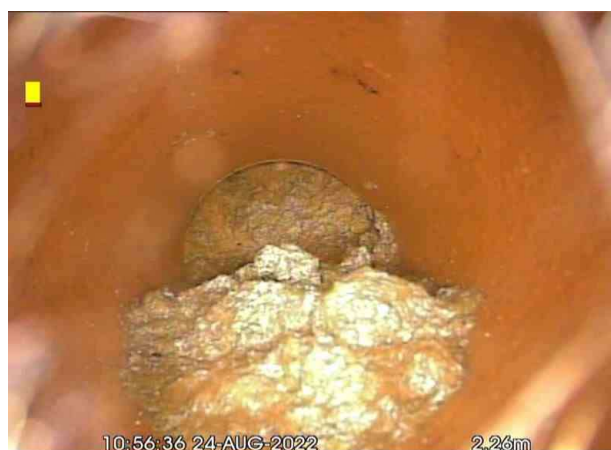
CX_d38bf258-8cdb-428f-bb34-b1031d1f510b_20220830_120
557_855.jpg, 00:00:10, 2.16 m
Settled deposits, hard or compacted, 90% cross-sectional area
loss

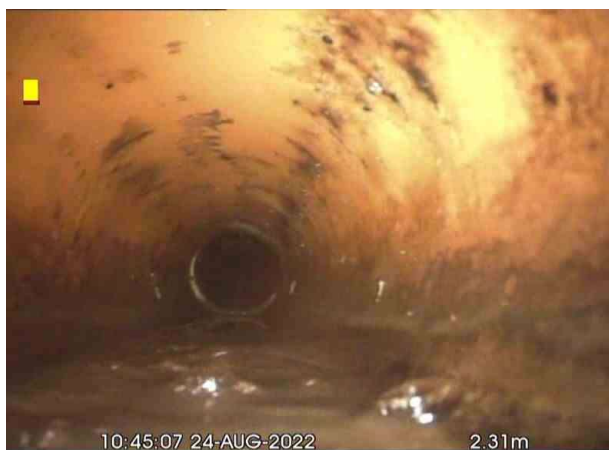
AX_b86a5d62-cf0d-4d0b-b385-77dd92a516f6_20220830_121
949_040.jpg, 00:00:13, 1.65 m
Joint displaced, medium

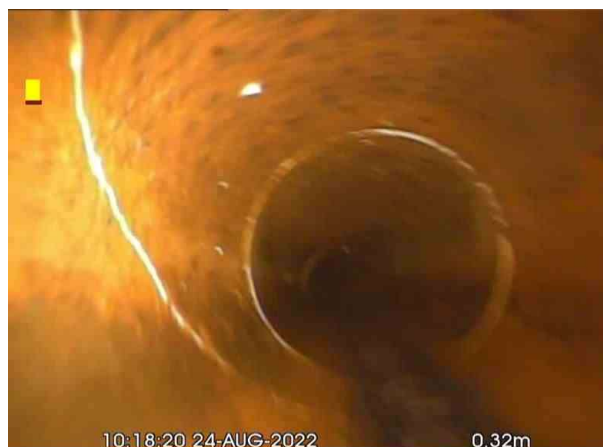
AX_cd5536f6-d665-48a6-b5b4-320da8415327_20220831_08
4948_141.jpg, 00:00:08, 0.32 m
Cracks, spiral from 7 o'clock to 10 o'clock

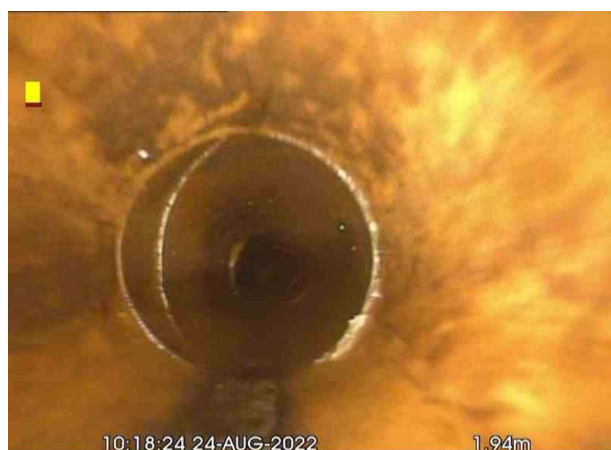
AX_0fa8d69e-d375-409f-ba34-bd15a1b1a549_20220831_085
940_765.jpg, 00:00:13, 1.94 m
Fracture, circumferential at joint from 7 o'clock to 11 o'clock

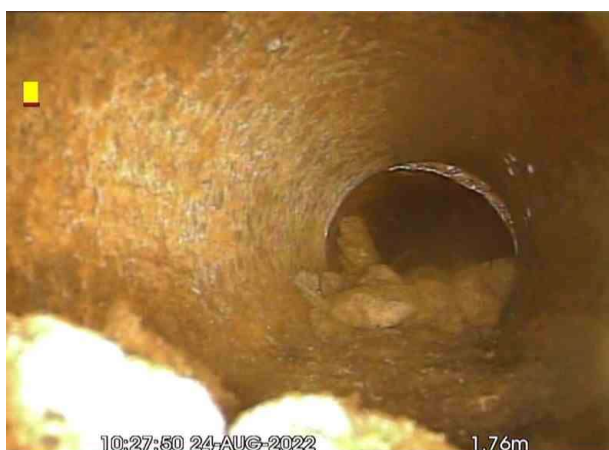
DX_6d1db3e8-1221-425a-87dd-3074f4980fe4_20220831_141
526_375.jpg, 00:00:18, 1.76 m
Settled deposits, coarse, 45% cross-sectional area loss

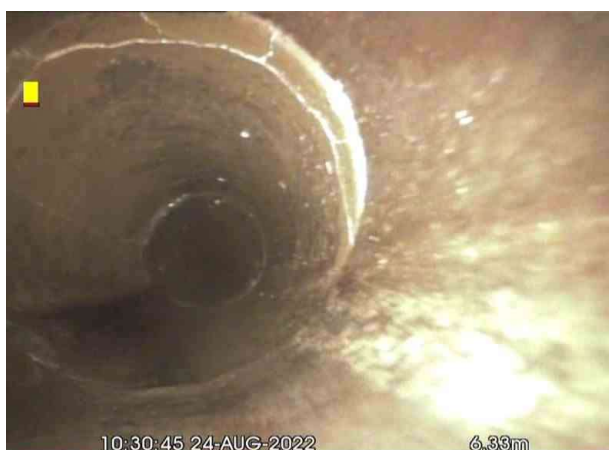
FMH8X_47d7b19c-1066-4d7b-844c-254ab95222e2_20220831_145604_091.jpg, 00:00:26, 6.33 m
Crack, circumferential at joint from 9 o'clock to 4 o'clock
