TLC Environmental Services Ltd

Asbestos Refurbishment survey Report

15th October 2018

**West Bergholt Parish Council
(Orpen & John Lampon Hall Loft Space)
Lexden Road
CO6 3BW**

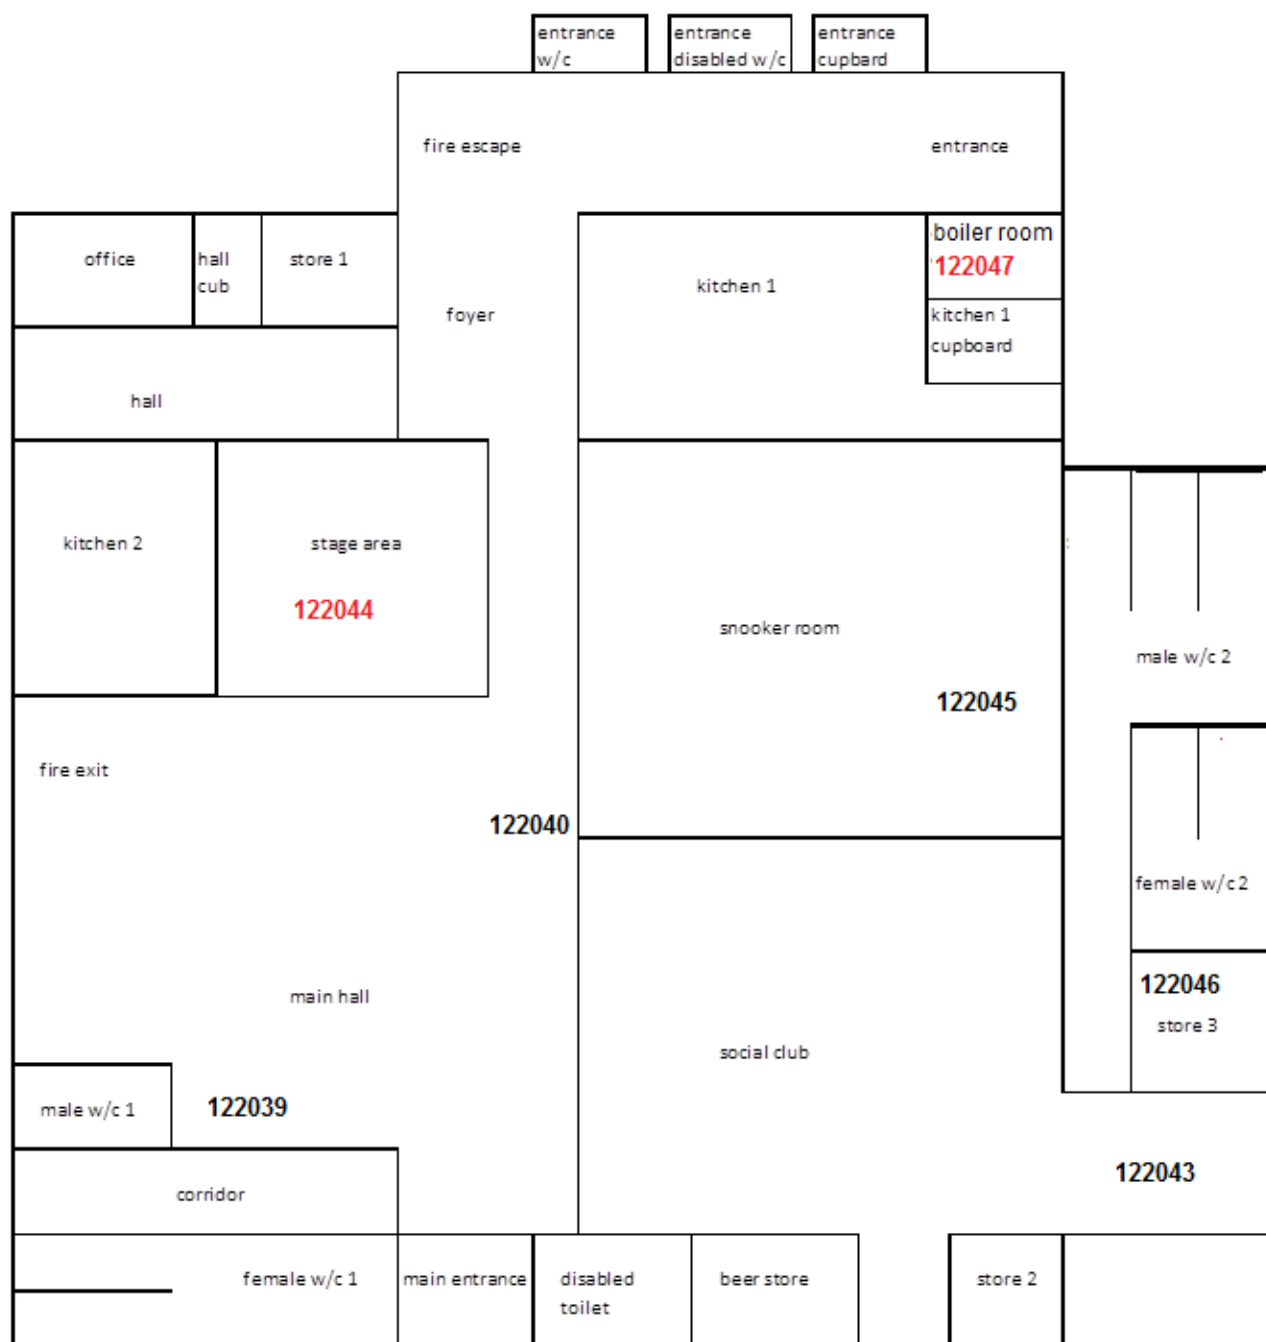
5 Marked drawings

122039-ceiling NAD
 122040-ceiling NAD
 122041-roof felt NAD
 122042-pipe lagging NAD
 122043-artex coating to ceiling NAD
 122044-ceiling
 122045-artex coating to ceiling NAD
 122046-ceiling NAD
 122047-ceiling

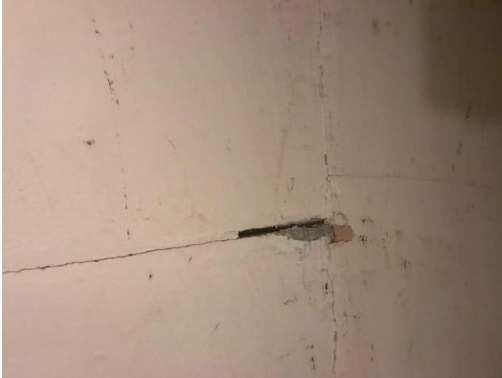
Photo 1

SN1-Slight damage to ceiling. Recommend repair/removal

Location	Risk Assessment	Recommendations
Stage-ceiling	Low	Repair/remove

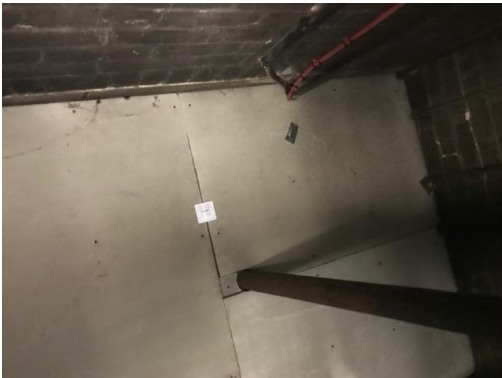
Photo 2

SN2-Mark and manage or remove if impeding works

Location	Risk Assessment	Recommendations
Boiler room-ceiling	Low	Manage/remove if impeding works
