ASBESTOS MANAGEMENT SURVEY REPORT

**Roman Business Centre
Le Neubourg Way
Gillingham
Dorset
SP8 4DN**

Project / Job Number: J114211

Survey Date(s): 6 Jan 2022

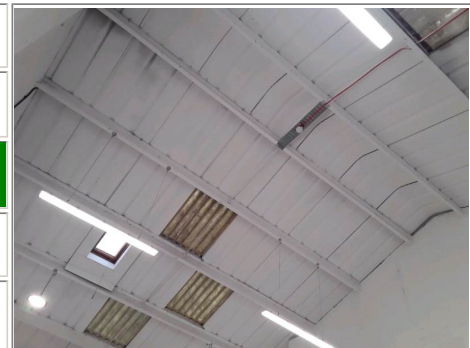
002 Workshop

Photo No. 1 - Corrugated roof sheets (internal layer - flat profile)

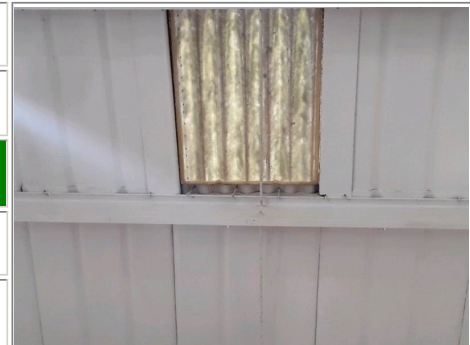
002 Workshop

Photo No. 2 - Corrugated roof sheets (external layer - curved profile) visible to edges of skylights

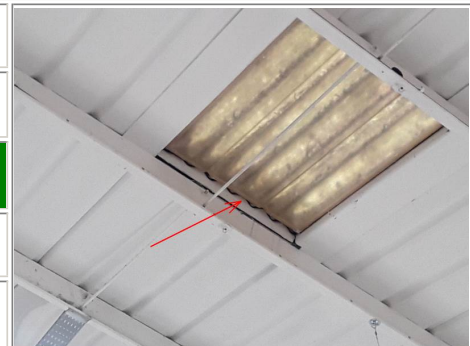
002	Workshop	3		Corrugated infill panels to edges of skylights - unable to access to sample	8-10 m	Presumed	Asbestos Cement (1)	Crocidolite (or unknown) (3)	Low Damage (1)	Surface Sealed (1)	Low	Low	D - Manage and Review	Sample prior to disturbance	As Required	Jan 2023
003	Circulation	4	DE002933	Textured coating to ceiling	1-2 m ²	Identified	Textured Coating (1)	Chrysotile (1)	Low Damage (1)	Surface Sealed (1)	Low	Low	D - Manage and Review	-	N/A	Jan 2023
004	W.C.	5		Textured coating to ceiling (as sample DE002933)	2-4 m ²	Strongly Presumed	Textured Coating (1)	Chrysotile (1)	Low Damage (1)	Surface Sealed (1)	Low	Low	D - Manage and Review	-	N/A	Jan 2023
004	W.C.	6	DE002934	Bitumen adhesive to floor	2-4 m ²	Identified	Well Bound Material (1)	Chrysotile (1)	Low Damage (1)	Completely Sealed (0)	Very Low	Low	D - Manage and Review	-	N/A	Jan 2023
005	Workshop	7		Corrugated roof sheets (internal layer - flat profile) (as sample DE002941)	80-100 m ²	Strongly Presumed	Asbestos Cement (1)	Chrysotile (1)	Low Damage (1)	Surface Sealed (1)	Low	Low	D - Manage and Review	-	N/A	Jan 2023

Photo No. 3 - Corrugated infill panels to edges of skylights - unable to access to sample

Sample prior to disturbance

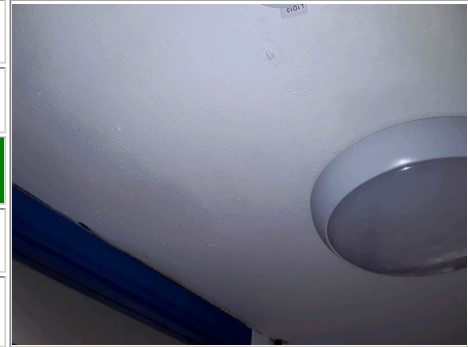
003 Circulation

Photo No. 4 - Textured coating to ceiling

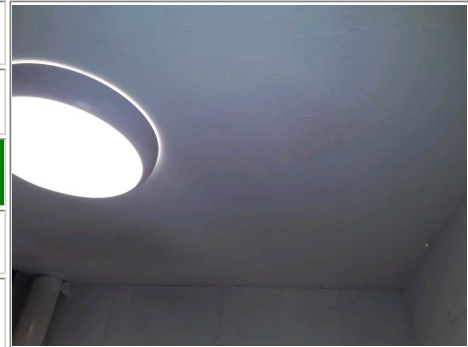
004 W.C.

Photo No. 5 - Textured coating to ceiling (as sample DE002933)

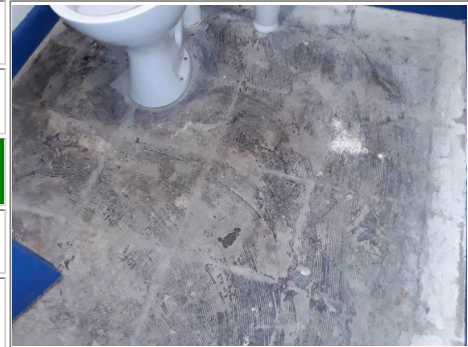
004 W.C.

Photo No. 6 - Bitumen adhesive to floor

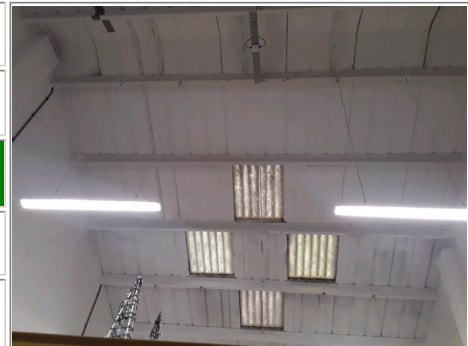
005 Workshop

Photo No. 7 - Corrugated roof sheets (internal layer - flat profile) (as sample DE002941)

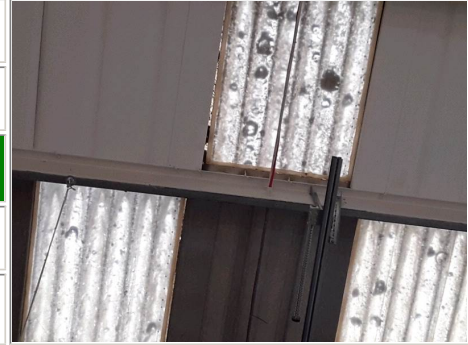
005	Workshop	8		Corrugated roof sheets (external layer - curved profile) visible to edges of skylights (as sample DE002942)	See external entry	Strongly Presumed	Asbestos Cement (1)	Chrysotile (1)	Low Damage (1)	Surface Sealed (1)	Low	Low	D - Manage and Review	-	N/A	Jan 2023

Photo No. 8 - Corrugated roof sheets (external layer - curved profile) visible to edges of skylights (as sample DE002942)

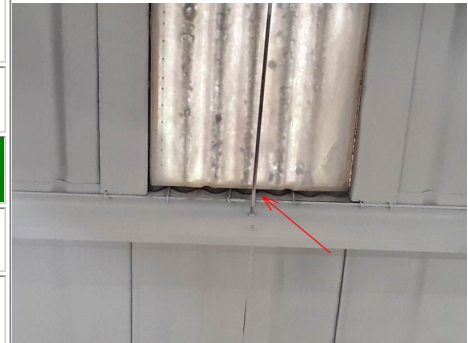
005 Workshop

Photo No. 9 - Corrugated infill panels to edges of skylights - unable to access to sample

Sample prior to disturbance

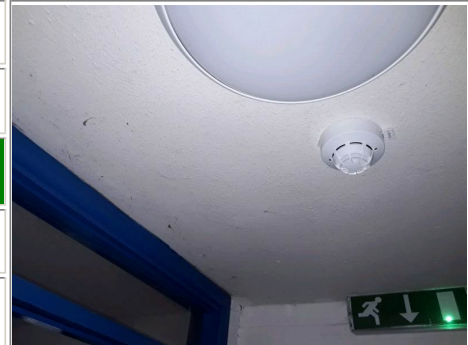
006 Circulation

Photo No. 10 - Textured coating to ceiling (as sample DE002933)

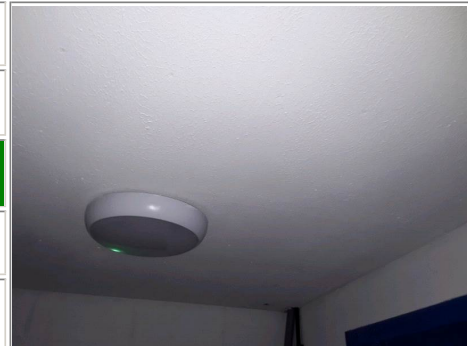
007 Store

Photo No. 11 - Textured coating to ceiling (as sample DE002933)

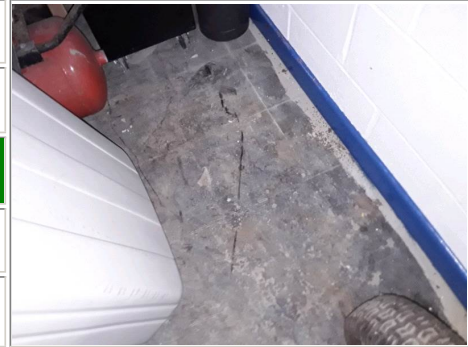
007	Store	12		Bitumen adhesive to floor (as sample DE002934)	2-4 m ²	Strongly Presumed	Well Bound Material (1)	Chrysotile (1)	Low Damage (1)	Completely Sealed (0)	Very Low	Low	D - Manage and Review	-	N/A	Jan 2023
008	Workshop	13		Corrugated roof sheets (internal layer - flat profile) (as sample DE002941)	80-100 m ²	Strongly Presumed	Asbestos Cement (1)	Chrysotile (1)	Low Damage (1)	Surface Sealed (1)	Low	Low	D - Manage and Review	-	N/A	Jan 2023
008	Workshop	14		Corrugated roof sheets (external layer - curved profile) visible to edges of skylights (as sample DE002942)	See external entry	Strongly Presumed	Asbestos Cement (1)	Chrysotile (1)	Low Damage (1)	Surface Sealed (1)	Low	Low	D - Manage and Review	-	N/A	Jan 2023
008	Workshop	15		Corrugated infill panels to edges of skylights - unable to access to sample	8-10 m	Presumed	Asbestos Cement (1)	Crocidolite (or unknown) (3)	Low Damage (1)	Surface Sealed (1)	Low	Low	D - Manage and Review	Sample prior to disturbance	As Required	Jan 2023

Photo No. 12 - Bitumen adhesive to floor (as sample DE002934)

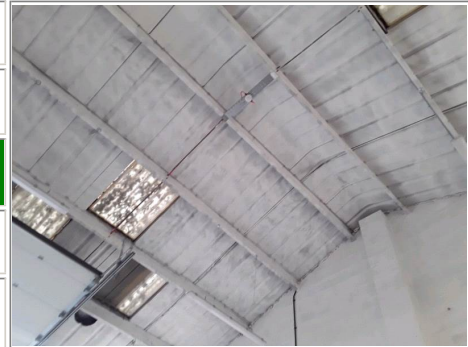
008 Workshop

Photo No. 13 - Corrugated roof sheets (internal layer - flat profile) (as sample DE002941)

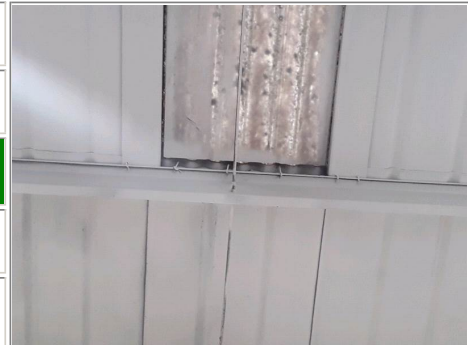
008 Workshop

Photo No. 14 - Corrugated roof sheets (external layer - curved profile) visible to edges of skylights (as sample DE002942)

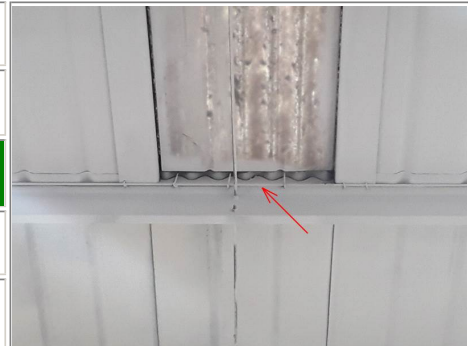
008 Workshop

Photo No. 15 - Corrugated infill panels to edges of skylights - unable to access to sample

Sample prior to disturbance

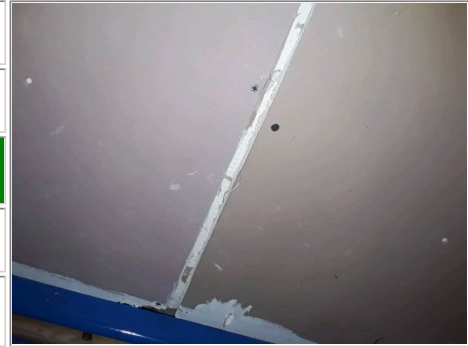
Please note: The ceiling within Circulation 009 is constructed of plasterboard panels that are visually consistent with the new plasterboard ceiling panels in the adjacent W.C. 010. Asbestos containing textured coating has been identified on the original ceiling above the new plasterboard ceiling panels in W.C. 010, via small gaps that are not present between the plasterboard panels in Circulation 009. It would be prudent to presume, therefore, that similar asbestos containing textured coating may also exist above the plasterboard ceiling panels in Circulation 009.

Photo No. 16 - Textured coating to original ceiling above new plasterboard ceiling panels (visible via small gap between new plasterboard ceiling panels) (as sample DE002933)

010 W.C.			
Strongly Presumed		Textured Coating (1)	
Chrysotile (1)		D - Manage and Review	
Material Assessment	Low	Priority Assessment	Low
-

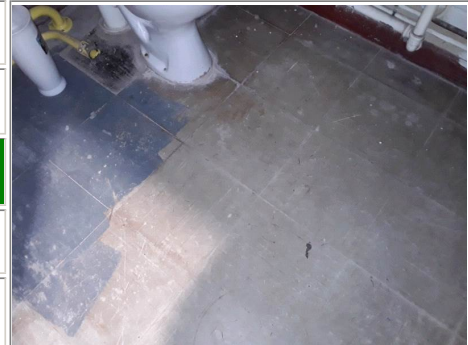
Photo No. 17 - Vinyl floor tiles (beige) and bitumen adhesive below

010 W.C.			
Identified		Well Bound Material (1)	
Chrysotile (1)		D - Manage and Review	
Material Assessment	Very Low	Priority Assessment	Low
-

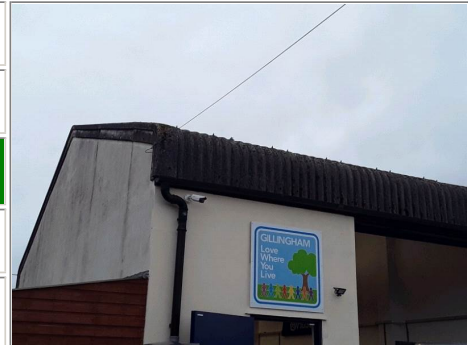
External	18		Corrugated roof sheets (curved profile) to main roof and associated edge capping panels to gable ends (as sample DE002942)	250-300 m ²	Strongly Presumed	Asbestos Cement (1)	Chrysotile (1)	Low Damage (1)	Surface Sealed (1)	Low	Very Low	D - Manage and Review	-	N/A	Jan 2023
	External	19	DE002936	Guttering to north side of Office 015 and W.C. 013		Identified	Not Applicable	No Asbestos Detected						-

Photo No. 18 - Corrugated roof sheets (curved profile) to main roof and associated edge capping panels to gable ends (as sample DE002942)

External			
Strongly Presumed		Asbestos Cement (1)	
Chrysotile (1)		D - Manage and Review	
Material Assessment	Low	Priority Assessment	Very Low
-

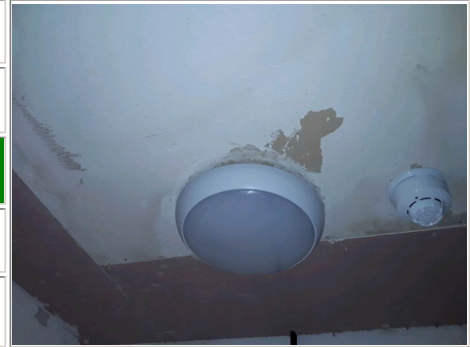
A005 Circulation

Photo No. 24 - Textured coating to ceiling

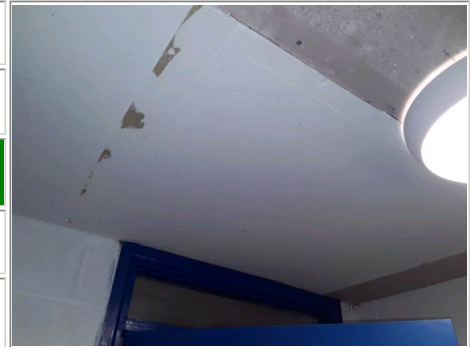
A006 W.C.

Photo No. 25 - Textured coating to ceiling to area above door (as sample DE002943)

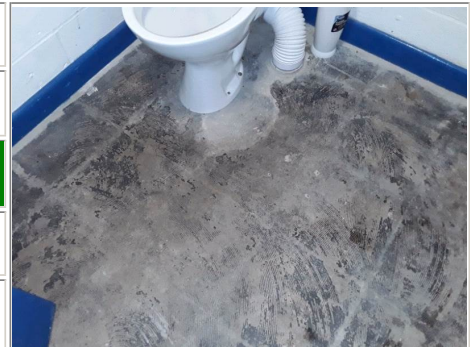
A006 W.C.

Photo No. 26 - Bitumen adhesive to floor

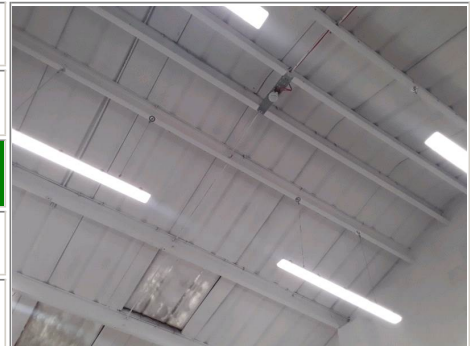
A007 Vehicle Store

Photo No. 27 - Corrugated roof sheets (internal layer - flat profile)

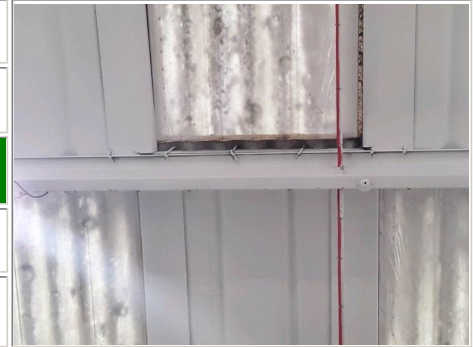
A007	Vehicle Store	28	DE002949	Corrugated roof sheets (external layer - curved profile) visible to edges of skylights	See external entry	Identified	Asbestos Cement (1)	Chrysotile (1)	Low Damage (1)	Surface Sealed (1)	Low	Low	D - Manage and Review	-	N/A	Jan 2023
A007	Vehicle Store	29		Corrugated infill panels to edges of skylights - unable to access to sample	6-8 m	Presumed	Asbestos Cement (1)	Crocidolite (or unknown) (3)	Low Damage (1)	Surface Sealed (1)	Low	Low	D - Manage and Review	Sample prior to disturbance	As Required	Jan 2023
A008	Vehicle Store	30		Corrugated roof sheets (internal layer - flat profile) (as sample DE002948)	80-100 m ²	Strongly Presumed	Asbestos Cement (1)	Chrysotile (1)	Low Damage (1)	Surface Sealed (1)	Low	Low	D - Manage and Review	-	N/A	Jan 2023
A008	Vehicle Store	31		Corrugated roof sheets (external layer - curved profile) visible to edges of skylights (as sample DE002949)	See external entry	Strongly Presumed	Asbestos Cement (1)	Chrysotile (1)	Low Damage (1)	Surface Sealed (1)	Low	Low	D - Manage and Review	-	N/A	Jan 2023

Photo No. 28 - Corrugated roof sheets (external layer - curved profile) visible to edges of skylights

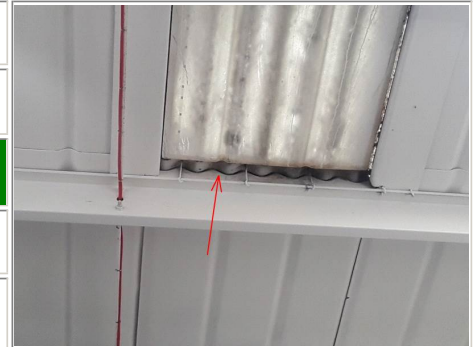
A007 Vehicle Store

Photo No. 29 - Corrugated infill panels to edges of skylights - unable to access to sample

Sample prior to disturbance

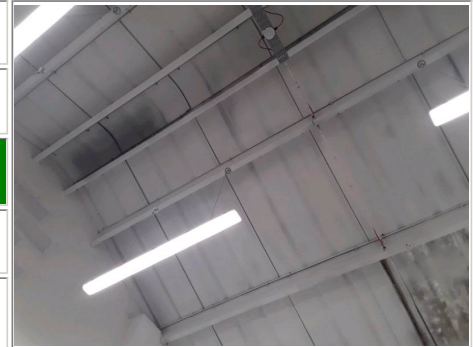
A008 Vehicle Store

Photo No. 30 - Corrugated roof sheets (internal layer - flat profile) (as sample DE002948)

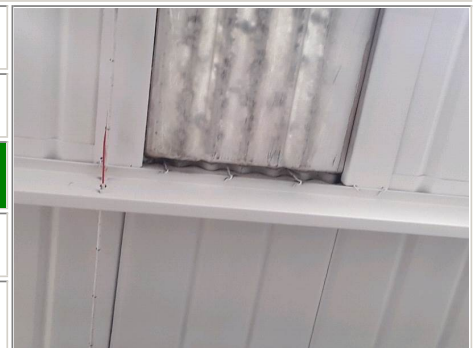
A008 Vehicle Store

Photo No. 31 - Corrugated roof sheets (external layer - curved profile) visible to edges of skylights (as sample DE002949)

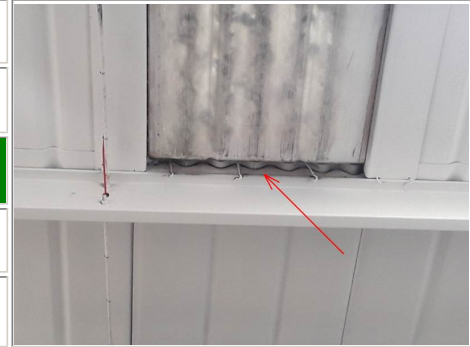
A008	Vehicle Store	32		Corrugated infill panels to edges of skylights - unable to access to sample	6-8 m	Presumed	Asbestos Cement (1)	Crocidolite (or unknown) (3)	Low Damage (1)	Surface Sealed (1)	Low	Low	D - Manage and Review	Sample prior to disturbance	As Required	Jan 2023
A009	Circulation	33		Textured coating to ceiling (as sample DE002943)	1-2 m ²	Strongly Presumed	Textured Coating (1)	Chrysotile (1)	Low Damage (1)	Surface Sealed (1)	Low	Low	D - Manage and Review	-	N/A	Jan 2023

Photo No. 32 - Corrugated infill panels to edges of skylights - unable to access to sample

Sample prior to disturbance

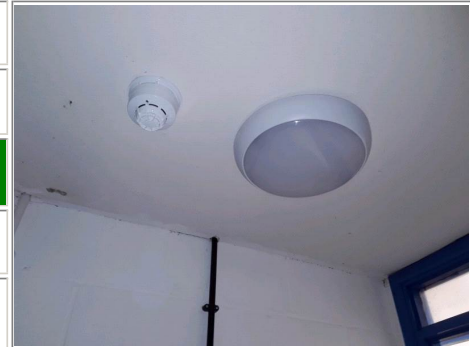
A009 Circulation

Photo No. 33 - Textured coating to ceiling (as sample DE002943)

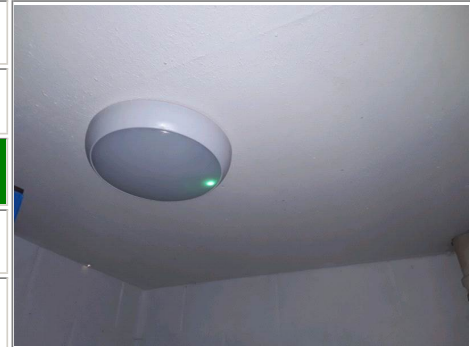
A010 W.C.

Photo No. 34 - Textured coating to ceiling (as sample DE002943)

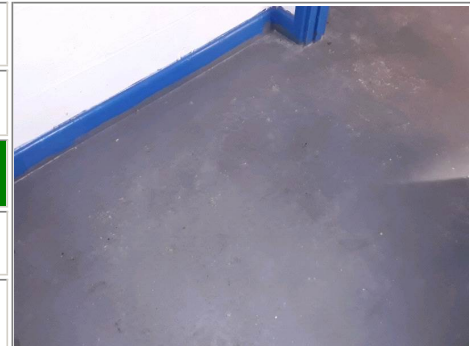
A010 W.C.

Photo No. 35 - Bitumen adhesive to floor below paint (grey) (as sample DE002944)

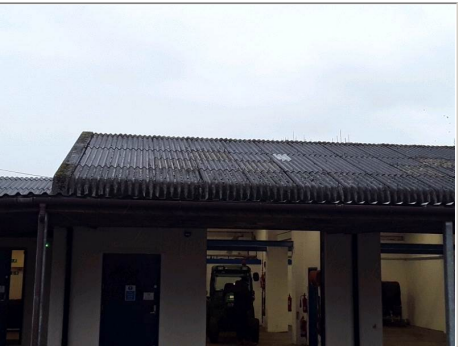
Photo No. 36 - Corrugated roof sheets (curved profile) to main roof and associated edge capping panels to gable ends (as sample DE002949)

External			
Strongly Presumed		Asbestos Cement (1)	
Chrysotile (1)		D - Manage and Review	
Material Assessment	Low	Priority Assessment	Very Low
-

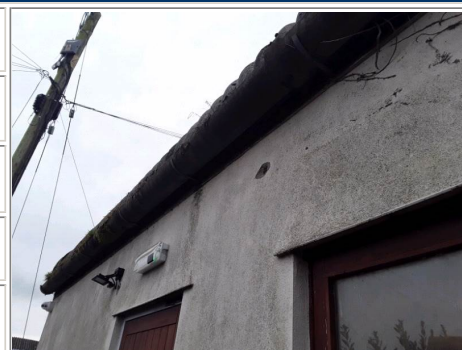
Photo No. 19 - Guttering to north side of Office 015 and W.C. 013

External			
Identified			
No Asbestos Detected		No Action Required	
Material Assessment	N/A	Priority Assessment	N/A
N/A

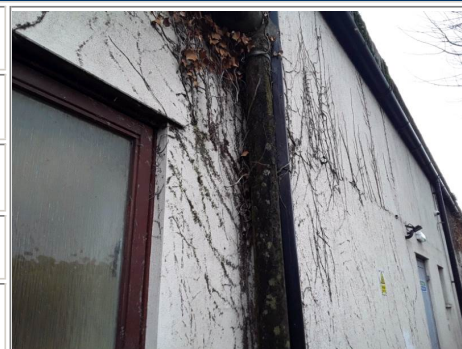
Photo No. 20 - Downpipe to north side of W.C. 013

External			
Identified			
No Asbestos Detected		No Action Required	
Material Assessment	N/A	Priority Assessment	N/A
N/A

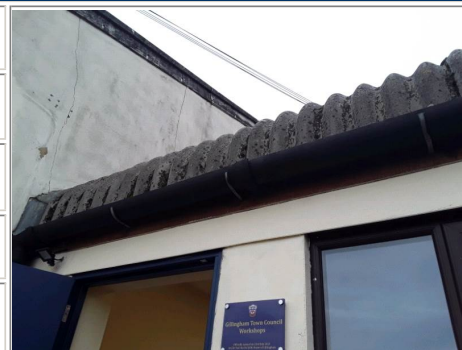
Photo No. 21 - Guttering to south side of Staff Room 011

External			
Identified			
No Asbestos Detected		No Action Required	
Material Assessment	N/A	Priority Assessment	N/A
N/A

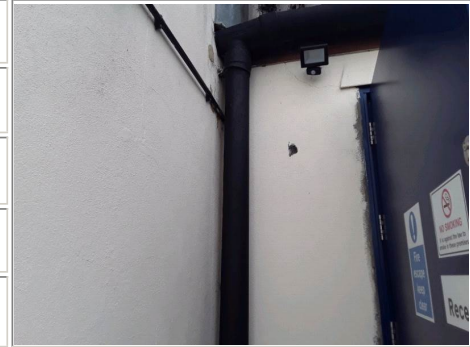
Photo No. 22 - Downpipe to southwest corner of Staff Room 011

External			
Identified			
No Asbestos Detected		No Action Required	
Material Assessment	N/A	Priority Assessment	N/A
N/A

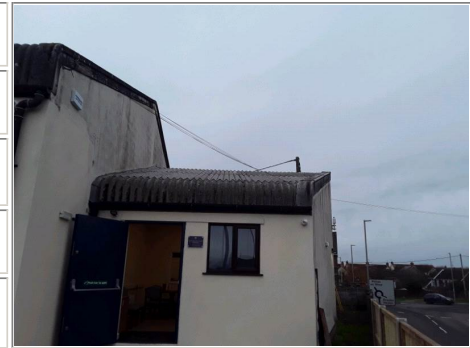
Photo No. 23 - Corrugated roof sheets (curved profile) to roof of extension to east side of building and associated edge capping panels to gable end

External			
Identified			
No Asbestos Detected		No Action Required	
Material Assessment	N/A	Priority Assessment	N/A
N/A

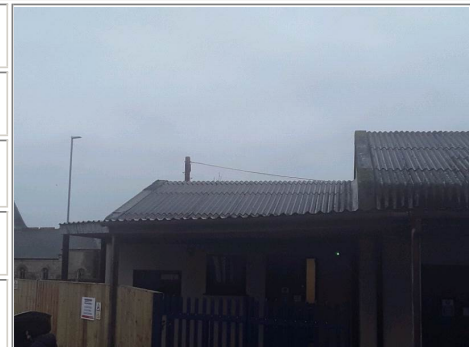
Photo No. 37 - Corrugated roof sheets (curved profile) to roof of extension to east side of building and associated edge capping panels to gable end

External			
Identified			
No Asbestos Detected		No Action Required	
Material Assessment	N/A	Priority Assessment	N/A
N/A

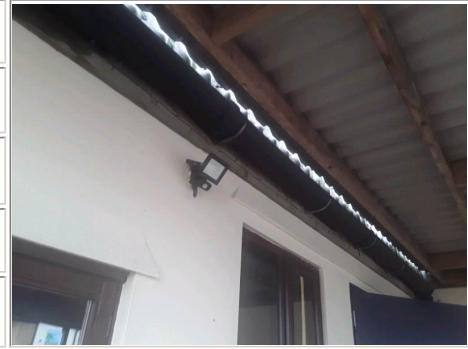
Photo No. 38 - Guttering to north side of Mess Room A001

External			
Identified			
No Asbestos Detected		No Action Required	
Material Assessment	N/A	Priority Assessment	N/A
N/A

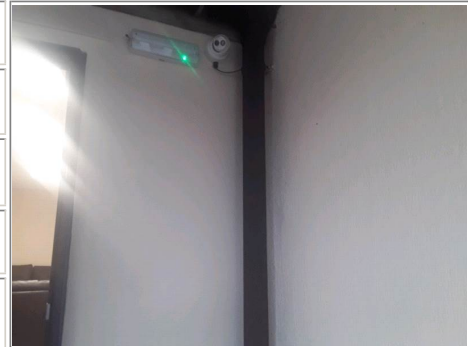
Photo No. 39 - Downpipe to northwest corner of Mess Room A001

External			
Identified			
No Asbestos Detected		No Action Required	
Material Assessment	N/A	Priority Assessment	N/A
N/A
