ASBESTOS REFURBISHMENT & DEMOLITION SURVEY REPORT FOR

MERMOND PUBLIC TOILET BLOCK

AUGUST 2017

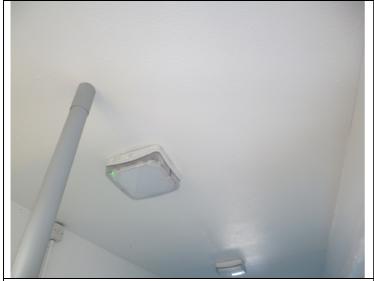
Ceilings – The ceilings have textured coating in all areas, a sample has been taken and found not to contain asbestos, the sub ceiling is visible from the loft area and confirmed as plasterboard.

Example of textured coating (Artex) to the plasterboard ceilings.

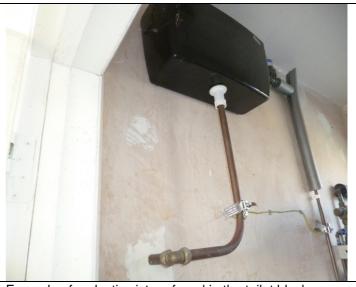
The cisterns in the tank room at the rear of the disabled wc are plastic and the electric hot water calorifier is a modern mega flow unit with modern man-made mineral fibre insulation within its casing.

Example of a plastic cistern found in the toilet block.

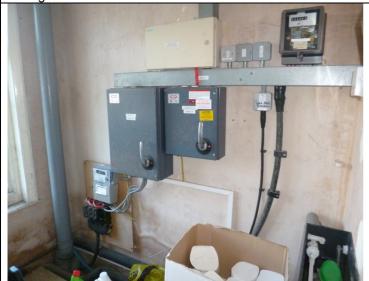
Modern electrical switch gear.

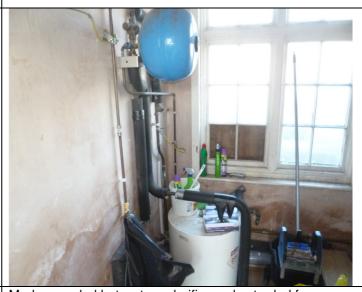
Modern sealed hot water calorifier and extruded foam pipework insulation.

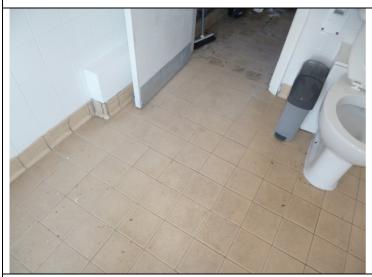
Floor - Ceramic tiles with a concrete sub floor.

Modern ceramic floor tiles.

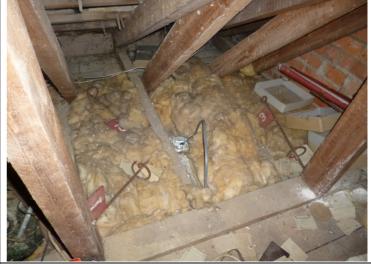
No suspicious materials or water storage tanks were detected in the loft space.

Man-made mineral fibre (glass) insulation above ceiling in roof space.
