**CONFIDENTIAL REPORT
ASBESTOS MANAGEMENT SURVEY REPORT
FOR SCC PREMISES**

Milford Recreation Ground (Community Hall)
Yeovil
BA21 4QD
JOB NO: J007226

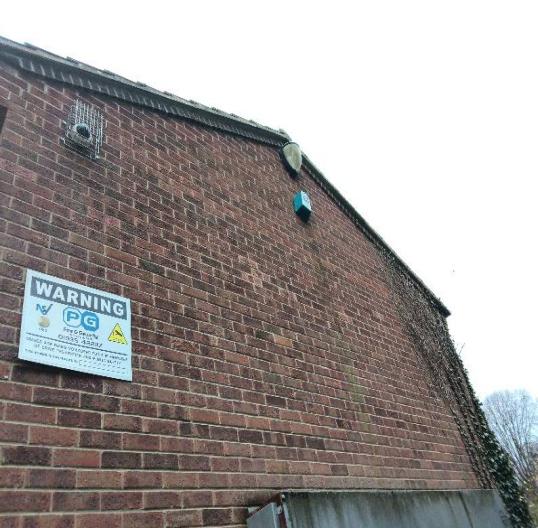
Item No	Building	Room	Position
28	Block A	External Ext01	Roof
Quantity	Item Description		Accessibility
12-14lm	Under tile edging to East Elevation of A023		Usually inaccessible or unlikely to be disturbed (0)
Sample No (S,SP,P,As)	Product Type	Surface Treatment	Condition
Visual (P)	Asbestos Cement (1)	Surface Sealed (1)	Good Condition (0)

Normal Occupancy	Score	Likelihood of disturbance	Score	Exposure Potential	Score	Maintenance Activity	Score
Main type of activity	0	Location	0	Number of occupants	0	Type of Maintenance	0
		Accessibility	0	Frequency of use	0	Frequency of maintenance	0
		Amount	2	Average Time	0		
Average Score	0	Average Score	1	Average Score	0	Average Score	0
Average of Priority	1						
Material Assessment Score	3						
Recommendation	D - No Attention Required, inspect at intervals

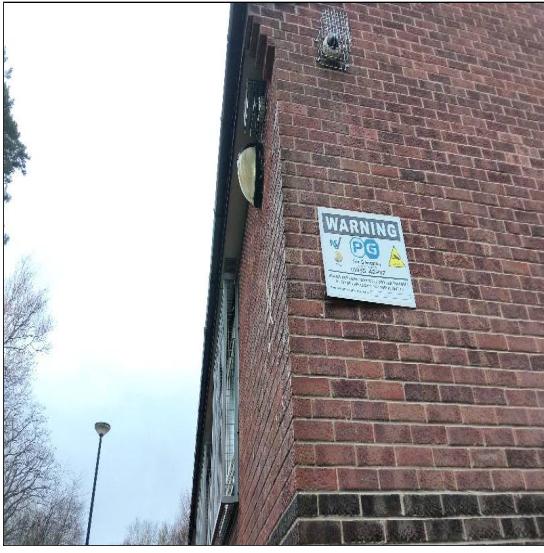
Item No	Building	Room	Position
30	Block A	External Ext01	Roof
Quantity	Item Description		Accessibility
26-28lm	Soffit to South elevation East end		Usually inaccessible or unlikely to be disturbed (0)
Sample No (S,SP,P,As)	Product Type	Surface Treatment	Condition
BD000801 {DN000196} (S)	Not applicable (No asbestos detected) (0)	Completely Sealed (0)	Good Condition (0)

Normal Occupancy	Score	Likelihood of disturbance	Score	Exposure Potential	Score	Maintenance Activity	Score
Main type of activity	N/A	Location	N/A	Number of occupants	N/A	Type of Maintenance	N/A
		Accessibility	N/A	Frequency of use	N/A	Frequency of maintenance	N/A
		Amount	N/A	Average Time	N/A		
Average Score	N/A	Average Score	N/A	Average Score	N/A	Average Score	N/A
Average of Priority	N/A						
Material Assessment Score	N/A						
Recommendation	No further action required

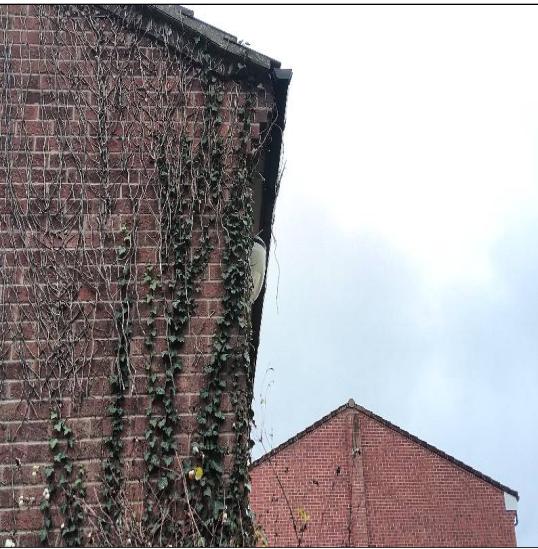
Item No	Building	Room	Position
29	Block A	External Ext01	Roof
Quantity	Item Description		Accessibility
20-25m	Soffit to North elevation East end.		Usually inaccessible or unlikely to be disturbed (0)
Sample No (S,SP,P,As)	Product Type	Surface Treatment	Condition
BD000802 {DN000195} (S)	Not applicable (No asbestos detected) (0)	Completely Sealed (0)	Good Condition (0)

Normal Occupancy	Score	Likelihood of disturbance	Score	Exposure Potential	Score	Maintenance Activity	Score
Main type of activity	N/A	Location	N/A	Number of occupants	N/A	Type of Maintenance	N/A
		Accessibility	N/A	Frequency of use	N/A	Frequency of maintenance	N/A
		Amount	N/A	Average Time	N/A		
Average Score	N/A	Average Score	N/A	Average Score	N/A	Average Score	N/A
Average of Priority	N/A						
Material Assessment Score	N/A						
Recommendation	No further action required

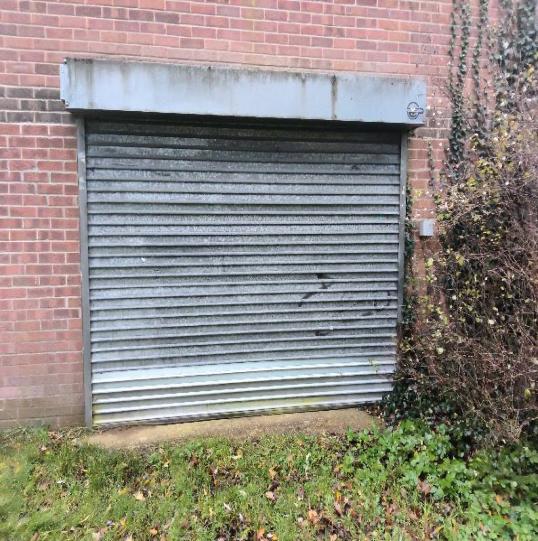
Item No	Building	Room	Position
27	Block A	Store A001Z	Inaccessible
Quantity	Item Description		Accessibility
N/A	Inaccessible Room		N/A
Sample No (S,SP,P,As)	Product Type	Surface Treatment	Condition
Visual (P)	N/A	N/A	N/A

Normal Occupancy	Score	Likelihood of disturbance	Score	Exposure Potential	Score	Maintenance Activity	Score
Main type of activity	N/A	Location	N/A	Number of occupants	N/A	Type of Maintenance	N/A
		Accessibility	N/A	Frequency of use	N/A	Frequency of maintenance	N/A
		Amount	N/A	Average Time	N/A		
Average Score	N/A	Average Score	N/A	Average Score	N/A	Average Score	N/A
Average of Priority	N/A						
Material Assessment Score	N/A						
Recommendation	Inspection Required

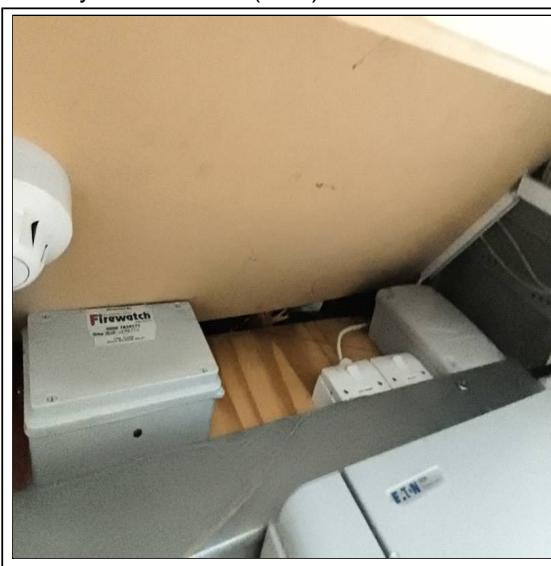
Item No	Building	Room	Position
19	Block A	Meters A002	Inaccessible
Quantity	Item Description		Accessibility
N/A	Ceiling Void		N/A
Sample No (S,SP,P,As)	Product Type	Surface Treatment	Condition
Visual (P)	N/A	N/A	N/A

Normal Occupancy	Score	Likelihood of disturbance	Score	Exposure Potential	Score	Maintenance Activity	Score
Main type of activity	N/A	Location	N/A	Number of occupants	N/A	Type of Maintenance	N/A
		Accessibility	N/A	Frequency of use	N/A	Frequency of maintenance	N/A
		Amount	N/A	Average Time	N/A		
Average Score	N/A	Average Score	N/A	Average Score	N/A	Average Score	N/A
Average of Priority	N/A						
Material Assessment Score	N/A						
Recommendation	Inspection Required

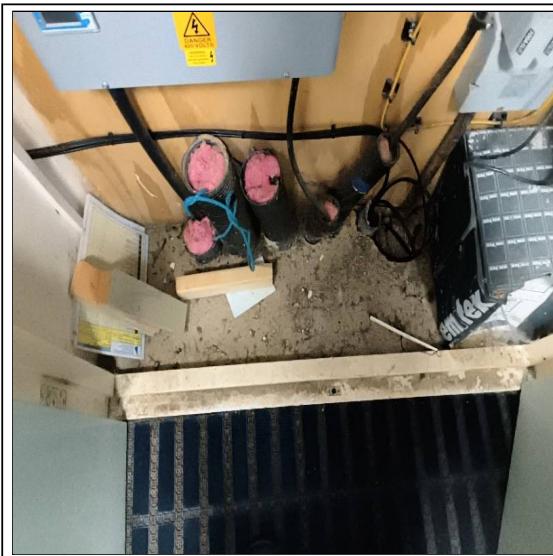
Item No	Building	Room	Position
20	Block A	Meters A002	Inaccessible
Quantity	Item Description		Accessibility
N/A	Voids where pipes enter floor construction.		N/A
Sample No (S,SP,P,As)	Product Type	Surface Treatment	Condition
Visual (P)	N/A	N/A	N/A

Normal Occupancy	Score	Likelihood of disturbance	Score	Exposure Potential	Score	Maintenance Activity	Score
Main type of activity	N/A	Location	N/A	Number of occupants	N/A	Type of Maintenance	N/A
		Accessibility	N/A	Frequency of use	N/A	Frequency of maintenance	N/A
		Amount	N/A	Average Time	N/A		
Average Score	N/A	Average Score	N/A	Average Score	N/A	Average Score	N/A
Average of Priority	N/A						
Material Assessment Score	N/A						
Recommendation	Inspection Required

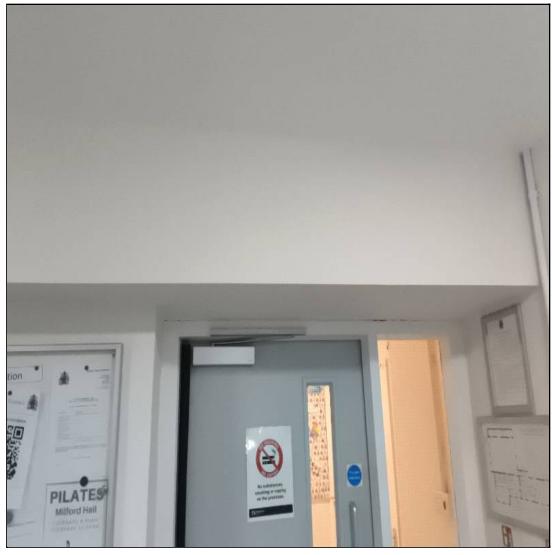
Item No	Building	Room	Position
7	Block A	Circulation A003	Inaccessible
Quantity	Item Description		Accessibility
N/A	Horizontal plasterboard boxing above door to A017.		N/A
Sample No (S,SP,P,As)	Product Type	Surface Treatment	Condition
Visual (P)	N/A	N/A	N/A

Normal Occupancy	Score	Likelihood of disturbance	Score	Exposure Potential	Score	Maintenance Activity	Score
Main type of activity	N/A	Location	N/A	Number of occupants	N/A	Type of Maintenance	N/A
		Accessibility	N/A	Frequency of use	N/A	Frequency of maintenance	N/A
		Amount	N/A	Average Time	N/A		
Average Score	N/A	Average Score	N/A	Average Score	N/A	Average Score	N/A
Average of Priority	N/A						
Material Assessment Score	N/A						
Recommendation	Inspection Required

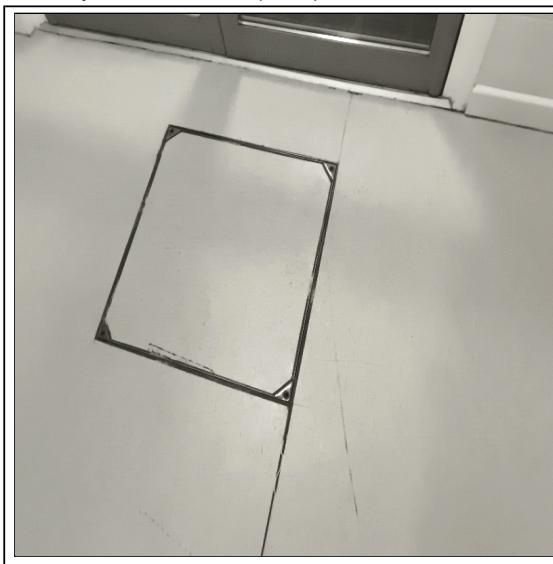
Item No	Building	Room	Position
8	Block A	Circulation A003	Inaccessible
Quantity	Item Description		Accessibility
N/A	Beneath manhole covers.		N/A
Sample No (S,SP,P,As)	Product Type	Surface Treatment	Condition
Visual (P)	N/A	N/A	N/A

Normal Occupancy	Score	Likelihood of disturbance	Score	Exposure Potential	Score	Maintenance Activity	Score
Main type of activity	N/A	Location	N/A	Number of occupants	N/A	Type of Maintenance	N/A
		Accessibility	N/A	Frequency of use	N/A	Frequency of maintenance	N/A
		Amount	N/A	Average Time	N/A		
Average Score	N/A	Average Score	N/A	Average Score	N/A	Average Score	N/A
Average of Priority	N/A						
Material Assessment Score	N/A						
Recommendation	Inspection Required

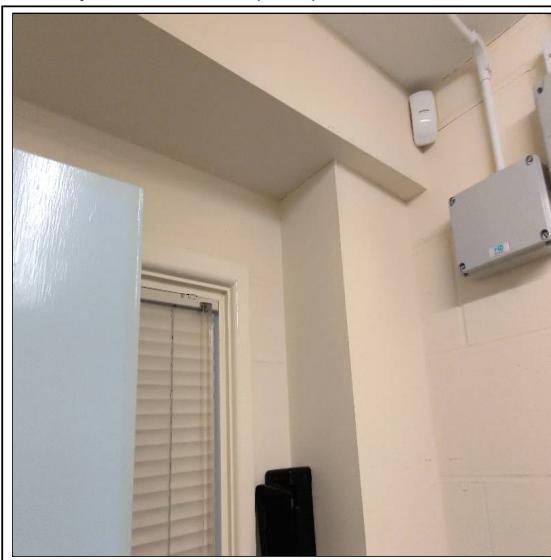
Item No	Building	Room	Position
9	Block A	Office A004	Inaccessible.
Quantity	Item Description		Accessibility
N/A	Horizontal and vertical MDF boxing		N/A
Sample No (S,SP,P,As)	Product Type	Surface Treatment	Condition
Visual (P)	N/A	N/A	N/A

Normal Occupancy	Score	Likelihood of disturbance	Score	Exposure Potential	Score	Maintenance Activity	Score
Main type of activity	N/A	Location	N/A	Number of occupants	N/A	Type of Maintenance	N/A
		Accessibility	N/A	Frequency of use	N/A	Frequency of maintenance	N/A
		Amount	N/A	Average Time	N/A		
Average Score	N/A	Average Score	N/A	Average Score	N/A	Average Score	N/A
Average of Priority	N/A						
Material Assessment Score	N/A						
Recommendation	Inspection Required

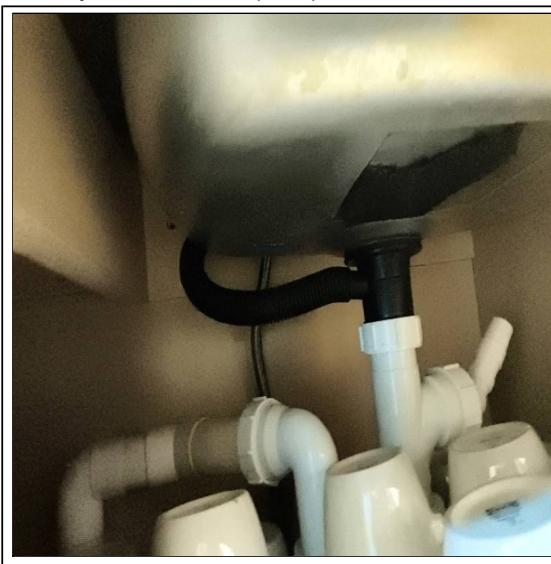
Item No	Building	Room	Position
6	Block A	Kitchen A011	Equipment
Quantity	Item Description		Accessibility
2no.	Under sink pads		Easily disturbed (2)
Sample No (S,SP,P,As)	Product Type	Surface Treatment	Condition
DN000189 (S)	Well Bound Material (1)	Completely Sealed (0)	Low Damage (1)

Normal Occupancy	Score	Likelihood of disturbance	Score	Exposure Potential	Score	Maintenance Activity	Score
Main type of activity	N/A	Location	N/A	Number of occupants	N/A	Type of Maintenance	N/A
		Accessibility	N/A	Frequency of use	N/A	Frequency of maintenance	N/A
		Amount	N/A	Average Time	N/A		
Average Score	N/A	Average Score	N/A	Average Score	N/A	Average Score	N/A
Average of Priority	N/A						
Material Assessment Score	N/A						
Recommendation	No further action required

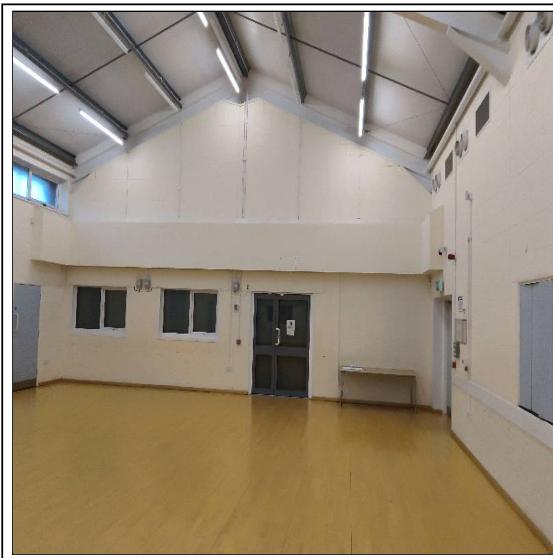
Item No	Building	Room	Position
3	Block A	Activity Space A013	Inaccessible
Quantity	Item Description		Accessibility
N/A	Within MDF boxing.		N/A
Sample No (S,SP,P,As)	Product Type	Surface Treatment	Condition
Visual (P)	N/A	N/A	N/A

Normal Occupancy	Score	Likelihood of disturbance	Score	Exposure Potential	Score	Maintenance Activity	Score
Main type of activity	N/A	Location	N/A	Number of occupants	N/A	Type of Maintenance	N/A
		Accessibility	N/A	Frequency of use	N/A	Frequency of maintenance	N/A
		Amount	N/A	Average Time	N/A		
Average Score	N/A	Average Score	N/A	Average Score	N/A	Average Score	N/A
Average of Priority	N/A						
Material Assessment Score	N/A						
Recommendation	Inspection Required

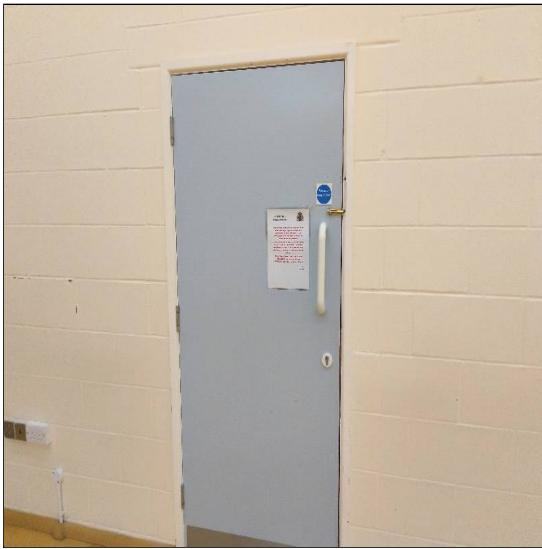
Item No	Building	Room	Position
4	Block A	Store A014	Inaccessible
Quantity	Item Description		Accessibility
N/A	Inaccessible room		N/A
Sample No (S,SP,P,As)	Product Type	Surface Treatment	Condition
Visual (P)	N/A	N/A	N/A

Normal Occupancy	Score	Likelihood of disturbance	Score	Exposure Potential	Score	Maintenance Activity	Score
Main type of activity	N/A	Location	N/A	Number of occupants	N/A	Type of Maintenance	N/A
		Accessibility	N/A	Frequency of use	N/A	Frequency of maintenance	N/A
		Amount	N/A	Average Time	N/A		
Average Score	N/A	Average Score	N/A	Average Score	N/A	Average Score	N/A
Average of Priority	N/A						
Material Assessment Score	N/A						
Recommendation	Inspection Required

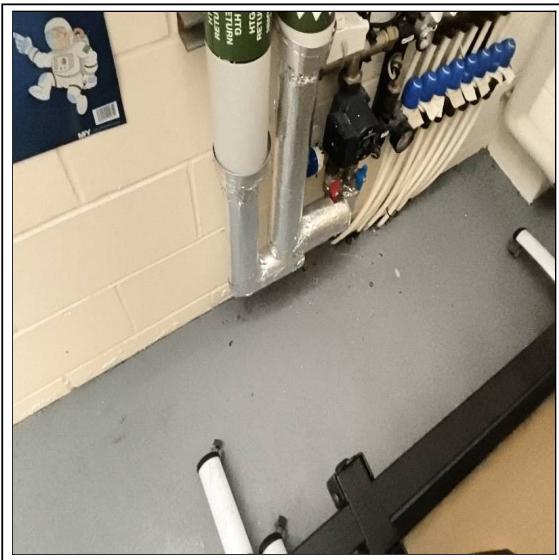
Item No	Building	Room	Position
5	Block A	Plant Room A016	Inaccessible
Quantity	Item Description		Accessibility
N/A	Voids where pipes enter floor construction.		N/A
Sample No (S,SP,P,As)	Product Type	Surface Treatment	Condition
Visual (P)	N/A	N/A	N/A

Normal Occupancy	Score	Likelihood of disturbance	Score	Exposure Potential	Score	Maintenance Activity	Score
Main type of activity	N/A	Location	N/A	Number of occupants	N/A	Type of Maintenance	N/A
		Accessibility	N/A	Frequency of use	N/A	Frequency of maintenance	N/A
		Amount	N/A	Average Time	N/A		
Average Score	N/A	Average Score	N/A	Average Score	N/A	Average Score	N/A
Average of Priority	N/A						
Material Assessment Score	N/A						
Recommendation	Inspection Required

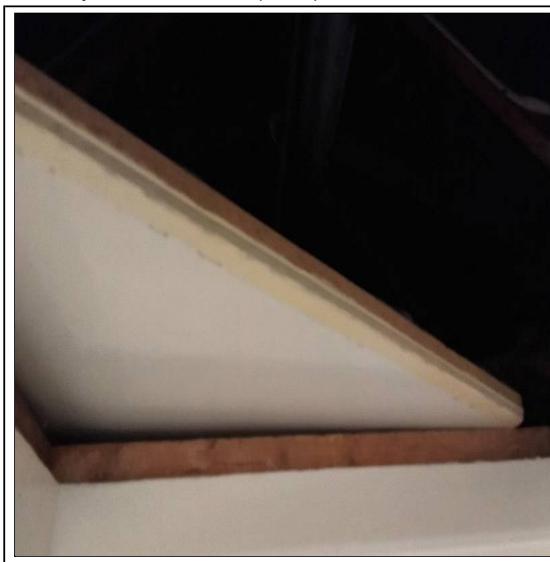
Item No	Building	Room	Position
22	Block A	Circulation A017	Ceiling
Quantity	Item Description		Accessibility
0-1m ²	Panel to underside of loft access panel		Usually inaccessible or unlikely to be disturbed (0)
Sample No (S,SP,P,As)	Product Type	Surface Treatment	Condition
BD000799 {DN000193} (S)	Not applicable (No asbestos detected) (0)	Completely Sealed (0)	Good Condition (0)

Normal Occupancy	Score	Likelihood of disturbance	Score	Exposure Potential	Score	Maintenance Activity	Score
Main type of activity	N/A	Location	N/A	Number of occupants	N/A	Type of Maintenance	N/A
		Accessibility	N/A	Frequency of use	N/A	Frequency of maintenance	N/A
		Amount	N/A	Average Time	N/A		
Average Score	N/A	Average Score	N/A	Average Score	N/A	Average Score	N/A
Average of Priority	N/A						
Material Assessment Score	N/A						
Recommendation	No further action required

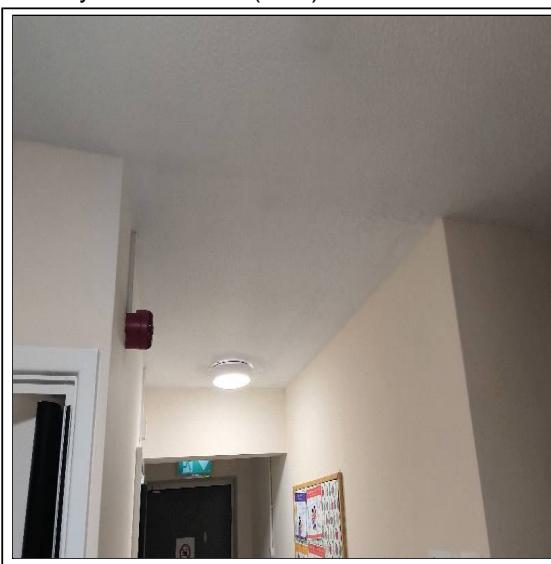
Item No	Building	Room	Position
23	Block A	Circulation A017	Ceiling
Quantity	Item Description		Accessibility
14-18m ²	Textured decorative coating on plasterboard		Occasionally likely to be disturbed (1)
Sample No (S,SP,P,As)	Product Type	Surface Treatment	Condition
As DN000192 (SP)	Textured Coating (1)	Surface Sealed (1)	Good Condition (0)

Normal Occupancy	Score	Likelihood of disturbance	Score	Exposure Potential	Score	Maintenance Activity	Score
Main type of activity	1	Location	2	Number of occupants	2	Type of Maintenance	0
		Accessibility	1	Frequency of use	3	Frequency of maintenance	0
		Amount	2	Average Time	0		
Average Score	1	Average Score	2	Average Score	2	Average Score	0
Average of Priority	5						
Material Assessment Score	3						
Recommendation	D - No Attention Required, inspect at intervals

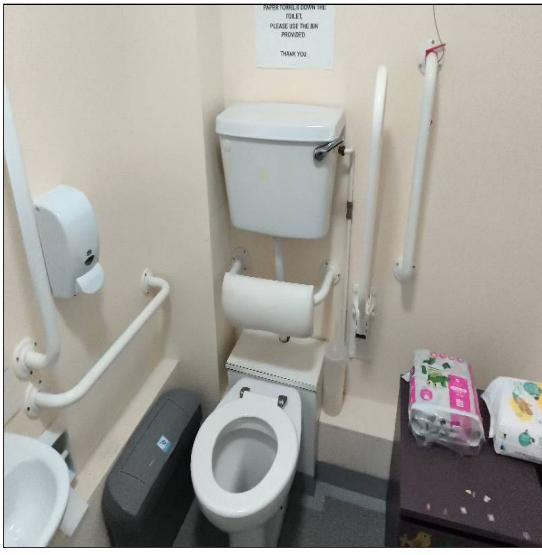
Item No	Building	Room	Position
17	Block A	Disabled WC A018	Inaccessible
Quantity	Item Description		Accessibility
N/A	Vertical and horizontal MDF boxing.		N/A
Sample No (S,SP,P,As)	Product Type	Surface Treatment	Condition
Visual (P)	N/A	N/A	N/A

Normal Occupancy	Score	Likelihood of disturbance	Score	Exposure Potential	Score	Maintenance Activity	Score
Main type of activity	N/A	Location	N/A	Number of occupants	N/A	Type of Maintenance	N/A
		Accessibility	N/A	Frequency of use	N/A	Frequency of maintenance	N/A
		Amount	N/A	Average Time	N/A		
Average Score	N/A	Average Score	N/A	Average Score	N/A	Average Score	N/A
Average of Priority	N/A						
Material Assessment Score	N/A						
Recommendation	Inspection Required

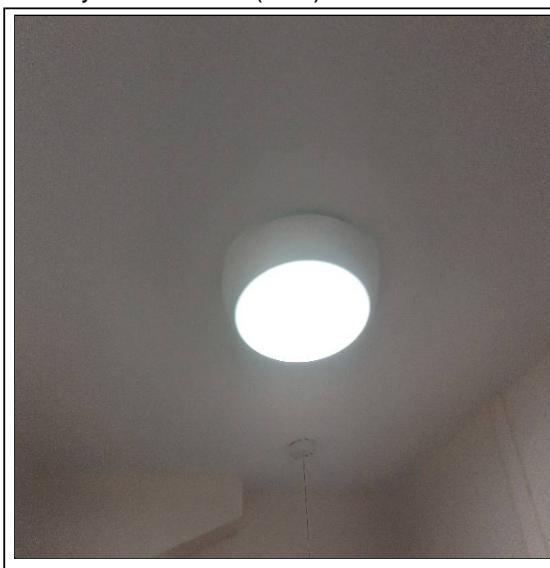
Item No	Building	Room	Position
16	Block A	Disabled WC A018	Ceiling
Quantity	Item Description		Accessibility
4-5m ²	Textured decorative coating on plasterboard,		Occasionally likely to be disturbed (1)
Sample No (S,SP,P,As)	Product Type	Surface Treatment	Condition
As BD000798 {DN000190} (SP)	Textured Coating (1)	Surface Sealed (1)	Good Condition (0)

Normal Occupancy	Score	Likelihood of disturbance	Score	Exposure Potential	Score	Maintenance Activity	Score
Main type of activity	1	Location	2	Number of occupants	1	Type of Maintenance	0
		Accessibility	1	Frequency of use	3	Frequency of maintenance	0
		Amount	1	Average Time	0		
Average Score	1	Average Score	2	Average Score	2	Average Score	0
Average of Priority	5						
Material Assessment Score	3						
Recommendation	D - No Attention Required, inspect at intervals

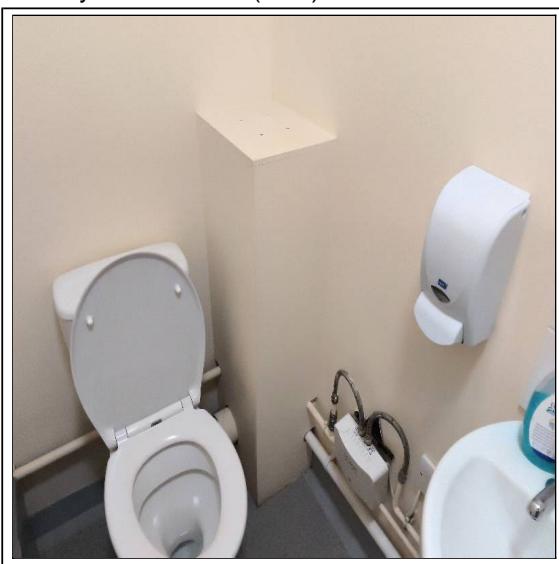
Item No	Building	Room	Position
15	Block A	Staff WC A019	Inaccessible
Quantity	Item Description		Accessibility
N/A	Vertical MDF boxing.		N/A
Sample No (S,SP,P,As)	Product Type	Surface Treatment	Condition
Visual (P)	N/A	N/A	N/A

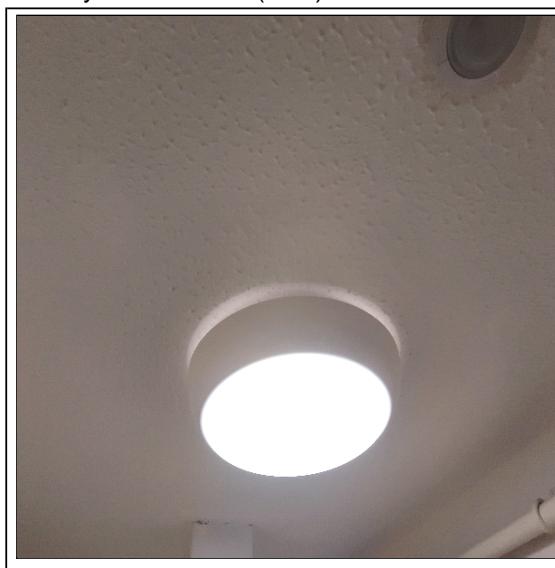
Item No	Building	Room	Position
14	Block A	Staff WC A019	Ceiling
Quantity	Item Description		Accessibility
2-3m ²	Textured decorative coating on plasterboard,		Occasionally likely to be disturbed (1)
Sample No (S,SP,P,As)	Product Type	Surface Treatment	Condition
As BD000798 {DN000190} (SP)	Textured Coating (1)	Surface Sealed (1)	Good Condition (0)

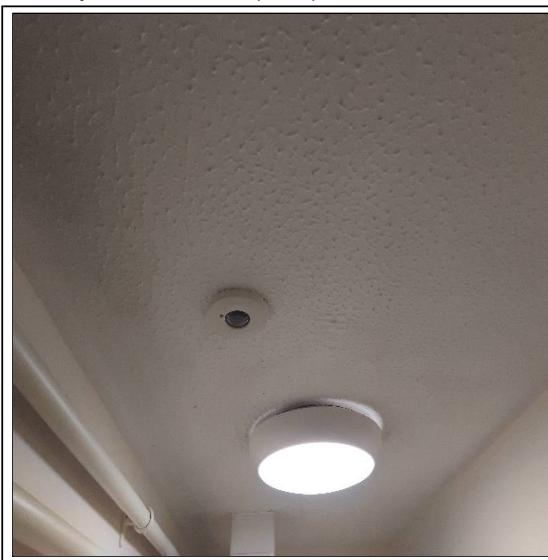
Item No	Building	Room	Position
11	Block A	Female WC A020	Ceiling
Quantity	Item Description		Accessibility
2-3m ²	Textured decorative coating on plasterboard.		Occasionally likely to be disturbed (1)
Sample No (S,SP,P,As)	Product Type	Surface Treatment	Condition
BD000798 {DN000190} (S)	Textured Coating (1)	Surface Sealed (1)	Good Condition (0)

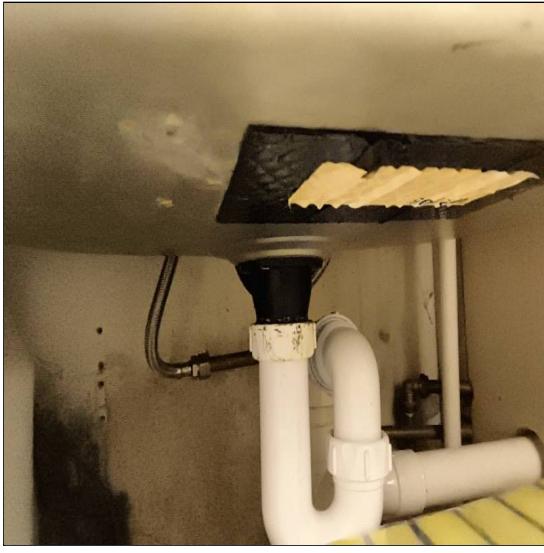
Item No	Building	Room	Position
13	Block A	Kitchen A022	Equipment
Quantity	Item Description		Accessibility
3no.	Under sink pads		Easily disturbed (2)
Sample No (S,SP,P,As)	Product Type	Surface Treatment	Condition
DN000191 (S)	Well Bound Material (1)	Completely Sealed (0)	Good Condition (0)

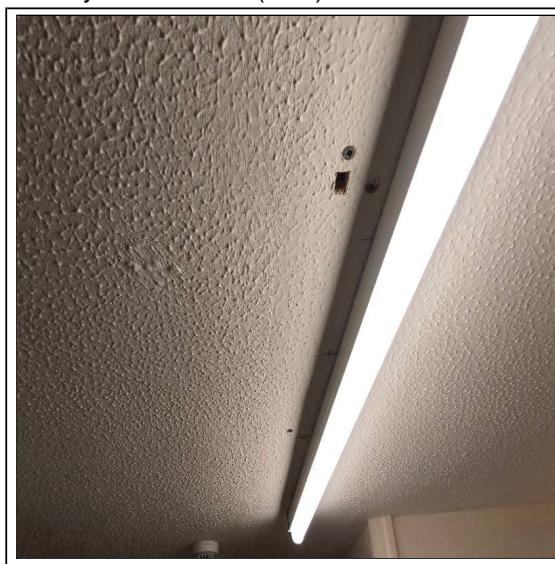
Item No	Building	Room	Position
12	Block A	Kitchen A022	Ceiling
Quantity	Item Description		Accessibility
10-12m ²	Textured decorative coating on plasterboard.		Occasionally likely to be disturbed (1)
Sample No (S,SP,P,As)	Product Type	Surface Treatment	Condition
DN000192 (S)	Textured Coating (1)	Surface Sealed (1)	Low Damage (1)

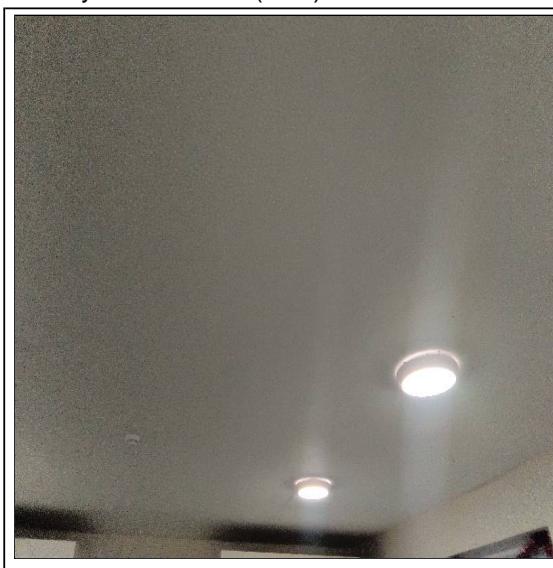
Item No	Building	Room	Position
1	Block A	Activity Space A023	Ceiling
Quantity	Item Description		Accessibility
60-70m ²	Textured decorative coating on plasterboard		Occasionally likely to be disturbed (1)
Sample No (S,SP,P,As)	Product Type	Surface Treatment	Condition
BD000796 {DN000187} (S)	Textured Coating/Asbestos Cement (1)	Surface Sealed (1)	Good Condition (0)

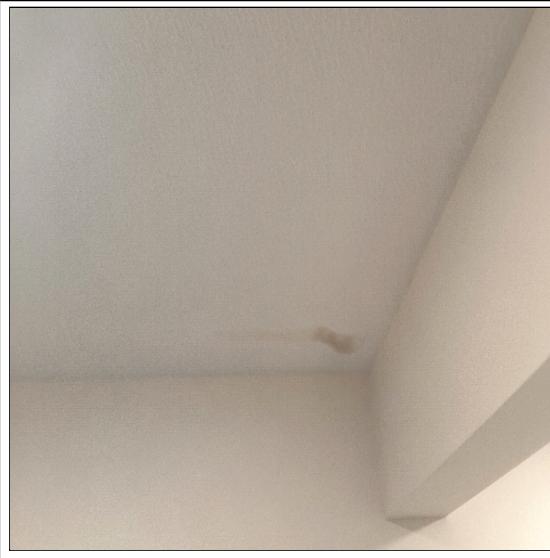
Item No	Building	Room	Position
21	Block A	Office A025	Ceiling
Quantity	Item Description		Accessibility
5-7m ²	Textured decorative coating on plasterboard to South side of room.		Occasionally likely to be disturbed (1)
Sample No (S,SP,P,As)	Product Type	Surface Treatment	Condition
As BD000796 {DN000187} (SP)	Textured Coating/Asbestos Cement (1)	Surface Sealed (1)	Good Condition (0)

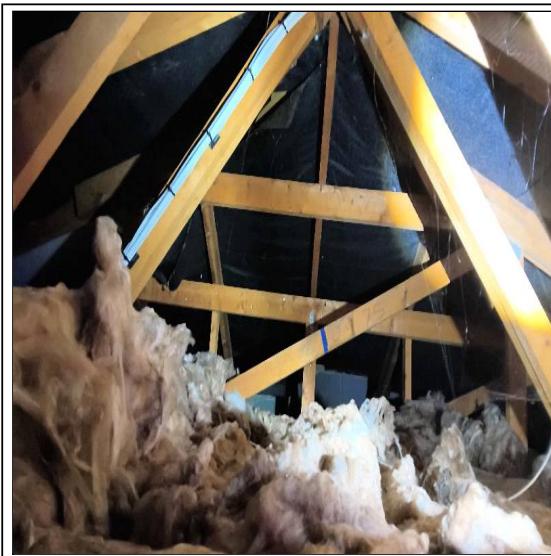
Item No	Building	Room	Position
25	Block A	Roof void accessed from A017 RV01	Inaccessible
Quantity	Item Description		Accessibility
N/A	Limited access		N/A
Sample No (S,SP,P,As)	Product Type	Surface Treatment	Condition
Visual (P)	N/A	N/A	N/A

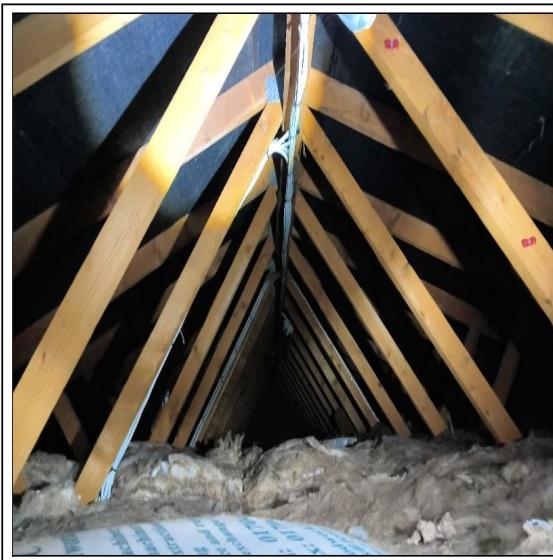
Item No	Building	Room	Position
24	Block A	Roof void accessed from A017 RV01	Roof void
Quantity	Item Description		Accessibility
Throughout	Roof felt to underside of roof.		Usually inaccessible or unlikely to be disturbed (0)
Sample No (S,SP,P,As)	Product Type	Surface Treatment	Condition
BD000795 {DN000194} (S)	Not applicable (No asbestos detected) (0)	Completely Sealed (0)	Low Damage (1)

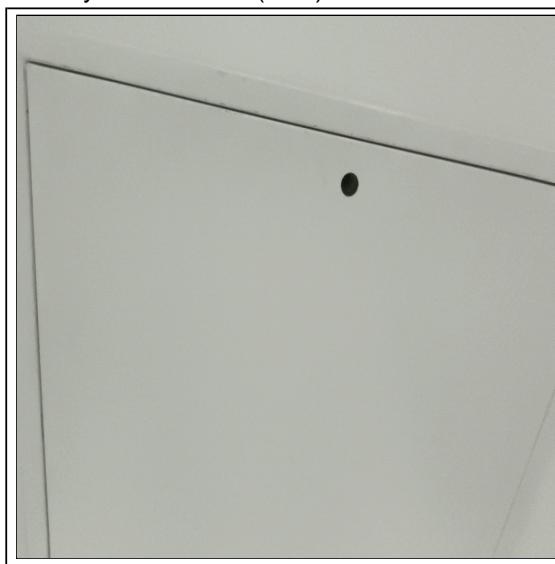
Item No	Building	Room	Position
26	Block A	Roof Void accessed from A003 RV02	Inaccessible
Quantity		Item Description	
N/A		Inaccessible Roof Void	
Sample No (S,SP,P,As)	Product Type	Surface Treatment	Condition
Visual (P)	N/A	N/A	N/A
