Asbestos Management Survey

The Town Hall

Shaftesbury

Survey Date: 30th June 2023

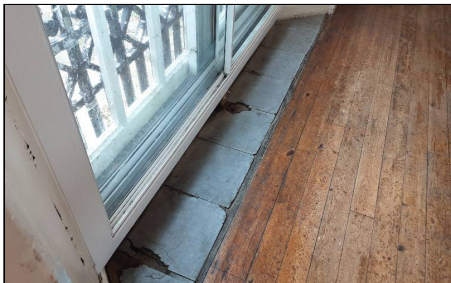
Survey Date:	Lead Surveyor	Survey Type	Floor	Analysis
	30 Jun 2023	Aaron Silvester	Management Survey	Ground Floor	No Asbestos Detected
	Building	Location / Room No.	Item	Quantity	
	Shaftesbury Town Hall	Hall / G03	Floor Tiles (Grey) & Bitumen Adhesive - Adjacent Windows	5lm	
	Sample No (S,SP,P,As)	Product Type	Surface Treatment	Condition	Accessibility
	CA001501 (S)	N/A	N/A	N/A	N/A
	Material Risk Score	Item / Plan Reference No.			
N/A	1				
Recommended action	No Further Action Required				
Surveyor comments	N/A

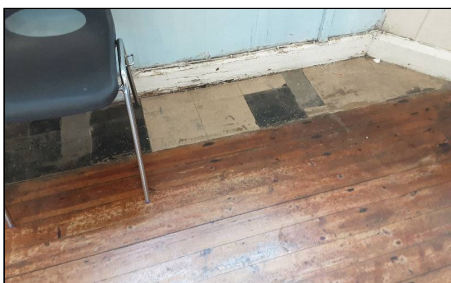
Survey Date:	Lead Surveyor	Survey Type	Floor	Analysis
	30 Jun 2023	Aaron Silvester	Management Survey	Ground Floor	No Asbestos Detected
	Building	Location / Room No.	Item	Quantity	
	Shaftesbury Town Hall	Hall / G03	Floor Tiles (Beige) & Bitumen Adhesive - Adjacent Window	2lm	
	Sample No (S,SP,P,As)	Product Type	Surface Treatment	Condition	Accessibility
	CA001502 (S)	N/A	N/A	N/A	N/A
	Material Risk Score	Item / Plan Reference No.			
N/A	2				
Recommended action	No Further Action Required				
Surveyor comments	N/A

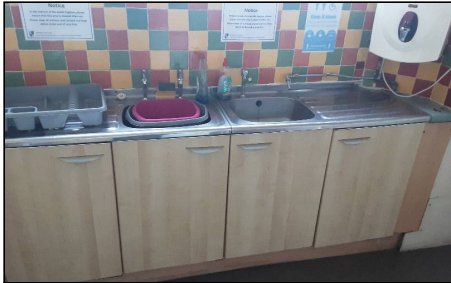
Survey Date:	Lead Surveyor	Survey Type	Floor	Analysis
	30 Jun 2023	Aaron Silvester	Management Survey	Ground Floor	No Asbestos Detected
	Building	Location / Room No.	Item	Quantity	
	Shaftesbury Town Hall	Kitchen / G05	Sink Pads - Underside Of Sinks & Drainers .	4no.	
	Sample No (S,SP,P,As)	Product Type	Surface Treatment	Condition	Accessibility
	CA001503 (S)	N/A	N/A	N/A	N/A
	Material Risk Score	Item / Plan Reference No.			
	N/A	3			
Recommended action	No Further Action Required				
Surveyor comments	N/A

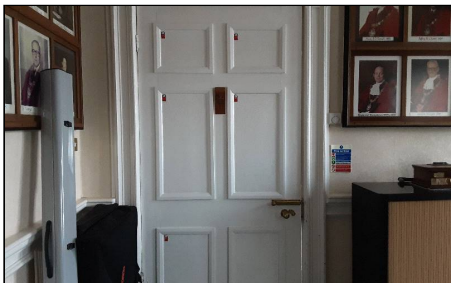
Survey Date:	Lead Surveyor	Survey Type	Floor	Analysis
	30 Jun 2023	Aaron Silvester	Management Survey	1st Floor	Amosite (2)
	Building	Location / Room No.	Item	Quantity	
	Shaftesbury Town Hall	Parlour / 102	Insulating Board Panels - Fire Door .	6no.	
	Sample No (S,SP,P,As)	Product Type	Surface Treatment	Condition	Accessibility
	CA001504 (S)	Asbestos Insulating Board (2)	Surface Sealed (1)	Low Damage (1)	Easily disturbed
	Material Risk Score	Item / Plan Reference No.			
	6	4			
Recommended action	Manage				
Surveyor comments	6 x Panels To 1 No. Door (Labelled) Opposite Door Has Timber Panels

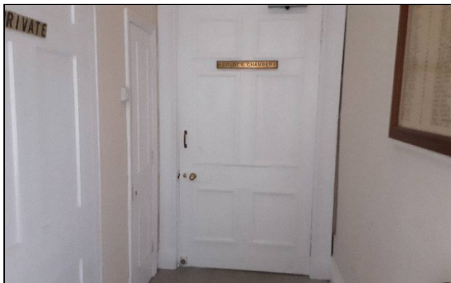
Survey Date:	Lead Surveyor	Survey Type	Floor	Analysis
	30 Jun 2023	Aaron Silvester	Management Survey	1st Floor	Amosite (2)
	Building	Location / Room No.	Item	Quantity	
	Shaftesbury Town Hall	Corridor & Cup' / 108	Insulating Board Panels - Fire Door .	6no.	
	Sample No (S,SP,P,As)	Product Type	Surface Treatment	Condition	Accessibility
	As CA001504 (SP)	Asbestos Insulating Board (2)	Surface Sealed (1)	Low Damage (1)	Easily disturbed
	Material Risk Score	Item / Plan Reference No.			
6	5				
Recommended action	Manage & Label				
Surveyor comments	6 x Panels To 1 No. Door (Not Labelled), Supalux Also Present, Opposite Door Has Timber Panels

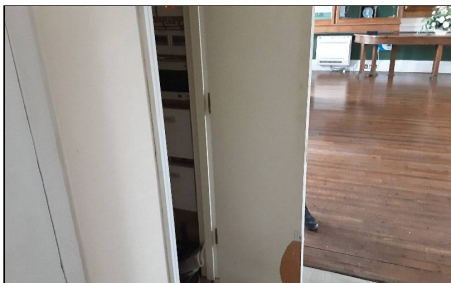
Survey Date:	Lead Surveyor	Survey Type	Floor	Analysis
	30 Jun 2023	Aaron Silvester	Management Survey	1st Floor	No Asbestos Detected
	Building	Location / Room No.	Item	Quantity	
	Shaftesbury Town Hall	Corridor & Cup' / 108	Supalux Panel - Inside Cup' Door .	1no.	
	Sample No (S,SP,P,As)	Product Type	Surface Treatment	Condition	Accessibility
	CA001505 (S)	N/A	N/A	N/A	N/A
	Material Risk Score	Item / Plan Reference No.			
N/A	6				
Recommended action	No Further Action Required				
Surveyor comments	N/A

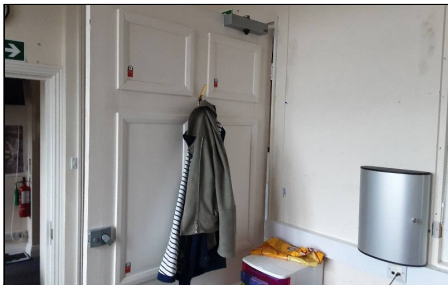
Building	Floor	Location /Room No.	Item	S,P,SP,AS Sample No	Product Type	Condition	Surface Treatment	Asbestos Type	Quantity	Accessibility	Material Score
Shaftesbury Town Hall	1st Floor	Parlour / 102	Insulating Board Panels - Fire Door .	S CA001504	Asbestos Insulating Board	Low Damage	Surface Sealed	Amosite	6no.	Easily disturbed	6
Recommendation	Manage										
Additional Comments	6 x Panels To 1 No. Door (Labelled) Opposite Door Has Timber Panels										
Shaftesbury Town Hall	1st Floor	Corridor & Cup' / 108	Insulating Board Panels - Fire Door .	SP As CA001504	Asbestos Insulating Board	Low Damage	Surface Sealed	Amosite	6no.	Easily disturbed	6
Recommendation	Manage & Label										
Additional Comments	6 x Panels To 1 No. Door (Not Labelled), Supalux Also Present, Opposite Door Has Timber Panels										
Shaftesbury Town Hall	1st Floor	Offices / 109	Insulating Board Panels - Fire Door .	SP As CA001504	Asbestos Insulating Board	Low Damage	Surface Sealed	Amosite	12no.	Easily disturbed	6

Survey Date:	Lead Surveyor	Survey Type	Floor	Analysis
	30 Jun 2023	Aaron Silvester	Management Survey	1st Floor	Amosite (2)
	Building	Location / Room No.	Item	Quantity	
	Shaftesbury Town Hall	Offices / 109	Insulating Board Panels - Fire Door .	12no.	
	Sample No (S,SP,P,As)	Product Type	Surface Treatment	Condition	Accessibility
	As CA001504 (SP)	Asbestos Insulating Board (2)	Surface Sealed (1)	Low Damage (1)	Easily disturbed
	Material Risk Score	Item / Plan Reference No.			
6	7				
Recommended action	Manage				
Surveyor comments	12 x Panels To 2 No. Doors (Labelled)

Recommendation	Manage										
Additional Comments	12 x Panels To 2 No. Doors (Labelled)

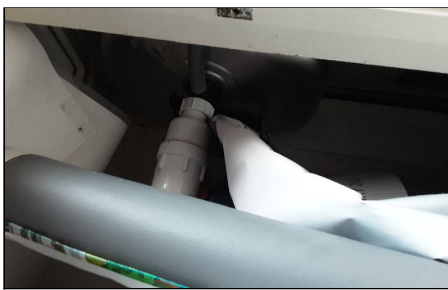
Survey Date:	Lead Surveyor	Survey Type	Floor	Analysis
	30 Jun 2023	Aaron Silvester	Management Survey	1st Floor	No Asbestos Detected
	Building	Location / Room No.	Item	Quantity	
	Shaftesbury Town Hall	Offices / 109	Sink Pads - Underside Of Sinks & Drainers .	2no.	
	Sample No (S,SP,P,As)	Product Type	Surface Treatment	Condition	Accessibility
	As CA001503 (SP)	N/A	N/A	N/A	N/A
	Material Risk Score	Item / Plan Reference No.			
	N/A	8			
Recommended action	No Further Action Required				
Surveyor comments	N/A
