**ASBESTOS REFURBISHMENT SURVEY
FIRST FLOOR - BREGENZ HOUSE
QUAY STREET
BANGOR
BT20 5ED**

1.0 SUMMARY
PROJECT NUMBER A-05609
1.1 REPORT SUMMARY

| Survey Type: | Refurbishment Survey |
| Site Address | FIRST FLOOR - BREGENZ HOUSE QUAY STREET BANGOR BT20 5ED |

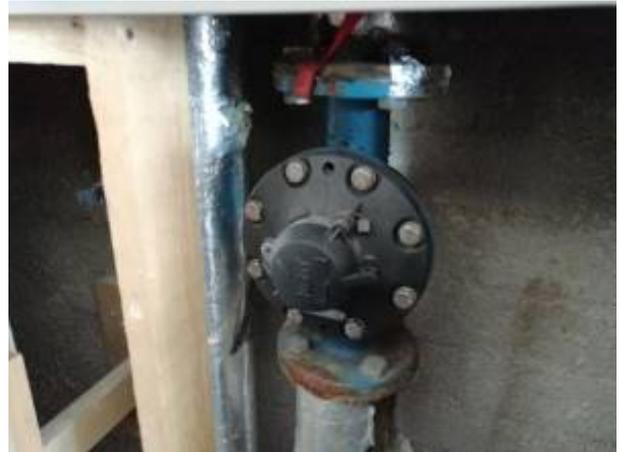
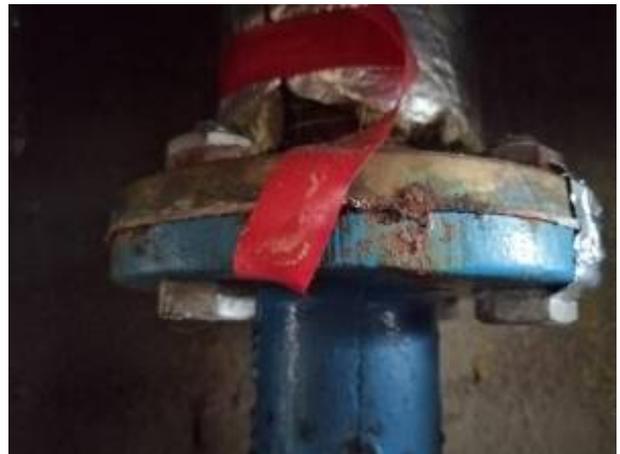
| Location | First Floor - Bregenz House, 1st Floor, Conference room 003 |

| Description | Flange - Gasket |
| Quantity | 2 no. |

| Material Algorithm | | |
|---|--|---|
| Product Type | AIB; gaskets; millboard textiles; paper; felt, rope | 2 |
| Damage | Low Damage | 1 |
| Asbestos Type | Chrysotile | 1 |
| Assessment Total | | 4 |

| Behind timber boxing. |

| Manage / remove if affected by scope of works |
