**CLIENT:**  
**LEEDS FEDERATED HOUSING ASSOCIATION**  
Arthington House  
30 Westfield Road  
LEEDS  
West Yorkshire  
LS3 1DE

**PROJECT NO:** 38187/JB/MS

**DATE:** 15 NOVEMBER 2010

**MANAGEMENT SURVEY  
OF  
10 MARLBOROUGH GROVE, LEEDS LS2 9AJ**

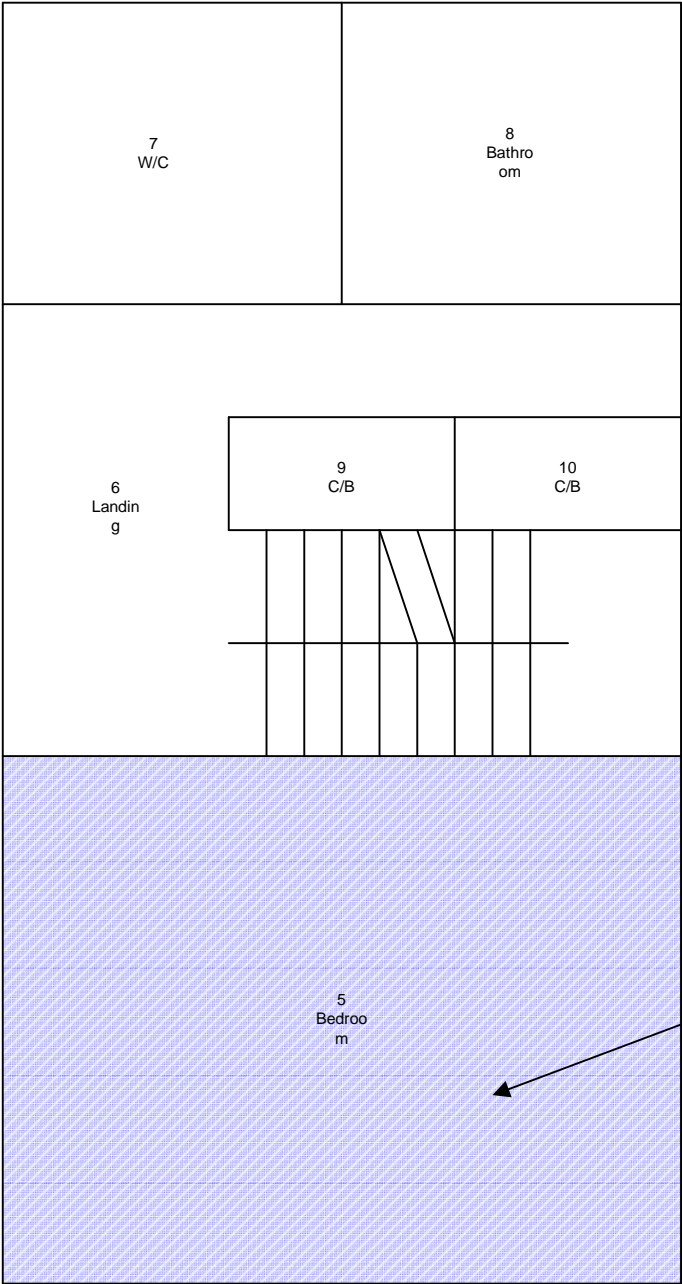
Page No: 3 of 5

Not Accessed As  
Occupied By  
Sleeping Tenant.
