JOB TITLE:
PROPOSED ALTERATIONS AT PENZANCE DRY DOCK WHARF ROAD, PENZANCE, CORNWALL, TR18 4BW

DETAIL:
EXISTING WORKSHOP ROOF TRUSS CONDITION SURVEY. ROOF PLAN SHOWING TRUSS LOCATIONS

JOB NO:	DRAWING No:	REV:
24060	20	B

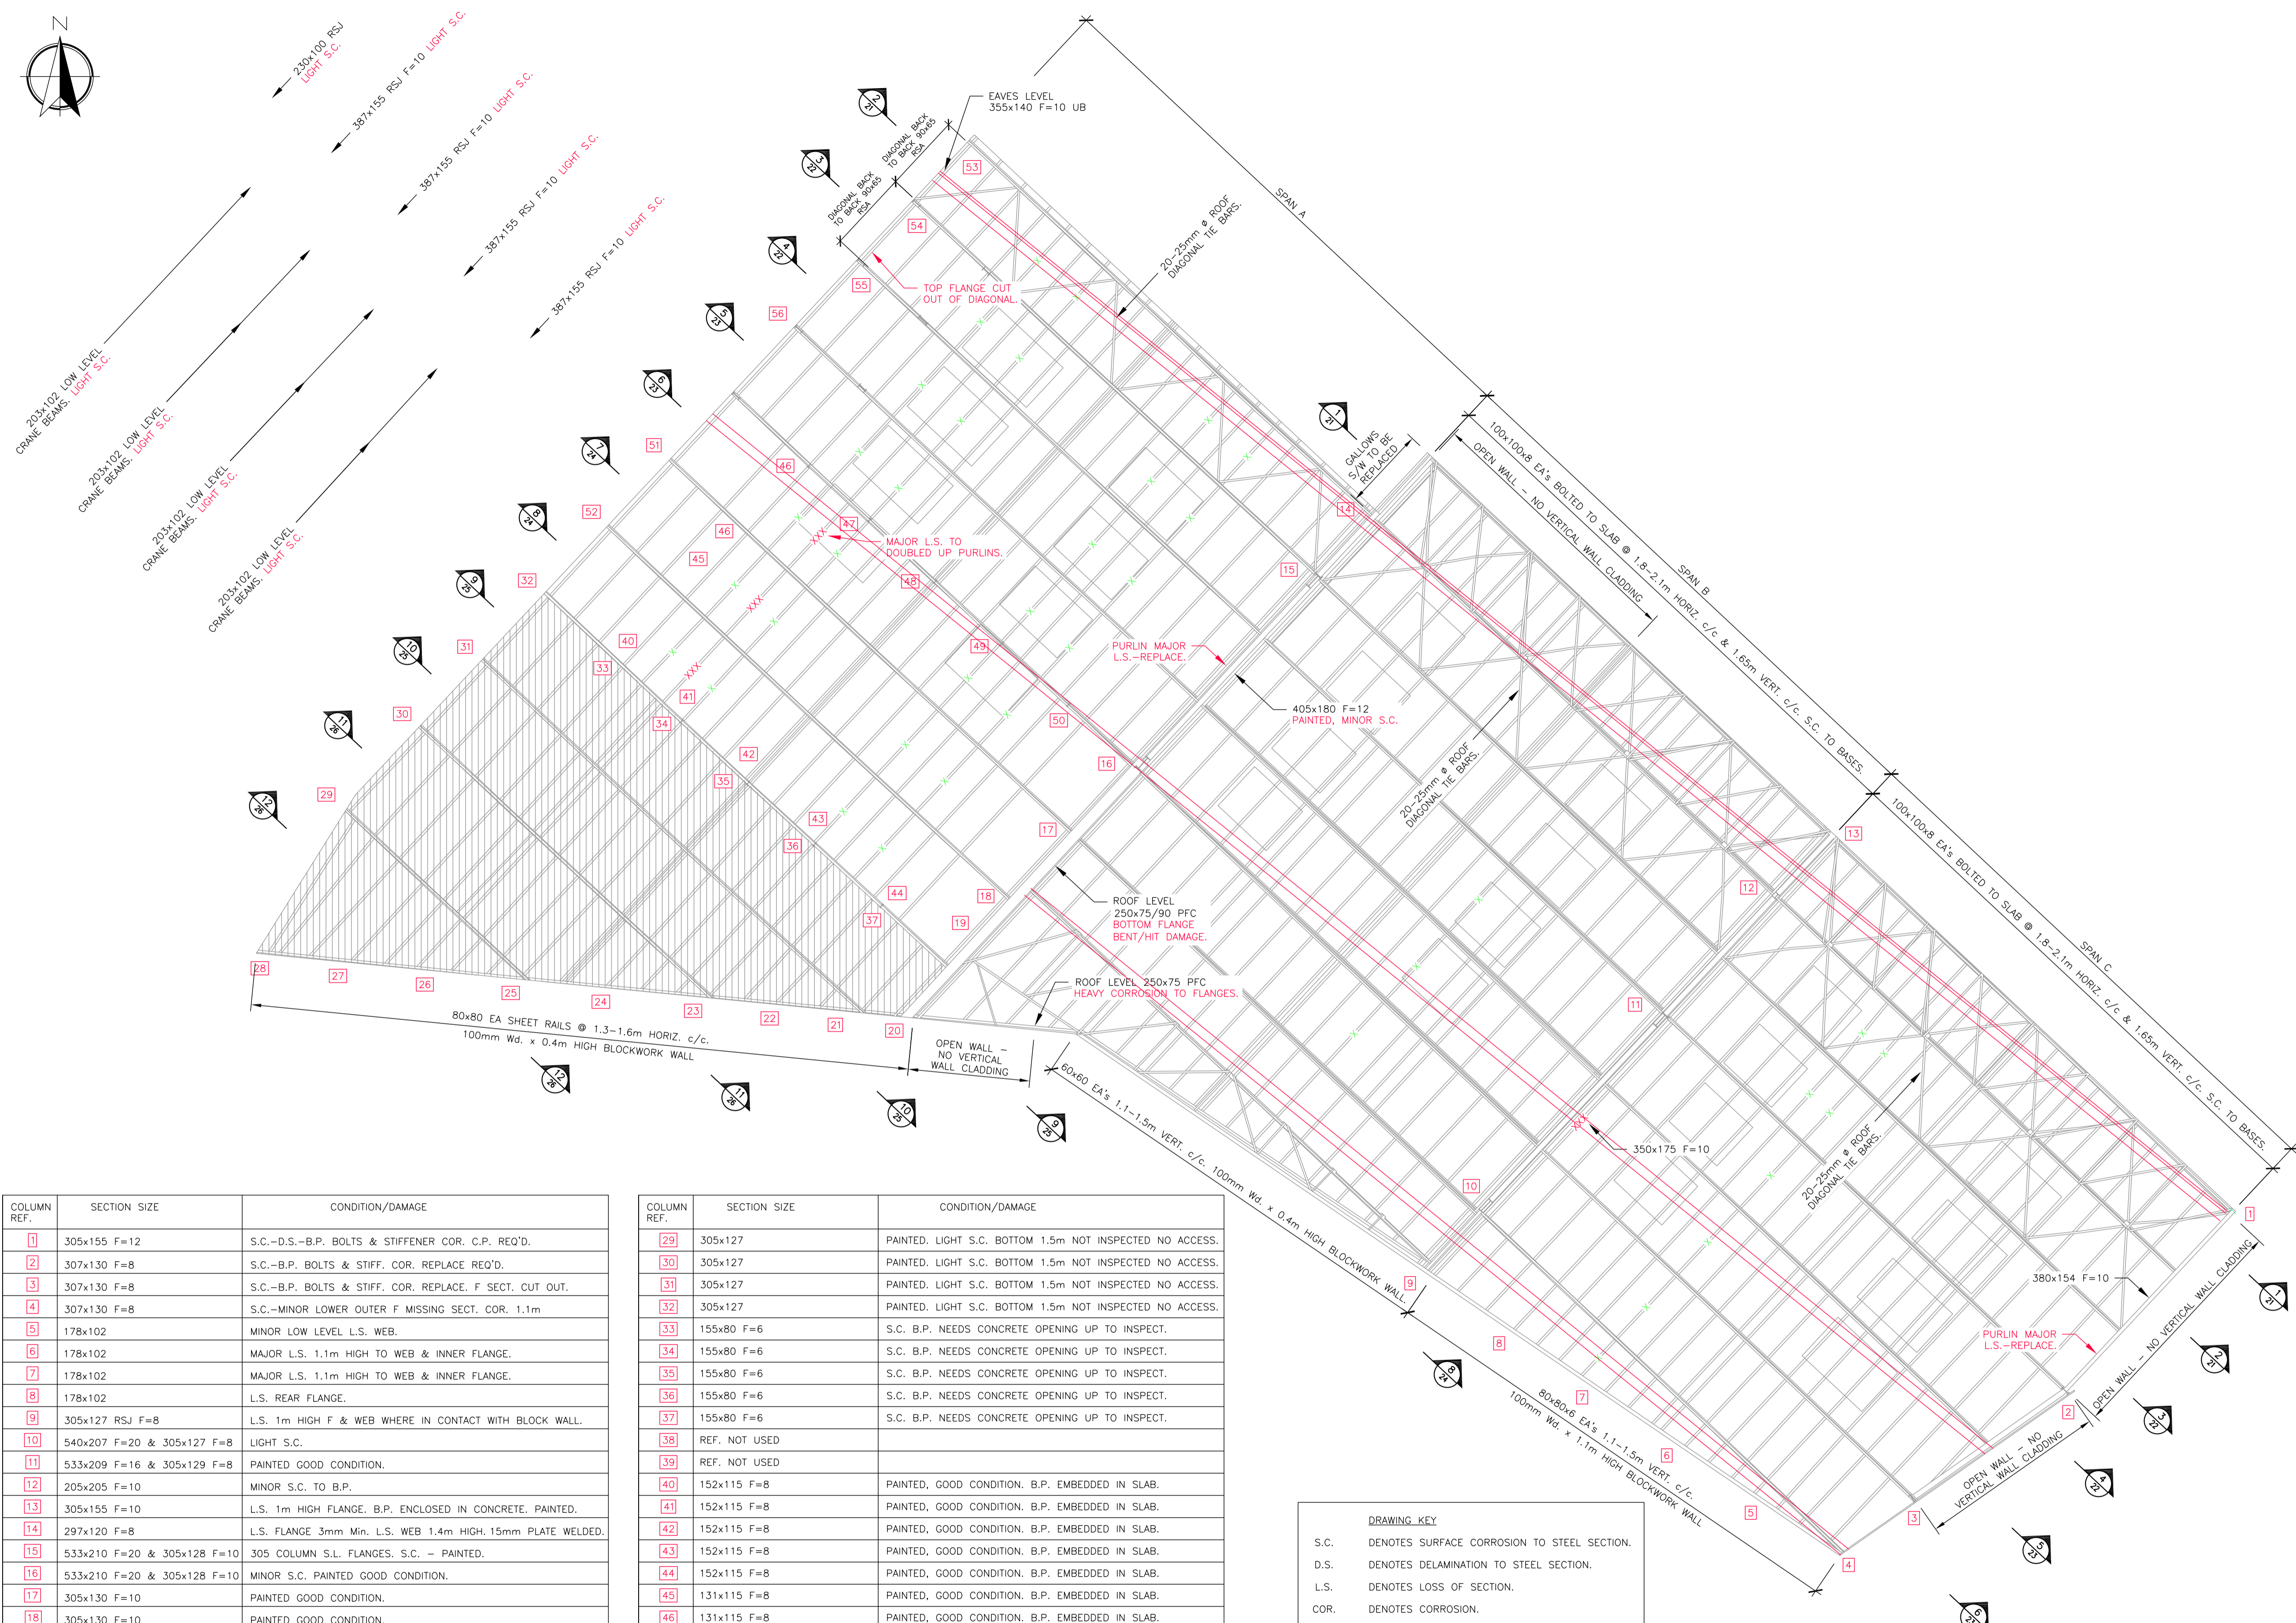
COLUMN REF.	SECTION SIZE	CONDITION/DAMAGE
1	305x155 F=12	S.C.-D.S.-B.P. BOLTS & STIFFENER COR. C.P. REQ'D.
2	307x130 F=8	S.C.-B.P. BOLTS & STIFF. COR. REPLACE REQ'D.
3	307x130 F=8	S.C.-B.P. BOLTS & STIFF. COR. REPLACE. F SECT. CUT OUT.
4	307x130 F=8	S.C.-MINOR LOWER OUTER F MISSING SECT. COR. 1.1m
5	178x102	MINOR LOW LEVEL L.S. WEB.
6	178x102	MAJOR L.S. 1.1m HIGH TO WEB & INNER FLANGE.
7	178x102	MAJOR L.S. 1.1m HIGH TO WEB & INNER FLANGE.
8	178x102	L.S. REAR FLANGE.
9	305x127 RSJ F=8	L.S. 1m HIGH F & WEB WHERE IN CONTACT WITH BLOCK WALL.
10	540x207 F=20 & 305x127 F=8	LIGHT S.C.
11	533x209 F=16 & 305x129 F=8	PAINTED GOOD CONDITION.
12	205x205 F=10	MINOR S.C. TO B.P.
13	305x155 F=10	L.S. 1m HIGH FLANGE. B.P. ENCLOSED IN CONCRETE. PAINTED.
14	297x120 F=8	L.S. FLANGE 3mm Min. L.S. WEB 1.4m HIGH. 15mm PLATE WELDED.
15	533x210 F=20 & 305x128 F=10	305 COLUMN S.L. FLANGES. S.C. - PAINTED.
16	533x210 F=20 & 305x128 F=10	MINOR S.C. PAINTED GOOD CONDITION.

17	305x130 F=10	PAINTED GOOD CONDITION.
18	305x130 F=10	PAINTED GOOD CONDITION.
19	305x130 F=10	PAINTED GOOD CONDITION.
20	305x130 F=10	L.S. 1m FLANGES. 0.9m WEB PLATE. MAJOR S.C. BOT.1m REPLACE.
21	254x115 RSJ F=8	L.S. BOTH FLANGES-REPAIR. PLATES BOTH SIDES OF WEB 0.6 HIGH
22	178x102	PLATES BOTH SIDES OF WEB 0.35 HIGH. L.S.-D.S. F 0.35 HIGH
23	254x115 RSJ F=8	PLATES BOTH SIDES OF WEB 0.35 HIGH. L.S.-D.S. F 0.6-0.7 HIGH
24	178x102	PLATES BOTH SIDES OF WEB 0.35 HIGH. L.S.-D.S. F 0.6-0.7 HIGH
25	254x115 RSJ F=8	S.C.-L.S. OUTER FLANGE 0.6m HIGH.
26	178x102	S.C.-D.S. OUTER FLANGE 0.7m HIGH.
27	178x102	S.C.-D.S. OUTER FLANGE 0.7m HIGH.
28	178x102	S.C.-D.S. OUTER FLANGE 0.7m HIGH.

COLUMN REF.	SECTION SIZE	CONDITION/DAMAGE
29	305x127	PAINTED. LIGHT S.C. BOTTOM 1.5m NOT INSPECTED NO ACCESS.
30	305x127	PAINTED. LIGHT S.C. BOTTOM 1.5m NOT INSPECTED NO ACCESS.
31	305x127	PAINTED. LIGHT S.C. BOTTOM 1.5m NOT INSPECTED NO ACCESS.
32	305x127	PAINTED. LIGHT S.C. BOTTOM 1.5m NOT INSPECTED NO ACCESS.
33	155x80 F=6	S.C. B.P. NEEDS CONCRETE OPENING UP TO INSPECT.
34	155x80 F=6	S.C. B.P. NEEDS CONCRETE OPENING UP TO INSPECT.
35	155x80 F=6	S.C. B.P. NEEDS CONCRETE OPENING UP TO INSPECT.
36	155x80 F=6	S.C. B.P. NEEDS CONCRETE OPENING UP TO INSPECT.
37	155x80 F=6	S.C. B.P. NEEDS CONCRETE OPENING UP TO INSPECT.
38	REF. NOT USED	
39	REF. NOT USED	
40	152x115 F=8	PAINTED, GOOD CONDITION. B.P. EMBEDDED IN SLAB.
41	152x115 F=8	PAINTED, GOOD CONDITION. B.P. EMBEDDED IN SLAB.
42	152x115 F=8	PAINTED, GOOD CONDITION. B.P. EMBEDDED IN SLAB.
43	152x115 F=8	PAINTED, GOOD CONDITION. B.P. EMBEDDED IN SLAB.
44	152x115 F=8	PAINTED, GOOD CONDITION. B.P. EMBEDDED IN SLAB.

45	131x115 F=8	PAINTED, GOOD CONDITION. B.P. EMBEDDED IN SLAB.
46	131x115 F=8	PAINTED, GOOD CONDITION. B.P. EMBEDDED IN SLAB.
47	152x115 F=8 & 155x80 F=6	PAINTED, GOOD CONDITION. B.P. EMBEDDED IN SLAB.
48	152x115 F=8 & 155x80 F=6	PAINTED, GOOD CONDITION. B.P. EMBEDDED IN SLAB.
49	152x115 F=8 & 155x80 F=6	PAINTED, GOOD CONDITION. B.P. EMBEDDED IN SLAB.
50	152x115 F=8 & 155x80 F=6	PAINTED, GOOD CONDITION. B.P. EMBEDDED IN SLAB.
51	305x130	PAINTED, GOOD CONDITION.
52	305x130	PAINTED, GOOD CONDITION.
53	310x155 F=15	S.C.-D.S. OUTER F's 0.6-0.7m HIGH. B.P. EMBEDDED IN SLAB.
54	310x155 F=15	PAINTED, FAIR CONDITION. B.P. EMBEDDED IN SLAB.
55	310x155 F=15	PAINTED, FAIR CONDITION. B.P. EMBEDDED IN SLAB.
56	310x155 F=15	PAINTED, FAIR CONDITION. B.P. EMBEDDED IN SLAB.
