Kingsdale Foundation School
Fee Proposal Tender Information

Project Outputs

The image below annotates the various flat roof areas of the school. This project proposes to reroof areas 2, 3 & 3a and repair specialist covering roof area 1.

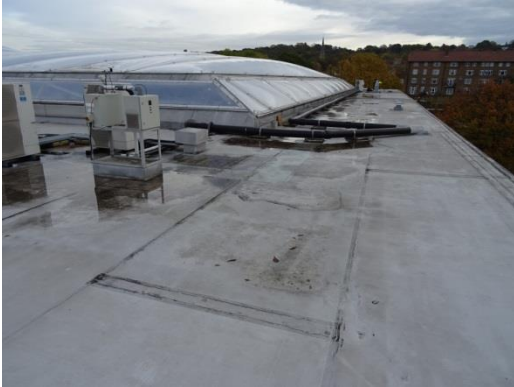
Photo 1

General view of the roof illustrating single ply membrane and specialist 'bubble' roof fabric.

- Photos 1 to 10 illustrate various remedial works which have been carried out over the last 5yrs to try to prevent water ingress. The installation of a single ply membrane to a roof which will frequently be accessed for maintenance (i.e. to service the plant and repair/clean the 'bubble') is not appropriate as single ply is not a robust finish. This work was completed under the BSF programme with the government leaving the school with a maintenance legacy of an inappropriate finish. Refer to proposal section below describing an appropriate solution.

- Strip off defective single ply water proofing and insulation to the previous asphalt roof covering (which had failed) and overlay with a 3 layer high performance felt roof covering. Works include lifting all plant and reinstatement where plant will be installed in accordance with manufacturer's instructions.
- Roofing system to be complete with a 25yr insurance backed guarantee.

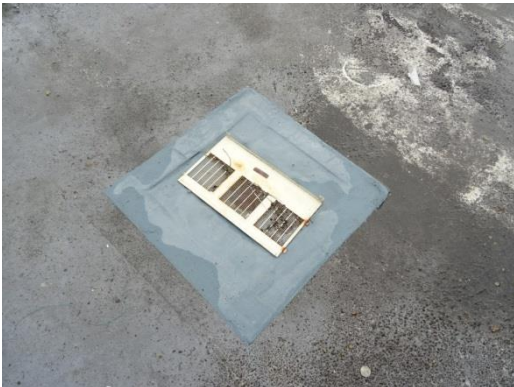
Photo 2

Typical example of patch repair to outlet and temporary grate due to leaking internal down pipe.

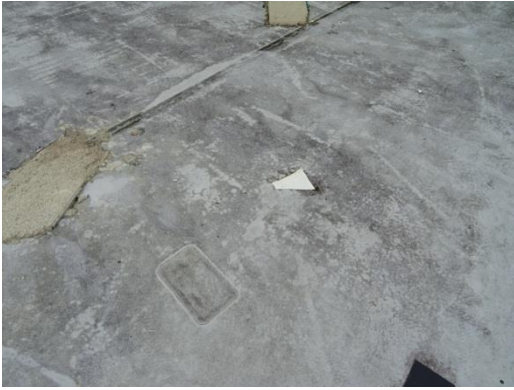
Photo 3

Typical example of patch repair due to punctured single ply membrane.

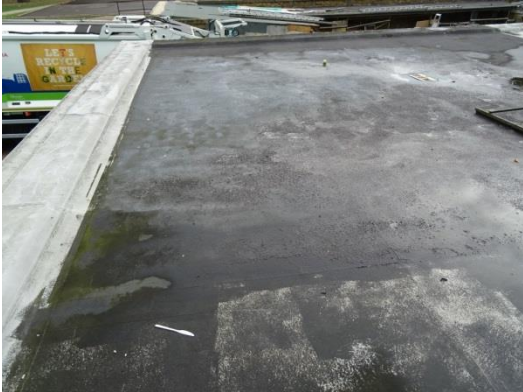
Photo 4

The natural colour of the single ply membrane is light grey (see other pictures). This picture illustrates a significant area of dark material which is a liquid water proofing which has been used to try to stop various leaks in the single ply membrane.

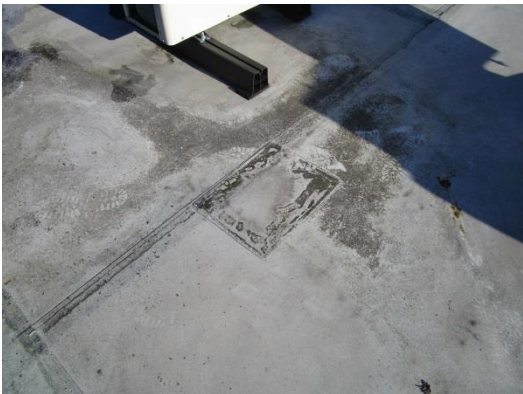
Photo 5

Further patch repair example.

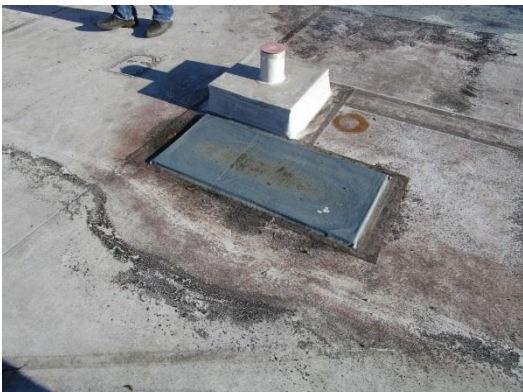
Photo 6

Further patch repair example.

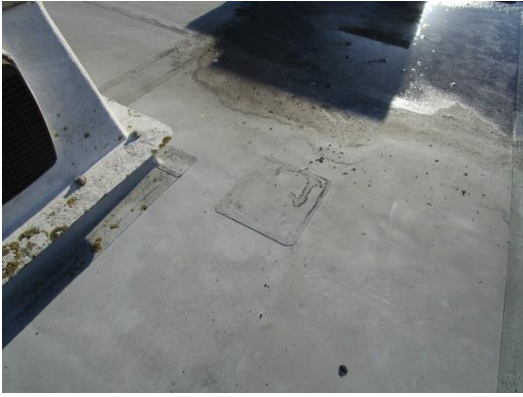
Photo 7

Further patch repair example.

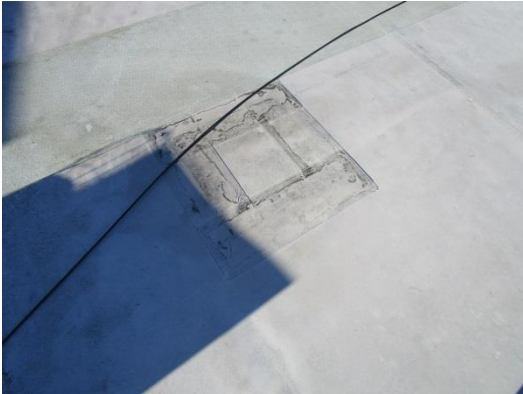
Photo 8

Further patch repair example.

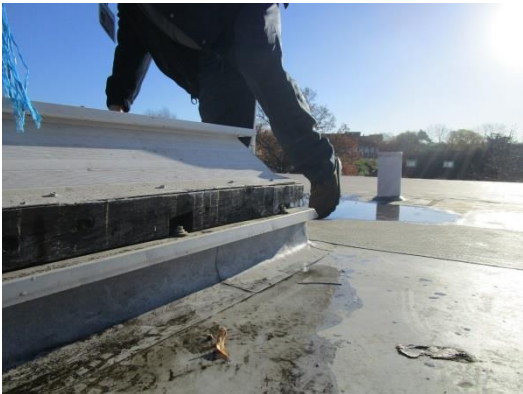
Photo 9

Bottom right corner of this photo illustrates damage to single ply, yet to be repaired.

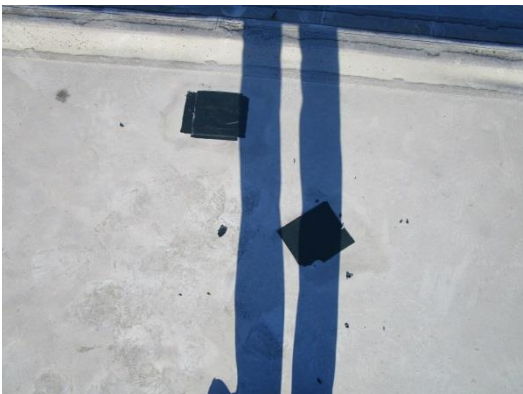
Photo 10

Further example of temporary patch repairs.

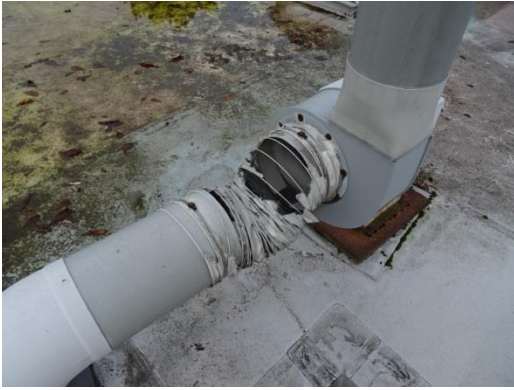
Photo 11

Damaged roof plant ducting allowing water ingress to services and fabric below.

- Photos 11 to 13 illustrate defects and damage to roof plant which will be repaired as part of the plant removal and reinstatement works.
- Photo 14 illustrates the culprit causing the damage to the specialist roofing membrane 'bubble'. This roof was installed under the BSF programme, however due to lack of funds protection was not installed to the roof to prevent damage

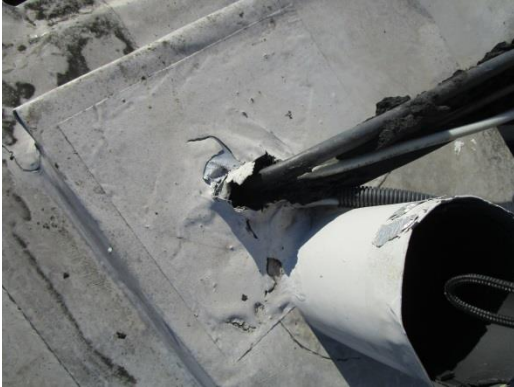
Photo 12

Defects to service pipe junctions allowing water to penetrate roof structure.

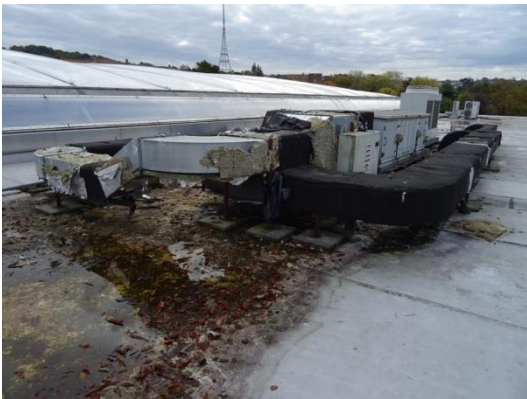
Photo 13

Poor condition plant insulation which will be replaced / protected as part of the plant removal / reinstatement works.

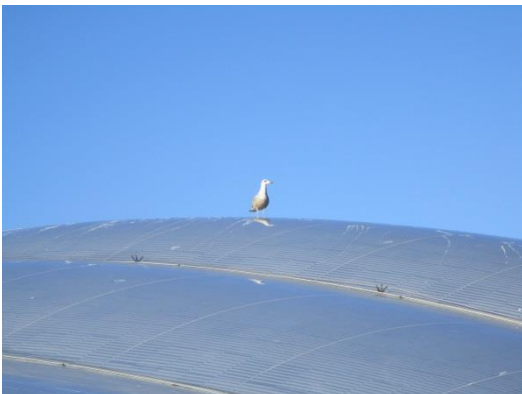
Photo 14

The specialist roof is being damaged by birds – Photo illustrates typical example of birds that rest on the roof and peck the membrane which causes damage.

from birds. This has left the school with an ongoing and costly maintenance issue. Refer to proposal section below describing an appropriate solution.

- The defective ETFE cushions are to be repaired, or replaced where necessary, by specialist contractors including the provision of a replacement inflation plant. In addition, bird netting is to be installed to prevent further damage being caused to the bubble.

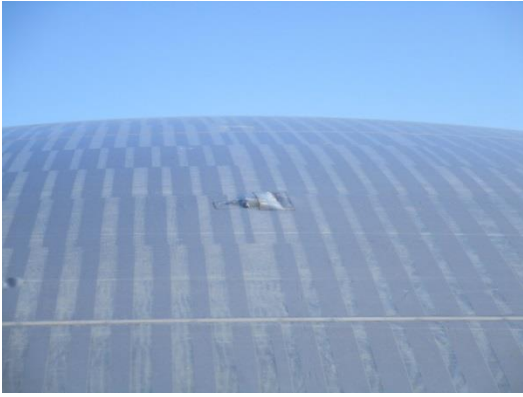
Photo 15

Illustrates damage and temporary repair to the 'bubble'.

- Photos 15 to 18 illustrate the defects being caused by bird damage and patch repairs caused. Photo 18 illustrates a section of the roof bubble which is yet to be repaired, also see comment regarding similar issue at 'Greater Manchester Station'.
- Photos 19 to 26 illustrate significant internal fabric damage being caused by the roof leaks.
- Photos 27 and 28 illustrate example of preventative measures that the school are putting in place to catch water leaking through the roof.
- Photo 29 is taken from report to highlight the sodden roof insulation. This should be 100% dry, not wet!

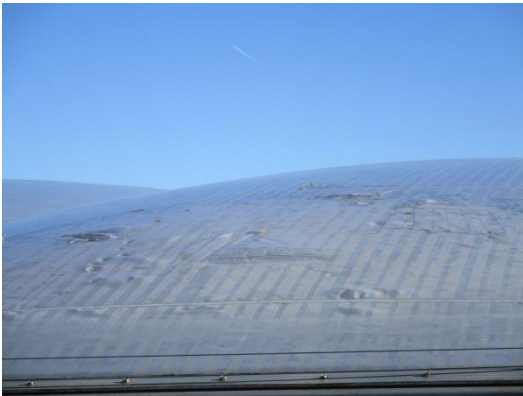
Photo 16

The ripples in the adjacent photos illustrate damage and remedial works.

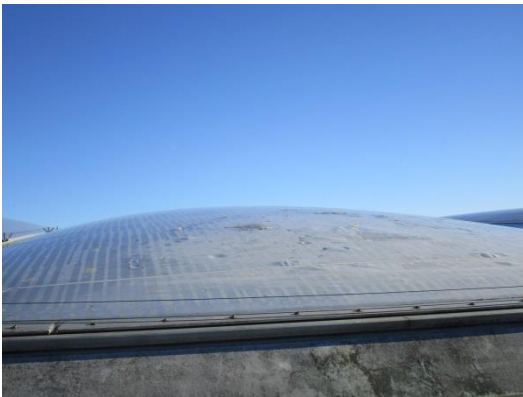
Photo 17

Further example of damage and remedial works.

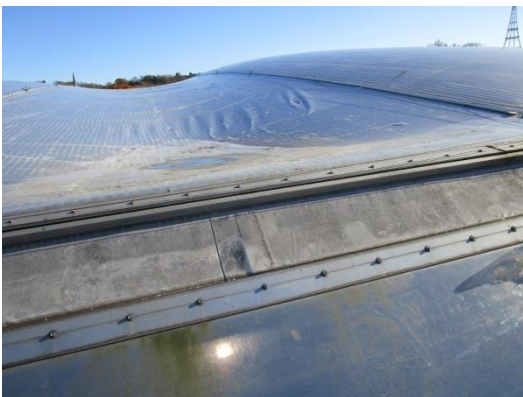
Photo 18

Deflated roof due to punctures – This is yet to be repaired. This is of significant concern as it is in this situation where water can gather and potentially fail as happened at 'Greater Manchester Station'

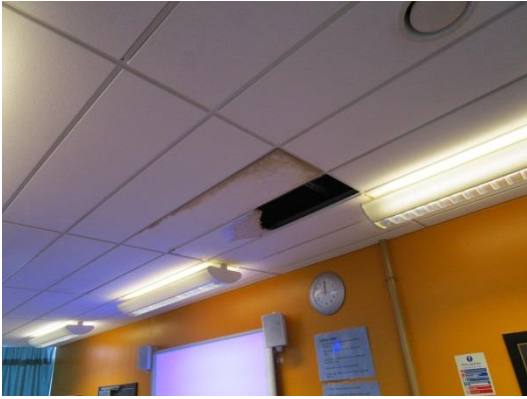
Photo 19

Stained / broken ceiling tiles due to water ingress from leaking roof.

- Ensuring the correct operation of the roof ventilation system following ETFE works.
- Internal repairs, making good and redecoration to classrooms affected by roof leaks.

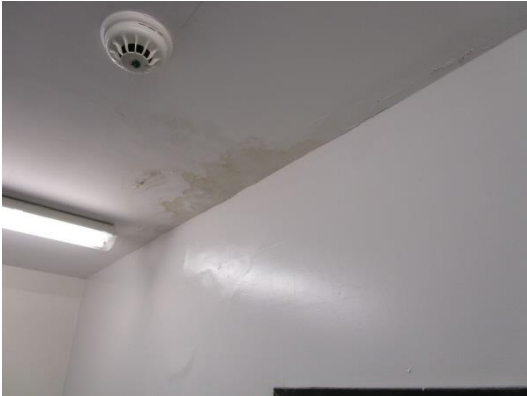
Photo 20

Stained / damaged ceiling due to water ingress.

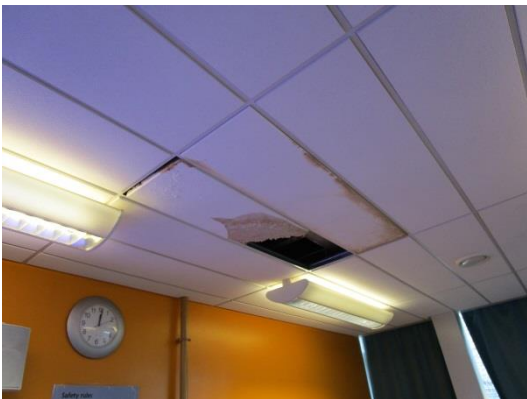
Photo 21

Further example of damage to ceiling tiles.

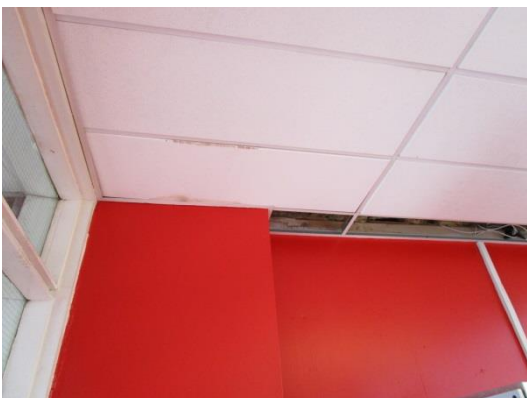
Photo 22

Stained ceiling tiles and missing tiles due to damage caused by leaking roof.

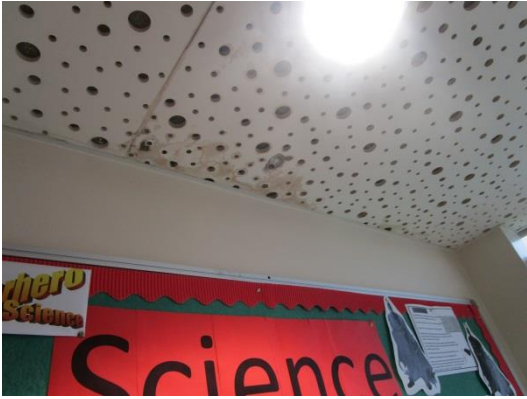
Photo 23

Staining to specialist acoustic ceiling finish.

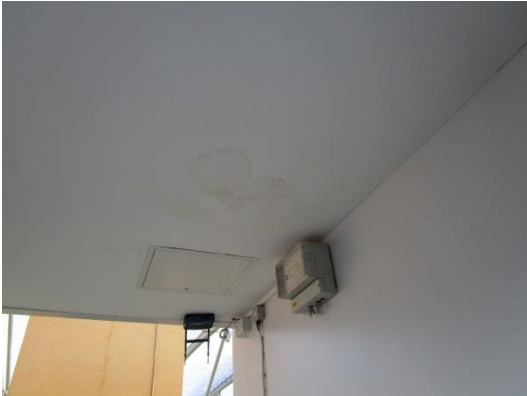
Photo 24

Staining to plasterboard ceiling.

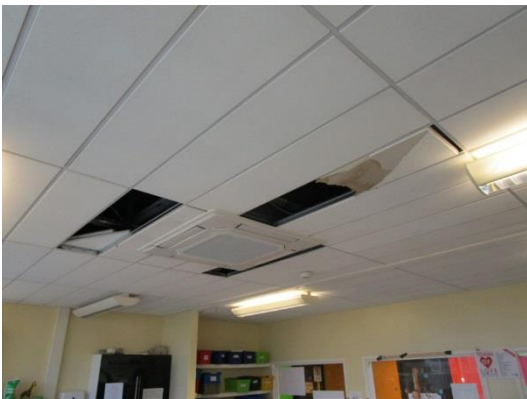
Photo 25

Significant damage to ceiling tiles due to leaking roofs.

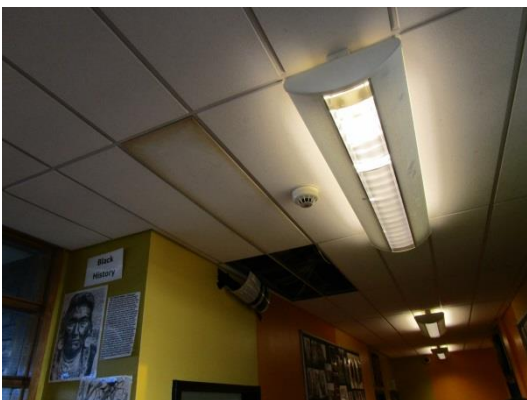
Photo 26

Stained and missing ceiling tiles due to roof leaks.

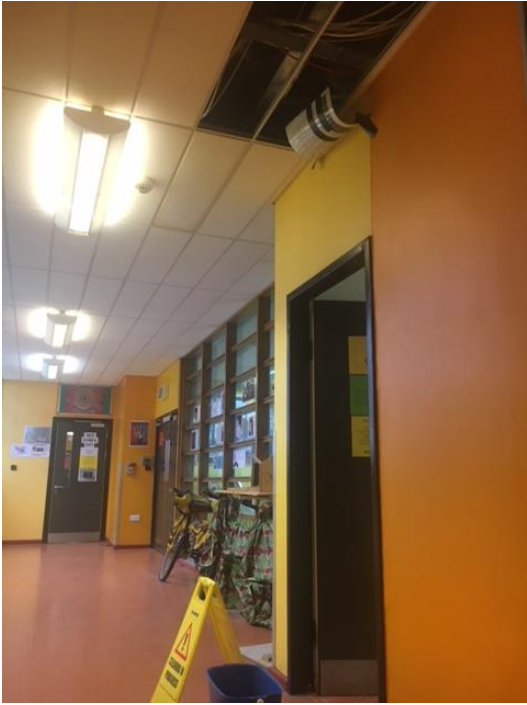
Photo 27

Evidence of leak. Note: School using laminated paper to direct the roof leak away from the classroom door so that the classroom can remain in use.

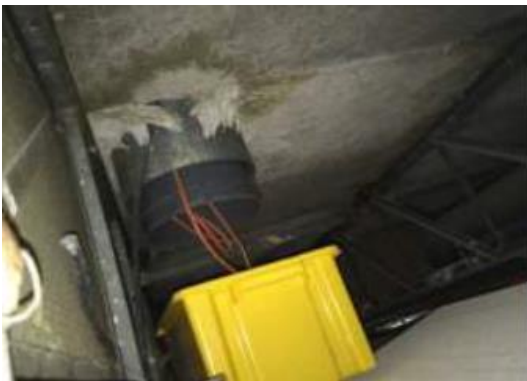
Photo 28

Buckets strategically placed above ceiling to try to catch water before it damages ceiling finishes.

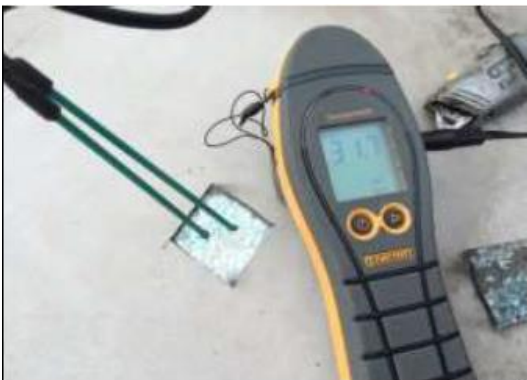
Photo 29

- Core sample analysis of roof 2 (main block) revealed high levels of moisture within the existing Polystyrene insulation. Wet insulation conducts energy instead of repelling it. When insulation becomes saturated, it can lose up to 40% of its U-value, which can result in significantly higher energy bills for the school.

Photo taken from [waterproofing report](#) giving evidence of water penetration as the insulation below the 'waterproof' membrane is WET. This should be completely DRY.
