Asbestos Management Survey Report

Job Ref No: **526967**, Account Ref No: **24359**, Contract Ref No: **79905**

Wellingborough Library and registration office 7 Pebble Ln, Wellingborough NN8 1AS

Title: Management survey of library and registration office, **Property refurbishment Works Scope:** Management survey to entire property

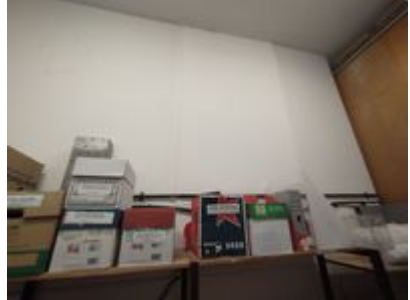
Building	Level	Location	Item / Product Examined	Sample No.	Material Description	Fibre Type	Material Score	Extent	Risk Level Assessment	Initial Control Recommendation	Photograph
Wellingborough Library	0	002/book store	Panels to wall adjacent to electrics room	526967-13	Asbestos-containing insulating board	Amosite, Chrysotile	6	5 m2	R3	Manage

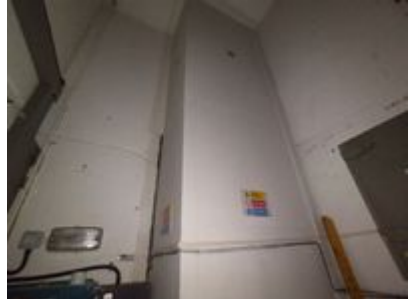
Wellingborough Library	0	003/electrics cupboard	Boxing	526967-13	Asbestos-containing insulating board	Amosite, Chrysotile	6	8 m2	R3	Manage

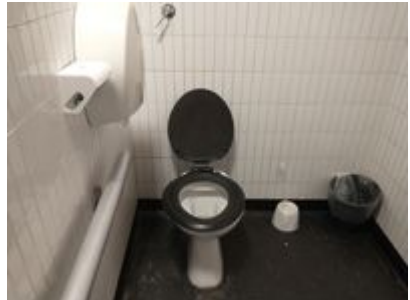
Wellingborough Library	1	001/wc and duct	Toilet seat		Asbestos-containing composite	Presume Chrysotile	3	2 No.	R3	Manage

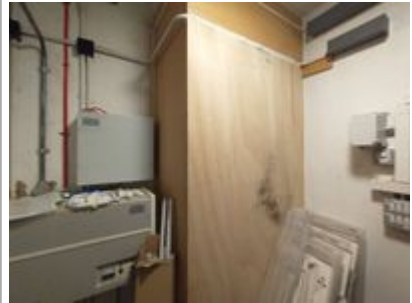
Building	Level	Location	Item / Product Examined	Sample No.	Material Description	Fibre Type	Material Score	Extent	Risk Level Assessment	Initial Control Recommendation	Photograph
Wellingborough Library	1	003/ electrics cupboard	Behind wooden boxing	526967-12	Asbestos-containing insulating board	Amosite, Chrysotile	7	5 m2	R3	Manage

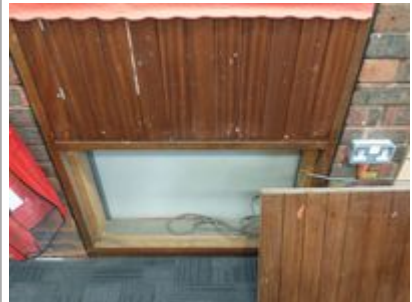
Wellingborough Library	1	004/ children's area	Behind panel to hoist	526967-12	Asbestos-containing insulating board	Amosite, Chrysotile	7	3 m2	R3	Manage

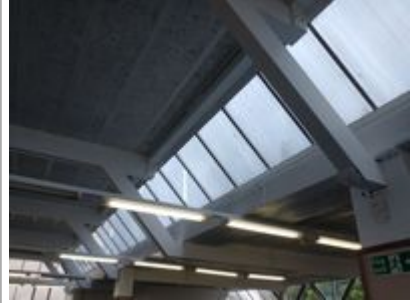
Wellingborough Library	1	005/main library	Sealant to metal window frames	526967-7	Asbestos-containing mastic	Chrysotile	3	3 Lm. per frame	R3	Manage

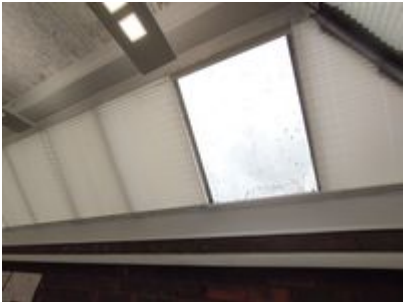
Wellingborough Library	1	007/office	Sealant to metal window frames	526967-7	Asbestos-containing mastic	Chrysotile	3	3 Lm. per frame	R3	Manage

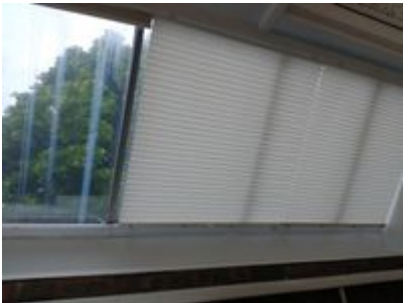
Wellingborough Library	1	008/office	Sealant to metal window frames	526967-7	Asbestos-containing mastic	Chrysotile	3	3 Lm. per frame	R3	Manage

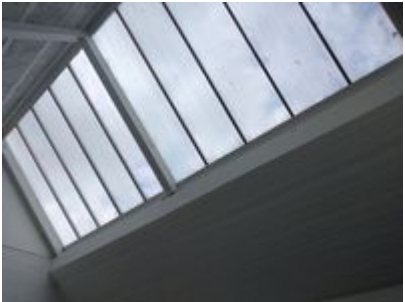
Wellingborough Library	2	002/stairwell	Sealant to metal window frames	526967-7	Asbestos-containing mastic	Chrysotile	3	3 Lm. per frame	R3	Manage

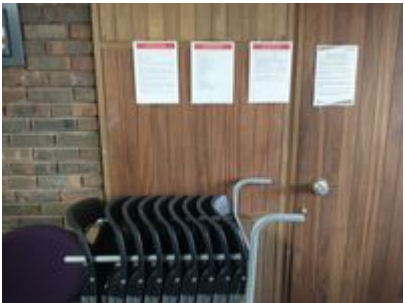
Wellingborough Library	2	003/staff office	Boxing to hoist		Asbestos-containing no access	Strongly Presume Amosite	7	3 m2	R3	Manage

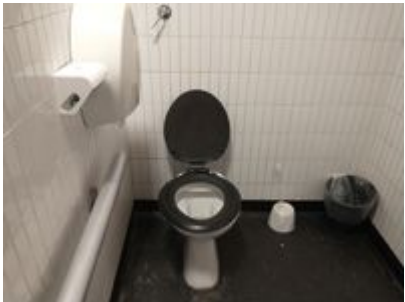
Wellingborough Library	1	001/wc and duct	Toilet seat	No Access	Unable to sample without potential to break toilet seat

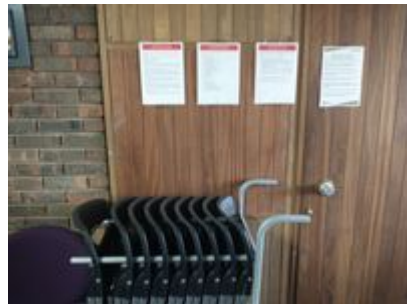
Building	Level	Location	Item / Product Examined	Accessibility	Access Comments	Photograph
Wellingborough Library	2	003/staff office	Boxing to hoist	No Access	Damage to decorative surfaces

🗨 Not accessible during survey, however presumed to be consistent with AIB panel found to same hoist on floor directly below.		
Wellingborough Library	2	003/staff office	Within electrics	No Access	Live service supply
