Wadebridge School  
Gonvena Hill  
Wadebridge  
Cornwall  
PL27 6BU

## Asbestos Refurbishment Survey Report

Report No: J002943  
UPRN: 4153  
Engineering Services Laboratory

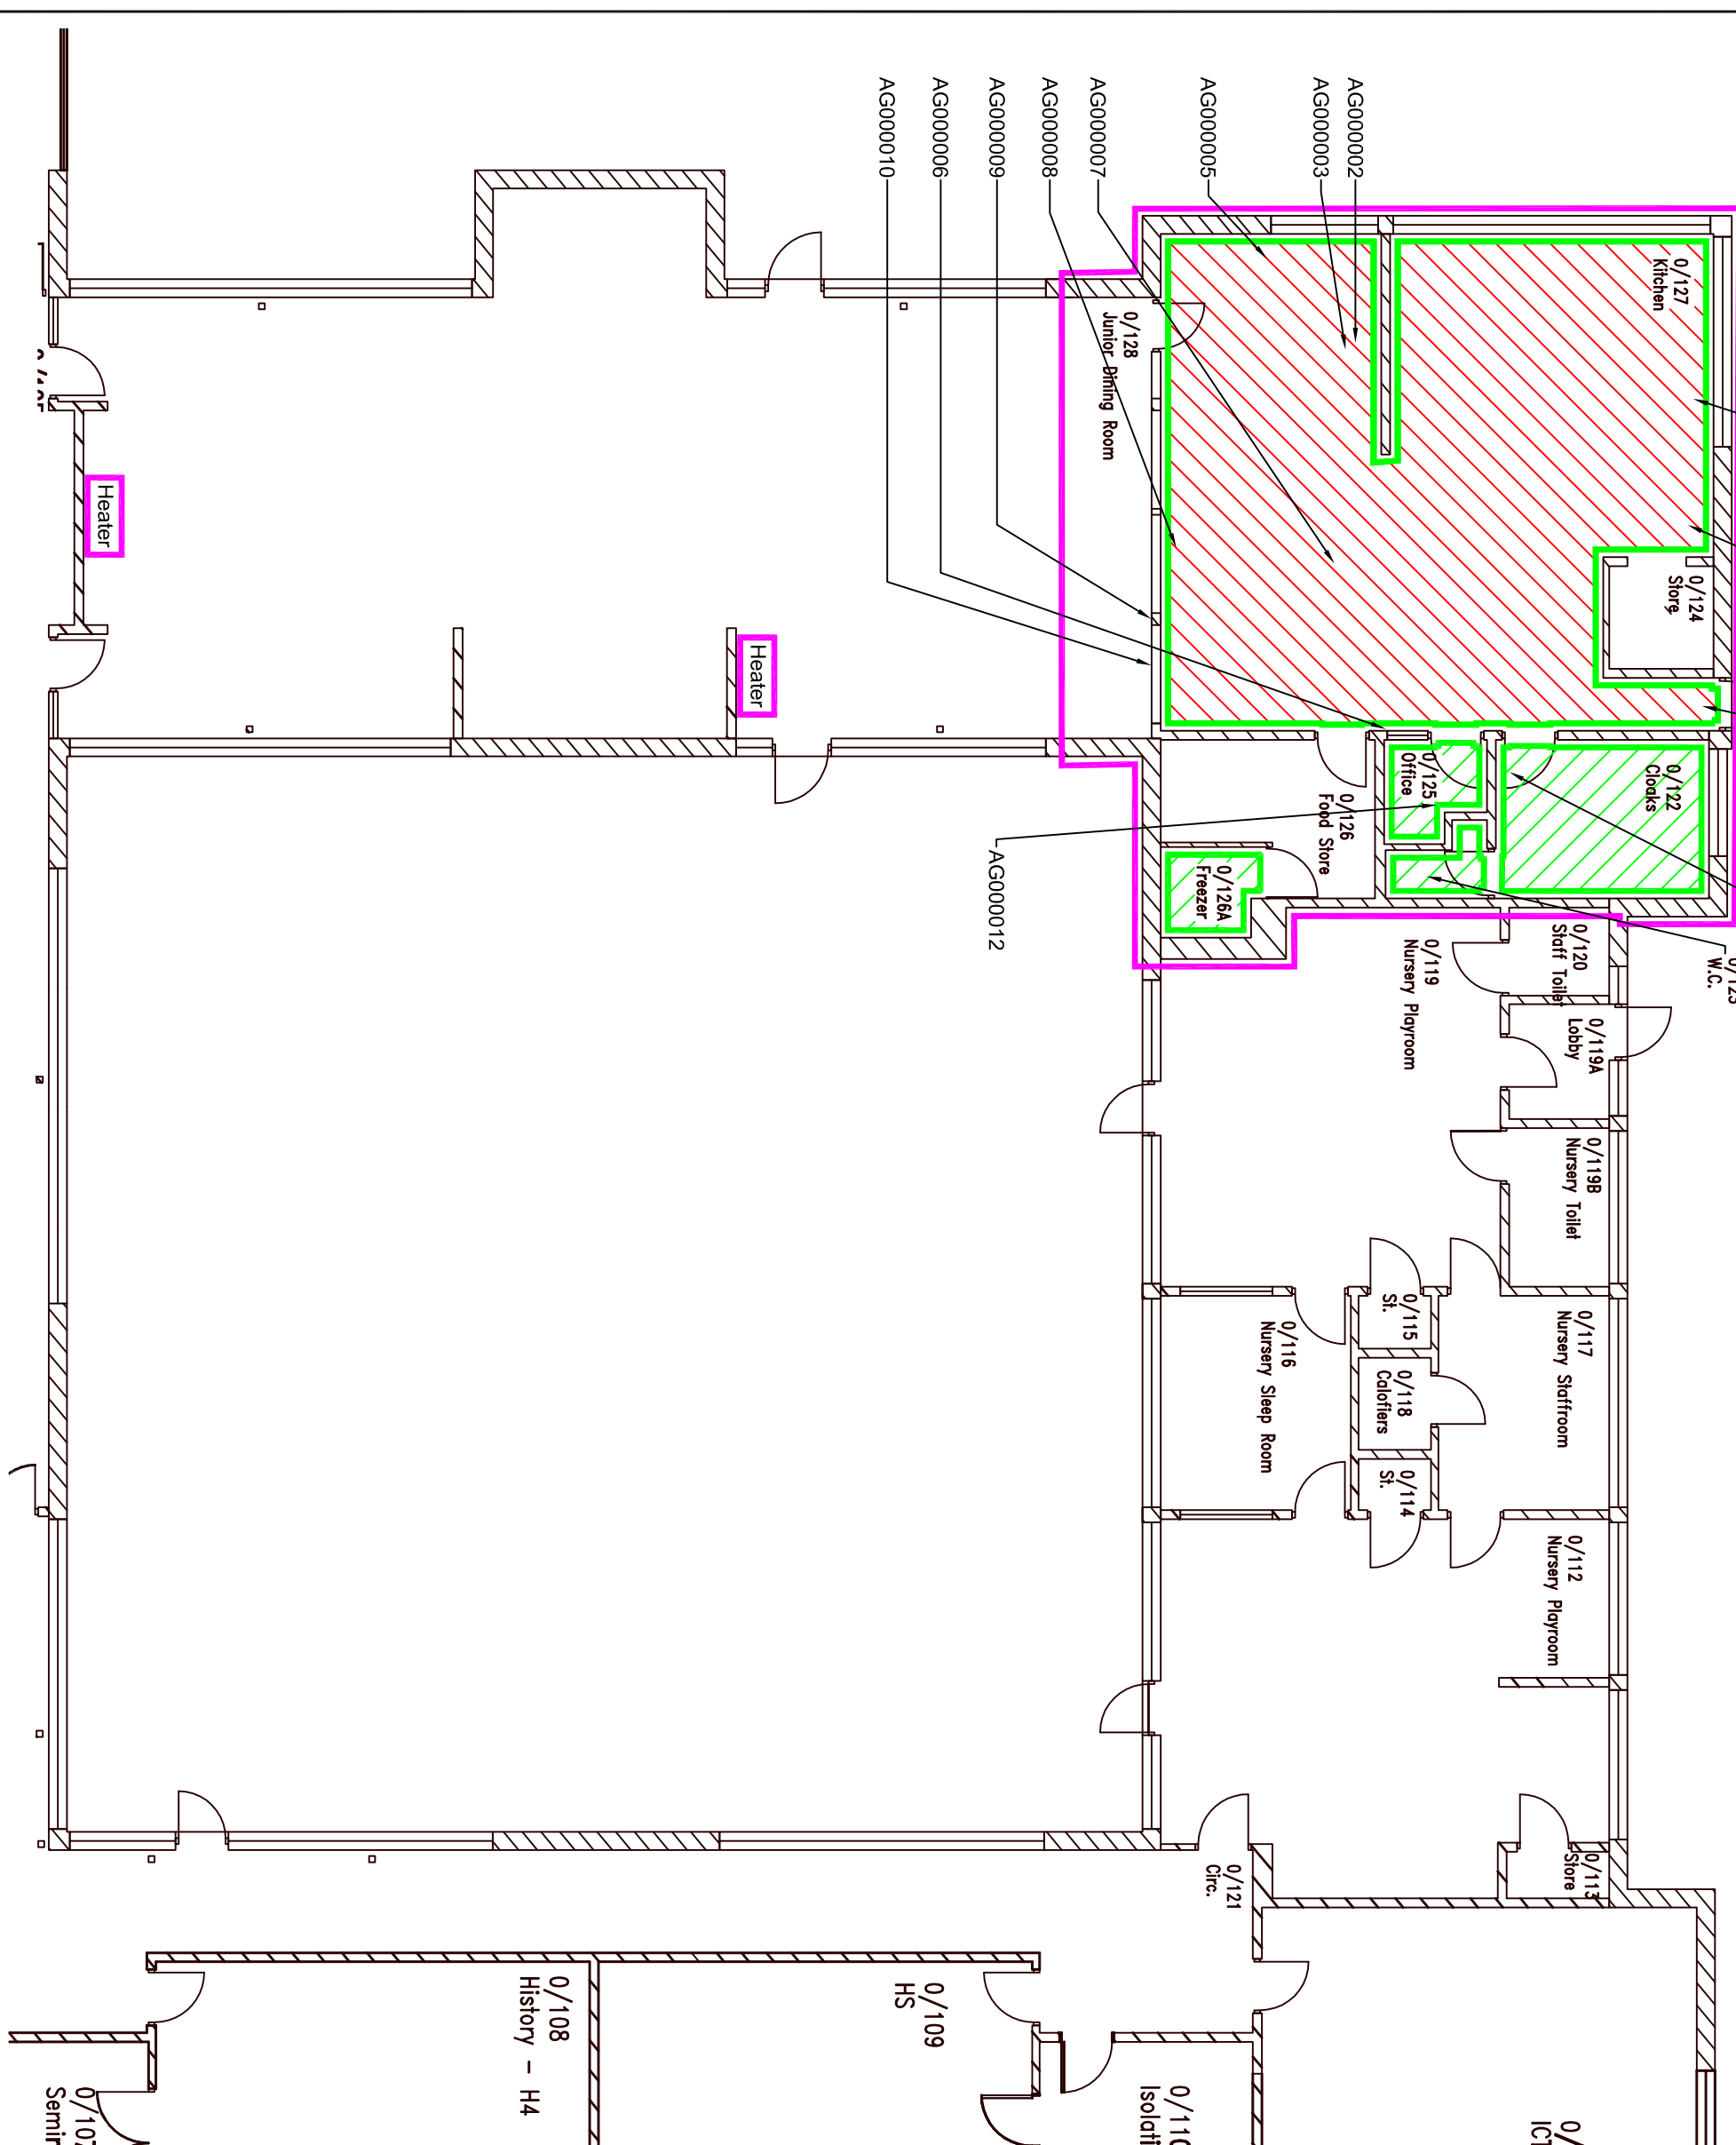
UPRN NUMBER: 4153  
 PROJECT TITLE: Wadebridge School Kitchen Wadebridge  
 DRAWING TITLE: ACM Location Plan

Areas/rooms with ACM's; both licensable and no-licensable are highlighted on the plan along with any inaccessible areas.

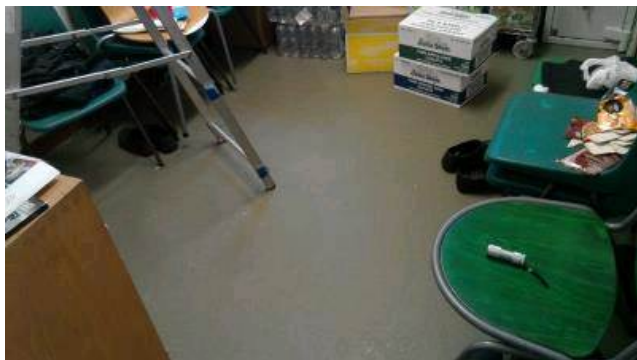
Item NO: 29 Block No. 1  
Floor No. 0 Room No. 122  
Sample Reference: AG000013  
Description: Screed with bitumen  
residue under lino

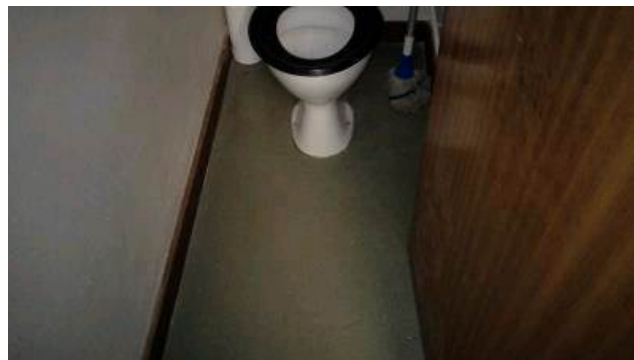
Item NO: 32 Block No. 1  
Floor No. 0 Room No. 123  
Sample Reference: AS AG000013  
Description: Screed with bitumen  
residue under lino

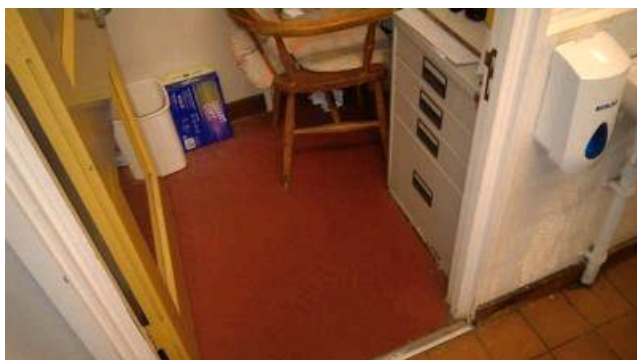
Item NO: 26 Block No. 1  
Floor No. 0 Room No. 125  
Sample Reference: AD002089  
{AG000012}  
Description: Screed under lino

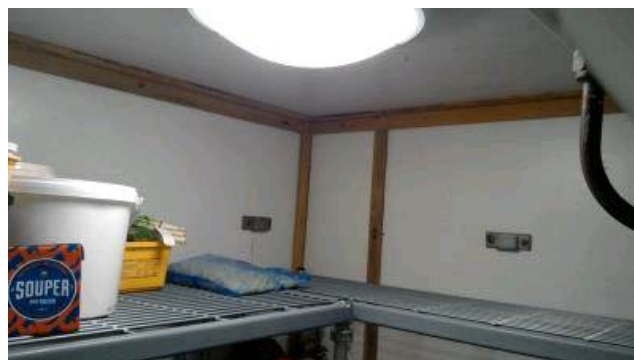
Item NO: 23 Block No. 1  
Floor No. 0 Room No. 126A  
Sample Reference:  
Description: Lining to freezer

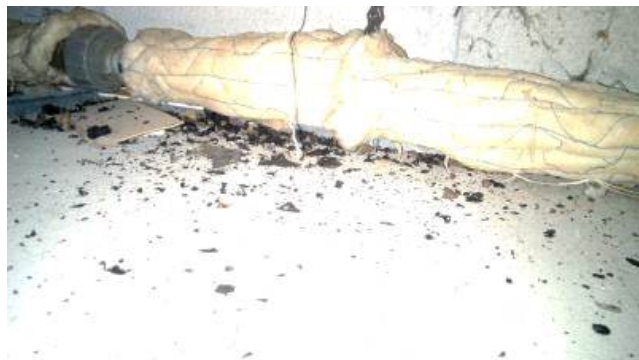
1	0	127	Kitchen	AG000003	Bitumen debris on back of ceiling tiles in void	Numerous	Well Bound Material	Chrysotile	Completely Sealed	Medium Damage	4	Occasionally likely to be disturbed	Found in various locations throughout void
1	0	127	Kitchen	AG000006	Panel below window to office 125	1m <sup>2</sup>	Asbestos Cement	Chrysotile	Sealed	Good Condition	3	Easily disturbed

Item NO: 3 Block No. 1  
Floor No. 0 Room No. 127  
Sample Reference: AG000003  
Description: Bitumen debris on back  
of ceiling tiles in void

It should be noted that the asbestos insulation board panels located at the base of the warming cupboards within Kitchen 0/127 were found to be in poor condition. Due to the bitumen debris in the ceiling void, the void should be put out of bounds until the material is removed.

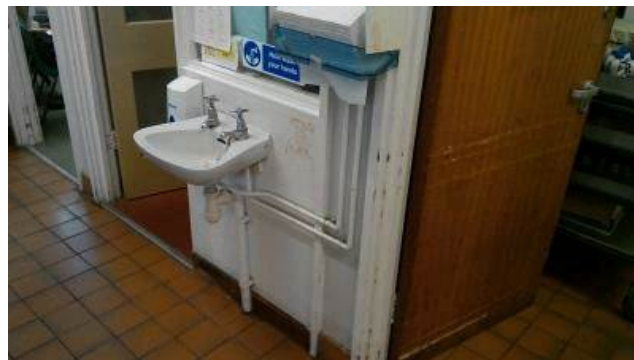
Item NO: 6 Block No. 1  
Floor No. 0 Room No. 127  
Sample Reference: AG000006  
Description: Panel below window to  
office 125

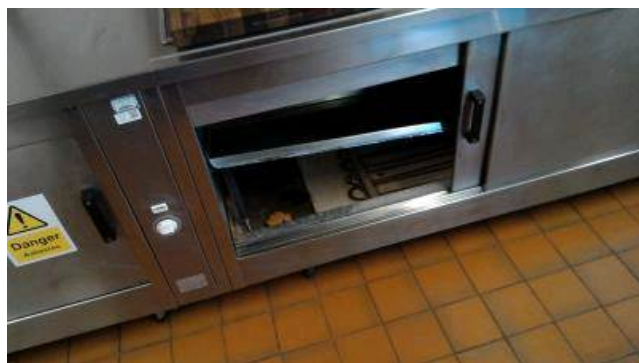
B	F	R	Room Description	Sample Ref. No:	Material Location	Approx. Quantity (m <sup>2</sup> )	Product Type	Asbestos Type	Surface Treatment	Condition	Material Assem't Score	Accessibility	Comments
1	0	127	Kitchen	AG000008	Panel within base of warming cupboards (3no.)	3m <sup>2</sup>	Asbestos Insulating Board	Chrysotile	Unsealed	High Damage	8	Usually inaccessible or unlikely to be disturbed

Item NO: 8 Block No. 1  
Floor No. 0 Room No. 127  
Sample Reference: AG000008  
Description: Panel within base of  
warming cupboards (3no.)

The type of asbestos insulating board detected included materials that are classed as notifiable / licensable, therefore only licensed asbestos removal contractors may work on or remove this type of material and will have to notify the Health and Safety Executive at least 14 days prior to any work.
