## Refurbishment Survey

Survey Reference Number: X-01119

Survey Date: 01 February 2018

19 Garrison Lane  
Isles of Scilly  
TR21 0JD

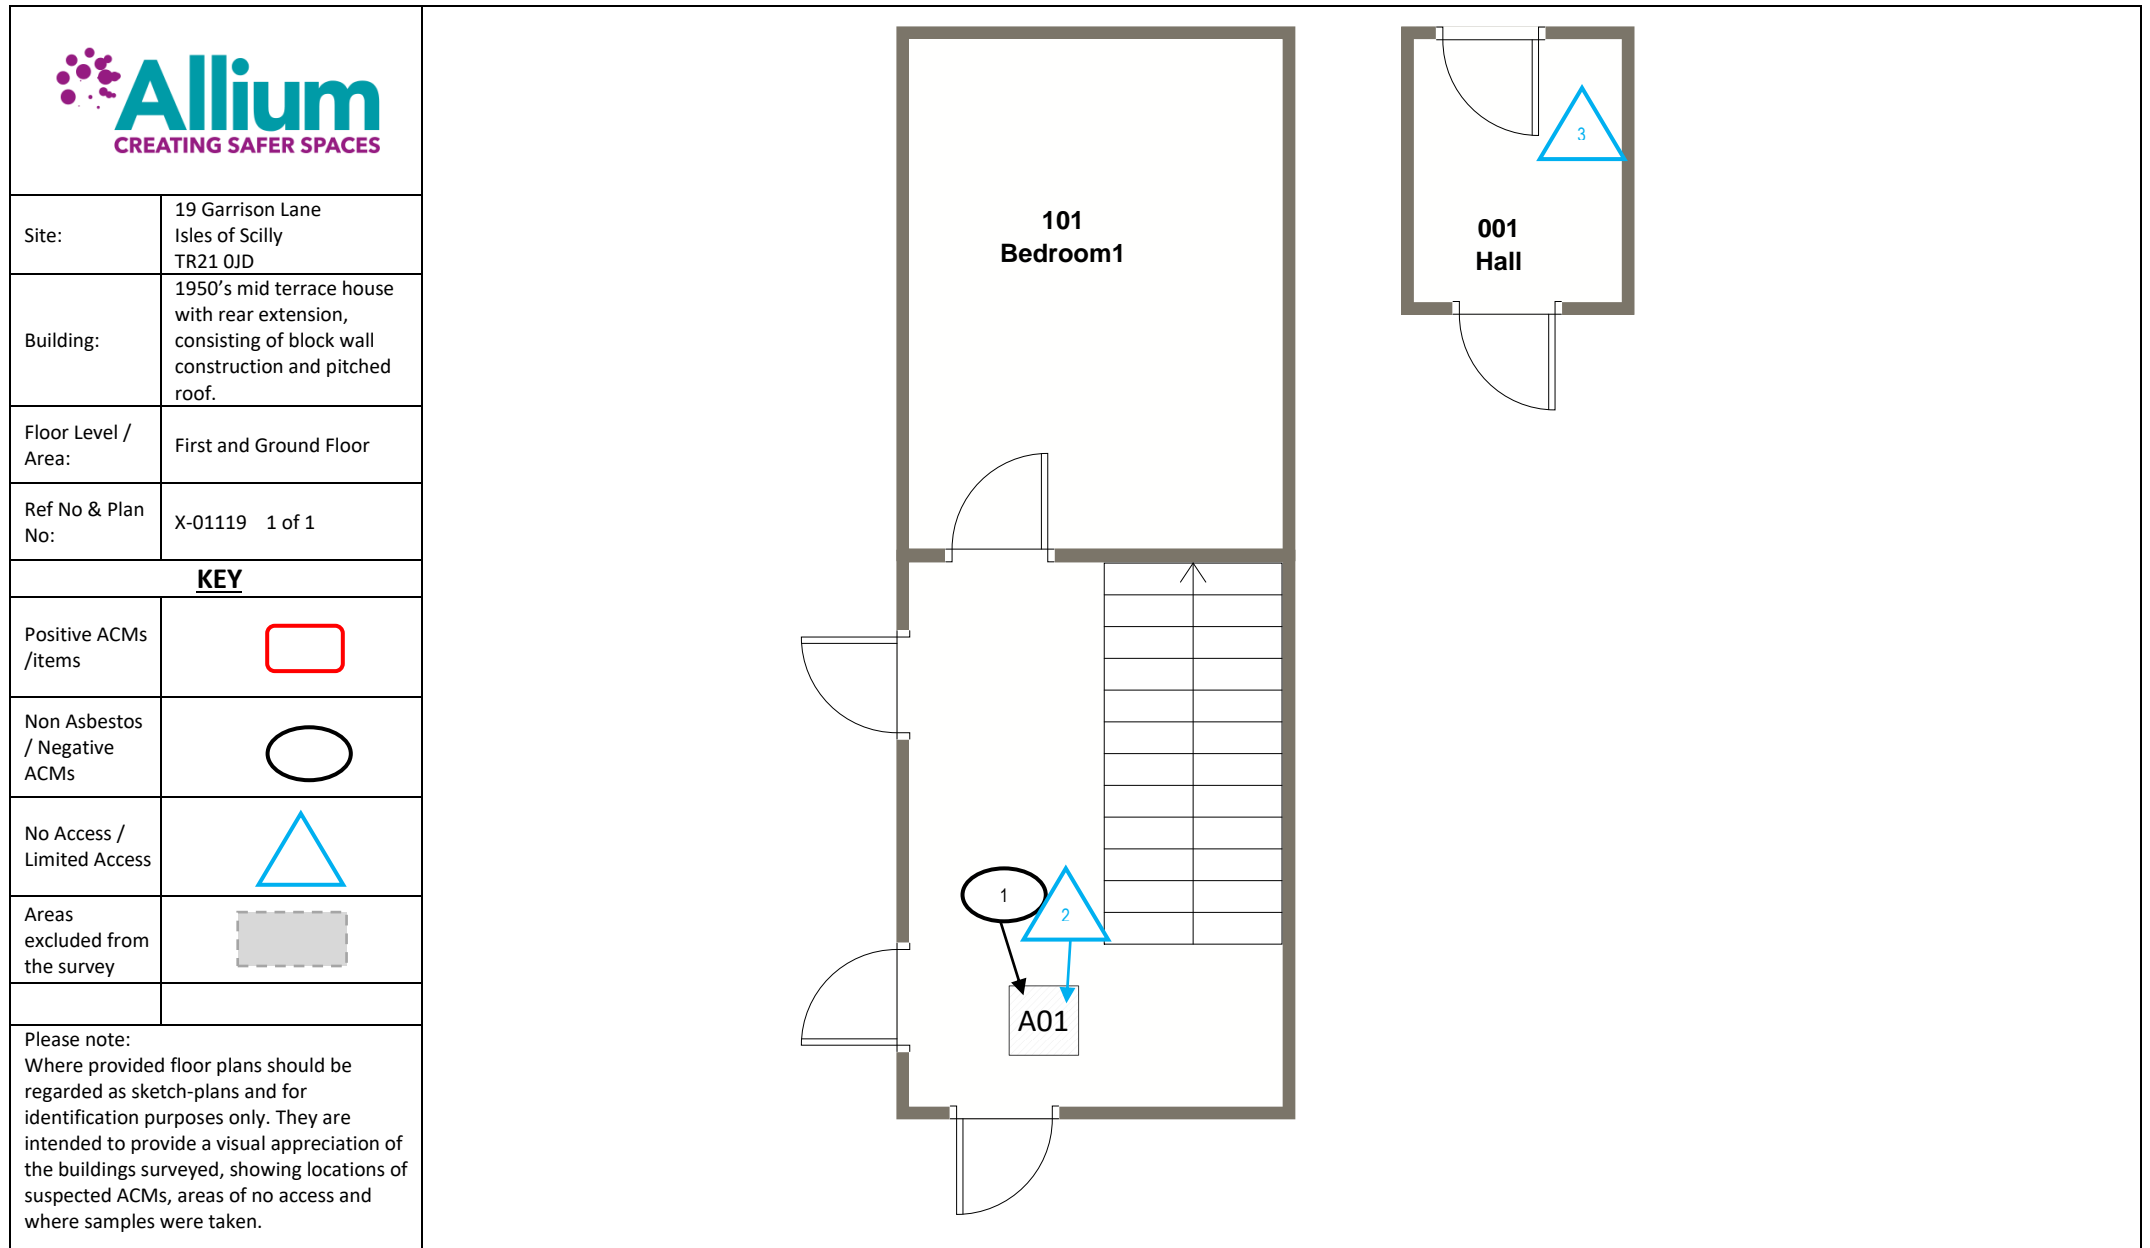
THIS PLAN SHOULD BE READ IN CONJUNCTION WITH THE MAIN BODY OF THE REPORT AND INDIVIDUAL ITEM RECORDS

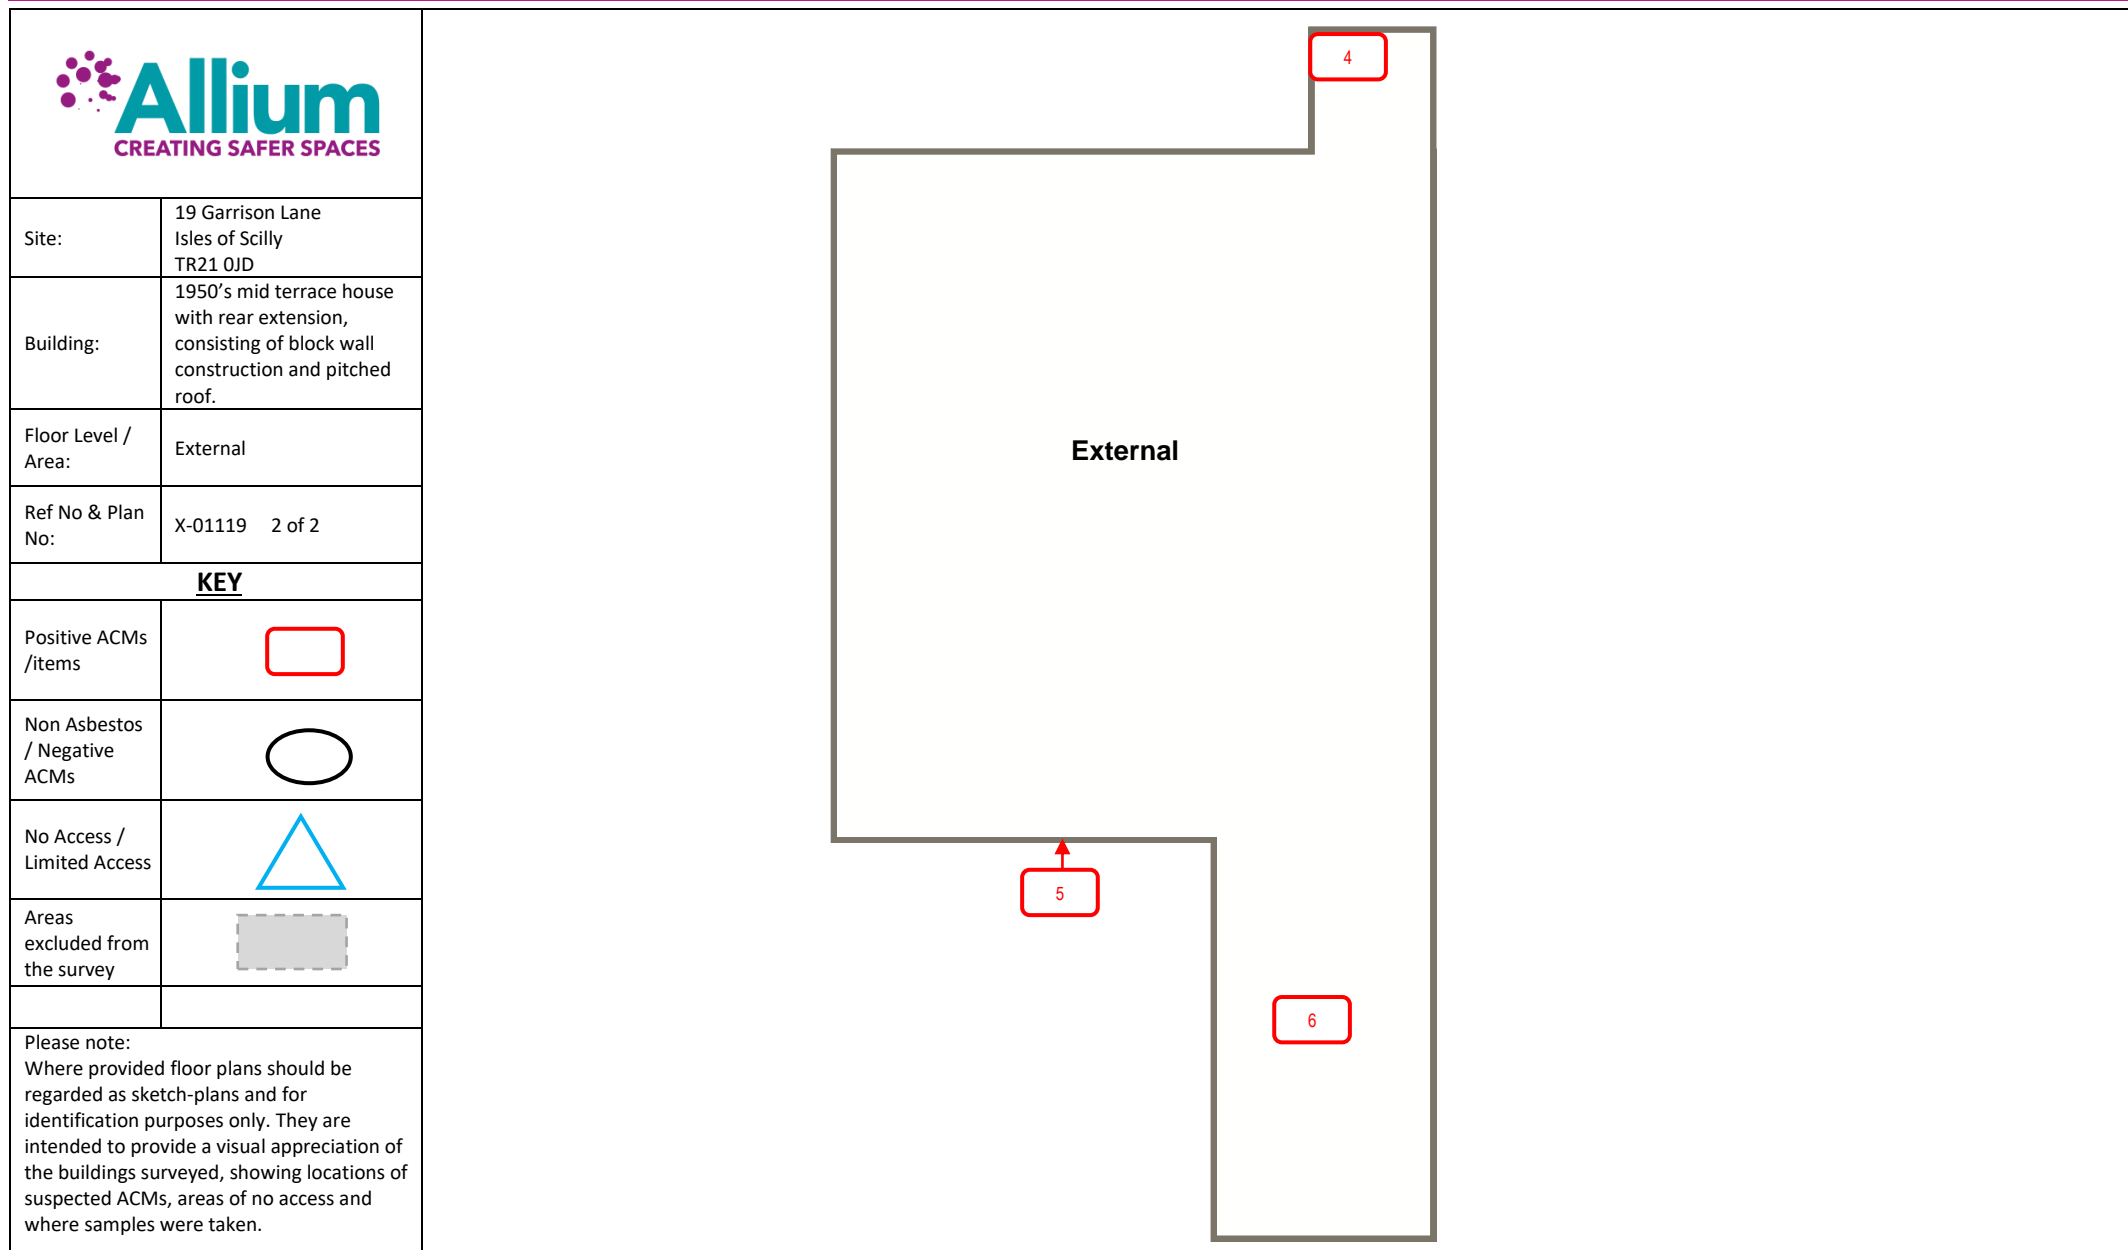
THIS PLAN SHOULD BE READ IN CONJUNCTION WITH THE MAIN BODY OF THE REPORT AND INDIVIDUAL ITEM RECORDS
