BUILDING SURVEY

1 and 2 Marlborough
Square
Coalville
LE67 3WD

Richard Leigh

Wednesday 25th April 2018

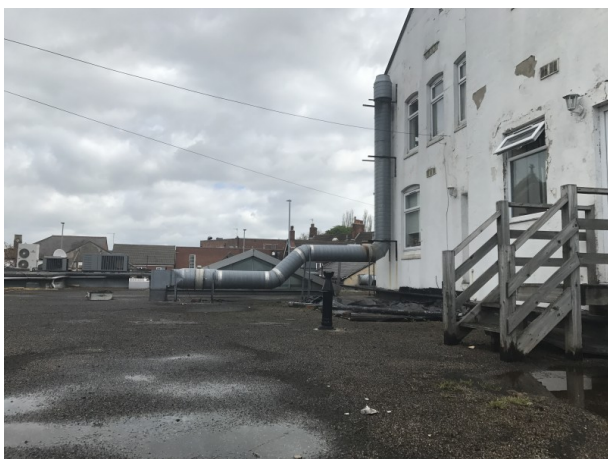
It was not possible to make a close inspection of roof coverings. The front parapet was too high for our 3m ladder and we were only able to view the roof from a distance at the rear as it was unsafe to climb on to the roof from the ladder. There is a pitched roof over part of the property and the pitched roof is covered with asbestos cement slates with a clay ridge bedded in sand cement mortar. The pitched roof is surrounded by flat roof areas which were not visible to us. There are numerous leaks evident from inside the property and we would suspect that the roof is leaking through the flat roof coverings although this can only be confirmed by closer inspection and further investigation. The flat roof coverings extend over the passageway which leads to the rear of the property and your legal advisers should clarify responsibility for this area as the flat roof coverings are common and continuous over the adjacent property. It should also be noted that there are first floor exits from the flats above which open onto the flat roof area. Foot traffic from the flats has the potential for causing damage. We would also be concerned about liability for persons who may access the roof from the flats as there is no edge protection to the roof or no obvious means of descending down from the roof area.

Photo - 2
Flat roof area over rear passageway

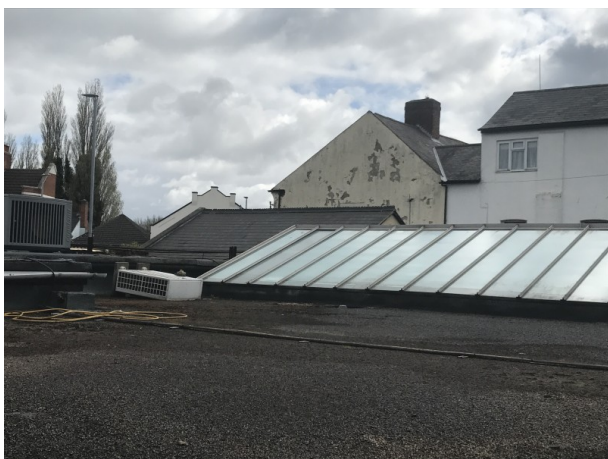
Photo - 4
Pitched roof is behind glazed roof which is over the neighbouring property

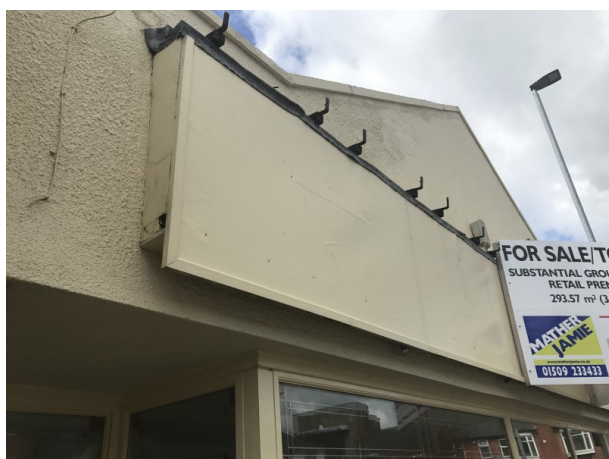
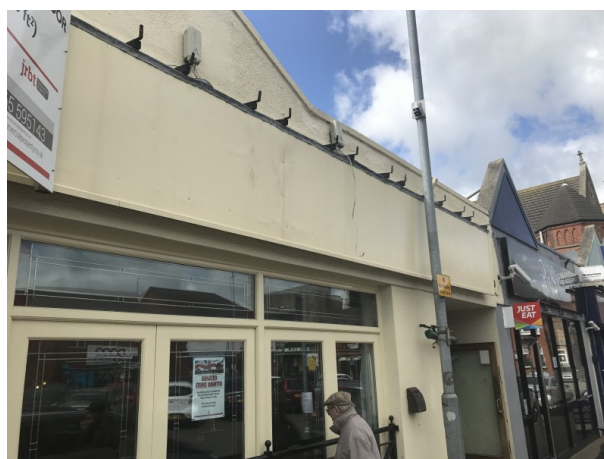
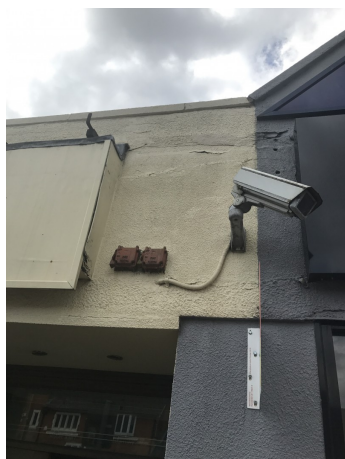
The external wall to the front of the property is rendered and painted up to the parapet. The render looks in reasonable condition although it should be said that a large part of the front gable is concealed by a fascia/signboard. The plywood fascia/signboard is in poor condition and should be removed. We assume that some making good will be required to the wall render following removal of the signboard. The junction of fascia to wall behind is also protected by a lead cover flashing at the top and once this is removed the render will need to be made good.

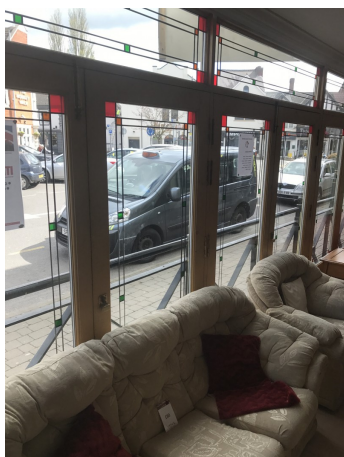
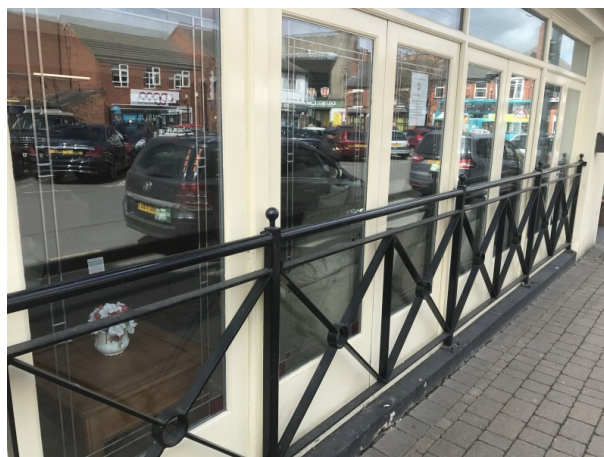
The shopfront comprises a fully glazed timber screen with a gloss painted finish. There are two pairs of opening doors to the centre of the screen but these were obstructed at time of survey and were not opened. The whole of the shop front is protected by a painted steel railing externally. Window glazing is double glazed with imitation lead on the inside face of the glass.

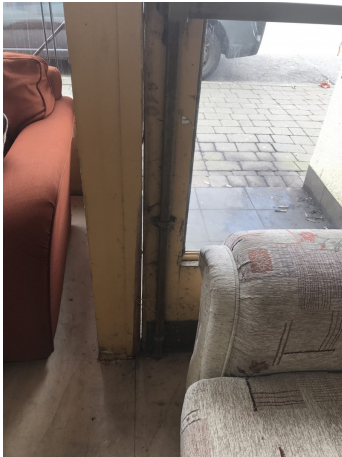
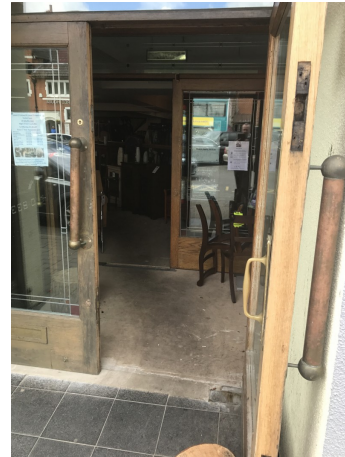
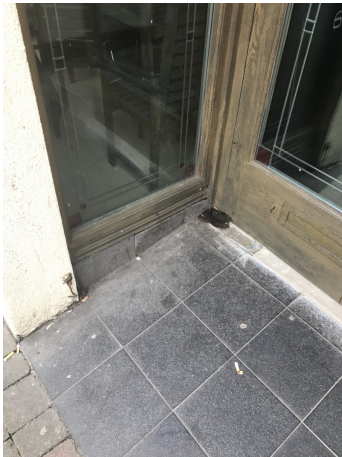
There is a fire escape door at the front of the property on the left which would benefit from some repair where the timber frame has been split. The glass in this door has also been replaced but is single glazed only which is held on the inside by a clear silicone bead. If this door is to be retained we recommend that the single glazed unit is replaced with a double glazed unit which should be fixed in place with timber beads all round.

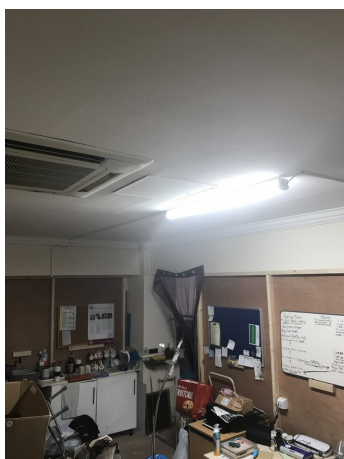
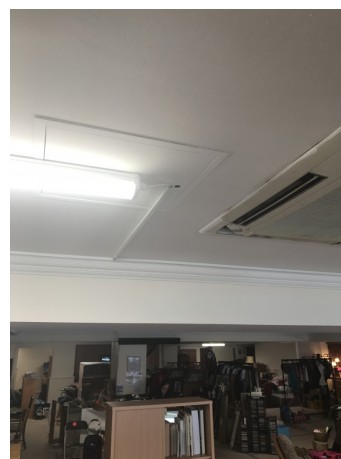
There are several small and locked hatches in the ceiling of the retail area and staff office area. We were unable to open to inspect the roof space above. One of the hatches is partly obstructed by a surface mounted light fitting.

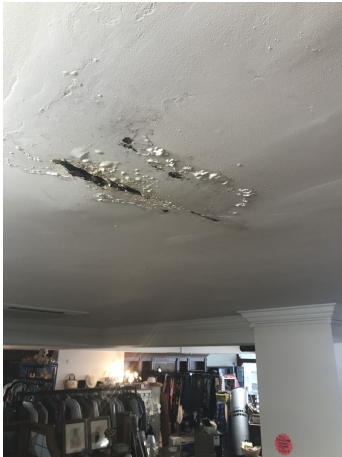
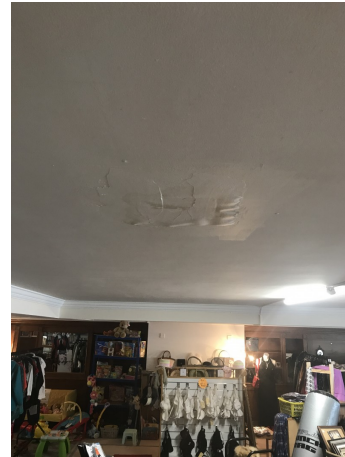
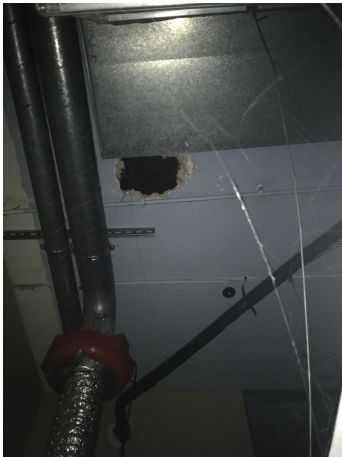
The plasterboard ceiling in the main shop area is damaged in a number of locations from water leaks. The worst of the damage can be found towards the rear of the shop.

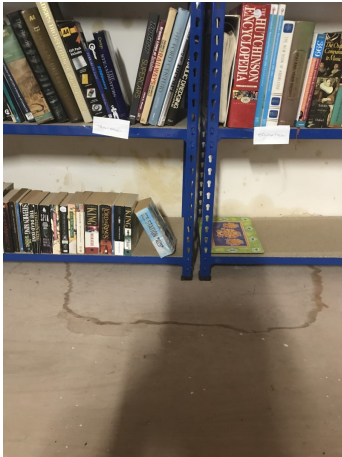
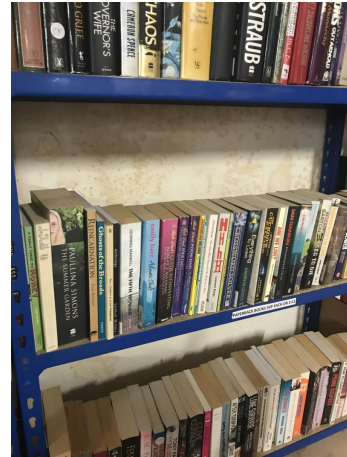
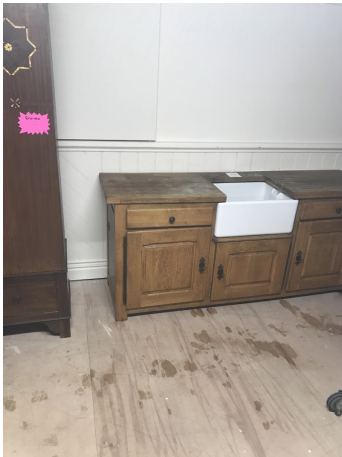
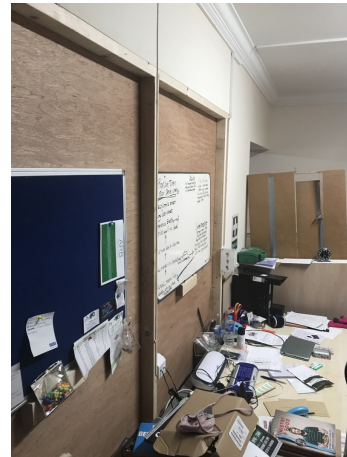
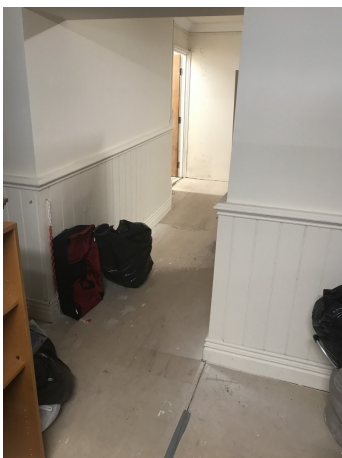
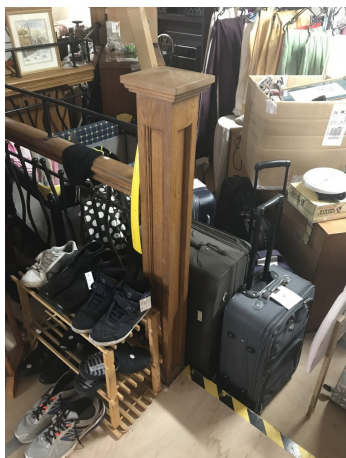
Internal walls are both solid plastered and painted they also were areas of dry lining and timber panelling to dado level. There is significant dampness in the solid wall to the left of the property at the rear. There may be further areas of dampness which are concealed by dry lining. Note the possibility of void areas behind lightweight studwork linings to the rear of the shop. The raised floor area in the shop is protected by a hardwood and steel balustrade which we assume will be removed as part of the proposed works.

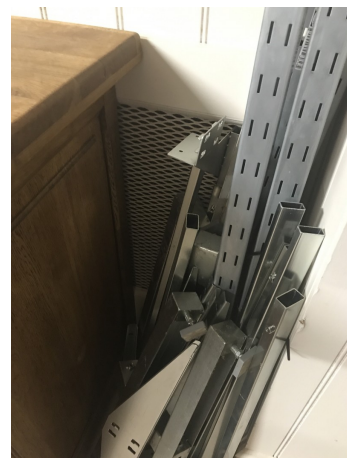
Photo - 24
Void behind panelling at rear.

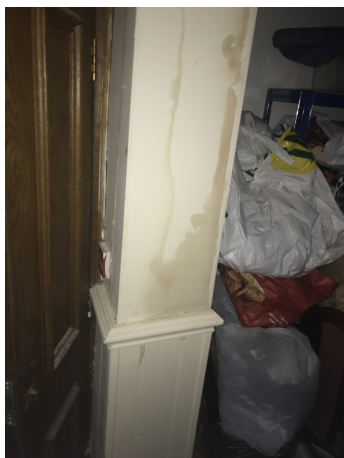
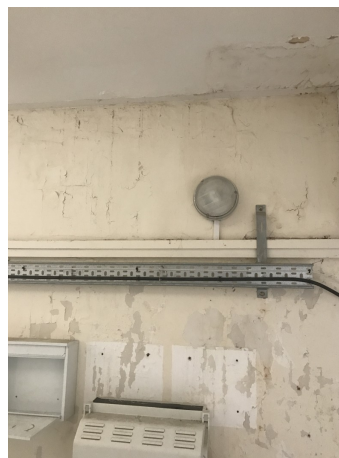
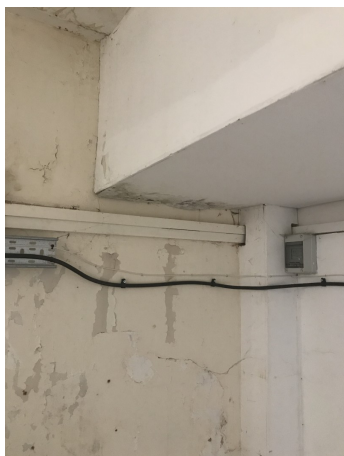
As has been mentioned previously there is penetrating dampness from the roof above. There has been significant water penetration near the storeroom with buckets on the floor half full with water. You should also note that there is evidence of penetrating damp in the rear passageway. Responsibility for the roof coverings over the passageway should be clarified prior to purchase of the property.

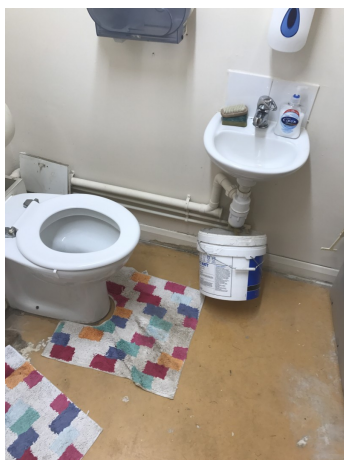
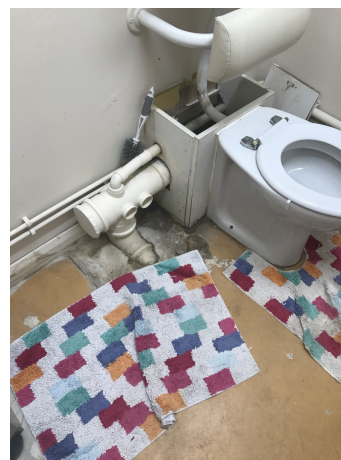
There was a leak on the plumbing below the wash hand basin and this should be repaired without delay.

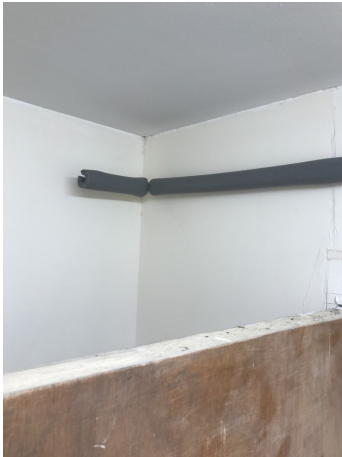
Photo - 44
Incoming water pipe.

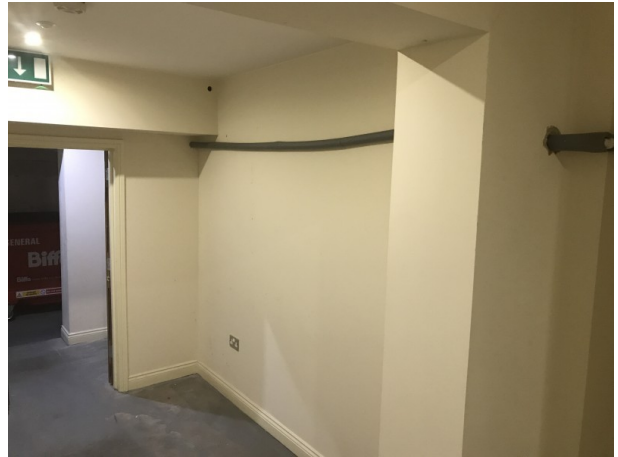
Photo - 45
Water supply to shop runs in ground floor circulation space serving flats

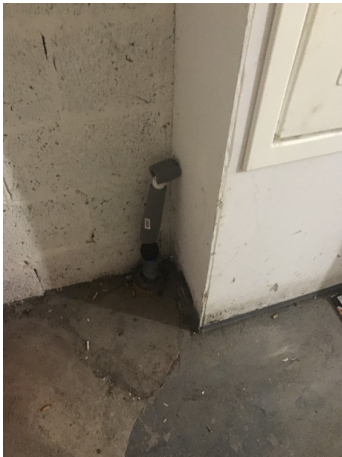
Photo - 46
Water supply to shop

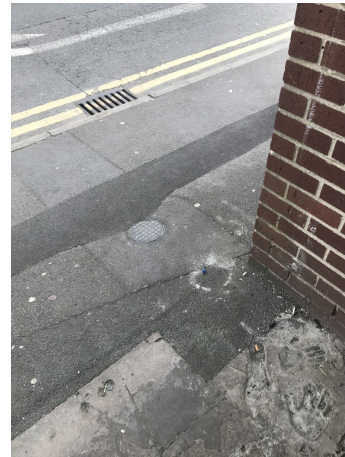
Photo - 47
Possible water meter location

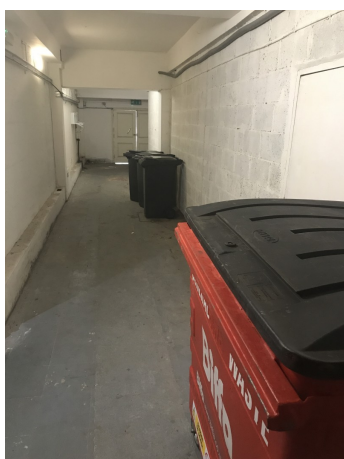
The fire escape route to the rear is shared with the flats behind the property. The escape route is also used as a bin storage area which is not entirely appropriate due to the fire risk from the waste containers and also the risk that containers may block the passageway. The former public house was fitted with an automatic fire detection system although this has since been disconnected and decommissioned. The only means of detection in the shop are battery powered domestic type smoke detectors. Ground floor flats at the rear of the property were once part of the public house. As these areas are now in separate occupation 60 minute fire resisting compartmentation is required between the different uses. The integrity of the walls dividing the 2 areas should be checked.
