## **CBC Asbestos Refurbishment & Demolition Survey Report Greenhill Rise – Shops Parade, Corby 24<sup>th</sup> April 2019**

## CBC Asbestos Refurbishment & Demolition Survey Report Greenhill Rise – Shop Parade, Corby April 2019

CBC undertook an Asbestos Refurbishment & Demolition Survey at Greenhill Rise – Shop Parade, Corby.

Daniel Payne undertook the survey on 1<sup>st</sup> December 2018.

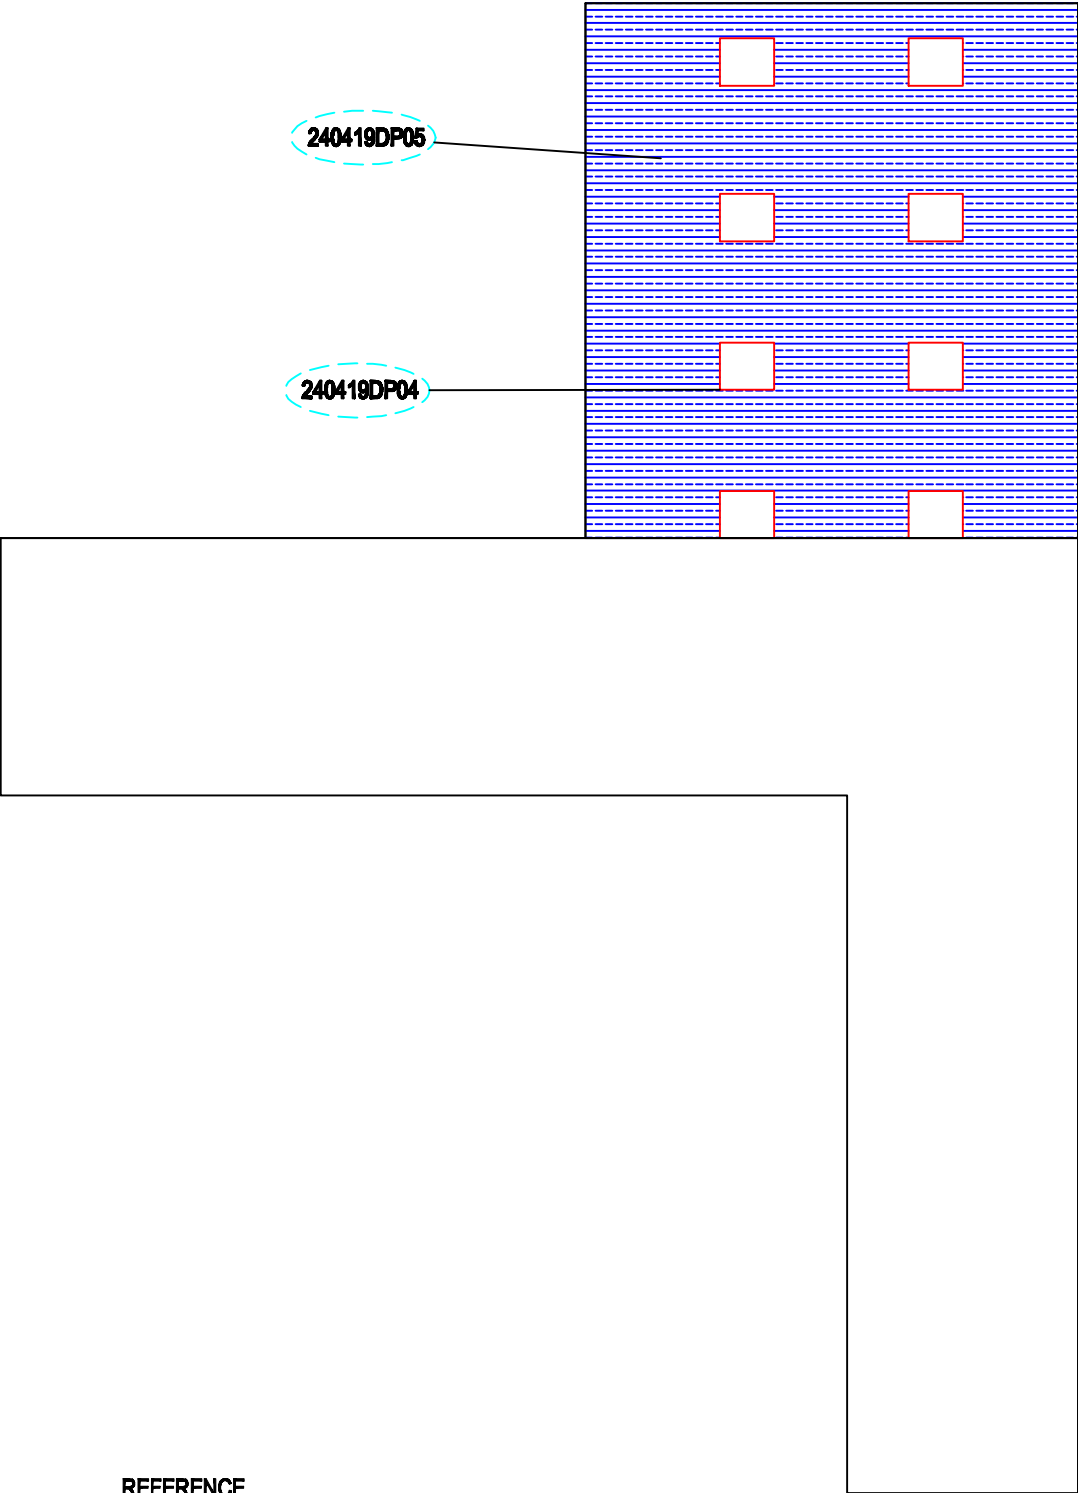
Drawing Title:  
Corby Borough Council  
Asbestos Survey Plan

Textured coating to ceiling (Render)

Textured coating to columns (Render)
