## **ASBESTOS SURVEY REPORT**

**TEMP UPRN-029  
COMMUNITY ROOM, BLOCK A,  
TRELICK TOWER, GOLBORNE ROAD,  
LONDON  
W10 5NY**

**Survey Report No: MT 9756**

**Date of Survey: 15-Dec-14**

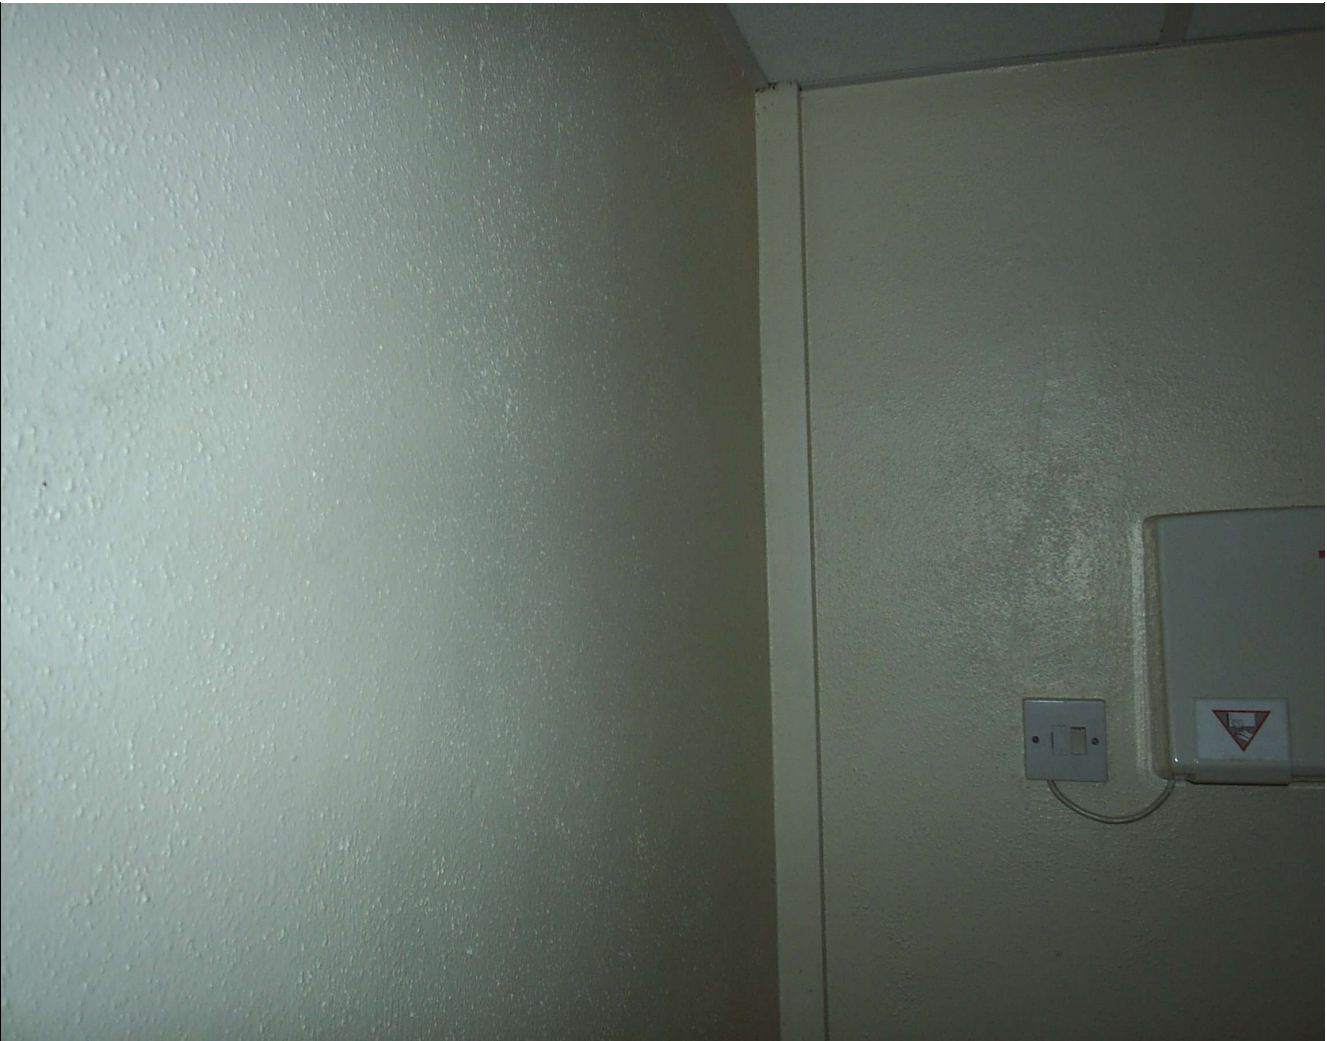
Photo No: 14

Location: TEXTURED COATING TO WALLS

Material: Sampled as No Asbestos Detected

Notes on sample: NON ASBESTOS TEXTURED COATING TO WALLS.

Recommendation: No Action Required

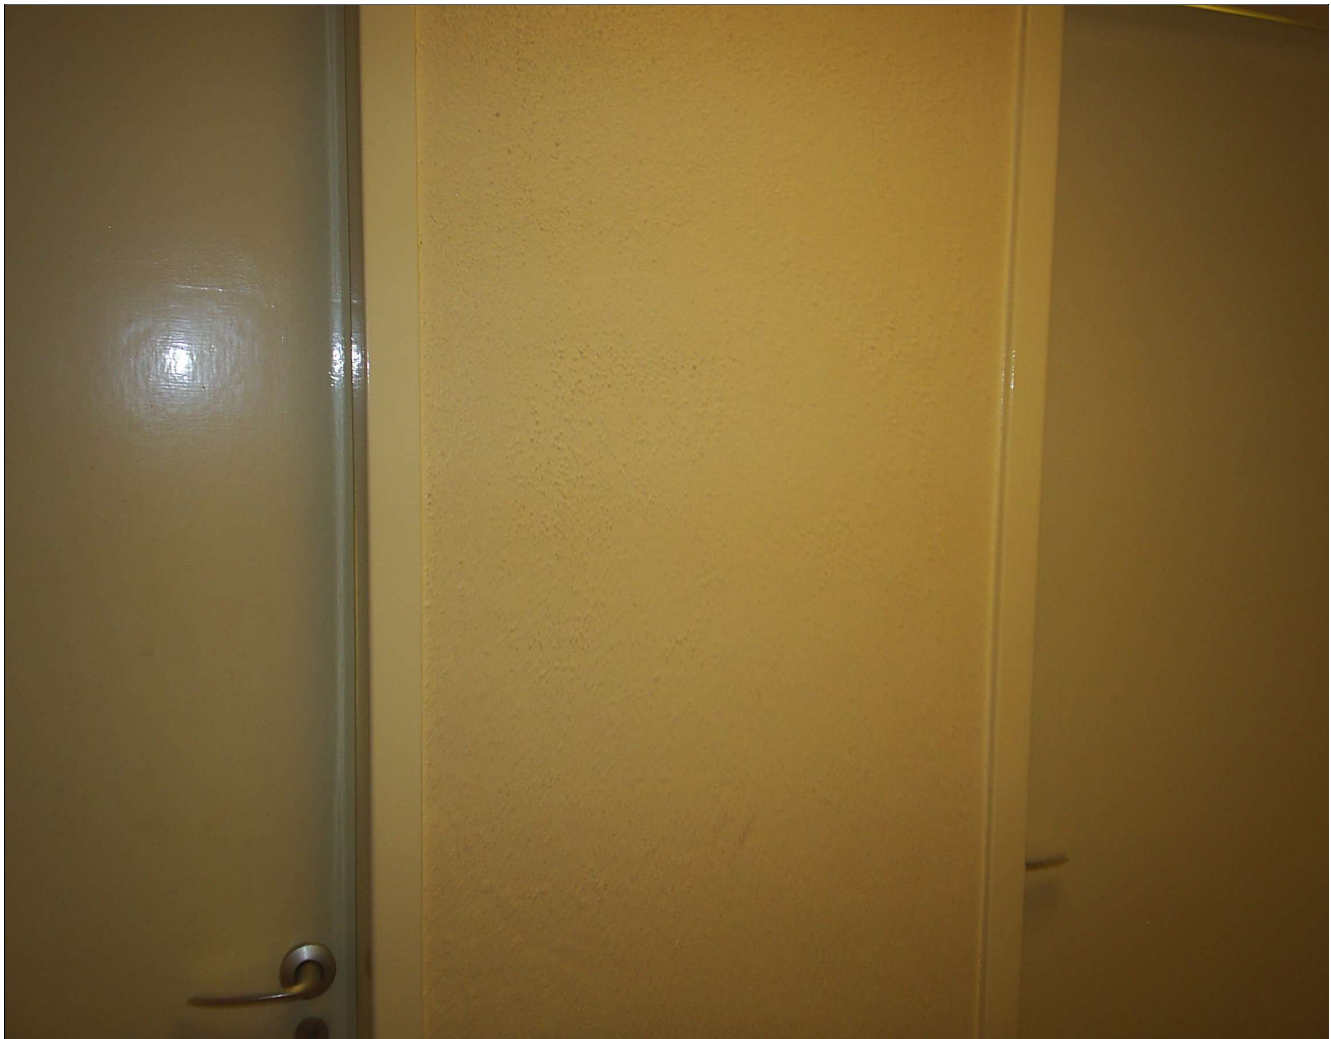
Photo No: 15

**Location: TEXTURED COATING TO WALLS**

**Material: Strongly presumed as No Asbestos Detected**

Notes on sample: NON ASBESTOS TEXTURED COATING TO WALLS.

**Recommendation: No Action Required**

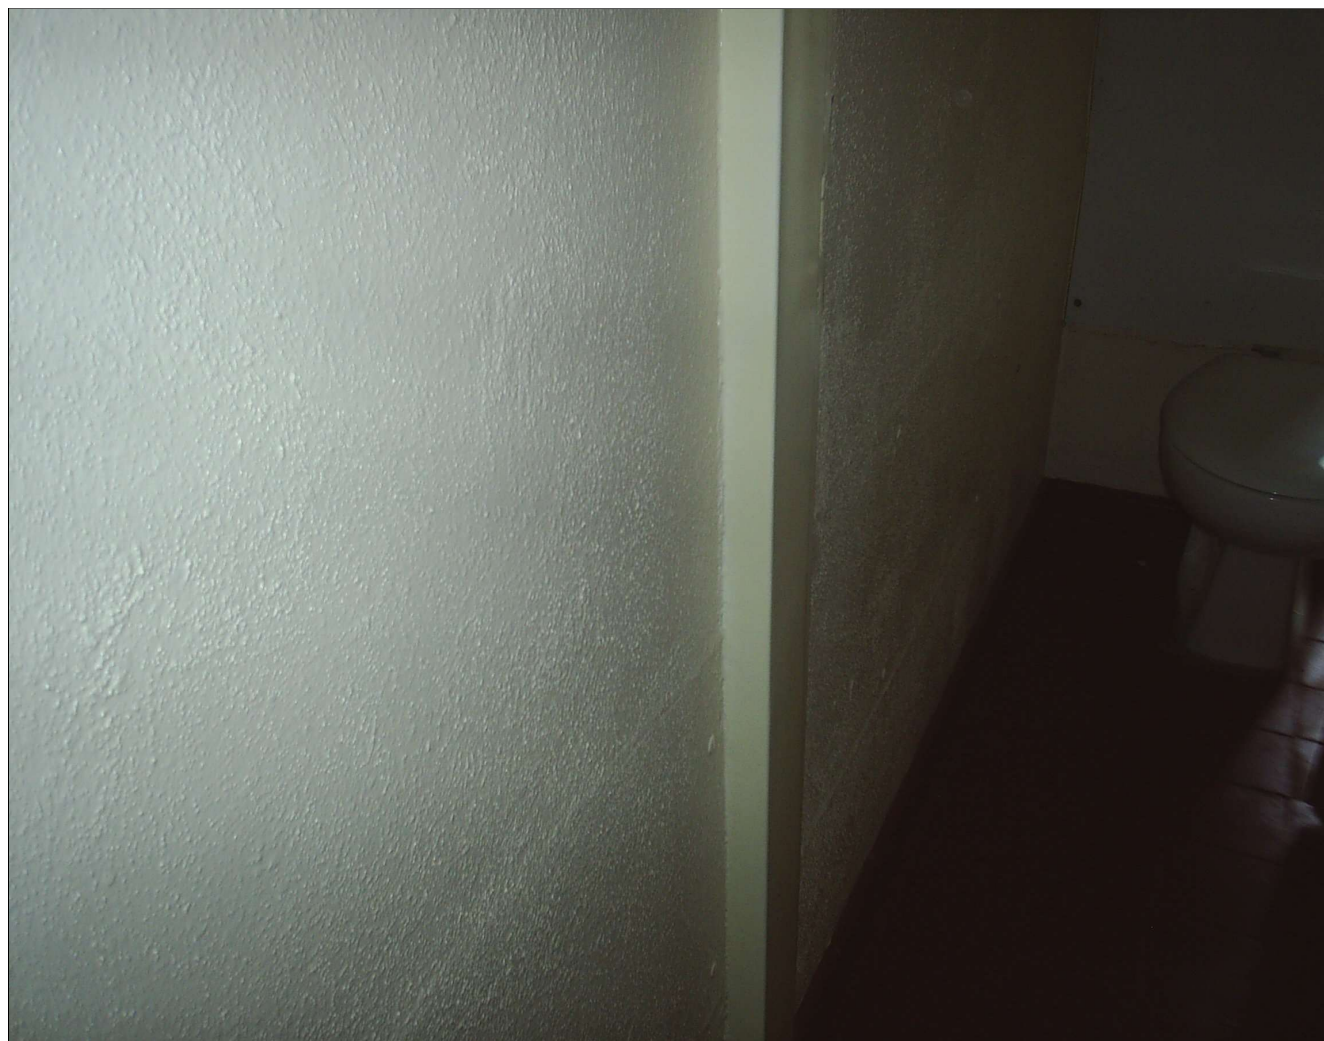
Photo No: 19

| Score 0-6 Low Risk Monitor | | Score 7-12 Medium Risk Monitor & Programme Works | Score 13-18 High Risk Monitor & Action Works | Score 19-24 Very High Risk Urgent Works | | | |
|---|---|---|---|---|---|---|---|
| 3 | COMMUNITY ROOM, BLOCK A, TRELICK TOWER GROUND TOILET 1 & 2 | WALL PANEL | Sampled Amosite & Chrysotile | 5 | 6 | 11 | Report, Record & Manage |

Location: WALL PANEL

**Material: Sampled as Amosite & Chrysotile**

Notes on sample: ASBESTOS INSULATION WALL PANEL.

**Recommendation: Report, Record & Manage**

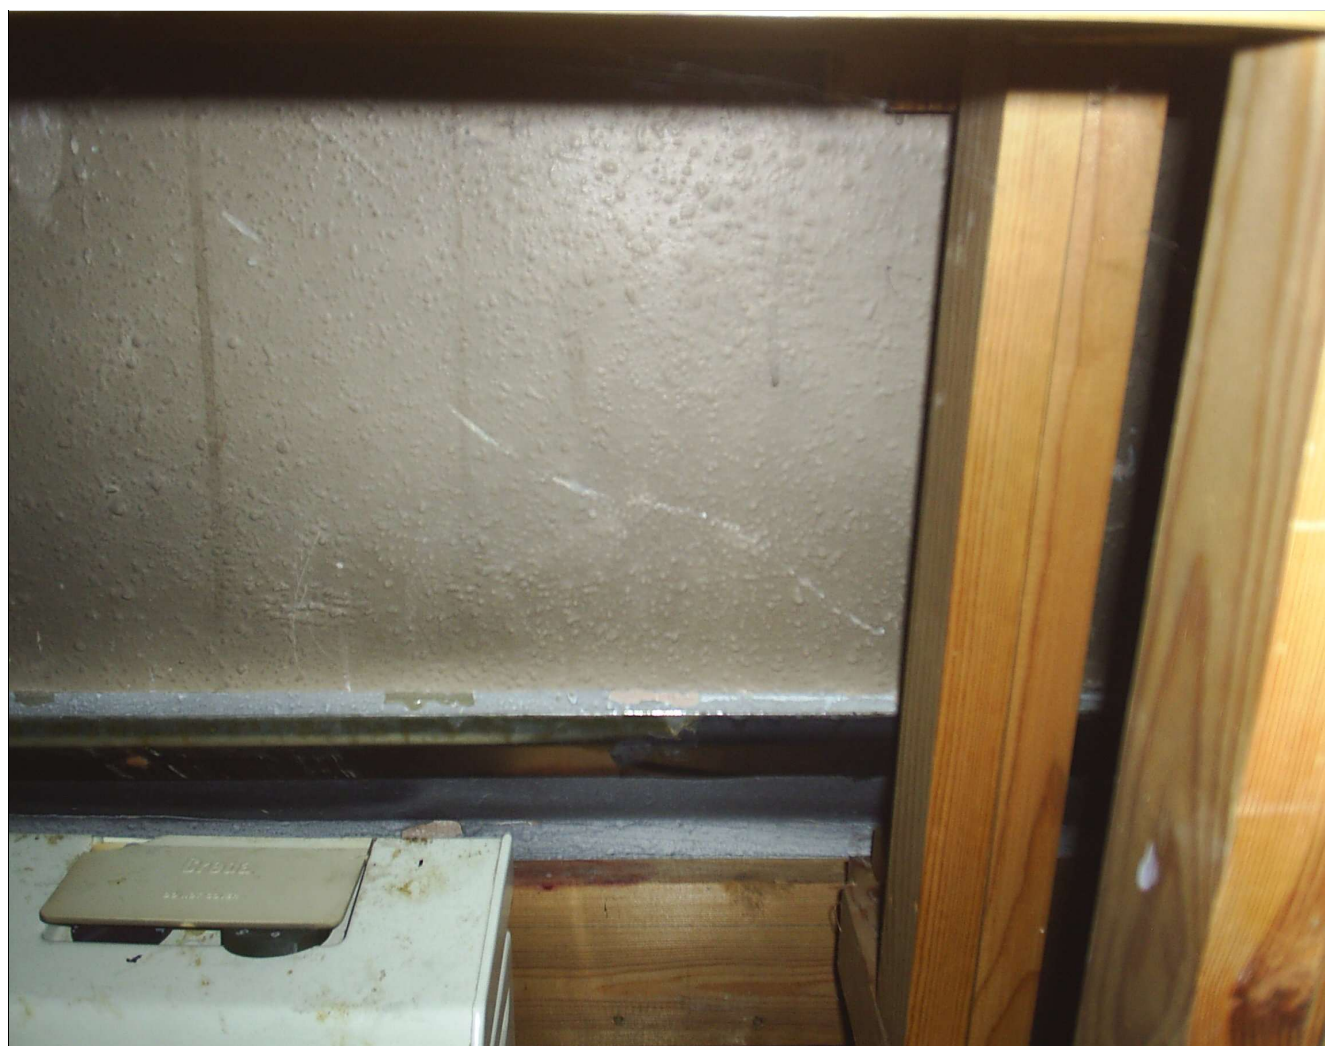
Photo No: 16

**Location:** TEXTURED COATING TO CEILING AND WALLS - GOES BEHIND TIMBER DUCTING

**Material: Sampled as No Asbestos Detected**

Notes on sample: NON ASBESTOS TEXTURED COATING TO CEILING AND WALLS.

**Recommendation: No Action Required**

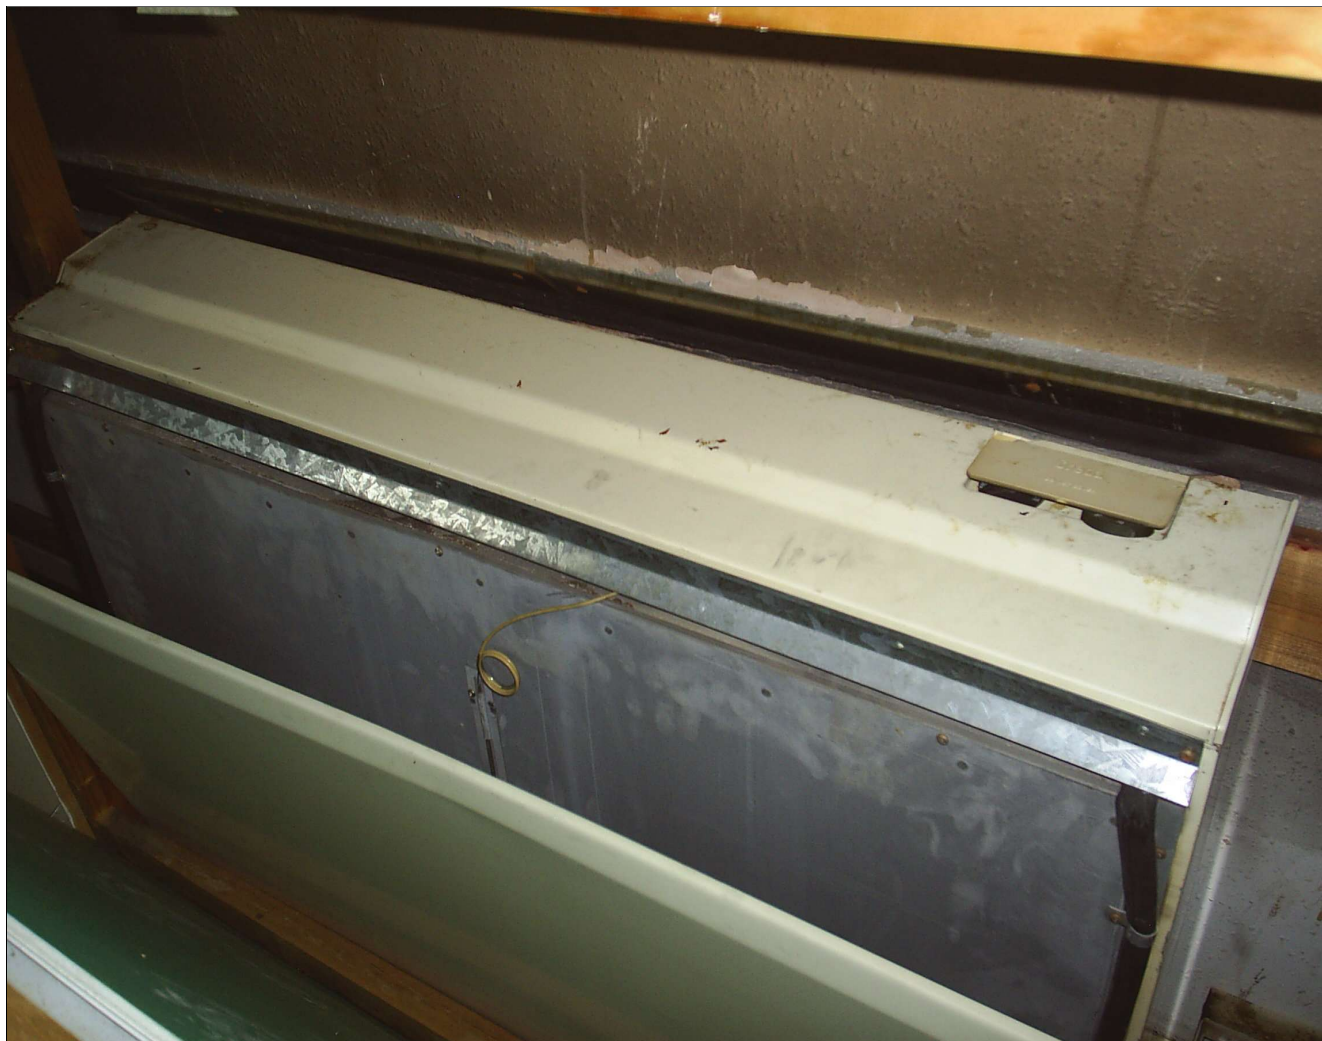
Photo No: 17

| Score 0-6 Low Risk Monitor | | Score 7-12 Medium Risk Monitor & Programme Works | Score 13-18 High Risk Monitor & Action Works | Score 19-24 Very High Risk Urgent Works | | | |
|---|---|---|---|---|---|---|---|
| 5 | COMMUNITY ROOM, BLOCK A, TRELICK TOWER GROUND MEETING ROOM | INSULATION TO STORAGE HEATERS BEHIND TIMBER | Presumed Amosite & Chrysotile | 5 | 5 | 10 | Report, Record & Manage |

**Location:** INSULATION TO STORAGE HEATERS BEHIND TIMBER

**Material: Presumed as Amosite & Chrysotile**

Notes on sample: PRESUMED ASBESTOS INSULATION TO STORAGE HEATER.

**Recommendation: Report, Record & Manage**

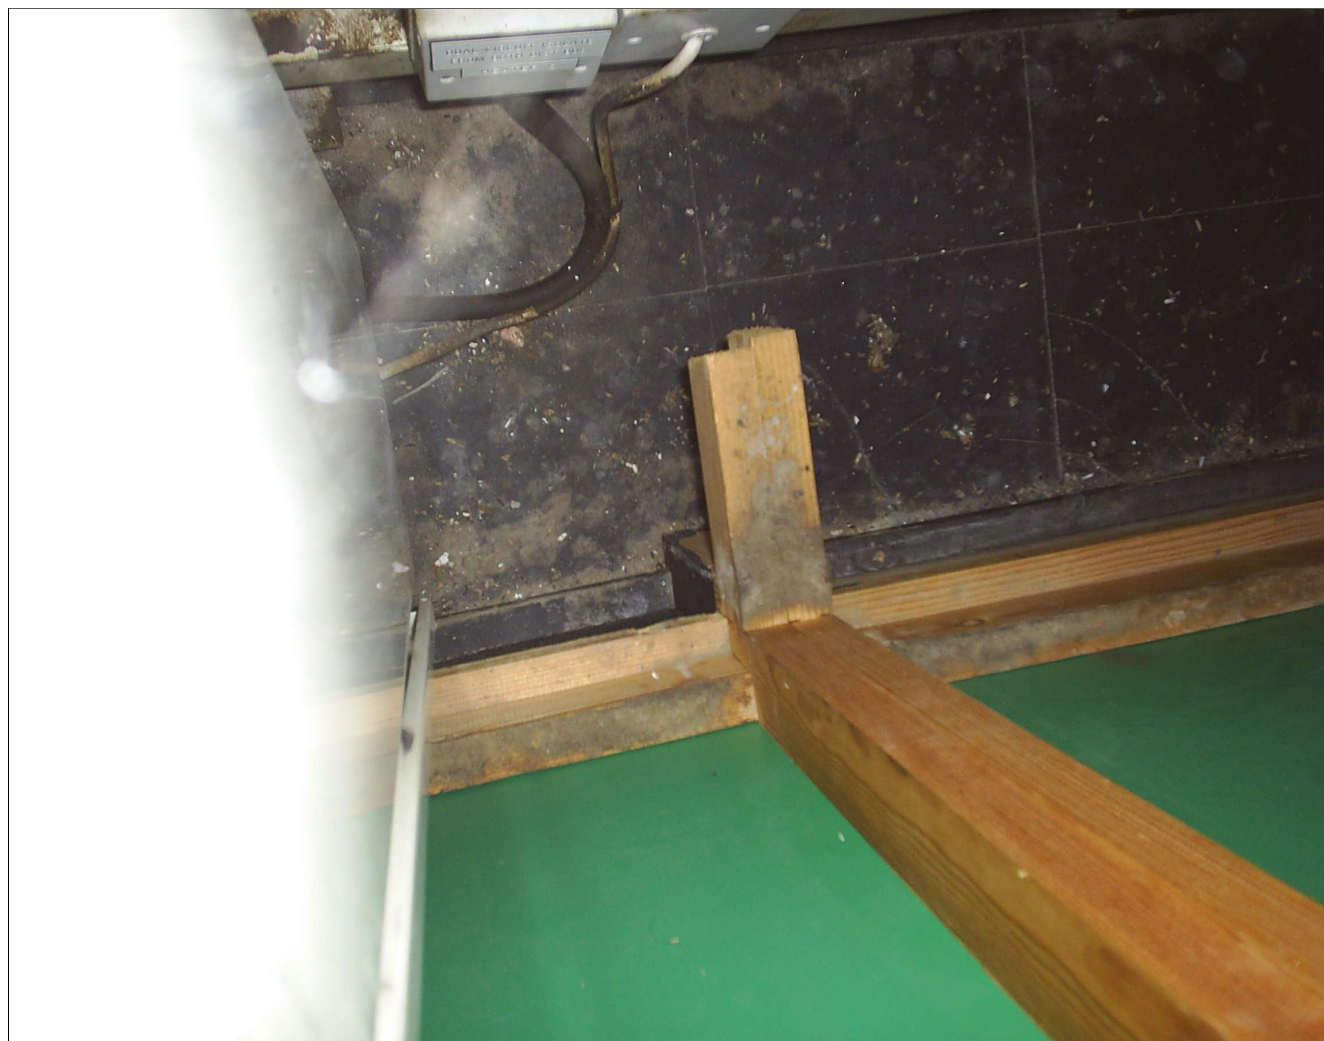
Photo No: 20

| Score 0-6 Low Risk Monitor | | Score 7-12 Medium Risk Monitor & Programme Works | Score 13-18 High Risk Monitor & Action Works | Score 19-24 Very High Risk Urgent Works | | | |
|---|---|---|---|---|---|---|---|
| 6 | COMMUNITY ROOM, BLOCK A, TRELICK TOWER GROUND MEETING ROOM & KITCHEN | FLOOR TILES BEHIND DUCTING | Sampled Chrysotile | 2 | 6 | 8 | Report, Record & Manage |

**Location:** FLOOR TILES BEHIND DUCTING

**Material: Sampled as Chrysotile**

Notes on sample: ASBESTOS CONTAINING FLOOR TILES.

**Recommendation: Report, Record & Manage**

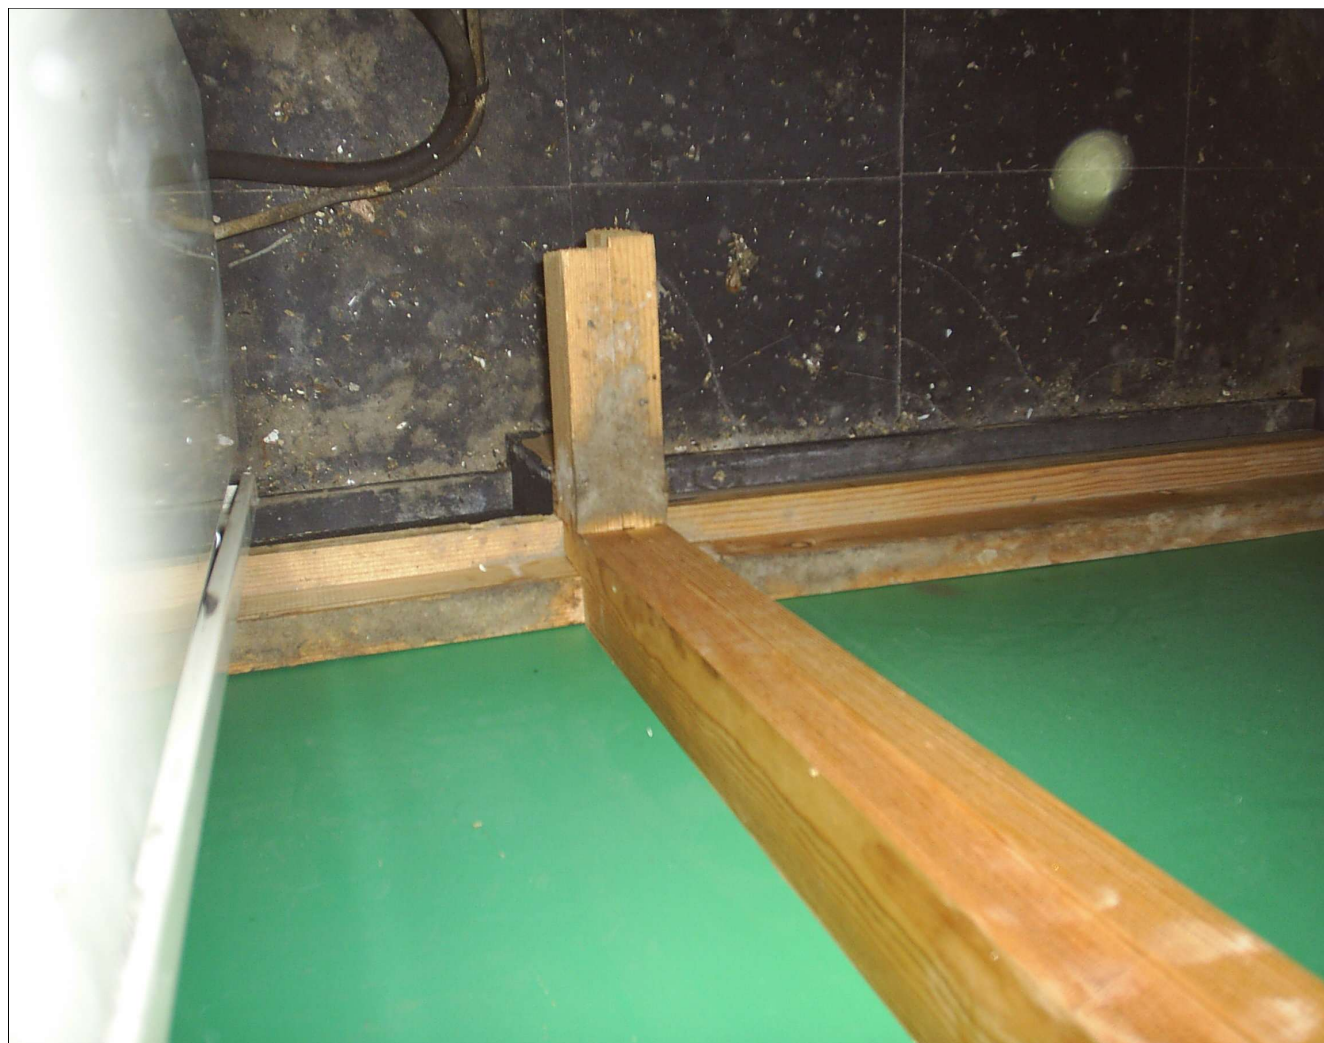
Photo No: 21

| Score 0-6 Low Risk Monitor | | Score 7-12 Medium Risk Monitor & Programme Works | Score 13-18 High Risk Monitor & Action Works | Score 19-24 Very High Risk Urgent Works | | | |
|---|---|---|---|---|---|---|---|
| 7 | COMMUNITY ROOM, BLOCK A, TRELICK TOWER GROUND MEETING ROOM & KITCHEN | BITUMEN UNDER LINO AND BEHIND DUCTING | Sampled Chrysotile | 2 | 6 | 8 | Report, Record & Manage |

**Location: BITUMEN UNDER LINO AND BEHIND DUCTING**

**Material: Sampled as Chrysotile**

Notes on sample: ASBESTOS CONTAINING BITUMEN.

**Recommendation: Report, Record & Manage**

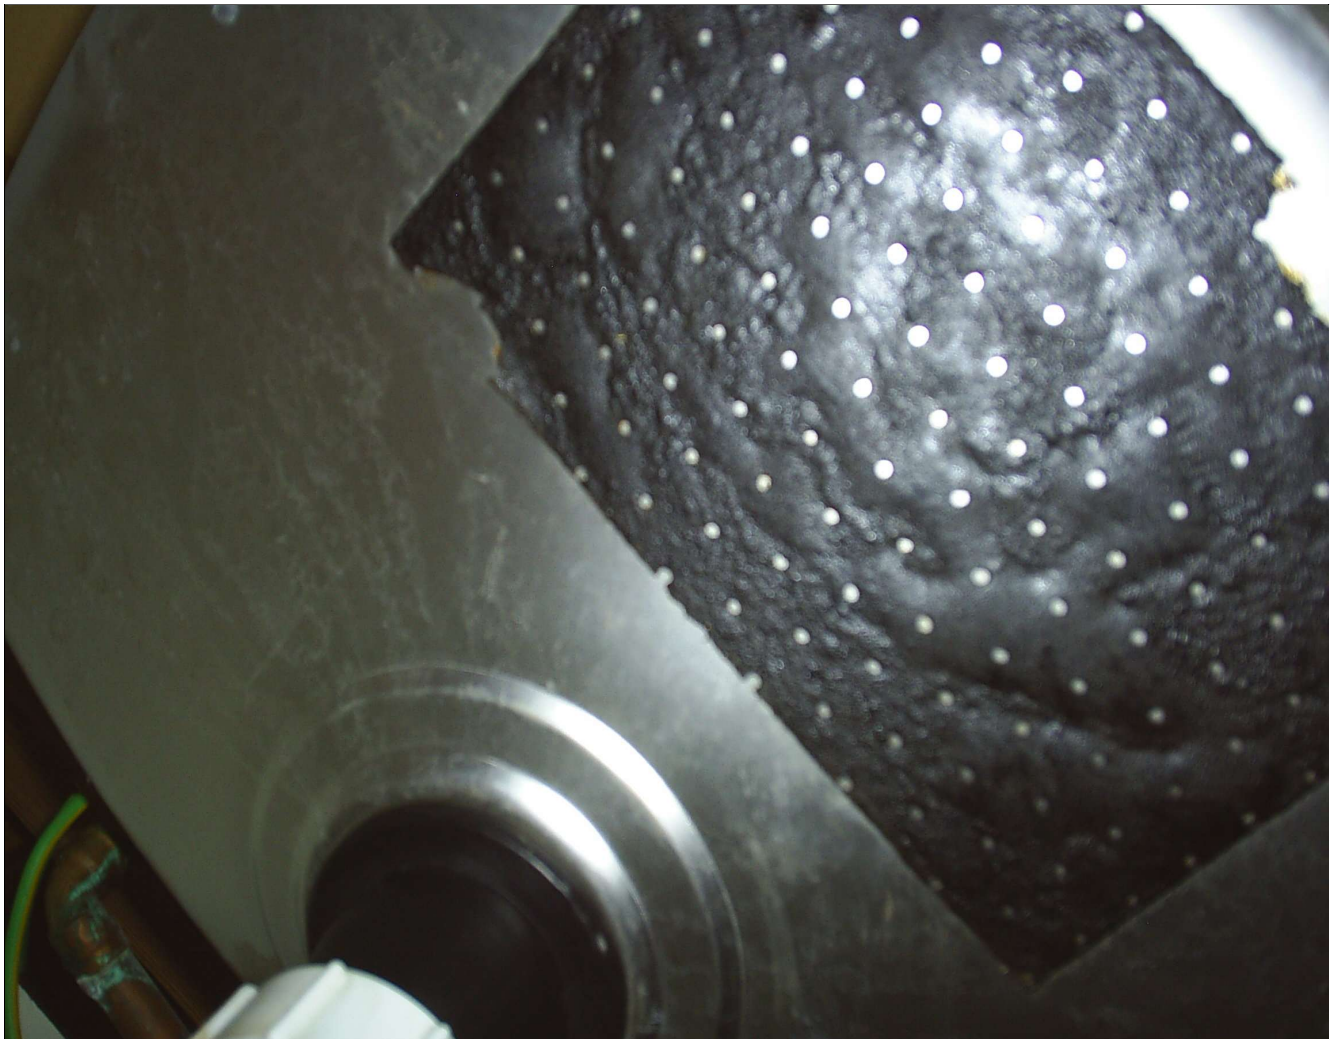
Photo No: 22

**Location: UNDERSINK PAD**

**Material: Sampled as No Asbestos Detected**

Notes on sample: NON ASBESTOS UNDERSINK PAD.

**Recommendation: No Action Required**

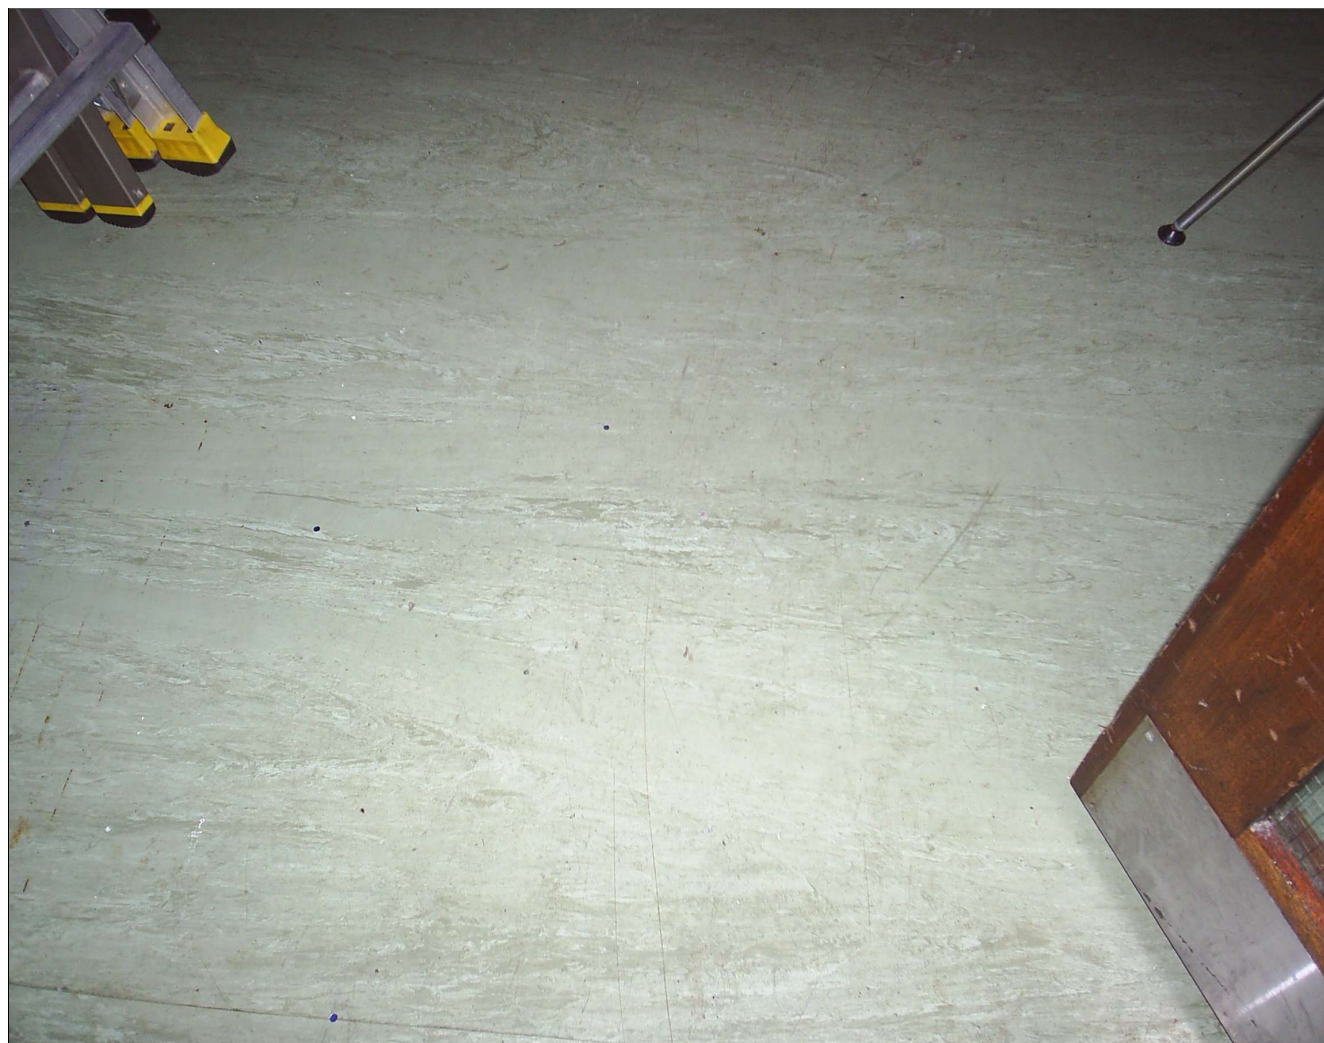
Photo No: 23

| Score 0-6 Low Risk Monitor | | Score 7-12 Medium Risk Monitor & Programme Works | Score 13-18 High Risk Monitor & Action Works | Score 19-24 Very High Risk Urgent Works | | | |
|---|---|---|---|---|---|---|---|
| 9 | COMMUNITY ROOM, BLOCK A, TRELICK TOWER GROUND HALLWAY | BITUMEN UNDER LINO | Same as IPN 7 Chrysotile | 2 | 5 | 7 | Report, Record & Manage |

Location: BITUMEN UNDER LINO

**Material: Strongly presumed as Chrysotile**

Notes on sample: ASBESTOS CONTAINING BITUMEN.

**Recommendation: Report, Record & Manage**
