**DALCOUR MACLAREN  
ENVIRONMENT AGENCY – PINKHILL LOCK HOUSE**

**STRUCTURAL ENGINEER'S REPORT  
ON CRACKED WALLS**

6<sup>th</sup> June 2017

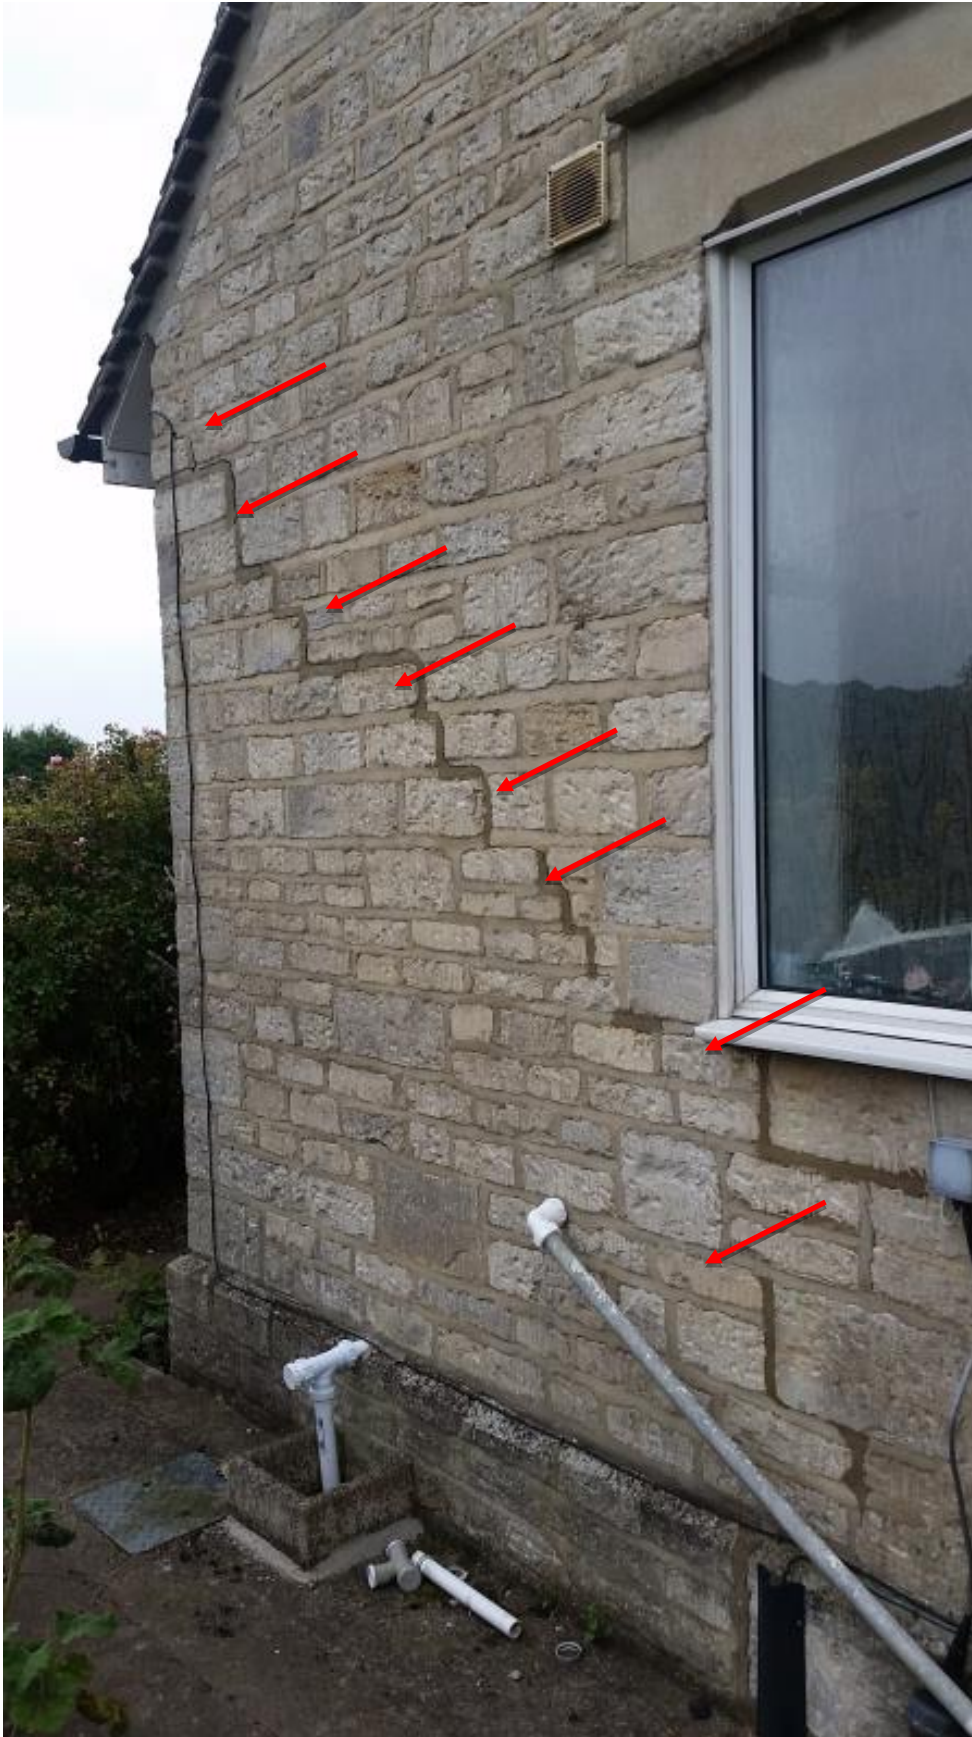
- On the north elevation there is a tapered diagonal crack running from ground level up to eaves level. This is wider at the top than at the bottom.
- The diagonal crack is not visible internally as the wall had recently been covered with new bathroom tiles at the time of inspection.

- The cracking observed in the infill extension walls is consistent with that caused by subsidence of the foundations. The subsidence has occurred because the infill walls are founded 1300mm below ground level (bgl) on Firm Clay which is shallower than the foundation for the original main building. These are at least 1600mm bgl but could be much deeper and will bear on firmer, probably original soils. Whoever built the extension took no recognition of the depth of the original house foundations.

- It was not possible to extend the trial pit to confirm the exact depth of foundation or soil type under the original building. The shallower soils at 1300mm are much more likely to be affected by changes in moisture content brought about by changes in ground water level, seasonal variations in rainfall and through the effect of tree roots. This is not necessarily shrinkage and heave but also softening of the soils due to their water content.

- It is not known if the subsidence is ongoing, accurate monitoring of the cracks would be required to verify this.
- The movement observed does not present an immediate risk to the building structure or its users however, if left unchecked it will eventually lead to an unstable situation. Cracks in the stone allow water to penetrate the structure, in winter this can allow freeze thaw action to occur which can degrade the underlying structure. In the long-term it is likely that underpinning of some form (traditional or piled) will be required to prevent further subsidence causing further differential movement.

Photo 5 – North elevation line of original house indicated by arrows.

- To verify if the subsidence is ongoing we recommend that accurate crack monitoring is carried out for a period of at least 6 months with readings taken once a month. If the monitoring proves the movement has stopped then the crack can be repaired. If the monitoring proves the movement is ongoing then we recommend the following:

- **Option 1** - If the Environment Agency takes the long-term view, underpinning of the infill extension should be carried out immediately to prevent the subsidence of the extension relative to the main building. Once the underpinning has been completed the repairs to the cracked masonry can be carried out.

- **Option 2** - If the Environment Agency would prefer to avoid the expense of the works now, they can be put off without significant risk to the structure or its inhabitants. Only the repairs to the cracked masonry need to be carried out immediately. It should be noted that it is likely the cracks will reform in the repaired masonry and ongoing movement could affect the internal finishes. The time it takes for the cracks to reform depends on the rate of differential movement which we do not know at this time. If this option is chosen it will be necessary to regularly monitor the cracking to determine the time when underpinning becomes necessary. The longer the cracks are left the more effort will be required to carry out the repairs.

- We recommend that the underpinning of the rear extension is carried out using traditional underpinning techniques (mass concrete 3 bay hit-miss-miss-hit sequence) which would extend the foundations to a similar depth as the original house to be founded on firm original ground. This method of underpinning is currently seen as preferable to piled underpinning techniques because the piled solution could lead to the infill walls being founded on stiffer material than the original house and a similar problem of differential settlement occurring with the main house moving relative to the infill.

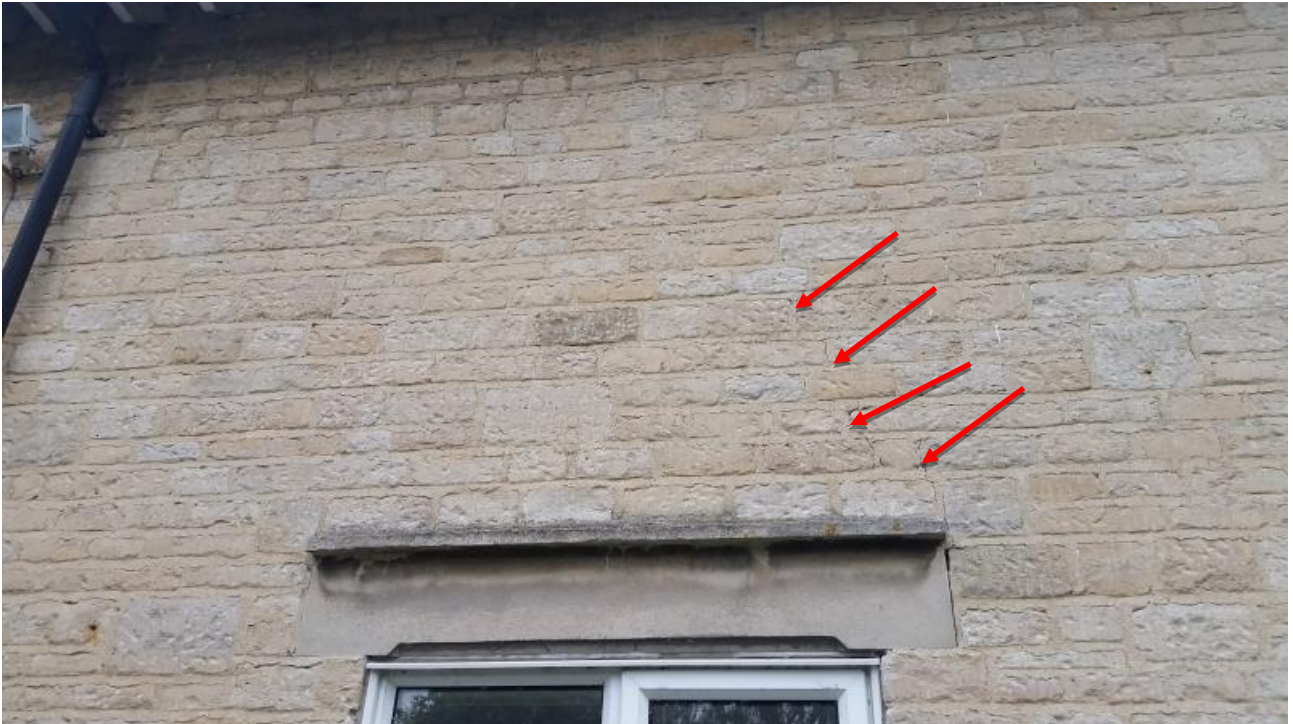
- There is a small diagonal crack in the outer stone masonry above the first floor window opening on the rear of the building.

- The cracking above the first floor window opening on the rear elevation is not structurally significant.

Photo 6 – Rear (west) elevation diagonal crack above first floor window opening.

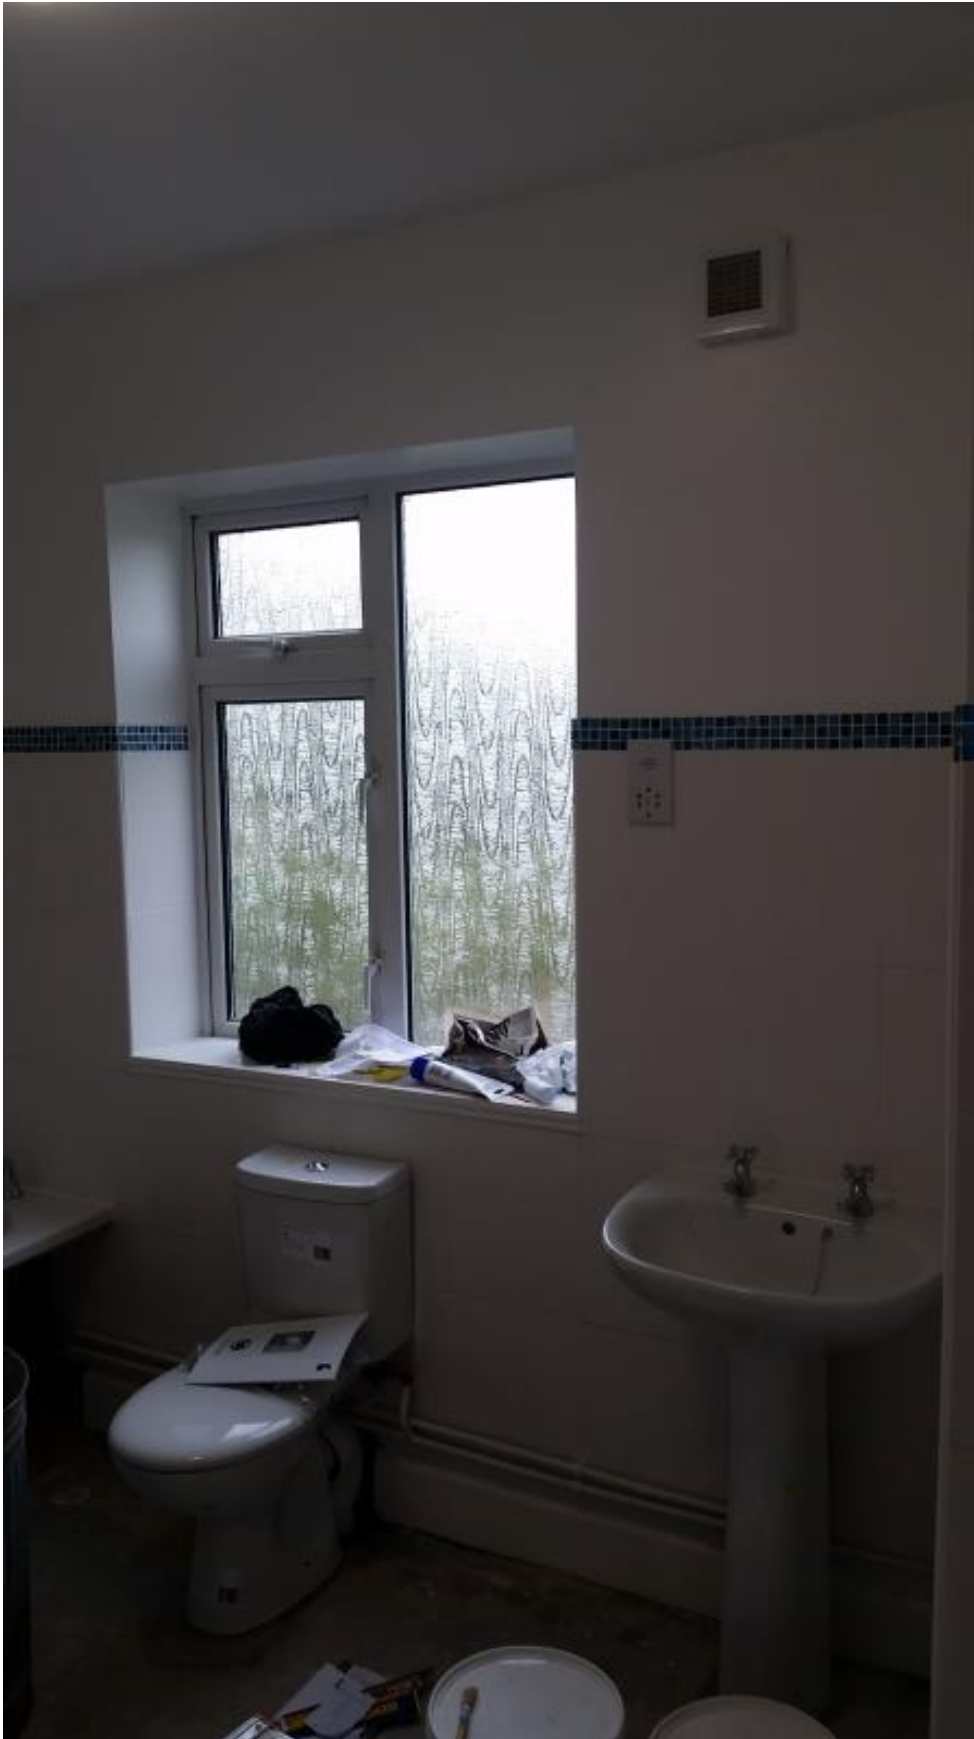
Photo 7 – Internal view of wall shown in Photo 5, any evidence of cracking is masked by the new tiles.

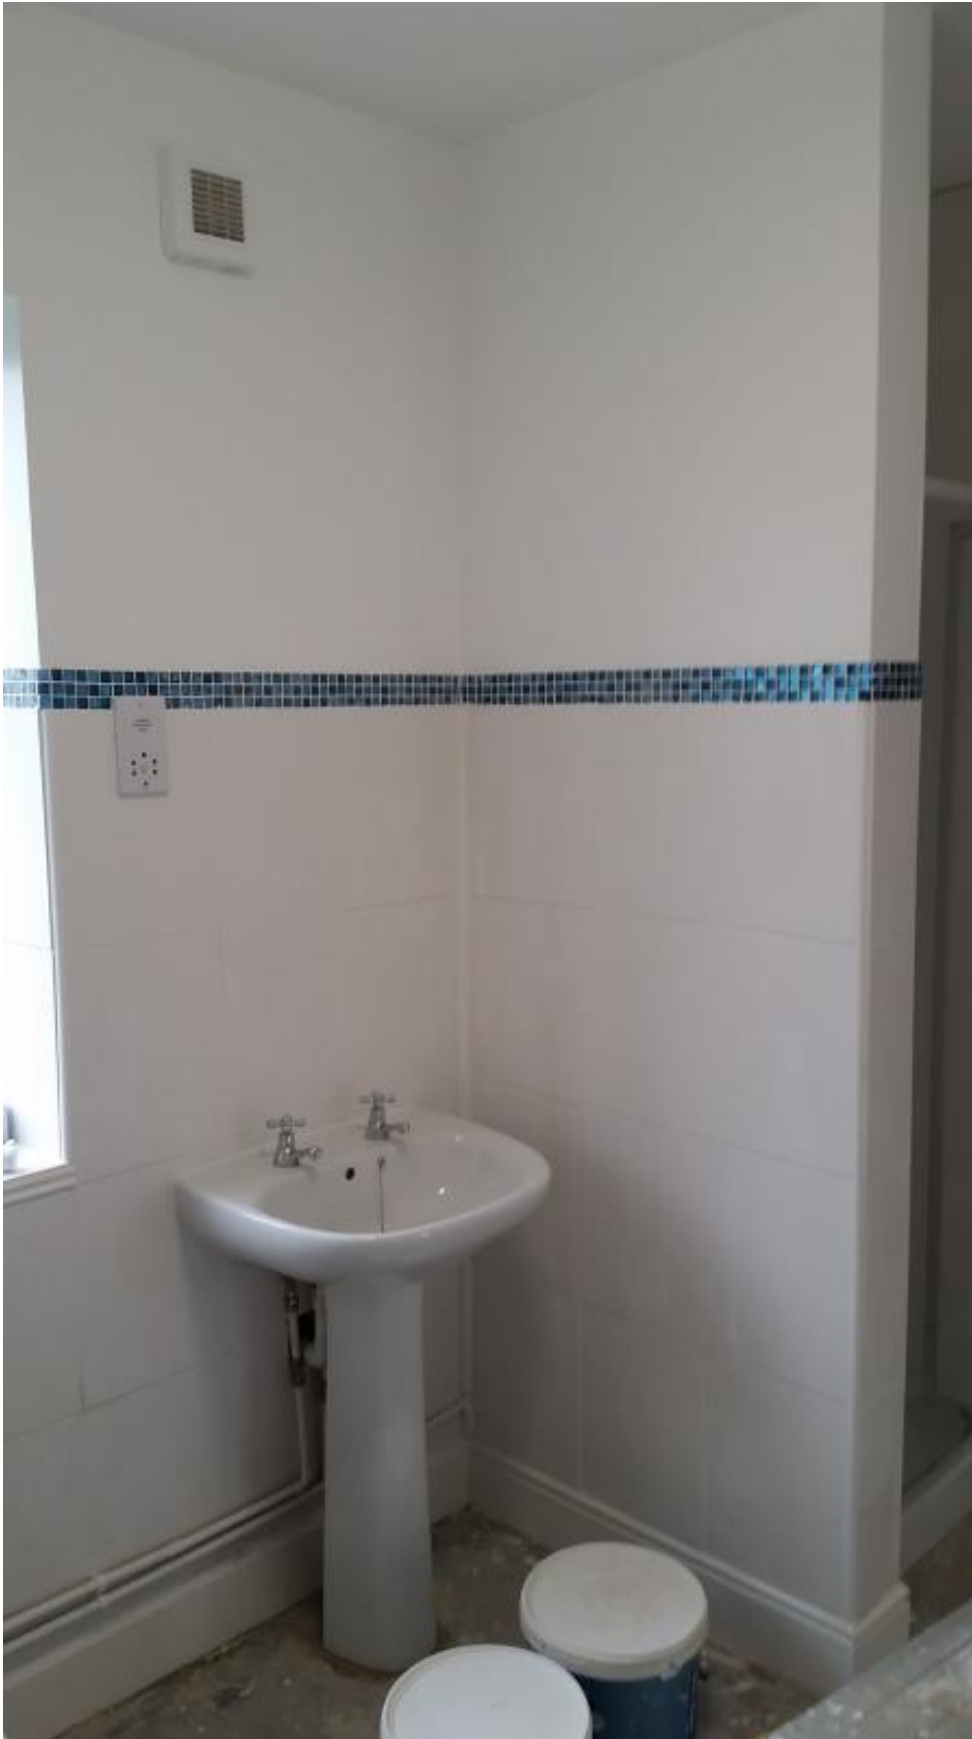
**Photo 8 – Internal view of wall shown in Photo 5, any evidence of cracking is masked by the new tiles.**

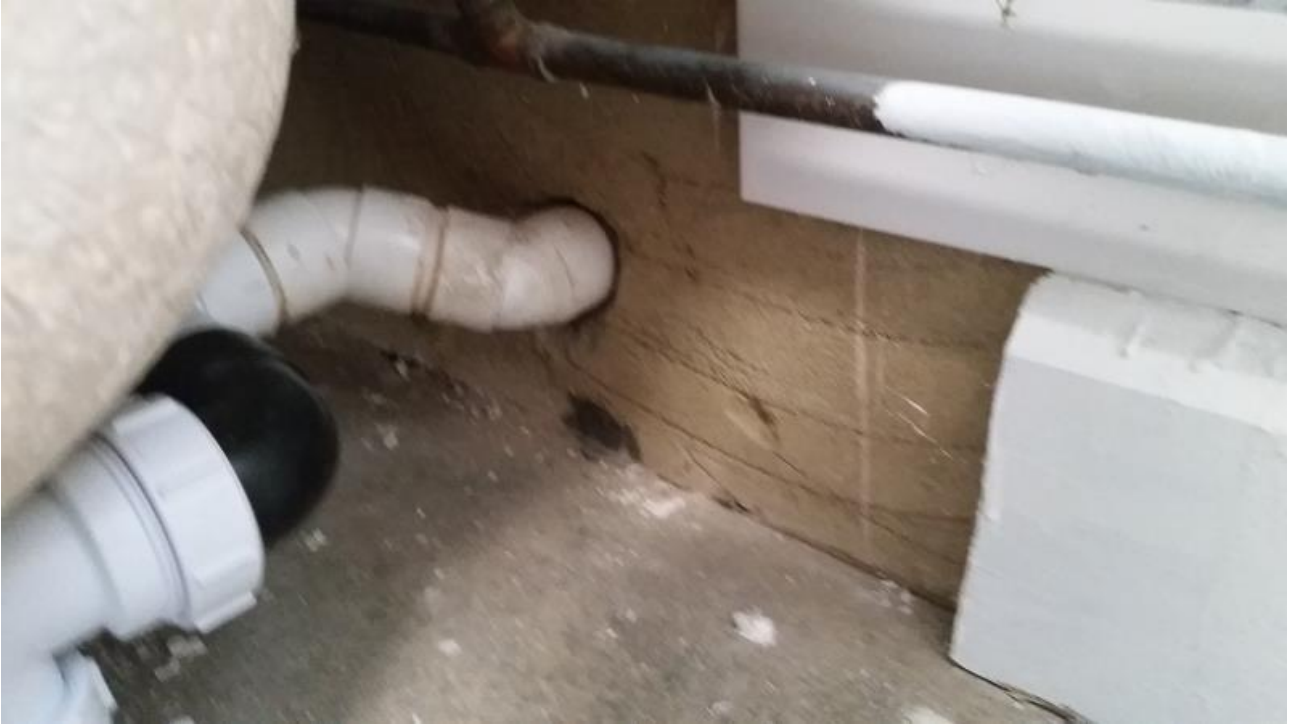
- The infill walls are a cavity construction with a blockwork inner leaf and natural stone masonry outer leaf.
- Trial pit TP01 had to be abandoned because the below ground services prevented it from being extended deep enough to encounter original foundation. It did however uncover the top of the concrete foundation to the new infill.

**Photo 9 – Exposed blockwork inner leaf visible below bath.**

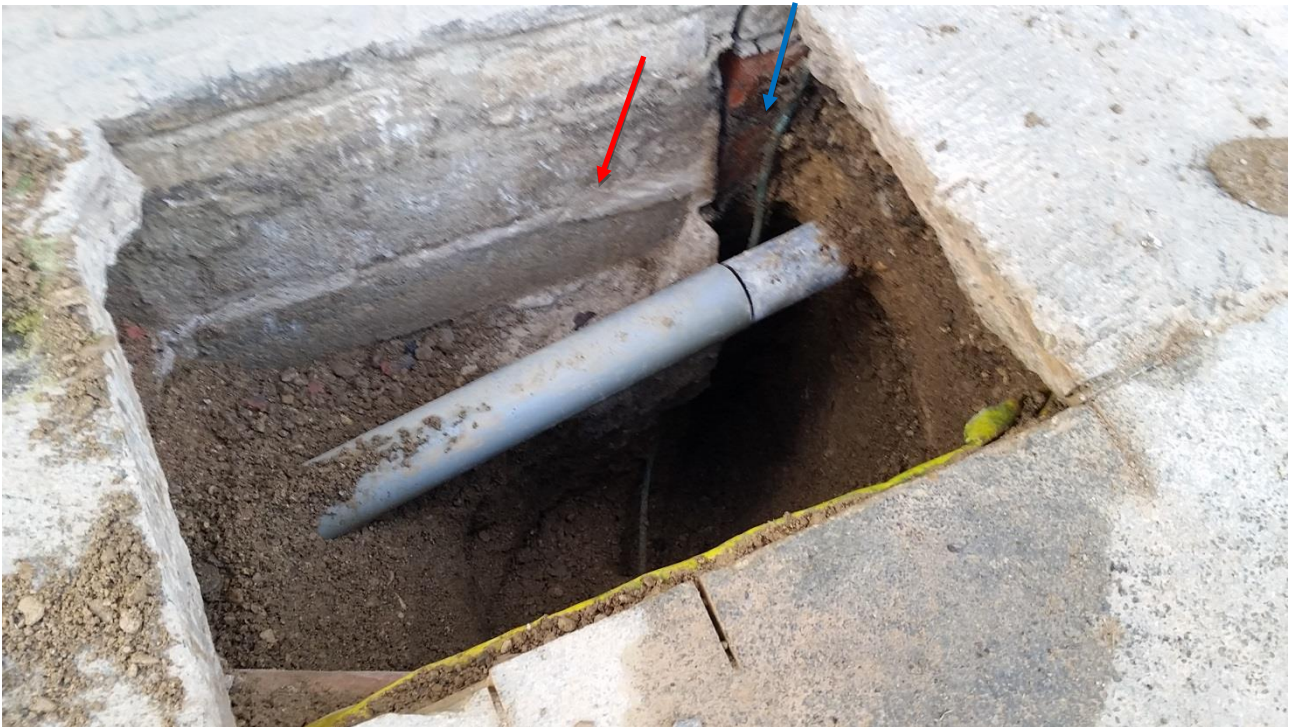
Photo 11 – View of Trial Pit TP01 red arrow is new foundation, blue arrow is original wall.

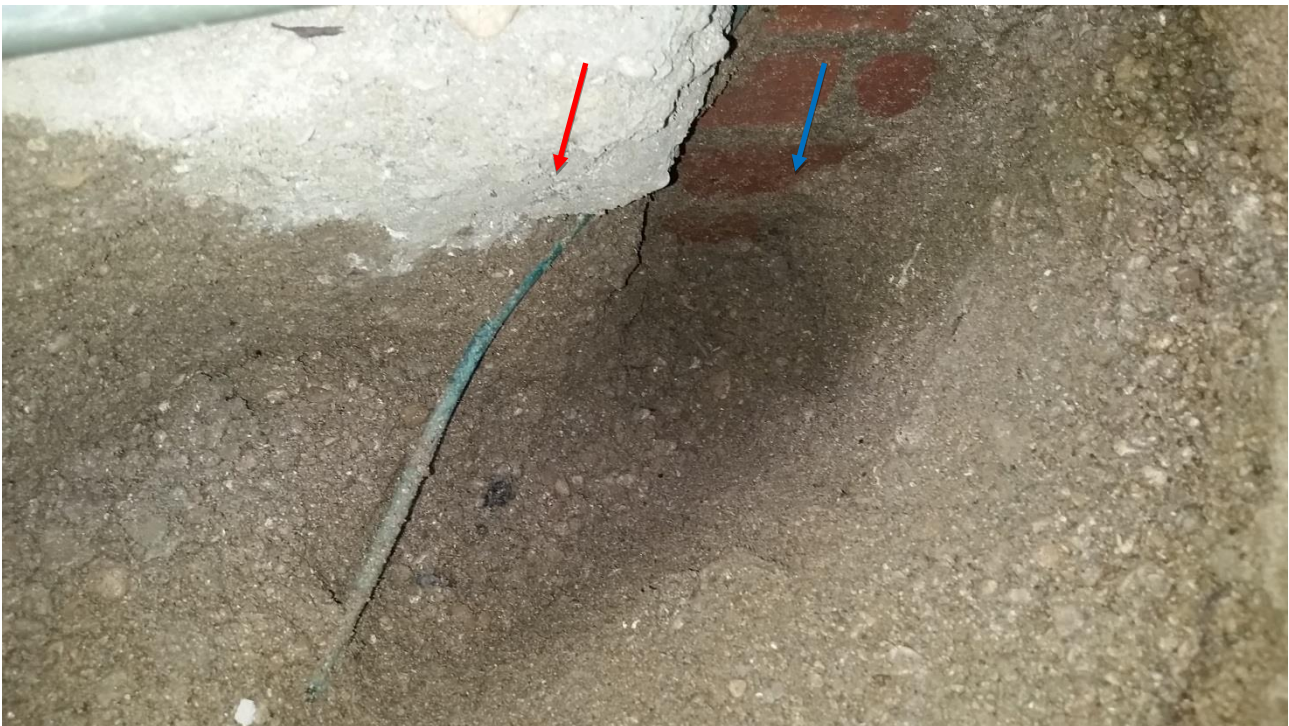
Photo 12 – View of Trial Pit TP01 red arrow is new foundation, blue arrow is original wall.

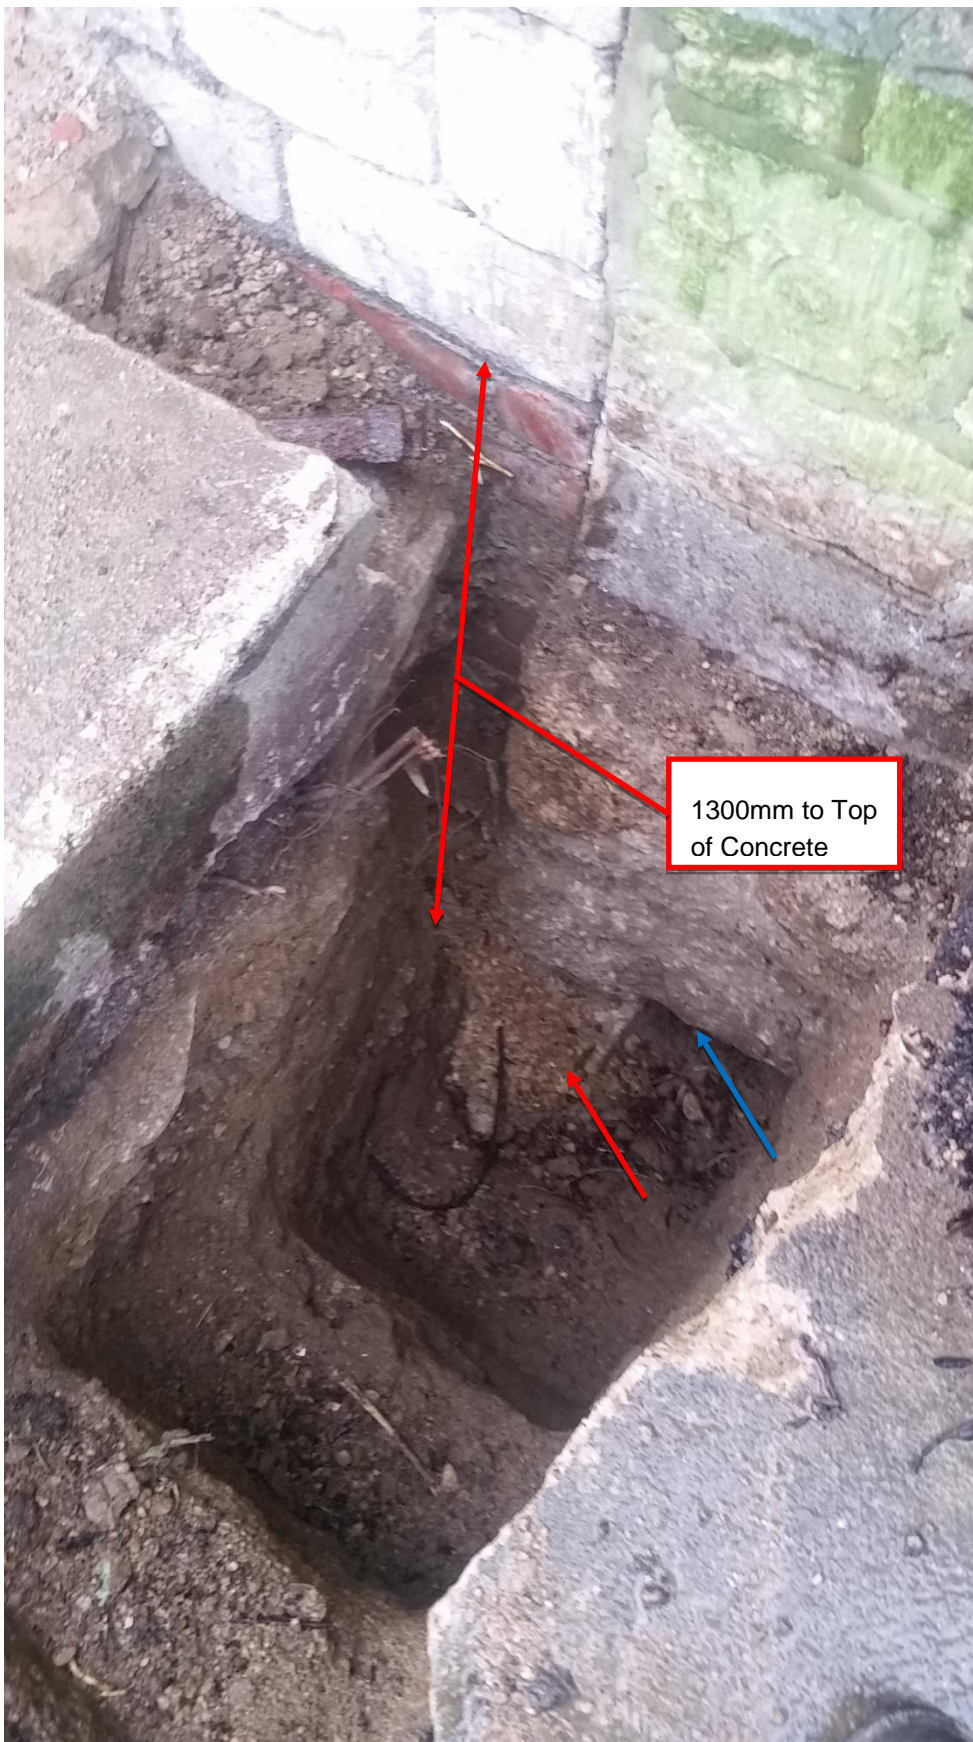
- Trial Pit TP02 shows the foundation for the original house consists of a concrete strip footing which is at least 600mm wide and founded more than 1600mm below ground level. It was not possible to extend the trial pit deep enough to prove the underside of the foundations to the original house.

- Trial Pit TP02 also shows that the foundation for the new infill walls consist of a concrete strip footing which is at least 600mm and founded at 1300mm below ground level. This founding level coincides with the top of the original foundation. Firm Clay soil was observed below the new foundation which was dry and brittle with signs of roots.

Photo 13 – Trial pit TP02 on front (east) elevation adjacent to front door, red arrow is top of original foundation blue arrow is underside of new foundation.

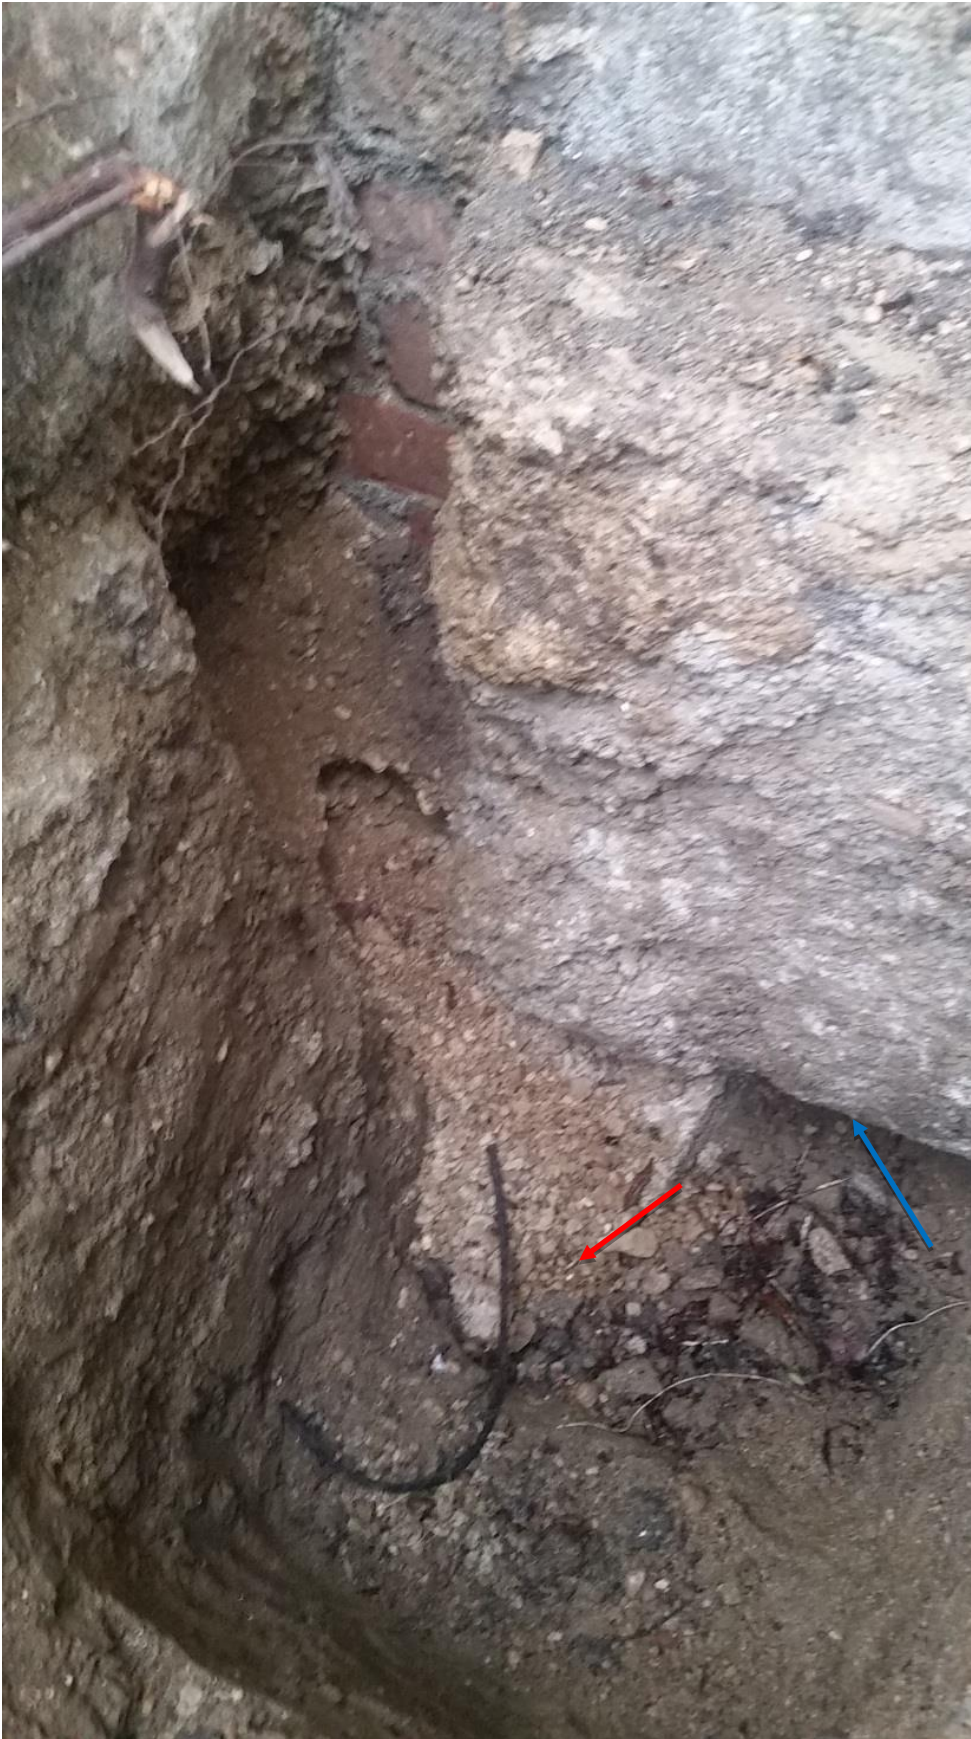
Photo 14 – Trial pit TP02 on front (east) elevation adjacent to front door, red arrow is top of original foundation blue arrow is underside of new foundation.

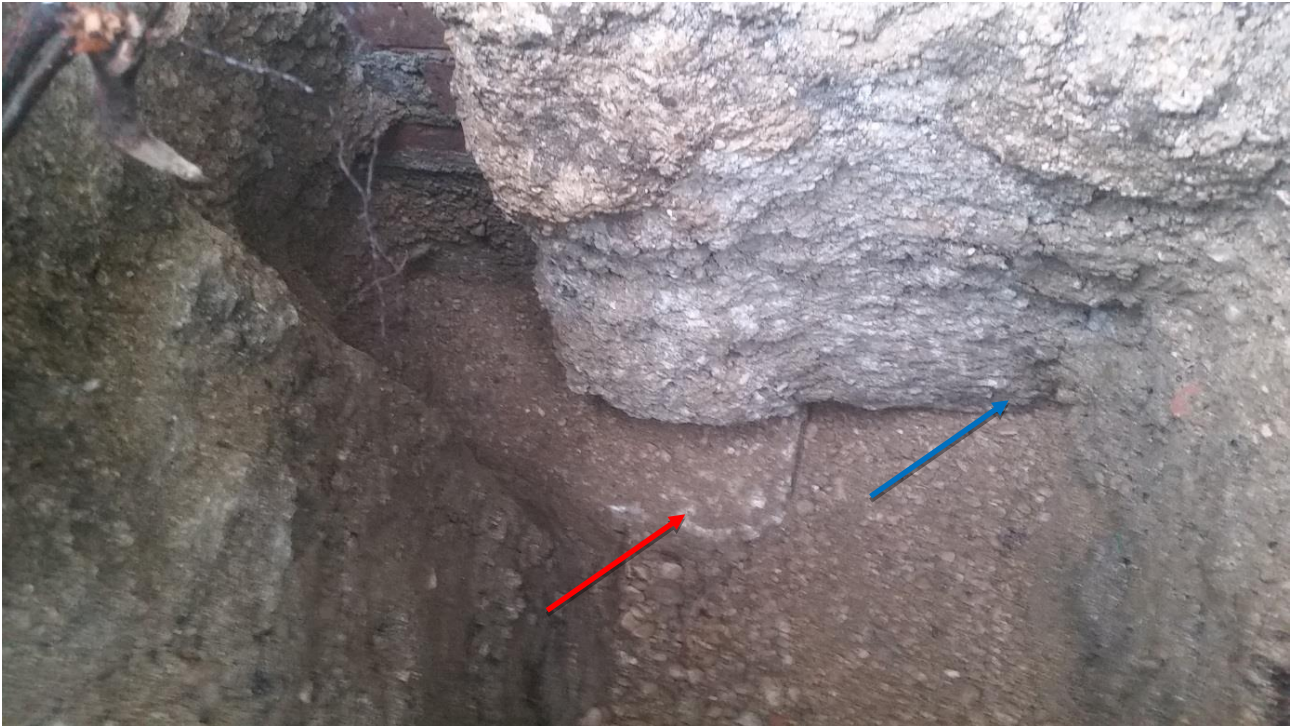
Photo 15 – Trial pit TP02 on front (east) elevation, red arrow is top of original foundation blue arrow is underside of new foundation.
