## **ASBESTOS REFURBISHMENT SURVEY REPORT**

**Basset Community Centre**  
Basset Road, Camborne TR14 8SL

Merit Report J3070a

Issue Date: 22<sup>nd</sup> February 2023

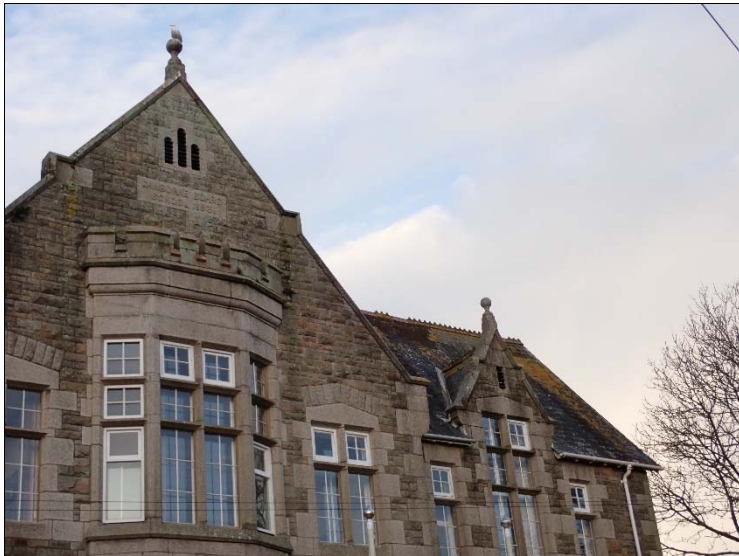
Photo Number	4	Sample Reference	S06
	Plan Ref	External		
	Location	Main Building		
	Position / Description	Asbestos Cement replacement roof tiles		
	Note / Comments	Manage and re-inspect or remove by an Unlicensed Asbestos Removal Contractor who has the appropriate insurance, training and following a safe system of work

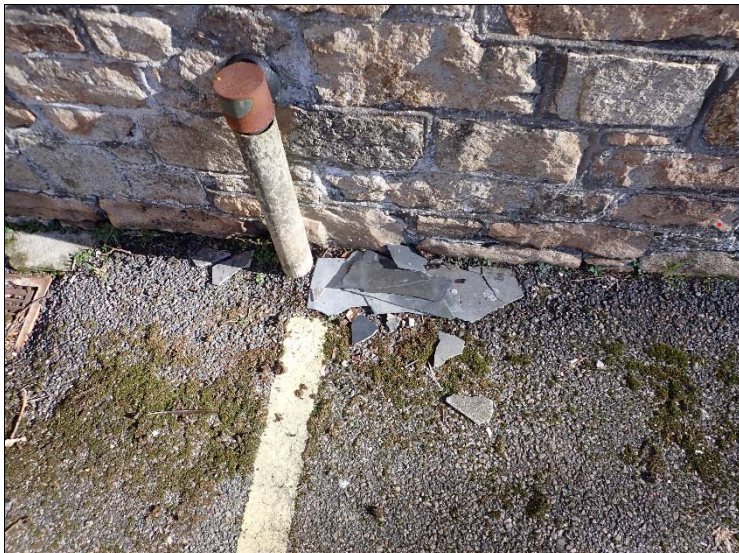
Photo Number	5	Sample Reference	AWS06
	Plan Ref	External		
	Location	Main Building		
	Position / Description	Asbestos Cement roof tile debris		
	Note / Comments	Remove by an Unlicensed Asbestos Removal Contractor who has the appropriate insurance, training and following a safe system of work

Locations	Comments
<b>External – Asbestos Cement roof tile debris</b>	<b>The debris should be removed by an Unlicensed Asbestos Removal Contractor who has the appropriate insurance, training and following a safe system of work</b>

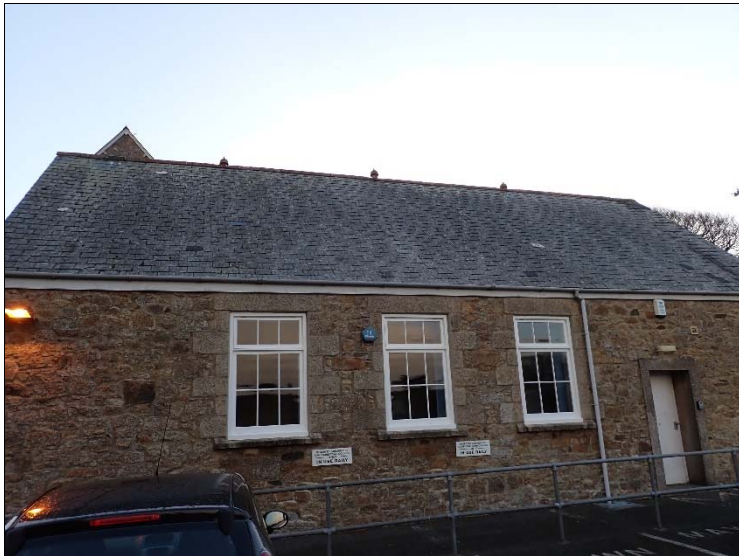
Photo Number	7	Sample Reference	S06
	Plan Ref	External		
	Location	-		
	Position / Description	Asbestos Cement replacement roof tiles		
	Note / Comments	Manage and re-inspect or remove by an Unlicensed Asbestos Removal Contractor who has the appropriate insurance, training and following a safe system of work

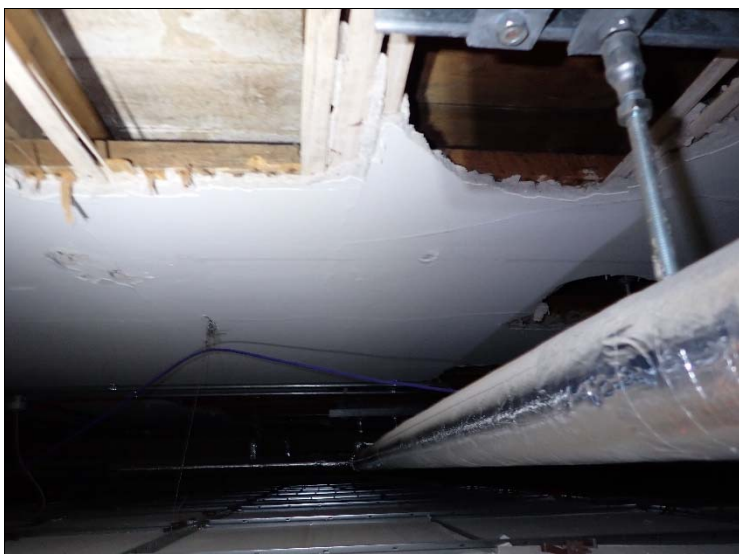
Photo Number	9	Sample Reference	For reference
	Plan Ref	GF01		
	Location	Office		
	Position / Description	Ceiling void		
	Note / Comments	No Action Required

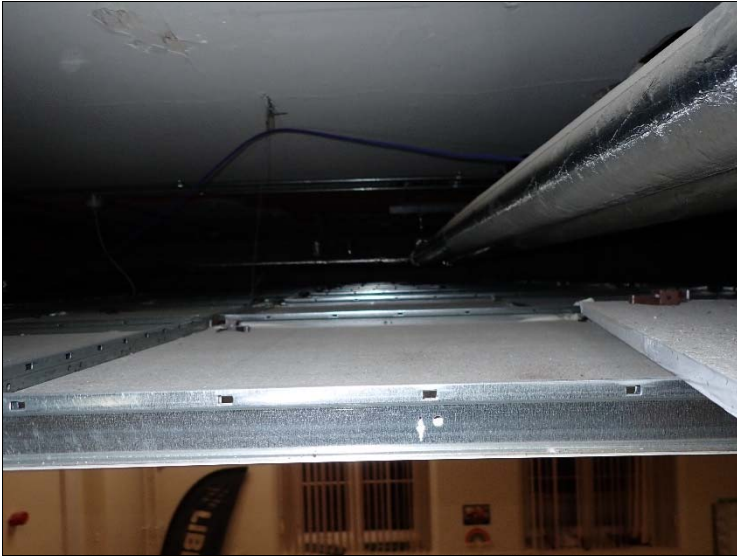
Photo Number	10	Sample Reference	For reference
	Plan Ref	GF01		
	Location	Office		
	Position / Description	Ceiling void		
	Note / Comments	No Action Required

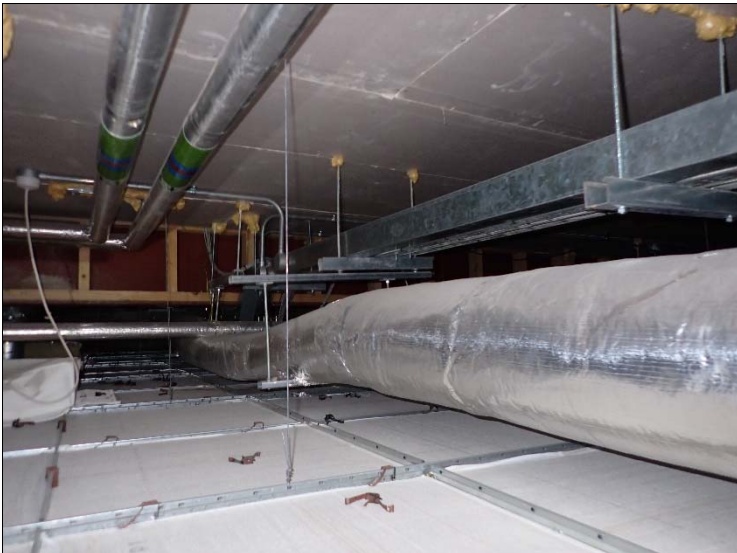
Photo Number	11	Sample Reference	For reference
	Plan Ref	GF06		
	Location	Library		
	Position / Description	Ceiling void		
	Note / Comments	No Action Required

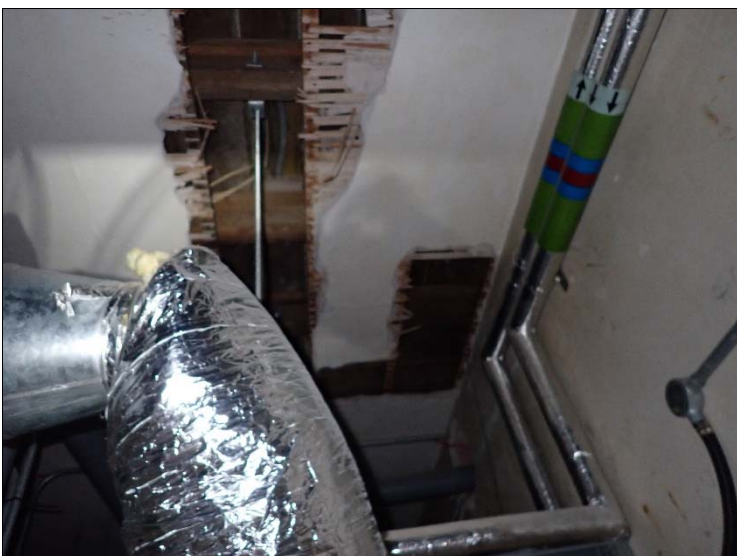
Photo Number	12	Sample Reference	For reference
	Plan Ref	GF08		
	Location	Lobby		
	Position / Description	Ceiling void		
	Note / Comments	No Action Required

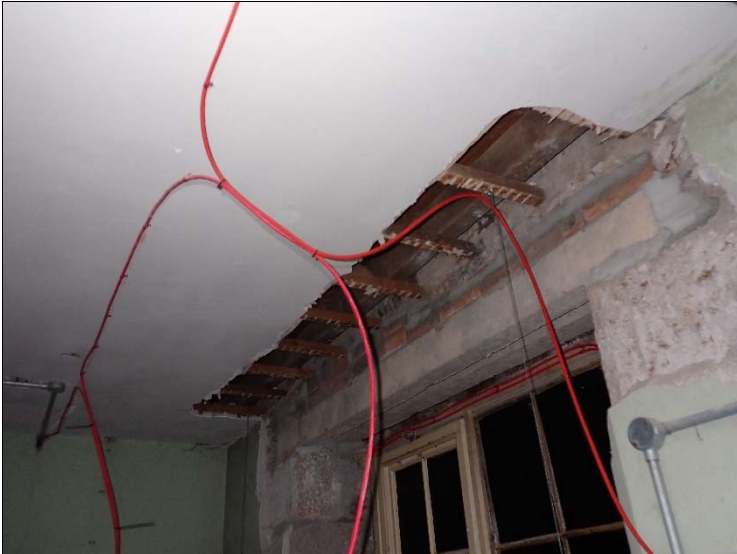
Photo Number	13	Sample Reference	For reference
	Plan Ref	GF10		
	Location	Interview Room		
	Position / Description	Ceiling void		
	Note / Comments	No Action Required

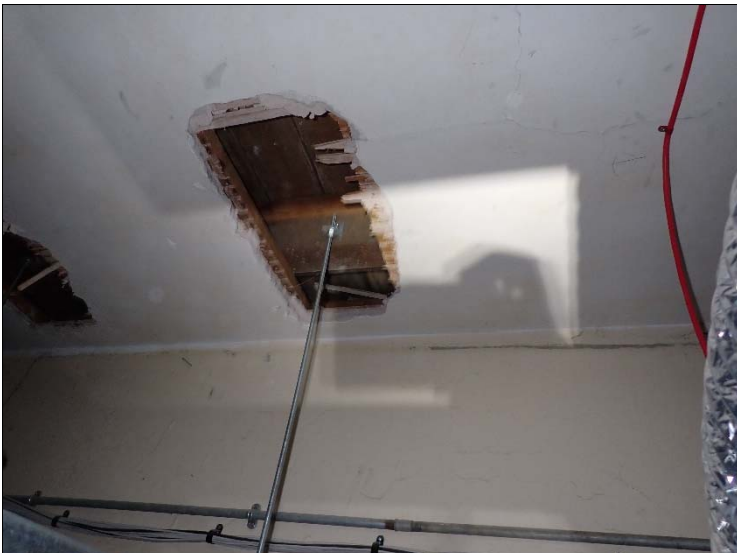
Photo Number	14	Sample Reference	For reference
	Plan Ref	GF14		
	Location	W.C.		
	Position / Description	Ceiling void		
	Note / Comments	No Action Required

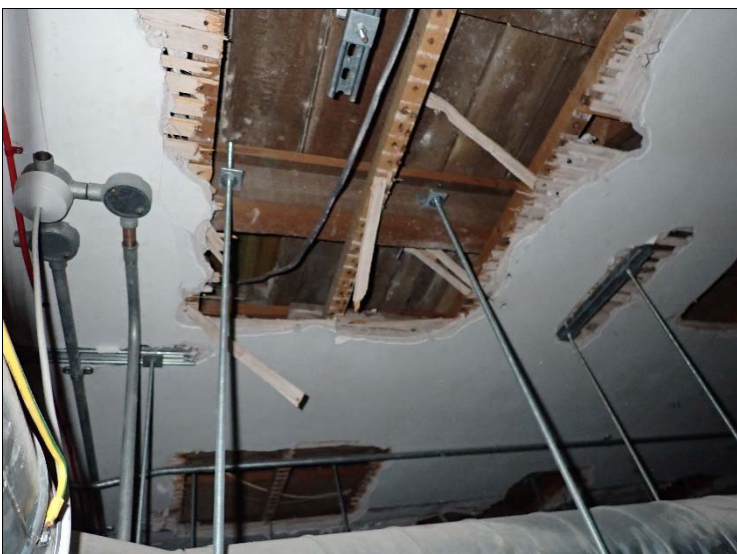
Photo Number	15	Sample Reference	For reference
	Plan Ref	GF14		
	Location	W.C.		
	Position / Description	Ceiling void		
	Note / Comments	No Action Required

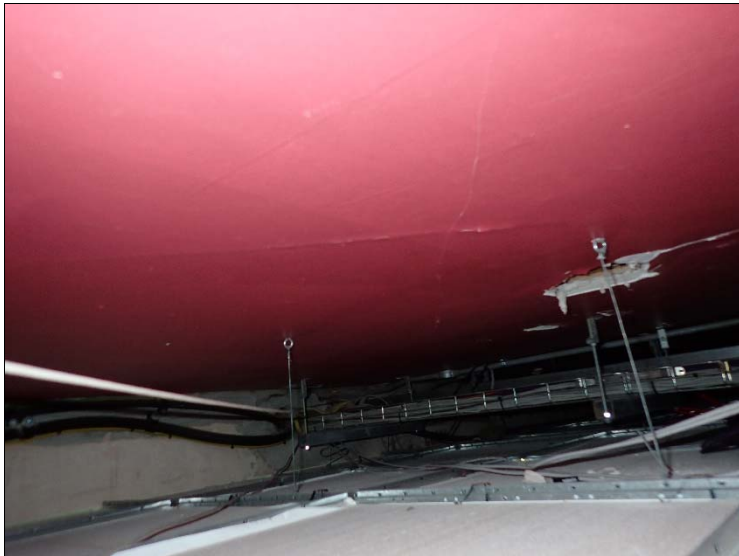
Photo Number	16	Sample Reference	For reference
	Plan Ref	GF23		
	Location	Meeting Room		
	Position / Description	Ceiling void		
	Note / Comments	No Action Required

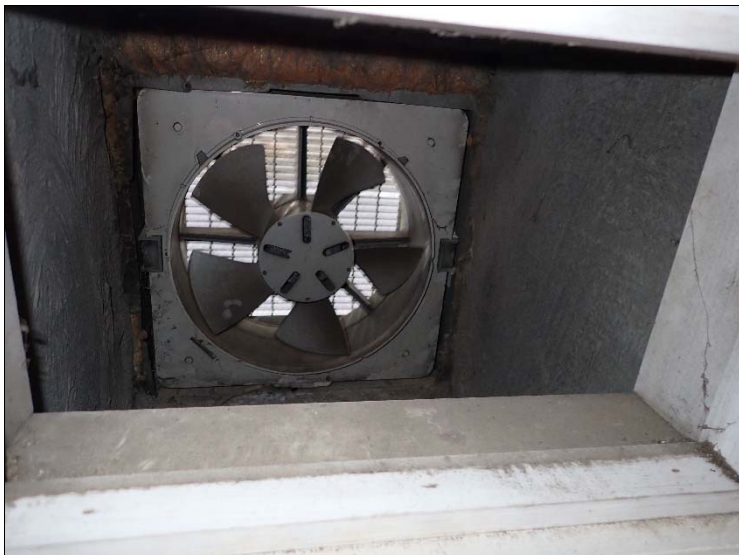
Photo Number	17	Sample Reference	For reference
	Plan Ref	GF30		
	Location	Store		
	Position / Description	Ceiling void		
	Note / Comments	No Action Required

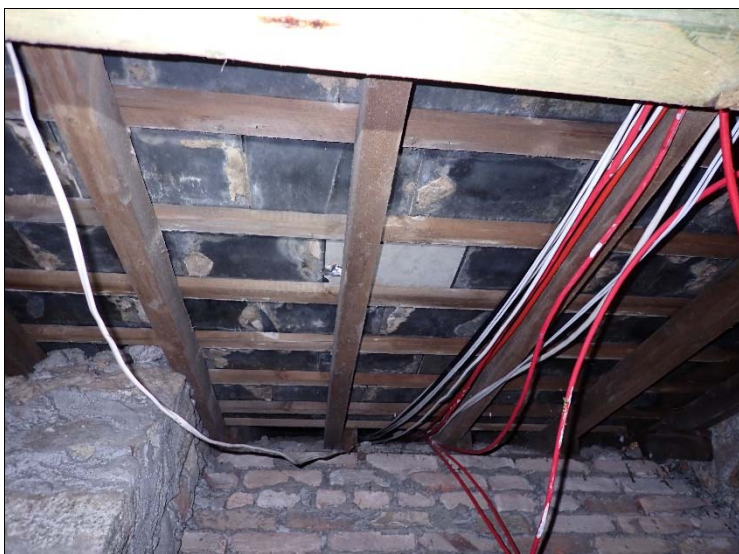
Photo Number	21	Sample Reference	S01
	Plan Ref	Loft		
	Location	Accessed from 1F02 Store		
	Position / Description	Replacement roof tiles		
	Note / Comments	No Action Required

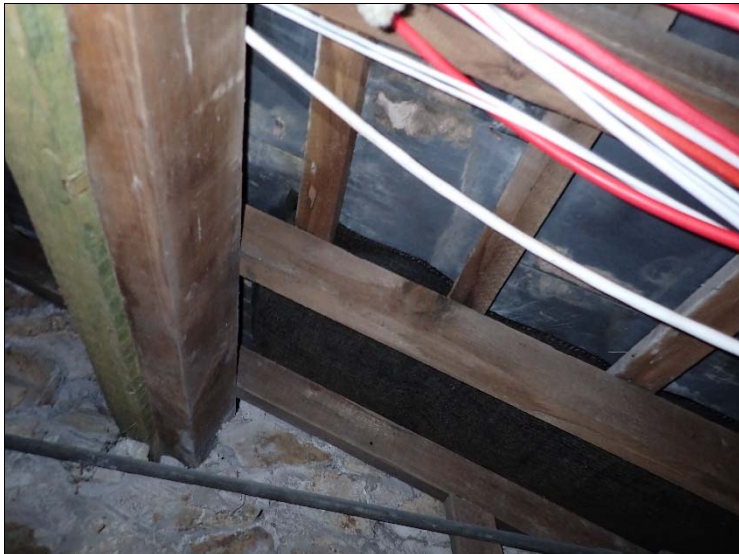
Photo Number	22	Sample Reference	S02
	Plan Ref	Loft		
	Location	Accessed from 1F02 Store		
	Position / Description	Roof felt		
	Note / Comments	No Action Required

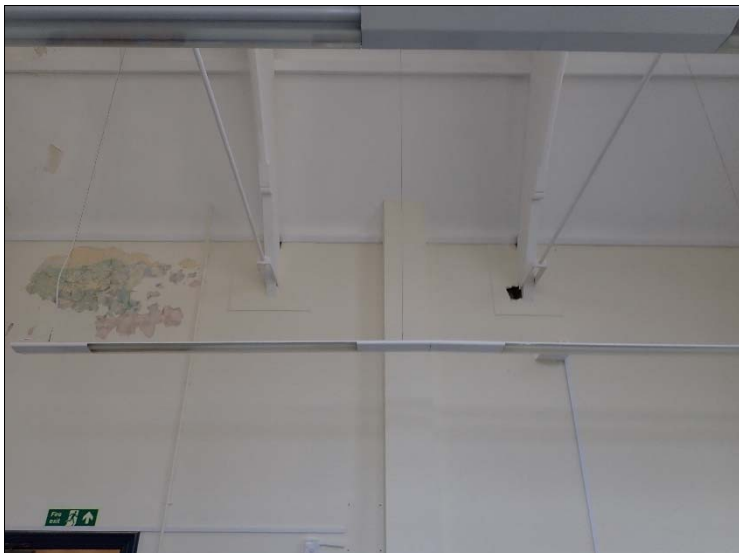
Photo Number	23	Sample Reference	For reference
	Plan Ref	1F09		
	Location	Office		
	Position / Description	Glass board panels around beams		
	Note / Comments	No Action Required

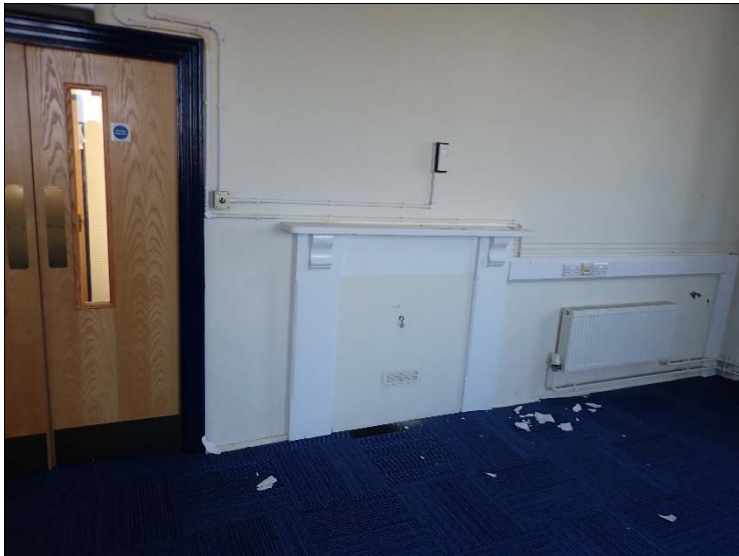
Photo Number	25	Sample Reference	For reference
	Plan Ref	1F10		
	Location	Office		
	Position / Description	Glass board panel to fireplace		
	Note / Comments	No Action Required

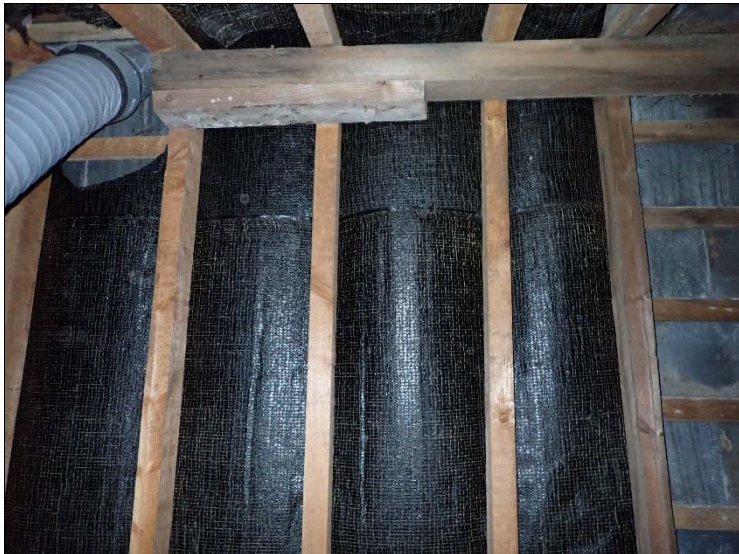
Photo Number	28	Sample Reference	AWS02
	Plan Ref	Loft		
	Location	Accessed from Void above W.C. 1F11		
	Position / Description	Roof felt		
	Note / Comments	No Action Required

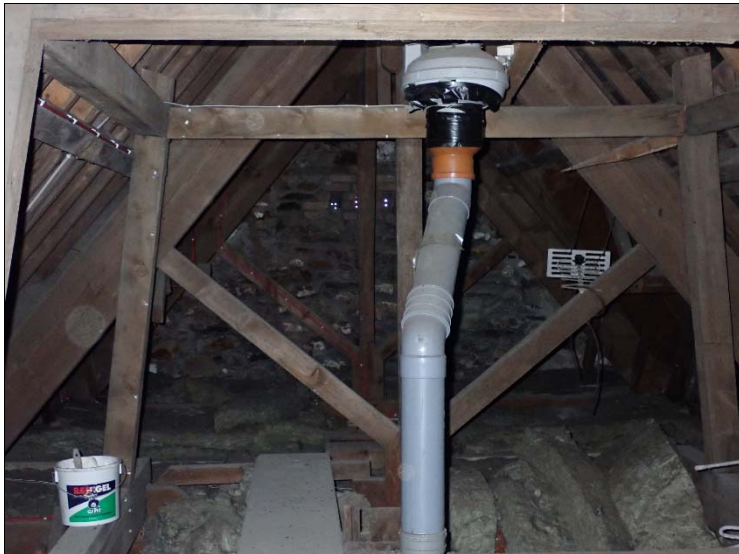
Photo Number	31	Sample Reference	For reference
	Plan Ref	Loft		
	Location	Accessed from Void above W.C. 1F11		
	Position / Description	-		
	Note / Comments	No Action Required

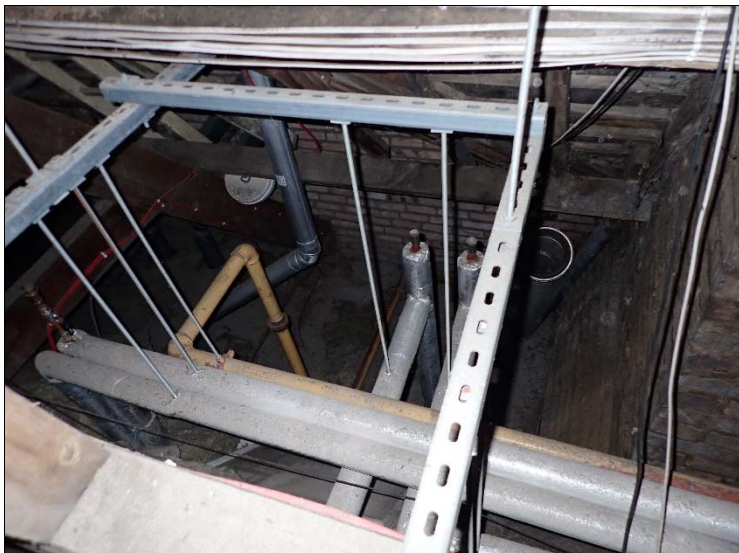
Photo Number	32	Sample Reference	For reference
	Plan Ref	Loft		
	Location	Accessed from Void above W.C. 1F11		
	Position / Description	-		
	Note / Comments	No Action Required
