Project address: The Horniman Museum and Gardens
 South Boiler Room

Pre Construction Information

Project number	238350
Date	17 August 2017
Client	The Horniman Museum and Gardens

**South Boiler Room Asbestos Removal
PRE CONSTRUCTION INFORMATION**

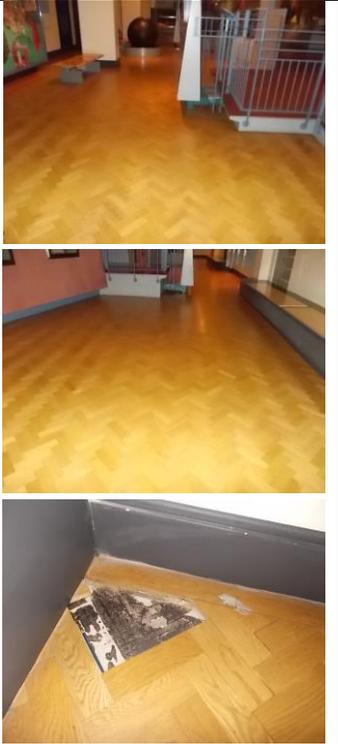
LG.01 South Hall Gallery	Bitumen product beneath the parquet flooring.	02	Non- asbestos	Bitumen	800m ²	Good Condition	Composite	N/A

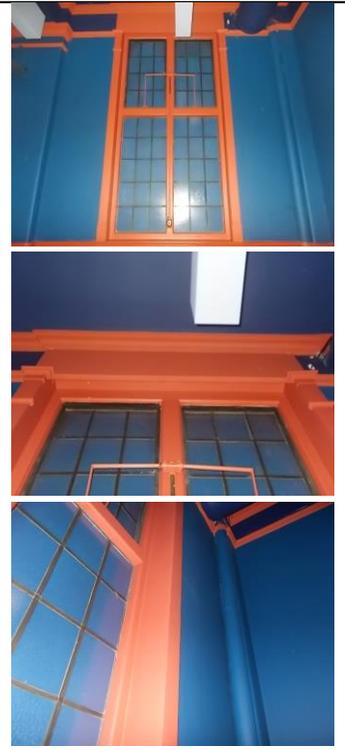
LG.03 Studio Space	Sealant behind the lead trim to the timber window frames.	10	Non- asbestos	Sealant	4m	Good Condition	Composite	N/A

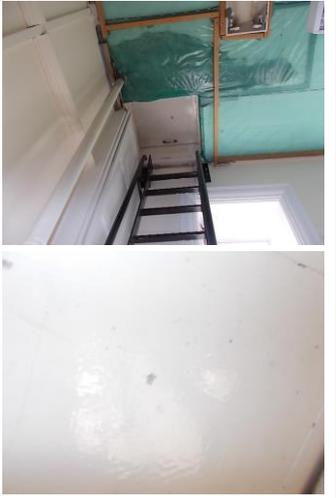
1.02 Office	Loft hatch insulating board.	05	Amosite Chrysotile	Insulating Board	<1m ²	Low	Sealed	Remove

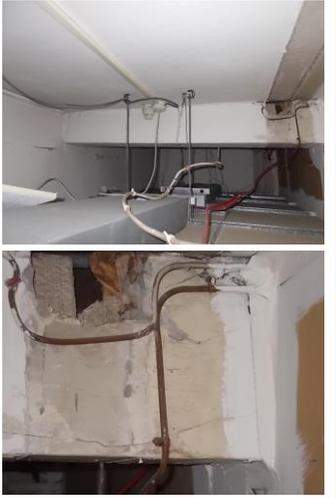
Room/Area	Observation/Comment	Inspection/ Sample No.	Analysis Result	Product	Quantity	Extent of Damage	Surface Treatment	Recommendation	Photo
1.03 Office and Lobby	Partly visualised which contains an RSJ beam. No access to the remaining solid casing to the ceiling due to causing significant damage. Further investigation required.	09	-	-	-	-	-	-

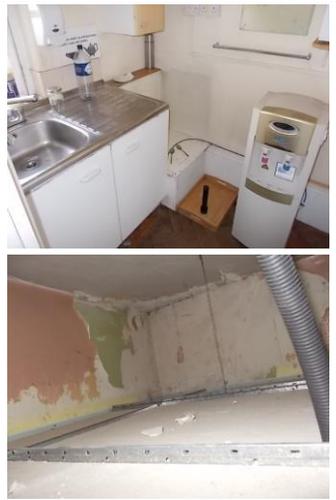
Room/Area	Observation/Comment	Inspection/ Sample No.	Analysis Result	Product	Quantity	Extent of Damage	Surface Treatment	Recommendation	Photo
1.05 Kitchen	Solid soffit ceiling and fibreboard suspended ceiling. Solid walls and timber parquet flooring. Timber boxing housing unlagged metal pipes. Kitchen sink unit. Timber door and glass header.	12	-	-	-	-	-	-

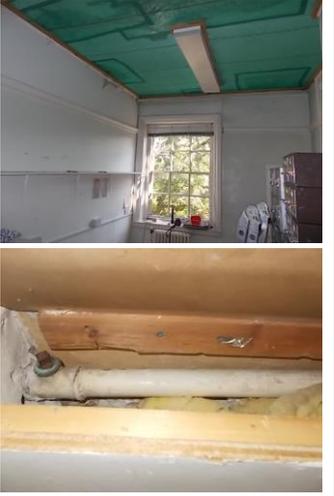
1.08 Office Room	Solid soffit ceiling, solid walls and timber parquet flooring. Bricked up chimney stack. Timber doors. Timber boxing with unlagged metal pipes and MMMF lagged metal pipes.	20	-	-	-	-	-	-

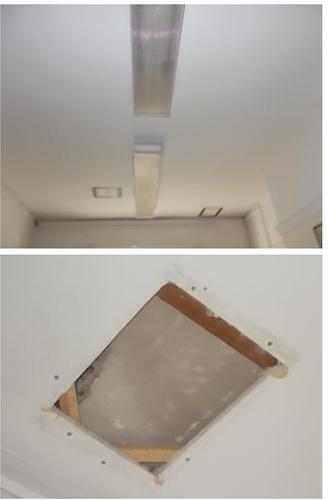
Room/Area	Observation/Comment	Inspection/ Sample No.	Analysis Result	Product	Quantity	Extent of Damage	Surface Treatment	Recommendation	Photo
1.10 Office	Clinker to the ceiling.	26	Non- asbestos	Cement	17m ²	Good Condition	Cement	N/A

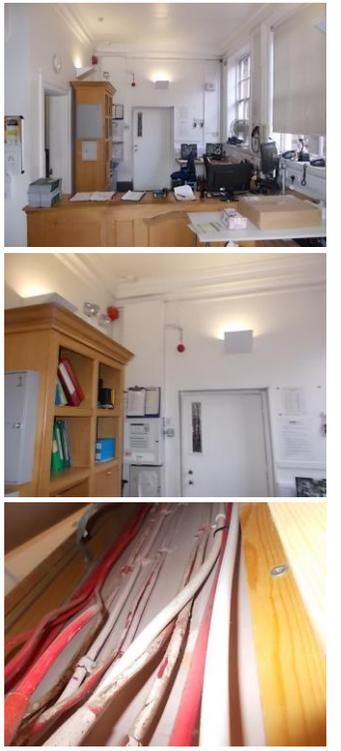
G.01 Reception	Clinker to the ceiling. Refer to sample 34 for analysis.	36R	Non- asbestos	Cement	20m ²	Low	Cement	N/A
