**3 Rainwater goods and disposal:**

**4 Exterior walls Stone Repairs/windows/doors:**

Rev	Description	Drawn By	Date
	Client: Shaftesbury Town Hall	SF	
	Dwg Title: North & West Elevations	BW	
	Project: Shaftesbury Town Hall, High Street, Shaftesbury, Dorset.	Scale: 1:50	Date: 27/3/23
	Job No.: 5131	Dwg No.: W05	Revision:

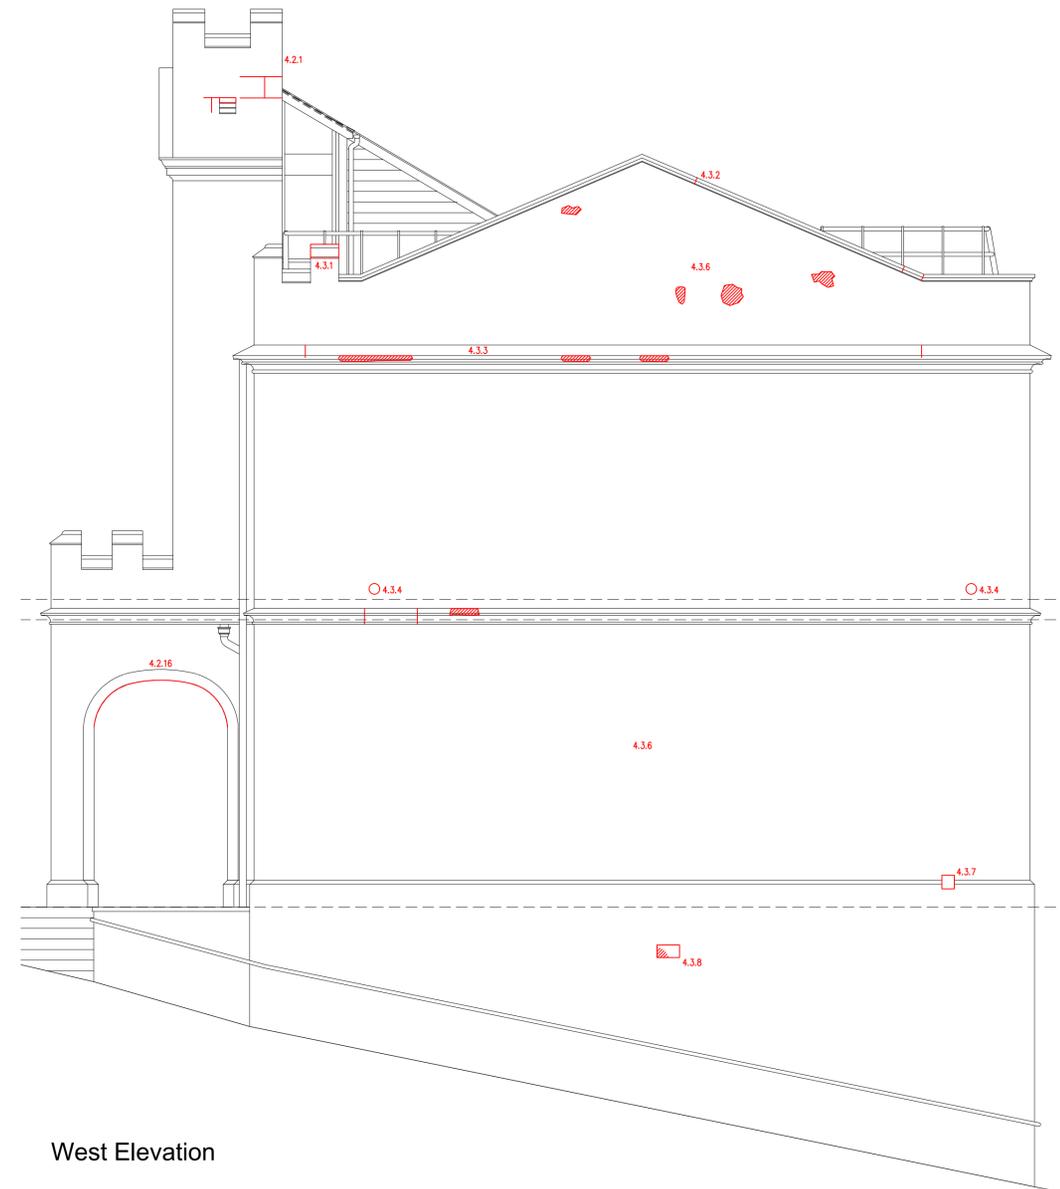
West Elevation

4.3.6 The whole gable elevation has a number of open joints, pitting and cavities where stone has failed in the past. Review with the architect prior to commencement, and carry out mortar repairs to prevent water ingress to these. Allow to carry out 20 such repairs to 100 x 100 x 12mm cavities within the tender price.

**4.3 West elevation**

4.3.1 Allow to dowel and re-bed the missing merlon capping to the N corner (currently stored in the clock chamber).

4.3.2 Re-point 3 open joints to the gable parapet coping.

4.3.3 Remove moss and vegetation as described in 4.1 above, and gently brush off exfoliation and scaling to the underside moulding of the cornice. Point open joints to the cornice, (allow to fully re-point 4 no joints to this elevation), and repair damaged or missing moulding to sections indicated on drawings with mortar repair as described in C41.

4.3.4 Remove 2 redundant circular flues through the wall above string course. Cut the facing stone to accept rectangular stone infill pieces of full course depth (greensand) and patch repair, maintaining the ashlar course line through the centre of the repair. Where the repair is less than 150mm from an existing perp, allow cutting out and replacing the stone upto the perp joint. Tool face of new stones to match existing. All as C41.

4.3.5 Gently brush off string course to remove exfoliation. Infill missing detail from mould as shown on drawing and using mortar repair, and re-point (4) open joints, all as C41.

4.3.7 Remove 1 no redundant rectangular flue crossing the plinth line close to the south corner. Cut the facing stone down to the course line below, and piece in a new stone of full course depth (greensand) with top edge weathered to match the existing plinth including the plinth. Tool face to match existing. All as C41.

4.3.8 Allow to cut out 1 badly spalled stone below the plinth line and repair with stone replacement as C41. Tool face of stone to match existing

4.3.9 Decorate metal grille and handrail as specified in M60.
