Supplementary Geotechnical Investigation

**The Corby Cube
George Street
Corby
NN17 1QG**

**Report No: 19.12.006a
May 2020**

Report Title	Supplementary Geotechnical Investigation Report
Development	Existing Sheet Pile Wall
Project Address	The Corby Cube, George Street, Corby, NN17 1QG
Project Number	19.12.006a
Client	David Smith Associates

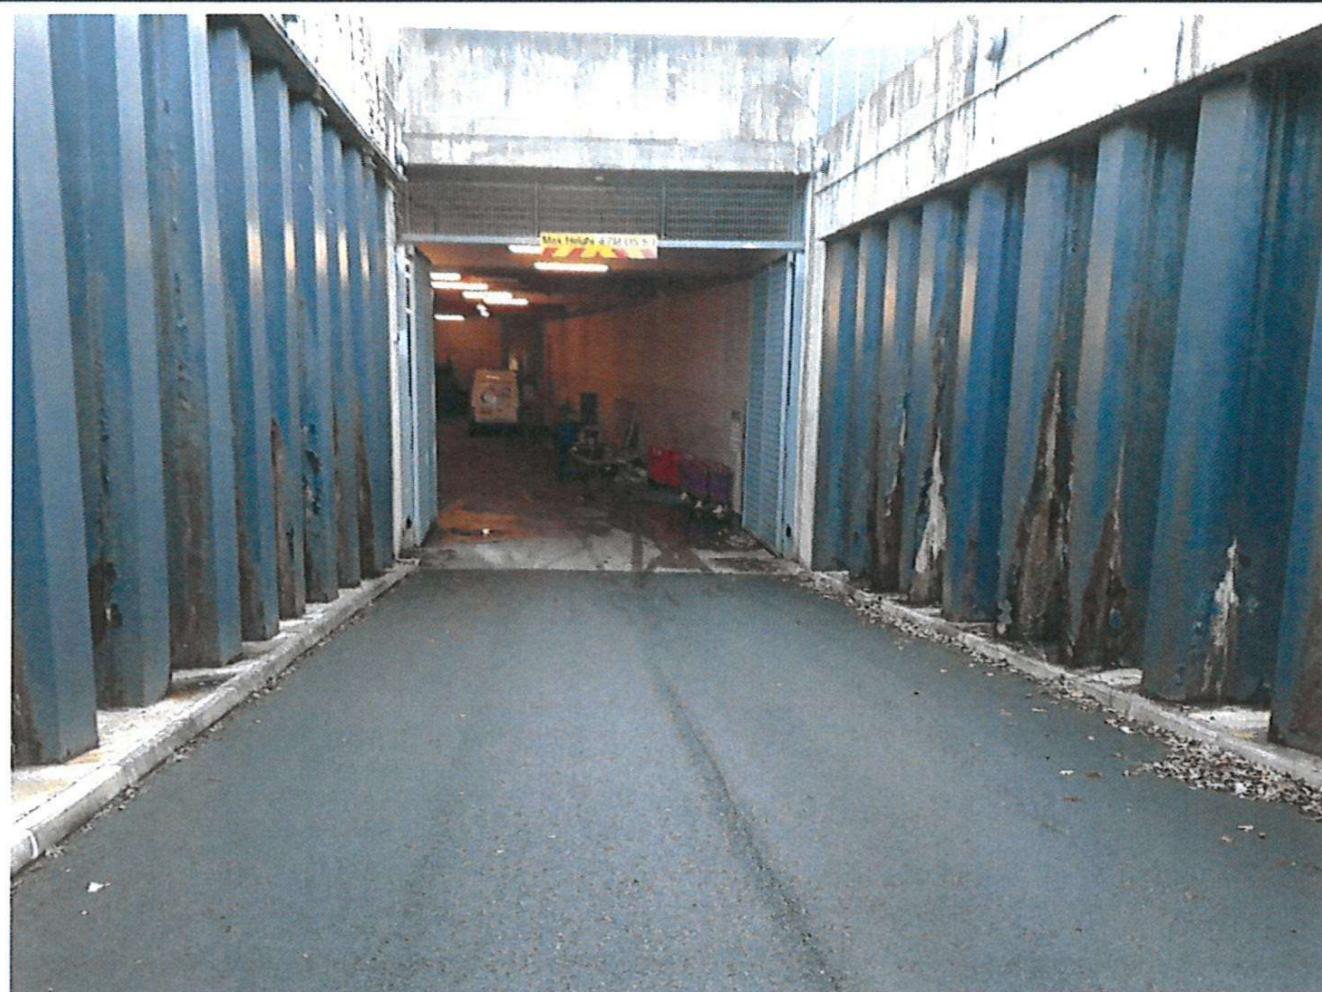
Photo 5: View to the east from in the east showing the sheet piled walls at the base of the ramp

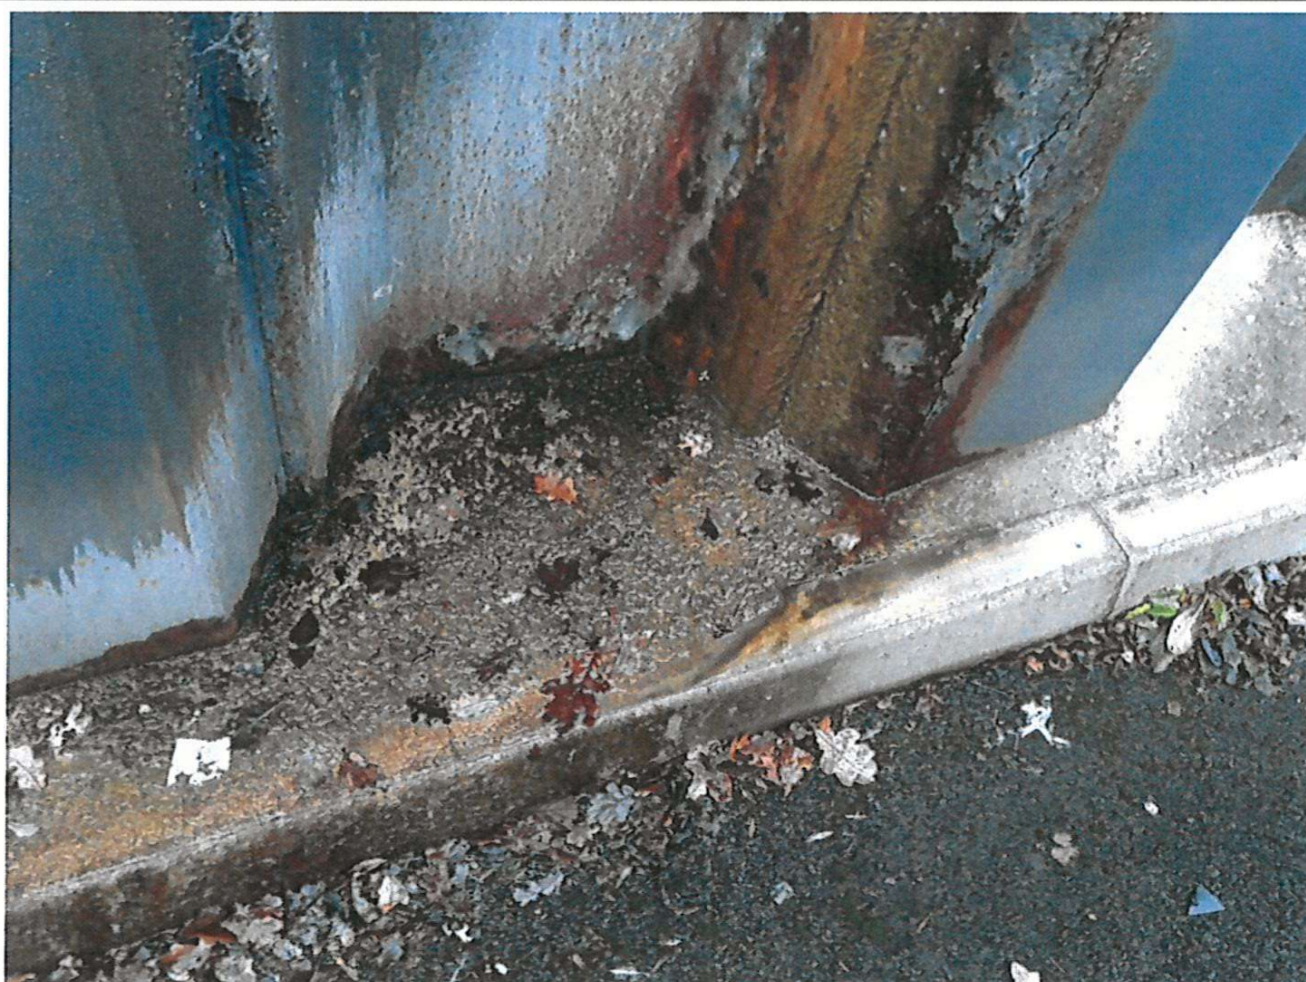
During the walkover, a cream/white residue was noted in the areas of heavy rusting and the sheet piles appeared to be damp with small puddles of water at their base.

Photo 6: Showing the cream/white residue and water at base of the sheet piled wall

We would recommend water pressure testing of the drainage surrounding the sheet pile walls to assess whether any leaks have occurred which could be adding water to the back of the sheet piled walls.

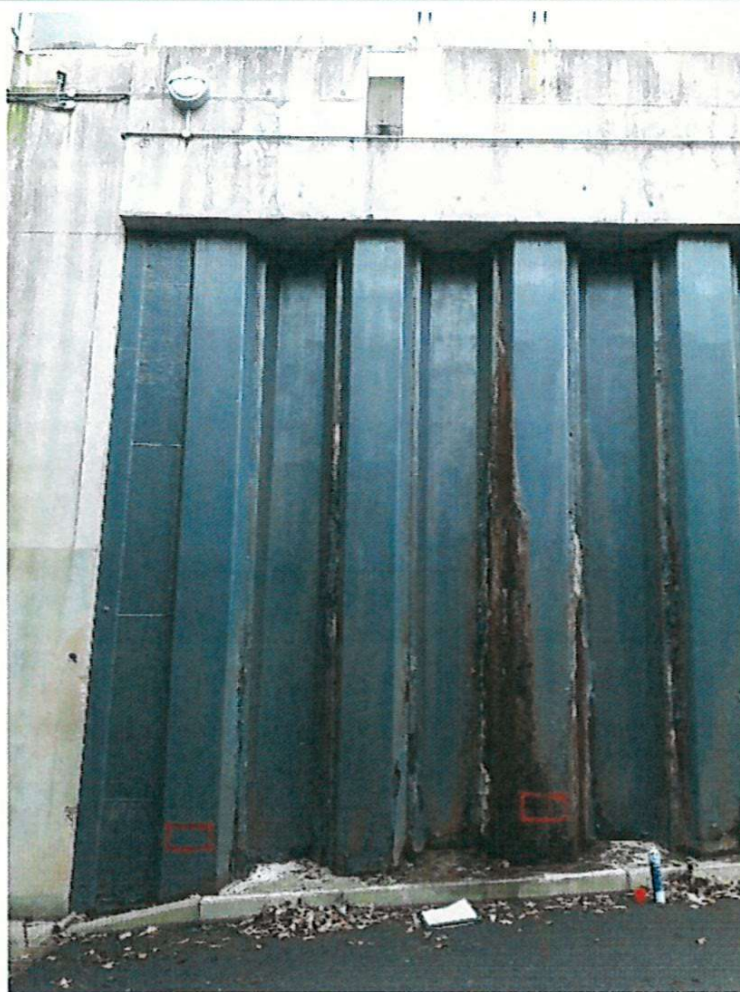
Photo 7: View to the south showing the sheet pile wall sample locations

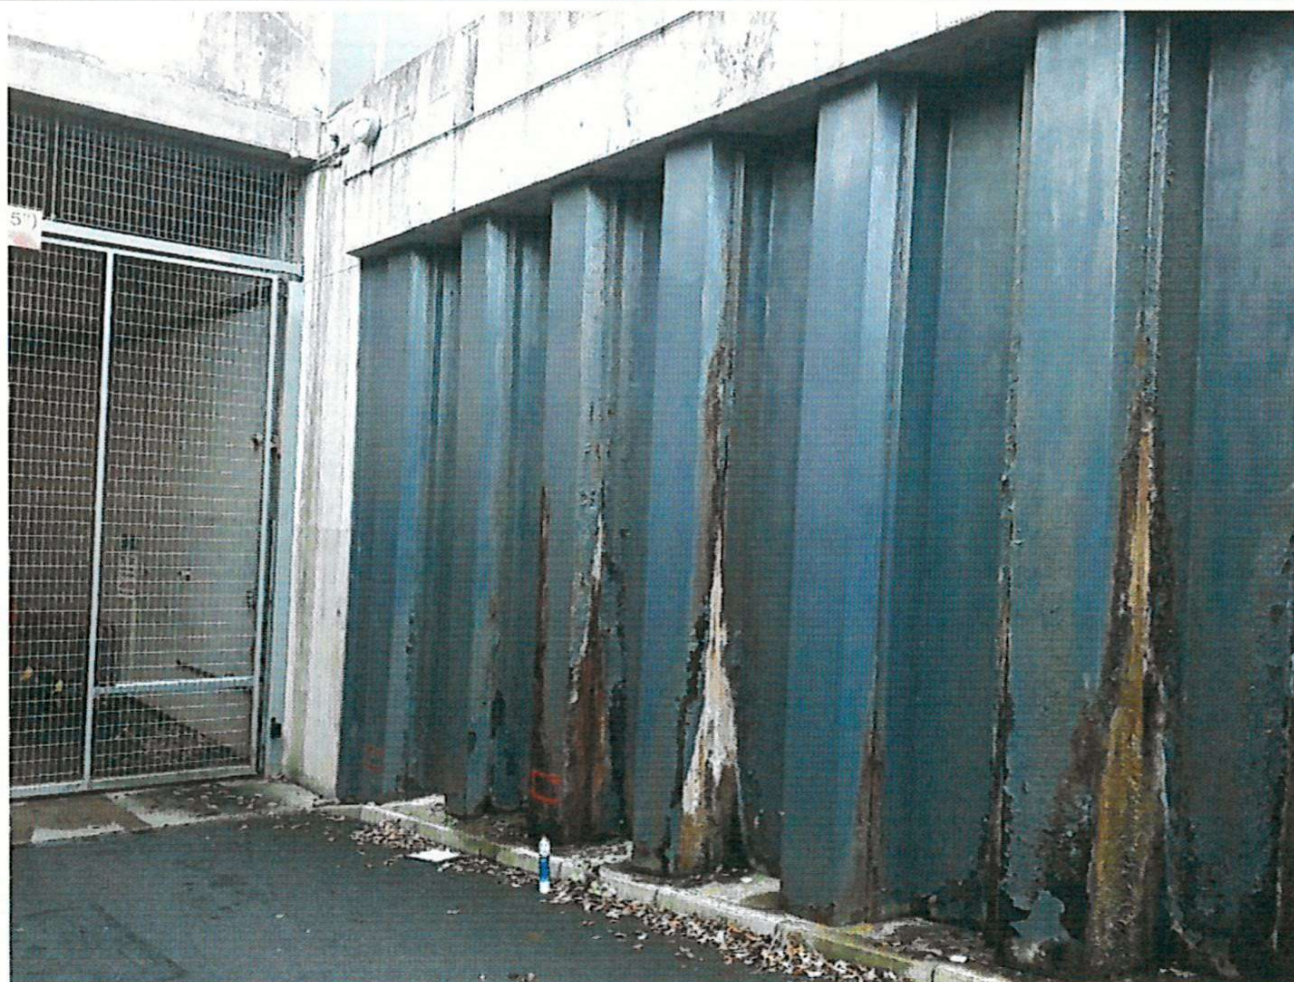
Photo 8: View to the southeast showing the southern sheet pile wall at the base of the ramp

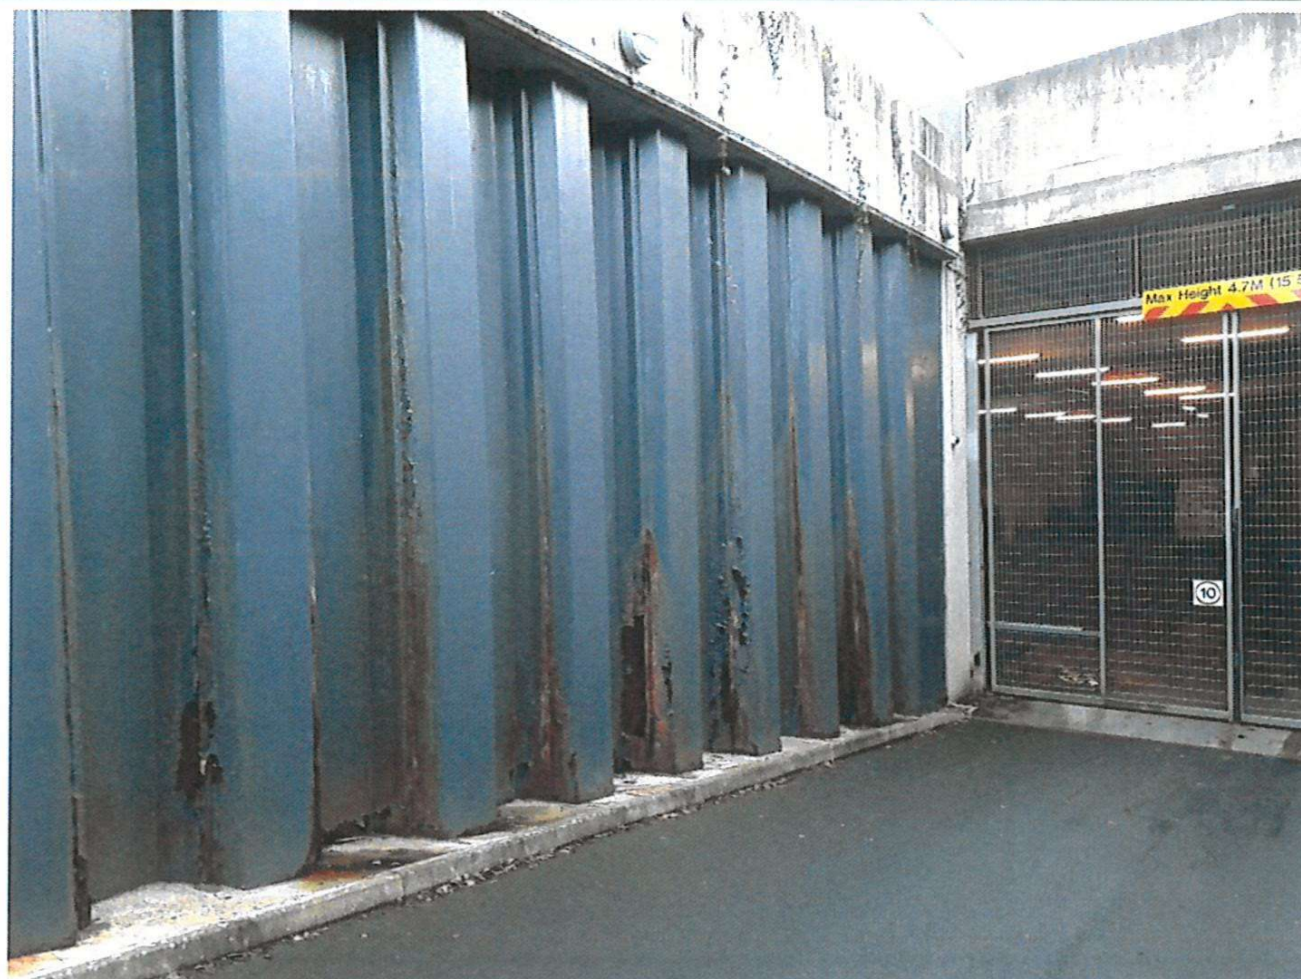
Photo 9: View to the northeast showing the northern sheet pile wall

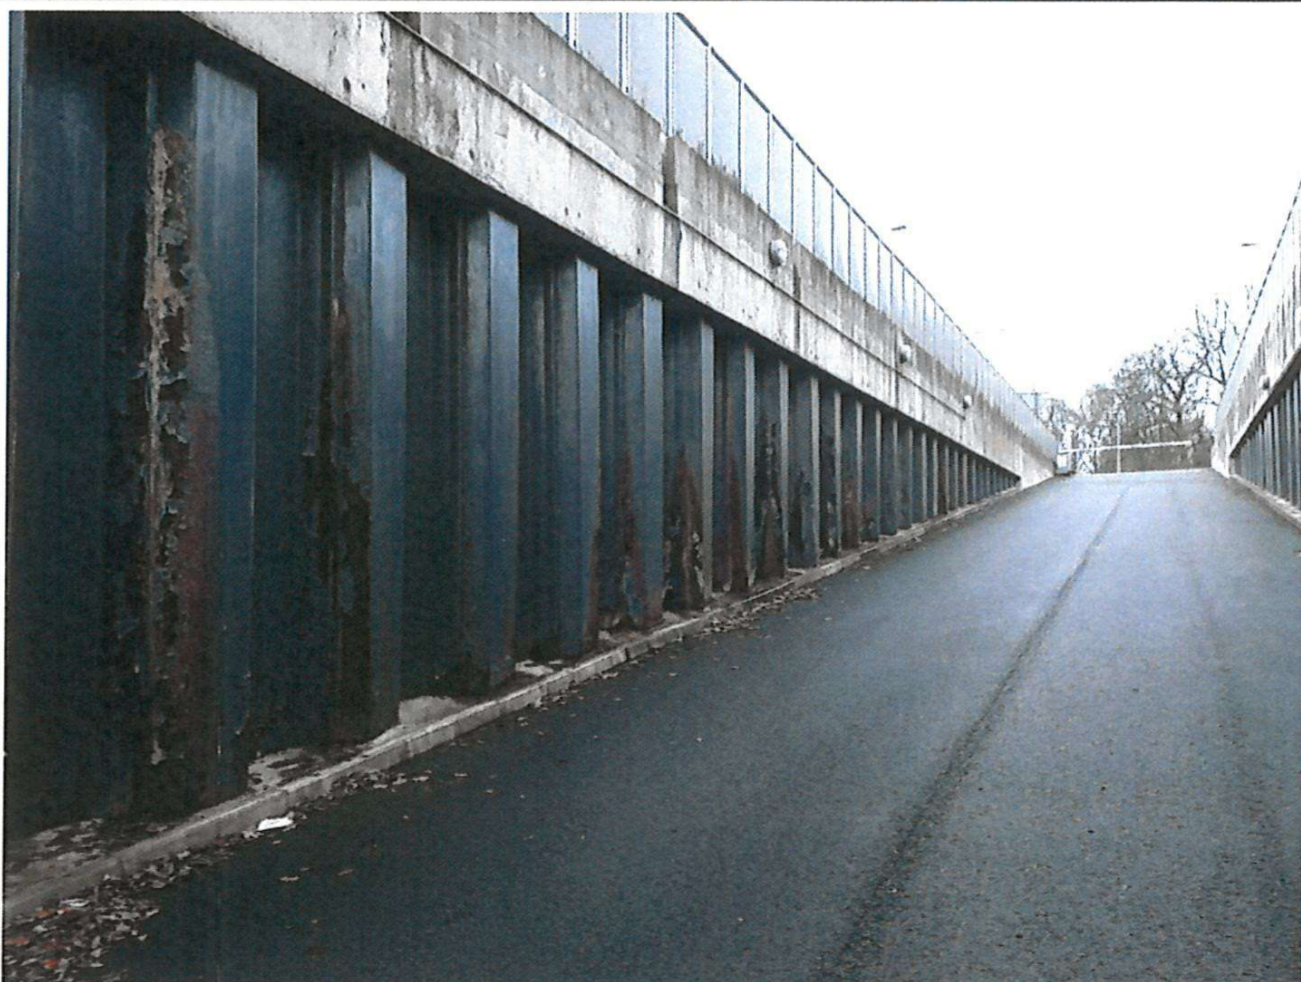
Photo 10: View to the southwest from the east of the site showing the southern sheet pile wall

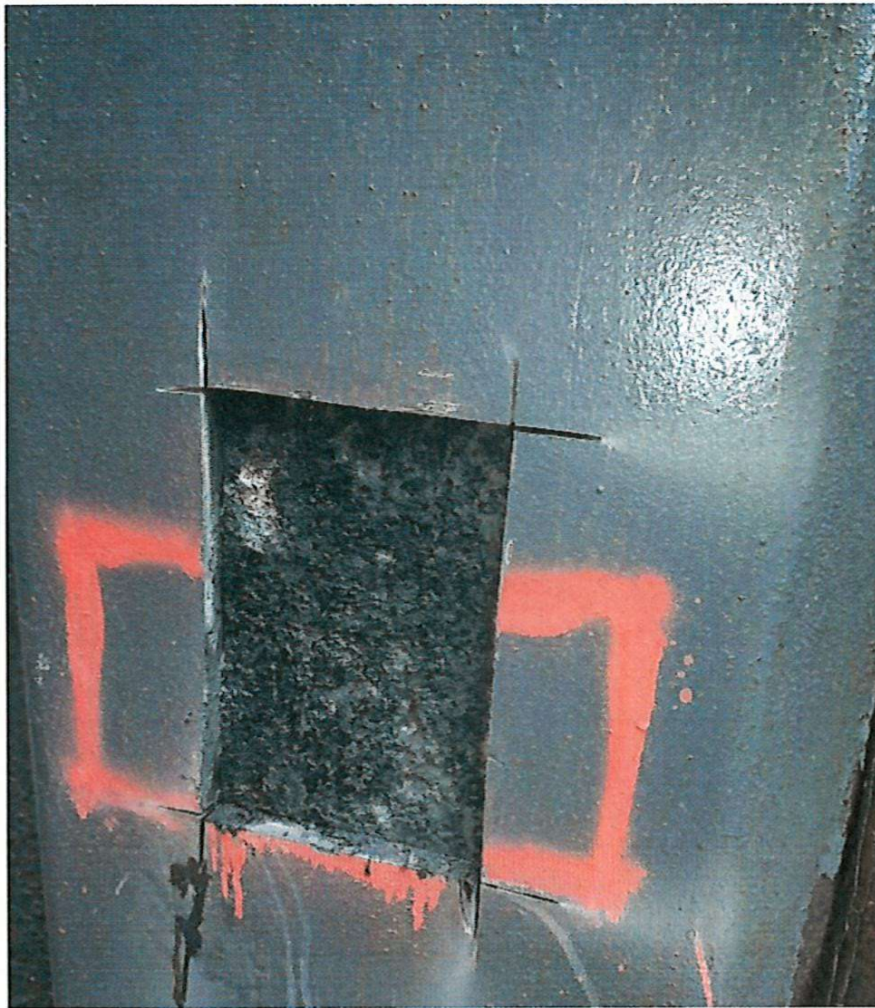
During the sampling of the sheet pile wall, a trickle of water was released from sample SL1 when the metal was removed, whereas only a small dribble was released from SL2. Water appeared to be trickling from the relic slip surface and from larger gravel pieces within the clay. Be it only a small amount, there appeared to be more water at SL1 which was taken from a heavily rusted area when compared to SL2 from an area away from the heavy rust. Groundwater has also been encountered within the monitoring wells at depths of around 2m depth, during monitoring in April 2020, and this appears to broadly correlate with the level of corrosion on the face of the sheet piles.

Photo 11: Showing S2 with the metal sheet pile wall sample removed

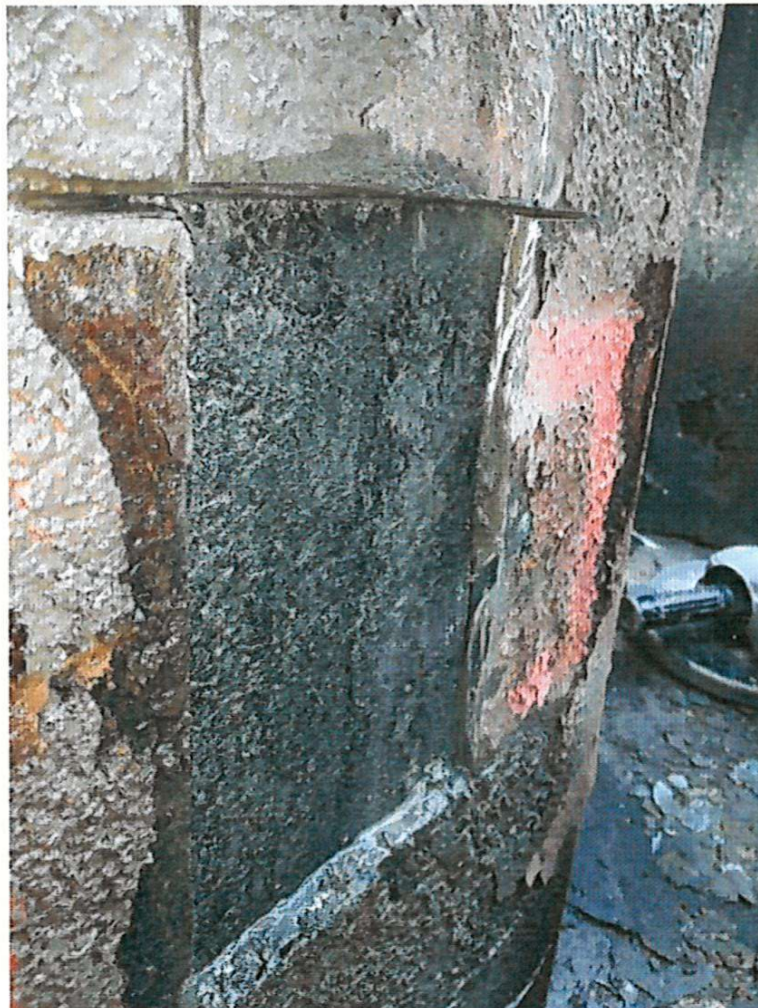
Photo 12: Showing S1 with the metal sheet pile wall sample removed

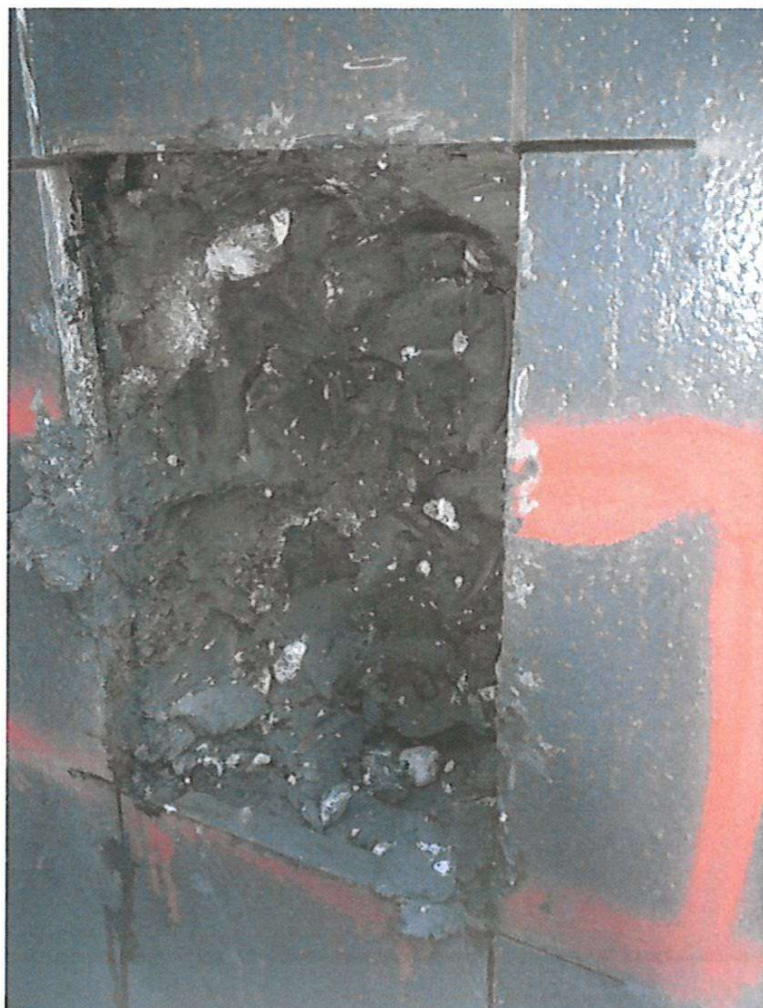
The soil behind the sheet pile sample locations SL1 and SL2 was encountered as the lower layer of the Oadby Member, as described above. A black layer only a few mm thick was noted on the surface of the fine-grained soils behind the metal sheet piled wall, at both sample locations. A possible relic slip surface was noted approximately 110mm behind the wall at sample location SL1. It is possible that this was formed during deposition of the Oadby Member, although it is considered more likely that it formed during the installation of the sheet pile.

Photo 13: Showing S2 with the soil sample removed

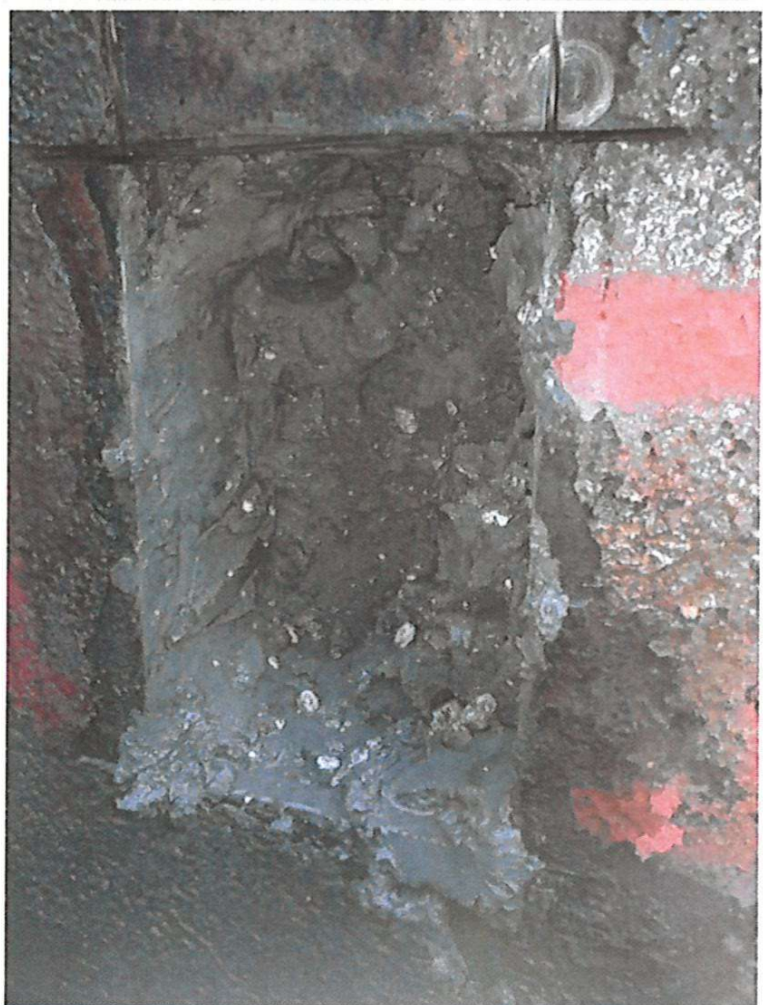
Photo 14: Showing S1 with the soil sample removed

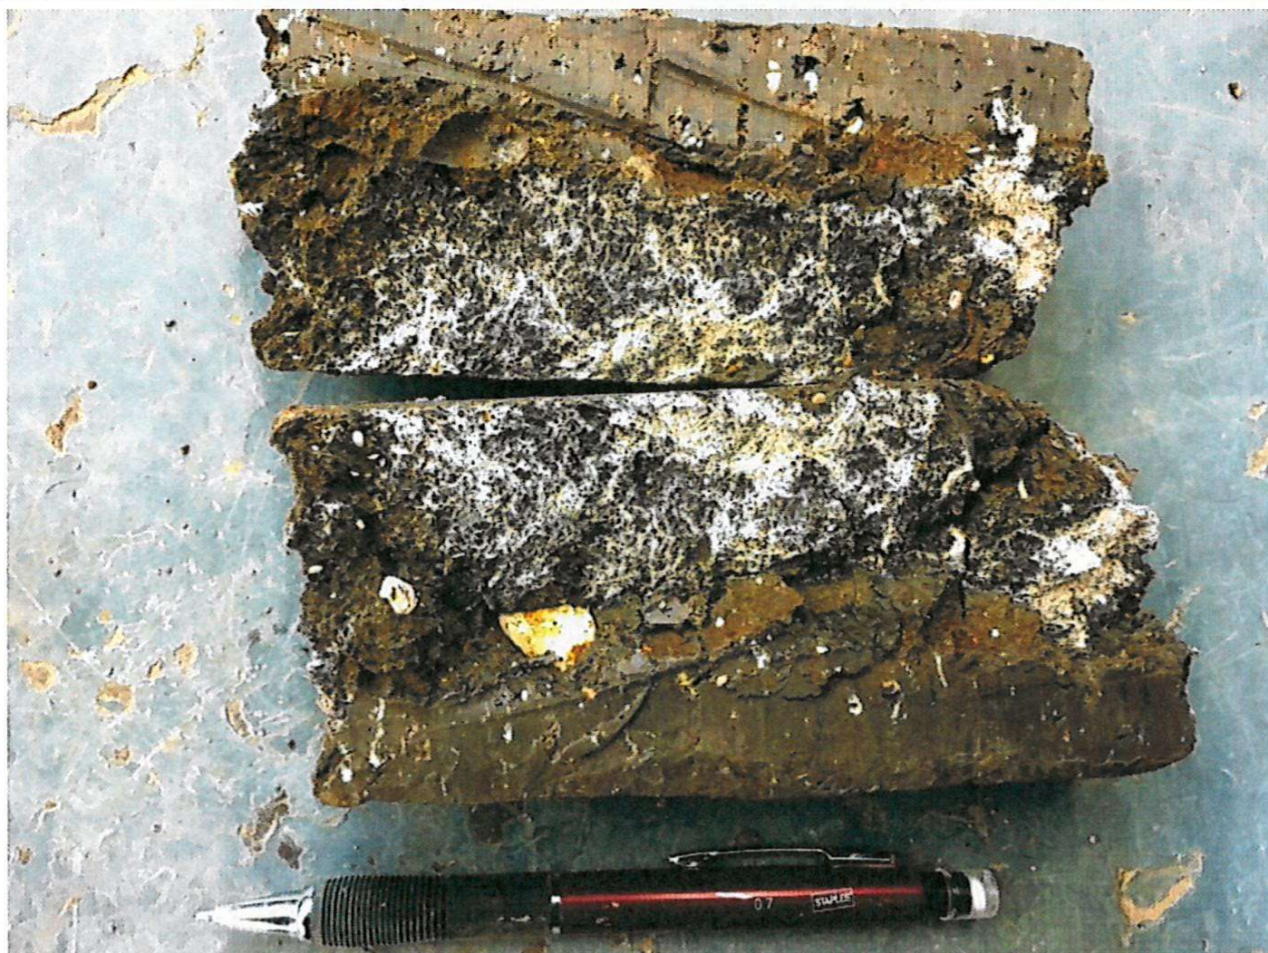
The selenite crystals are composed of calcium sulphate and the pyrite nodules are of a sulphide mineral composed of iron and sulphur. Oxidation of pyrite releases toxic metals / metalloids which can react with water to create iron sulphide and corrosive sulphuric acid. The selenite crystals and pyrite nodules encountered within the Oadby member may therefore be associated with the cause of the corrosion of the sheet piles.

Photo 15: Sample from CT01 at 2.50m showing possible fine selenite crystals

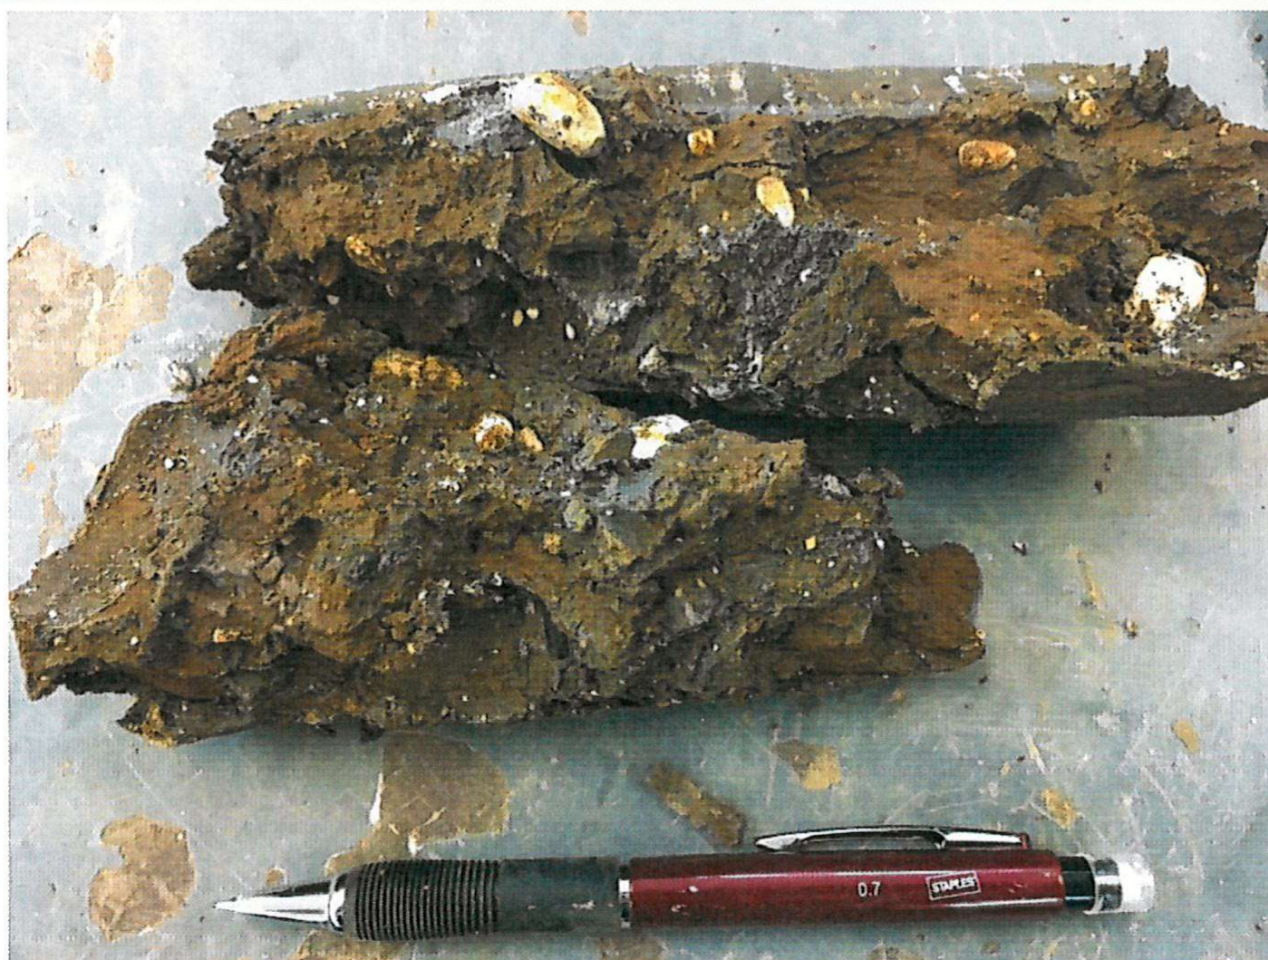
Photo 16: Sample from CT02 at 3.00m showing selenite crystals above the propelling pencil

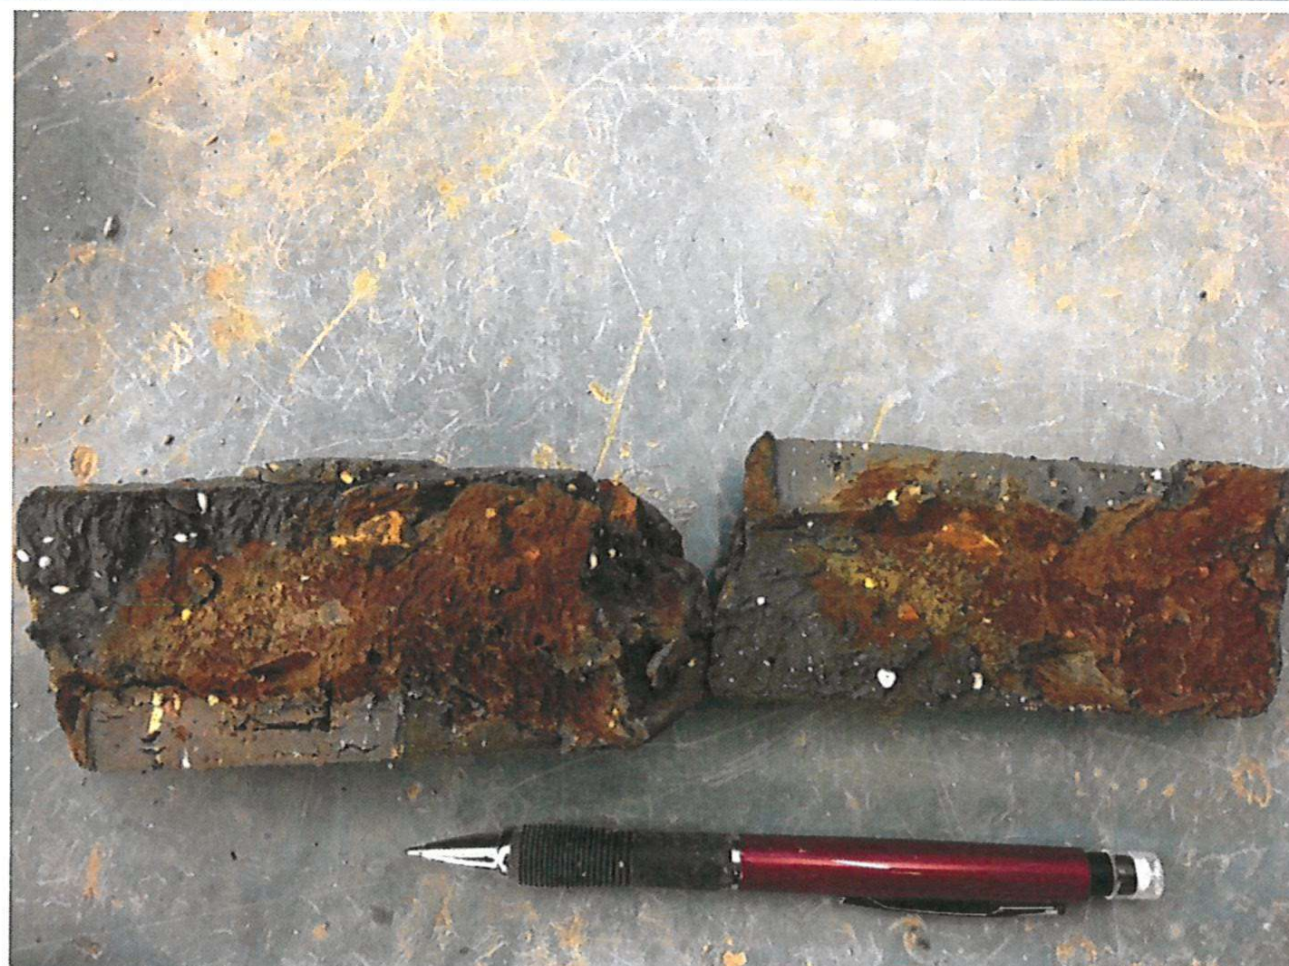
Photo 17: Sample from CT02 at 3.75m showing reddish brown staining

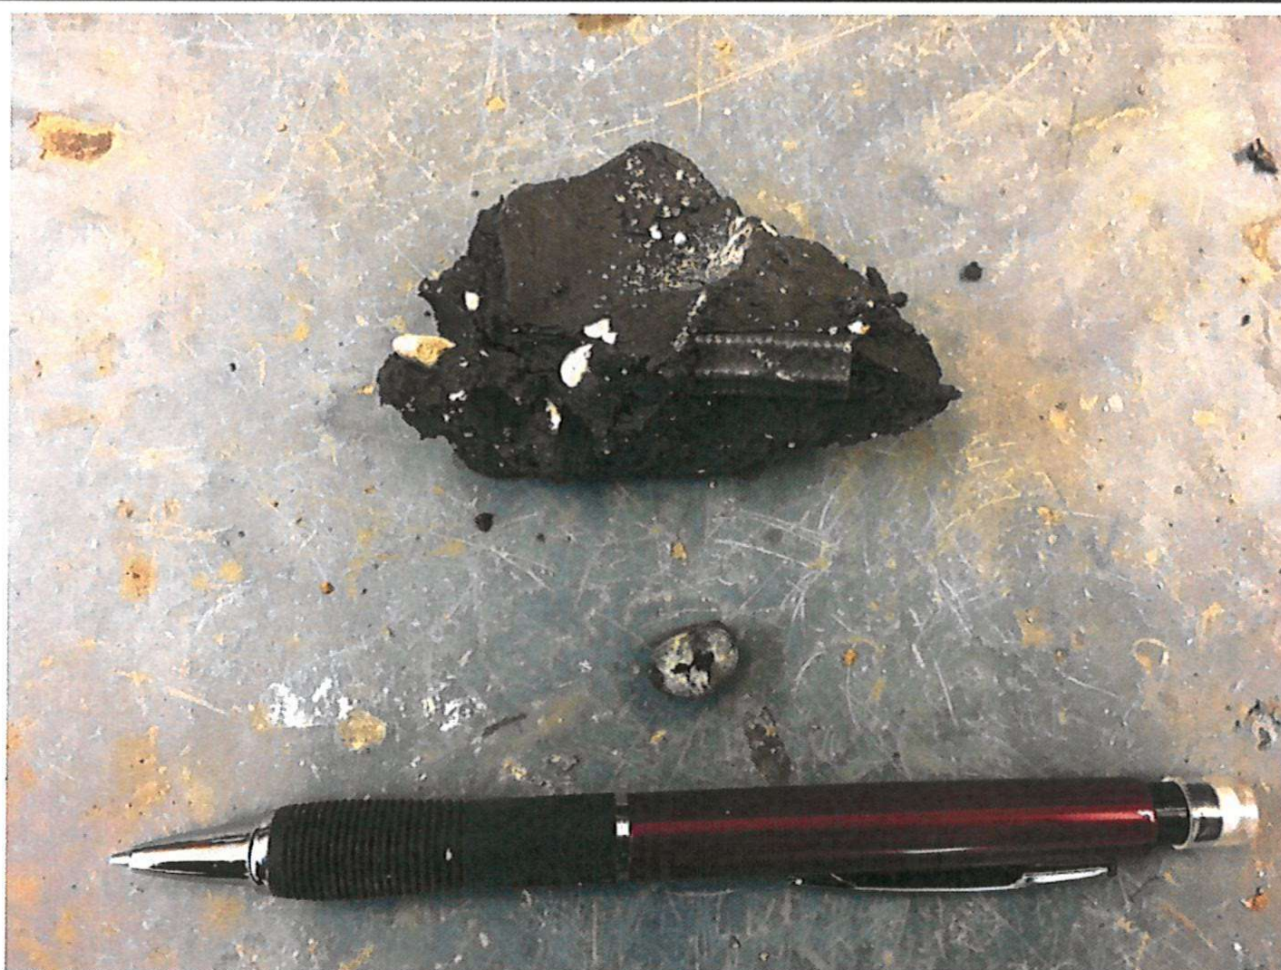
Photo 18: Sample from CT02 at 5.50m showing crinoid and pyrite nodule

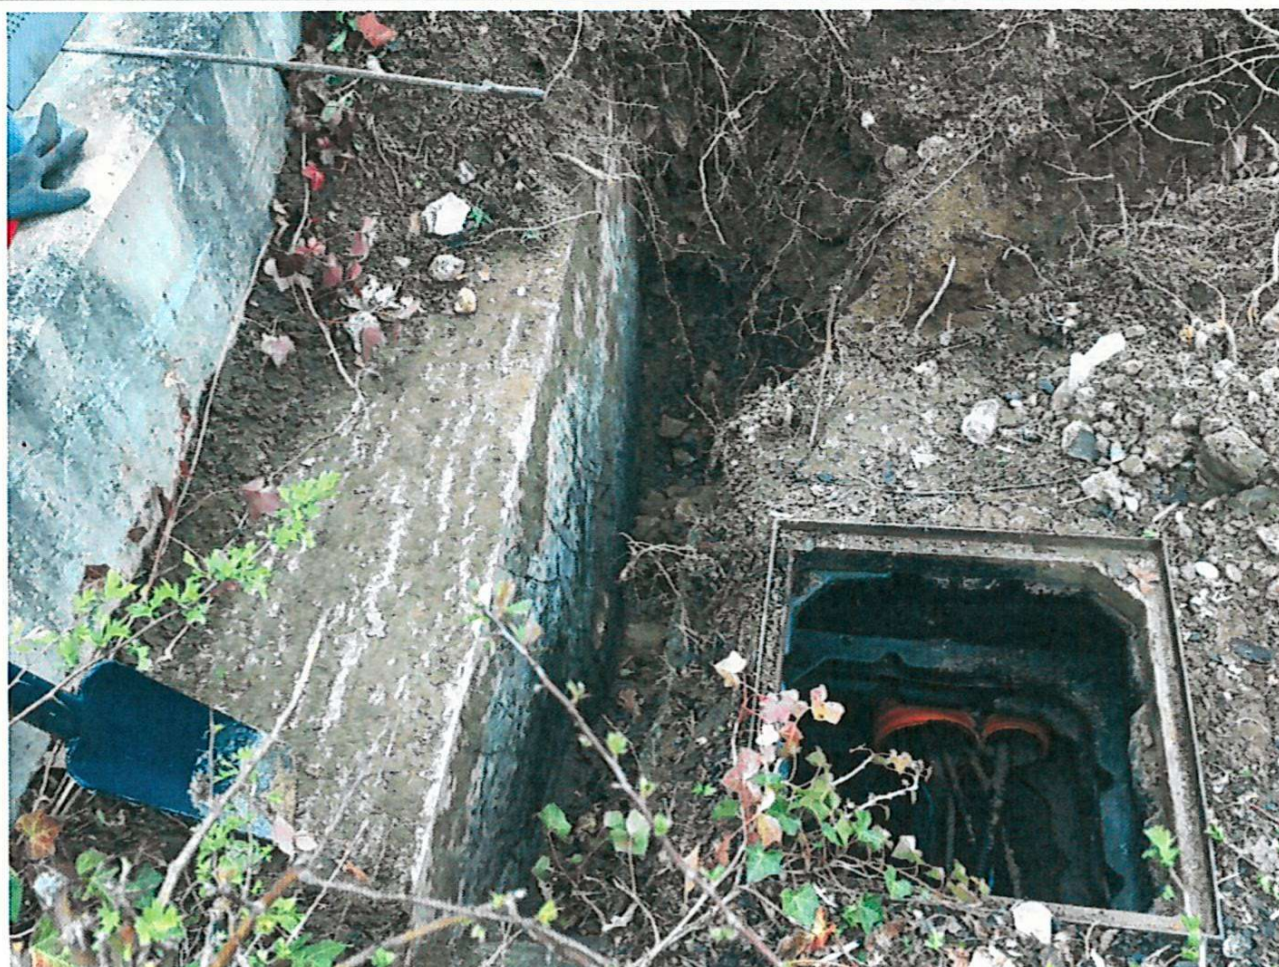
Concrete was encountered from surface and extended for 0.44m away from the wall. The pit was then excavated down 1.01m and further concrete was found at the base which extended beneath the services present around 0.7m away from the top of the retaining wall. The rear of the sheet piled retaining wall could therefore not be examined due to the presence of the concrete.

Photo 19: Photograph of TP101 showing the concrete and service run present in TP101

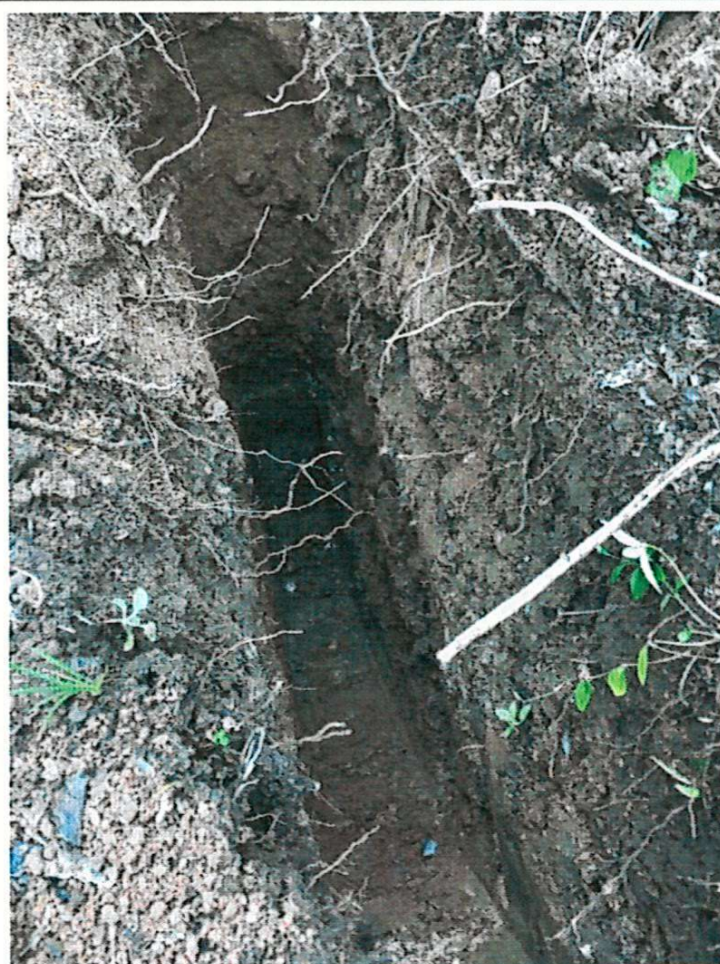
Photo 20: Photograph of TP102 showing the Made Ground and Oadby Member Soils at depth.
