Nature + Love Project - Horniman Museums & Gardens
Pre-Construction Information

North & South Halls, Horniman Museum & Gardens, 100 London Road, Forest Hill, London, SE23 3PQ

Title: Horniman Museum - Asbestos Reinspections 2022

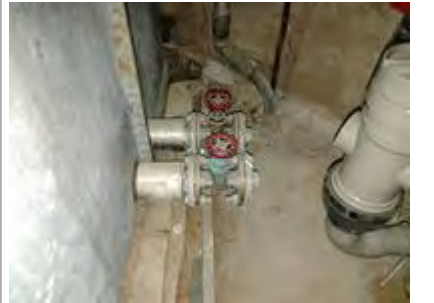
| Building | Level | Location | Item / Product Examined | Sample No. | Material Description | Fibre Type | Material Score | Extent | Risk Level Assessment | Initial Control Recommendation | Photograph |
|---|---|---|---|---|---|---|---|---|---|---|---|
| Clock Tower | 4 | 001/tank room | Pipework flange gasket | | Asbestos-containing gasket | Presume Chrysotile | 4 | 4 No. | R3 | Reinspect Periodically | |

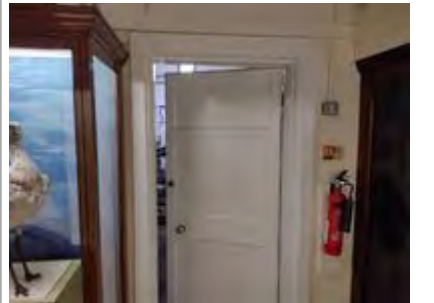
| Building | Level | Location | Item / Product Examined | Sample No. | Material Description | Fibre Type | Material Score | Extent | Risk Level Assessment | Initial Control Recommendation | Photograph |
|---|---|---|---|---|---|---|---|---|---|---|---|
| North Hall, First Floor | 1 | 002/north hall gallery | Panels on back of door to boiler room | 407376-7 | Asbestos-containing cement | Chrysotile | 4 | 2.5 Sqm. | R3 | Reinspect Periodically | |

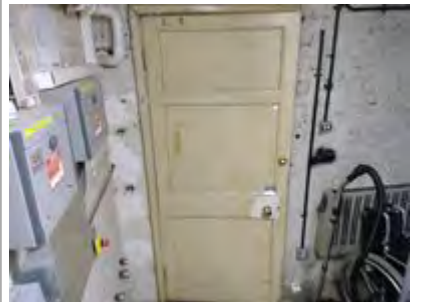
| Building | Level | Location | Item / Product Examined | Sample No. | Material Description | Fibre Type | Material Score | Extent | Risk Level Assessment | Initial Control Recommendation | Photograph |
|---|---|---|---|---|---|---|---|---|---|---|---|
| North Hall, First Floor | 1 | 003/North hall boiler room | Panels on door | 407376-7 | Asbestos-containing cement | Chrysotile | 4 | 2.5 Sqm. | R3 | Reinspect Periodically | |

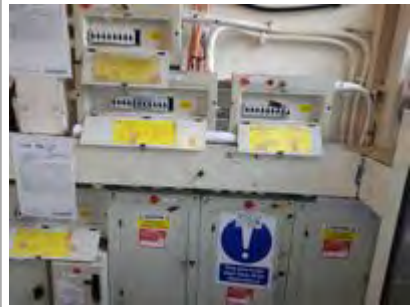
| Building | Level | Location | Item / Product Examined | Sample No. | Material Description | Fibre Type | Material Score | Extent | Risk Level Assessment | Initial Control Recommendation | Photograph |
|---|---|---|--|---|---|---|---|---|---|---|--|
| North Hall, First Floor | 1 | 008/former cleaners store | Electrics - Bill units | | Asbestos-containing woven product | Presume Chrysotile | 3 | 3 No. | R3 | Reinspect Periodically | |

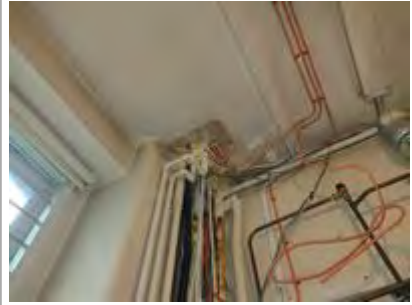
| Building | Level | Location | Item / Product Examined | Sample No. | Material Description | Fibre Type | Material Score | Extent | Risk Level Assessment | Initial Control Recommendation | Photograph |
|---|---|---|--|---|---|---|---|---|---|---|--|
| North Hall, First Floor | 1 | 008/former cleaners store | Woven material around ceiling pipe intrusion | 407376-12 | Asbestos-containing woven product | Amosite | 7 | Small Quantity Observed | R3 | Reinspect Periodically | |

| Item / Product Examined | Material Description | Sampling Strategy | Sample No. | Extent | Product Score | Material Condition | Surface Treatment | Fibre Id. | Material Score | Accessibility Score | Risk Level Assessment |
|--|---|---|---|---|---|---|---|---|---|---|--|
| Woven material around ceiling pipe intrusion | Asbestos-containing woven product | Previously Sampled | 407376-12 | Small Quantity Observed | 2 | 1 | 2 | Amosite | 7 | 1 | R3 |

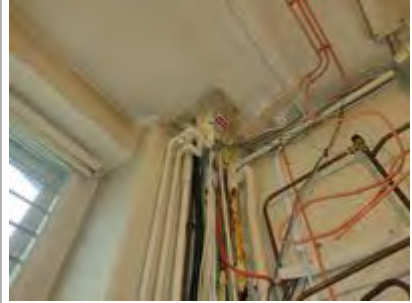
| Building | Level | Location | Item / Product Examined | Material Description | Risk Level (Material Score) | Initial Control Recommendation |
|--|---|---|--|--|---|---|
| North Hall, First Floor | 1 | 008/former cleaners store | Loose packing within pipe intrusion to ceiling | Asbestos-containing insulation | R3 (7) | Reinspect Periodically |

| Building | Level | Location | Item / Product Examined | Sample No. | Material Description | Fibre Type | Material Score | Extent | Risk Level Assessment | Initial Control Recommendation | Photograph |
|---|---|---|--|---|---|---|---|---|---|---|--|
| North Hall, First Floor | 1 | 008/former cleaners store | Loose packing within pipe intrusion to ceiling | 407376-11 | Asbestos-containing insulation | Amosite | 7 | Small Quantity Observed | R3 | Reinspect Periodically | |

| Item / Product Examined | Material Description | Sampling Strategy | Sample No. | Extent | Product Score | Material Condition | Surface Treatment | Fibre Id. | Material Score | Accessibility Score | Risk Level Assessment |
|--|---|---|---|---|---|---|---|---|---|---|--|
| Loose packing within pipe intrusion to ceiling | Asbestos-containing insulation | Previously Sampled | 407376-11 | Small Quantity Observed | 3 | 1 | 1 | Amosite | 7 | 1 | R3 |

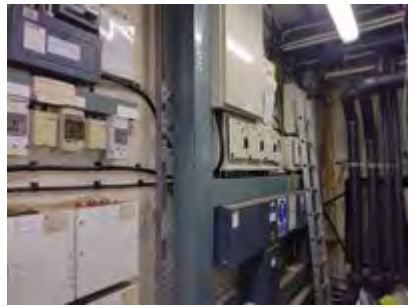
| Building | Level | Location | Item / Product Examined | Sample No. | Material Description | Fibre Type | Material Score | Extent | Risk Level Assessment | Initial Control Recommendation | Photograph |
|---|---|---|---|---|---|---|---|---|---|---|--|
| North Hall, Ground Floor Boiler Rooms | 0 | 001/entrance lobby/switch room | Electrics - MEM and Bill units | | Asbestos-containing woven product | Presume Chrysotile | 5 | 16 No. | R3 | Reinspect Periodically | |

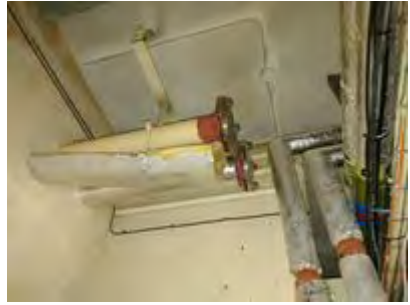
| Building | Level | Location | Item / Product Examined | Sample No. | Material Description | Fibre Type | Material Score | Extent | Risk Level Assessment | Initial Control Recommendation | Photograph |
|---|---|---|---|---|---|---|---|---|---|---|--|
| North Hall, Ground Floor Boiler Rooms | 0 | 001/entrance lobby/switch room | Pipework flange gasket | 407376-21 | Asbestos-containing gasket | Chrysotile | 5 | 3 No. | R3 | Reinspect Periodically | |

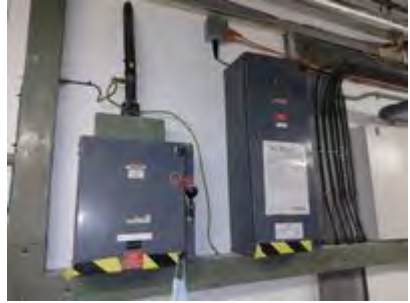
| Building | Level | Location | Item / Product Examined | Sample No. | Material Description | Fibre Type | Material Score | Extent | Risk Level Assessment | Initial Control Recommendation | Photograph |
|---|---|---|---|---|---|---|---|---|---|---|--|
| North Hall, Ground Floor Boiler Rooms | 0 | 003/boiler room | Electrics - oval labelled MEM units | | Asbestos-containing woven product | Presume Chrysotile | 5 | 2 No. | R3 | Reinspect Periodically | |

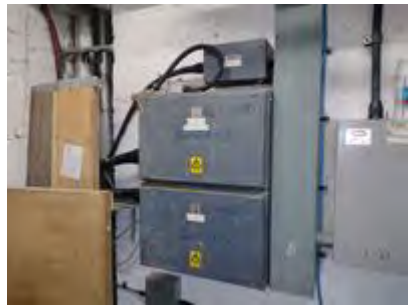
| Building | Level | Location | Item / Product Examined | Sample No. | Material Description | Fibre Type | Material Score | Extent | Risk Level Assessment | Initial Control Recommendation | Photograph |
|--|---|---|---|---|---|---|---|---|---|---|--|
| North Hall, Ground Floor Boiler Rooms | 0 | 005/boiler room corridor | Electrics | | Asbestos-containing woven product | Presume Chrysotile | 5 | 3 No. | R3 | Reinspect Periodically | |

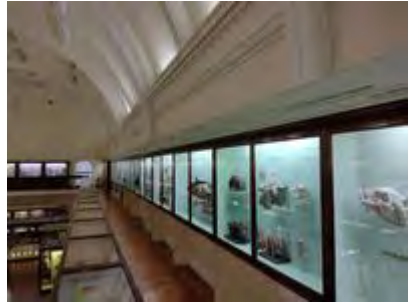
| Building | Level | Location | Item / Product Examined | Sample No. | Material Description | Fibre Type | Material Score | Extent | Risk Level Assessment | Initial Control Recommendation | Photograph |
|--|---|---|---|---|---|---|---|---|---|---|--|
| North Hall, Second Floor Gallery and Offices | 2 | 001/north hall gallery | Sealant to panel on top of cabinet | 407376-2 | Asbestos-containing mastic | Chrysotile | 3 | 0.25 Sqm. | R3 | Reinspect Periodically | |

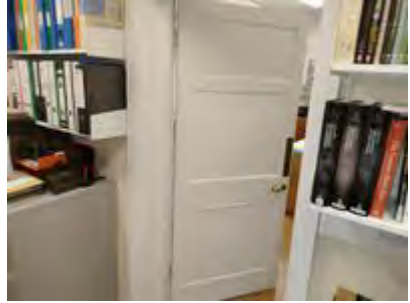
| Building | Level | Location | Item / Product Examined | Material Description | Risk Level (Material Score) | Initial Control Recommendation |
|--|---|---|--|--|---|---|
| North Hall, Second Floor Gallery and Offices | 2 | 006/office | Panels to face of door into 0/007 | Asbestos-containing cement | R3 (4) | Encapsulate small damaged areas |

| Building | Level | Location | Item / Product Examined | Sample No. | Material Description | Fibre Type | Material Score | Extent | Risk Level Assessment | Initial Control Recommendation | Photograph |
|--|---|---|---|---|---|---|---|---|---|---|--|
| North Hall, Second Floor Gallery and Offices | 2 | 006/office | Panels to face of door into 0/007 | 407376-3 | Asbestos-containing cement | Chrysotile | 4 | 2 Sqm | R3 | Encapsulate small damaged areas | |

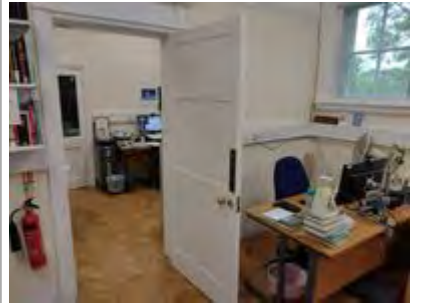
| Building | Level | Location | Item / Product Examined | Material Description | Risk Level (Material Score) | Initial Control Recommendation |
|--|---|---|--|--|---|---|
| North Hall, Second Floor Gallery and Offices | 2 | 007/office | Panels to back of door into 2/006 | Asbestos-containing cement | R3 (4) | Encapsulate small damaged areas |

| Building | Level | Location | Item / Product Examined | Sample No. | Material Description | Fibre Type | Material Score | Extent | Risk Level Assessment | Initial Control Recommendation | Photograph |
|--|---|---|---|---|--|---|---|---|---|---|---|
| North Hall, Second Floor Gallery and Offices | 2 | 007/office | Panels to back of door into 2/006 | 407376-3 | Asbestos-containing cement | Chrysotile | 4 | 2 Sqm. | R3 | Encapsulate small damaged areas | |

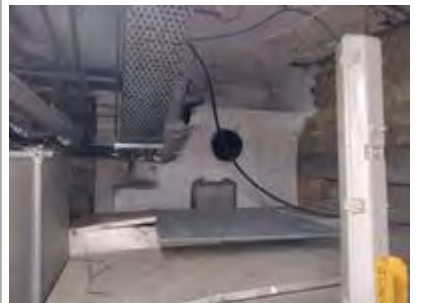
| Building | Level | Location | Item / Product Examined | Sample No. | Material Description | Fibre Type | Material Score | Extent | Risk Level Assessment | Initial Control Recommendation | Photograph |
|--|---|---|---|---|--|---|---|---|---|---|---|
| South Hall, Basement | -1 | 009/aquarium plant room | Residue to walls | | Asbestos-containing insulation | Presume Crocidolite | 9 | Extent Indiscernible | R2 | Reinspect Periodically | |

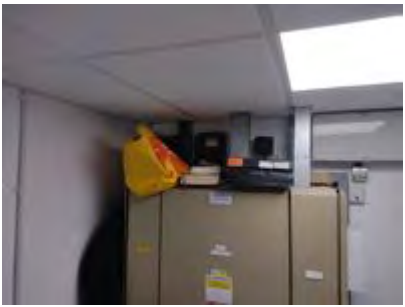
| Building | Level | Location | Item / Product Examined | Sample No. | Material Description | Fibre Type | Material Score | Extent | Risk Level Assessment | Initial Control Recommendation | Photograph |
|---|---|---|---|---|---|---|---|---|---|---|---|
| South Hall, Ground Floor | 0 | 006/staff area (old locations 4 6 7 9 merged) | Electrics in location - Armah, MEM | | Asbestos-containing woven product | Presume Chrysotile | 4 | 3 No. | R3 | Reinspect Periodically | |

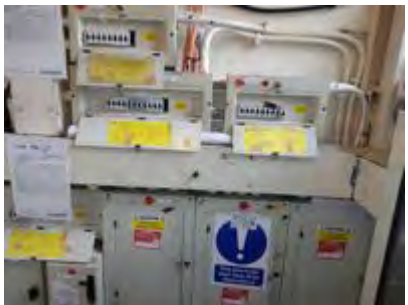
| Building | Level | Location | Item / Product Examined | Accessibility | Access Comments | Photograph |
|---|---|---|---|--|---|---|
| North Hall, First Floor | 1 | 008/former cleaners store | Electrics - Bill units | No Access | Live service supply | |

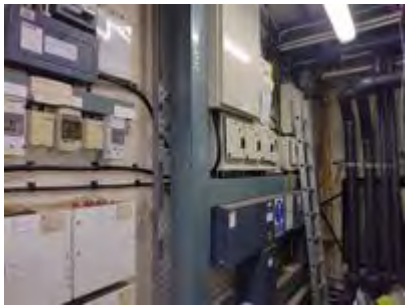
| Building | Level | Location | Item / Product Examined | Accessibility | Access Comments | Photograph |
|---|---|---|---|--|---|---|
| North Hall, Ground Floor Boiler Rooms | 0 | 001/entrance lobby/switch room | Electrics - MEM and Bill units | No Access | Live service supply | |
| | | | | 💡 Older electrical units are known to have used asbestos rope and paper fuse lining. | | |

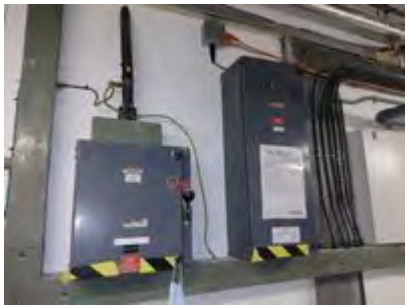
| Building | Level | Location | Item / Product Examined | Accessibility | Access Comments | Photograph |
|---|---|---|---|--|---|---|
| North Hall, Ground Floor Boiler Rooms | 0 | 003/boiler room | Electrics - oval labelled MEM units | No Access | Live service supply | |
| | | | | 💡 Old MEM units are known to have used asbestos rope and paper fuse lining. | | |

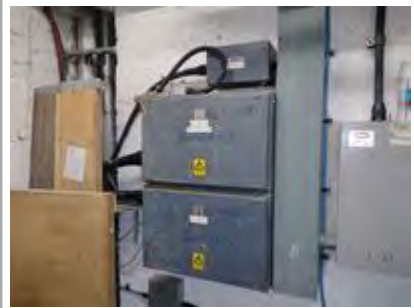
| Building | Level | Location | Item / Product Examined | Accessibility | Access Comments | Photograph |
|--|---|---|---|--|---|---|
| North Hall, Ground Floor Boiler Rooms | 0 | 005/boiler room corridor | Electrics | No Access | Live service supply | |
| | | | | Older MEM units are known to have used asbestos rope and paper fuse lining. | | |

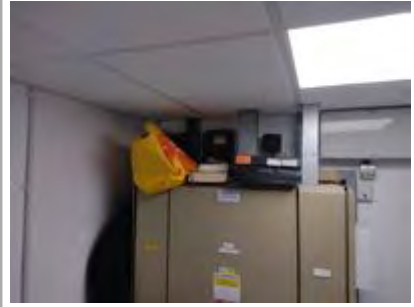
| Building | Level | Location | Item / Product Examined | Accessibility | Access Comments | Photograph |
|--|---|---|---|--|---|---|
| South Hall, Ground Floor | 0 | 006/staff area (old locations 4 6 7 9 merged) | Electrics in location - Armah, MEM | No Access | Live service supply | |
| | | | | Old electric units are known to have used asbestos rope and paper fuse lining. | | |
