## HXH/4a Contract Specification (Masonry Repair and Waterproofing Installation)

**Client name:** National Highways – Historical Railways Estate  
**Project name:** HRE Works Framework  
**Client reference:** HXH/4a  
**Document no:** 0451200  
**Revision no:** 03  
**Date:** May 2023  
**Project no:** B38380DE  
**Project manager:** Nigel Robson  
**Prepared by:** Christopher Doig  
**File name:** HXH 4a NEC ECC

### **HRE WORKS FRAMEWORK HXH/4a 'WHEATLEY VIADUCT' CONTRACT FOR REMEDIAL REPAIRS AND WATERPROOFING**

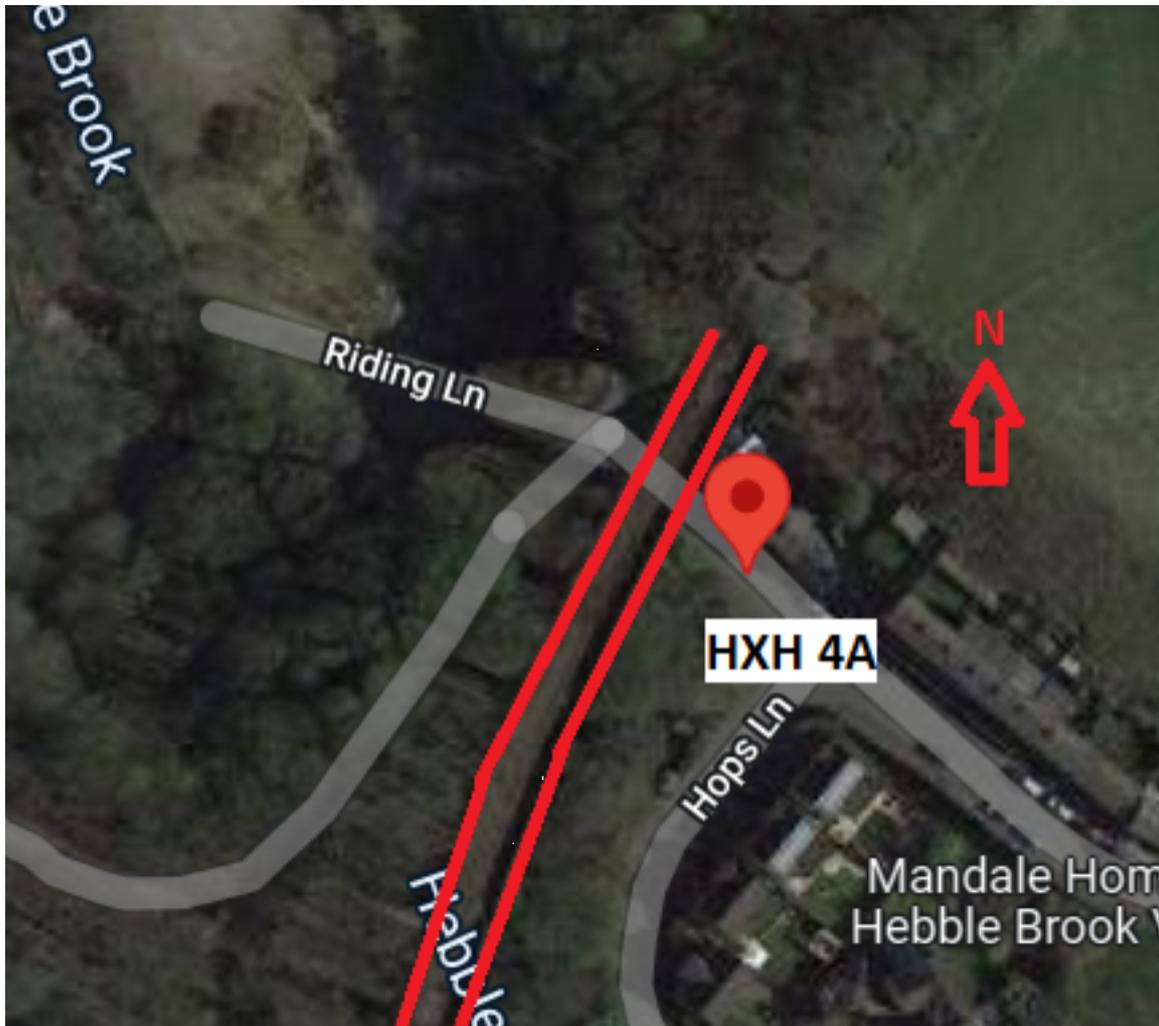
Photo No 1 - HXH - 199m - 0946yds - 43ch - Structure No - 4A - - 05/12/2022  
General Photo - East Elevation.

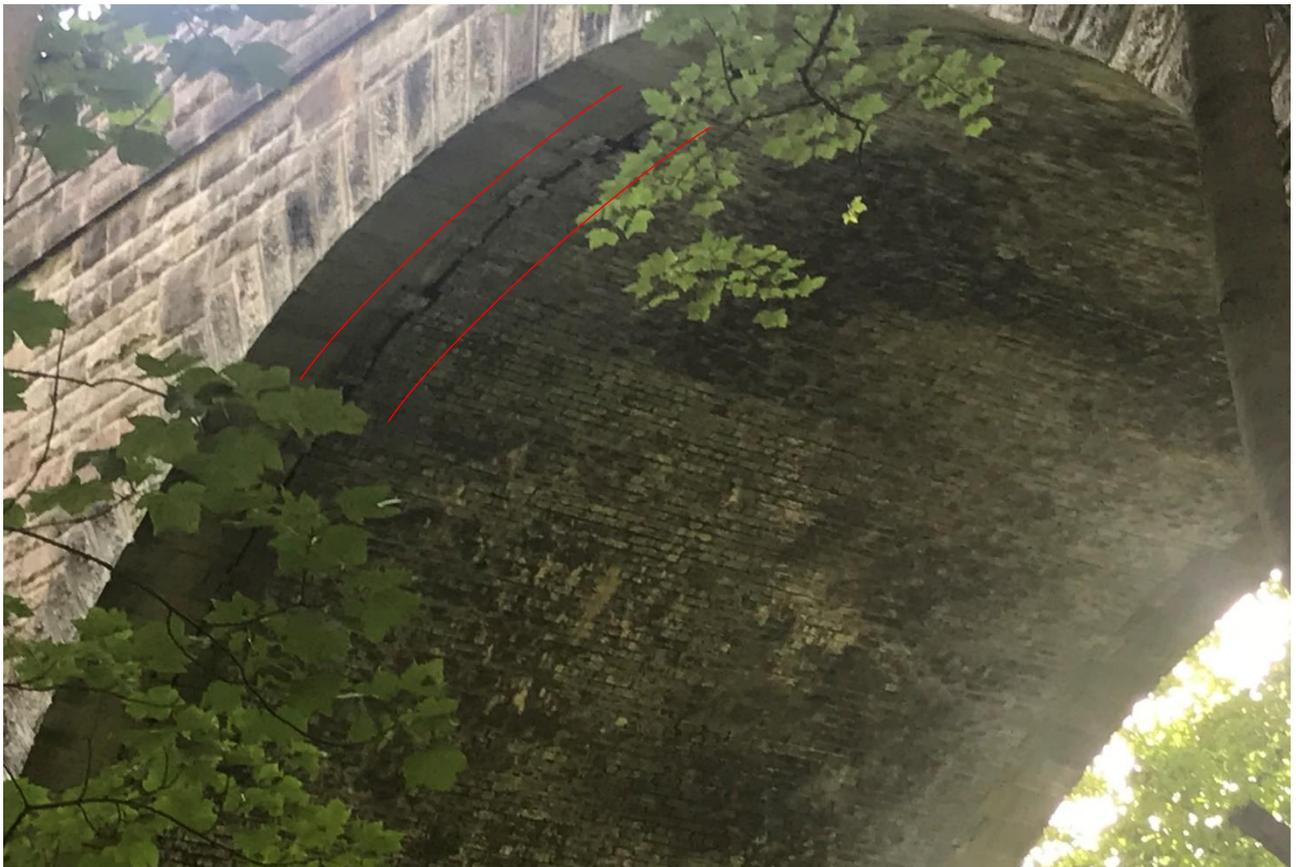
4. Voussoir fractures to Span 7.

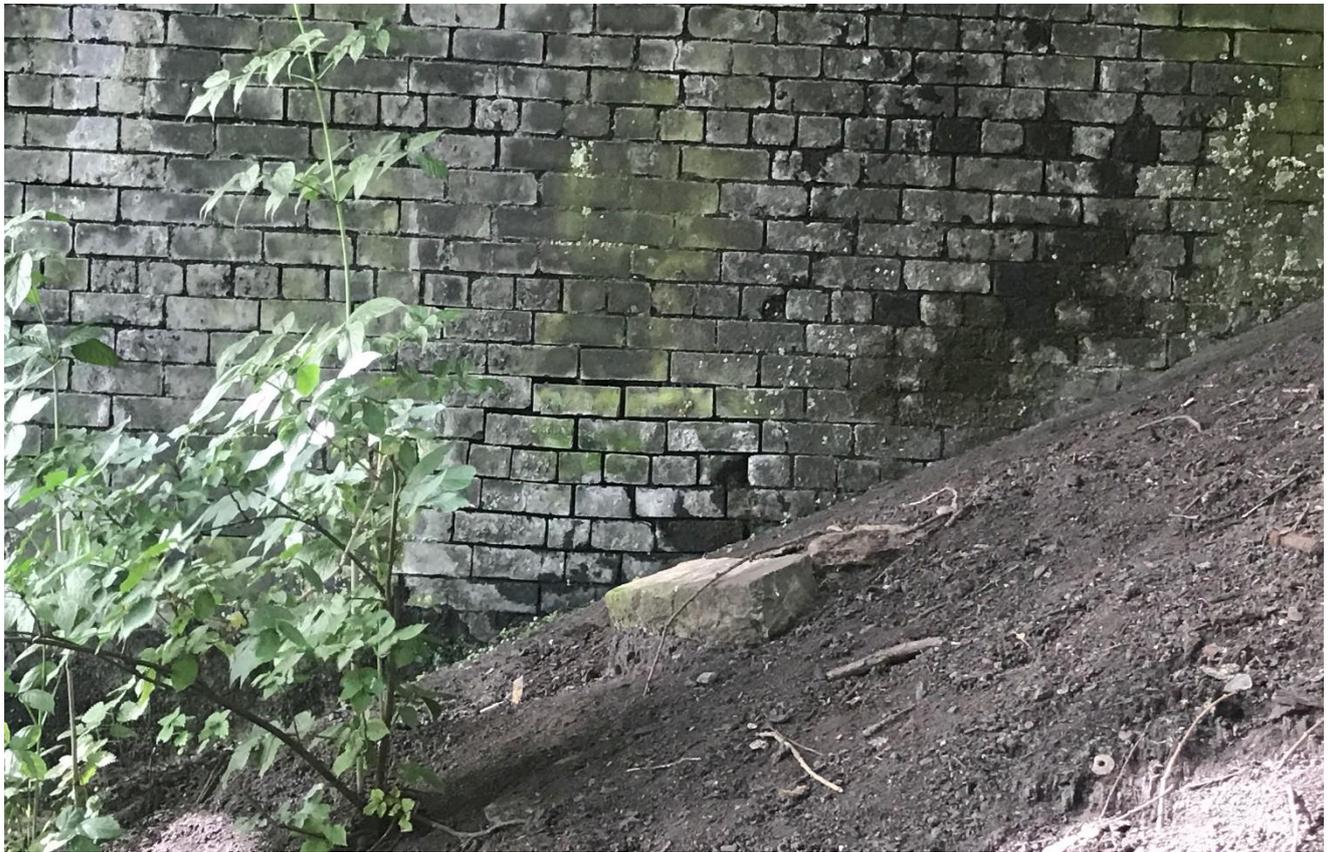
5. Loose and displaced brickwork to Span 10

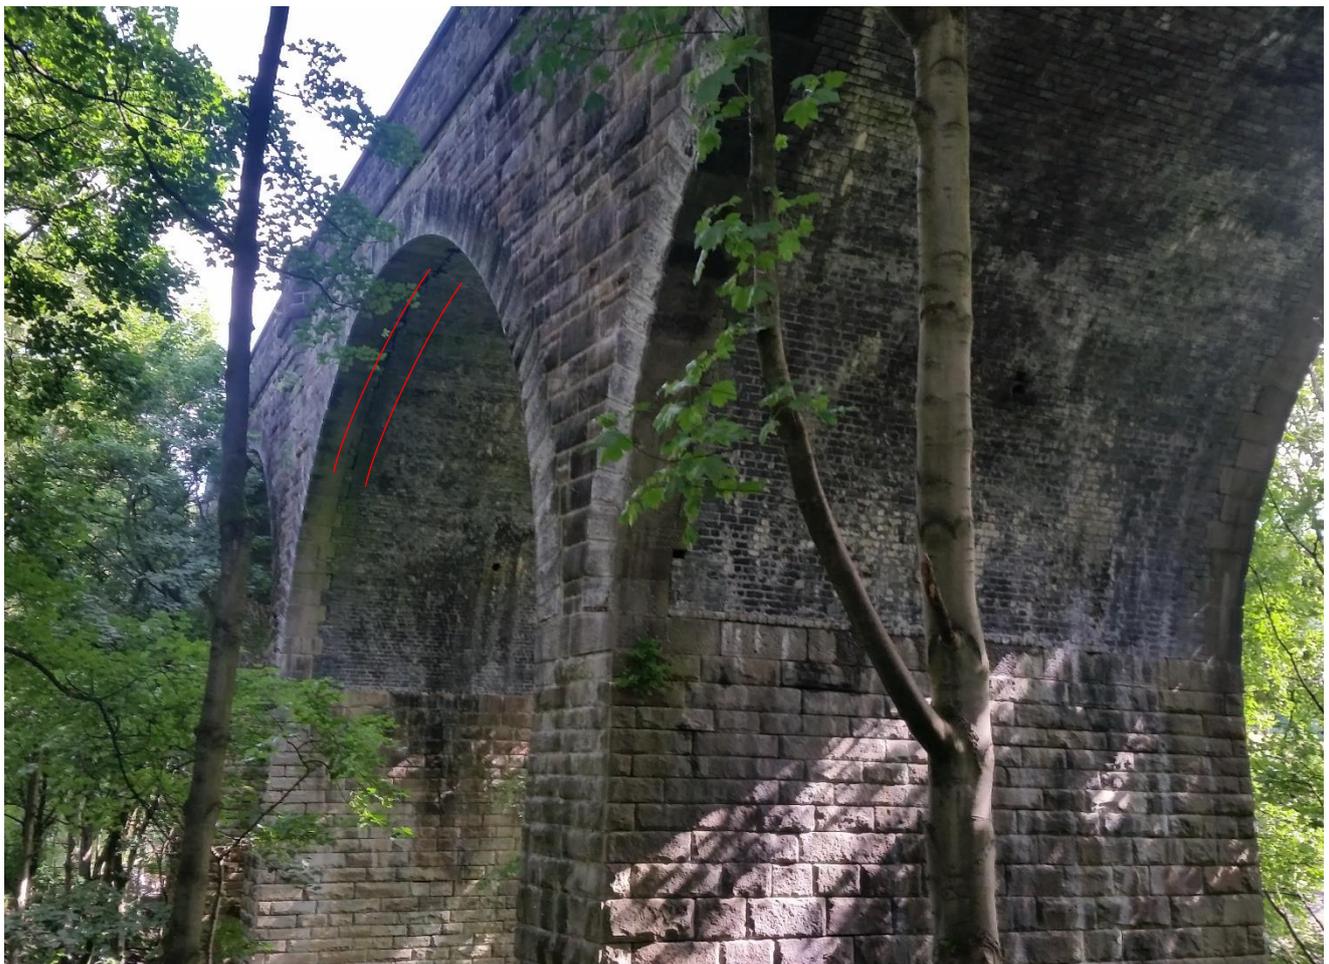
6. Voussoir Fractures and staining to Span 6  
HXH/4a 'Wheatley Viaduct' NEC ECC

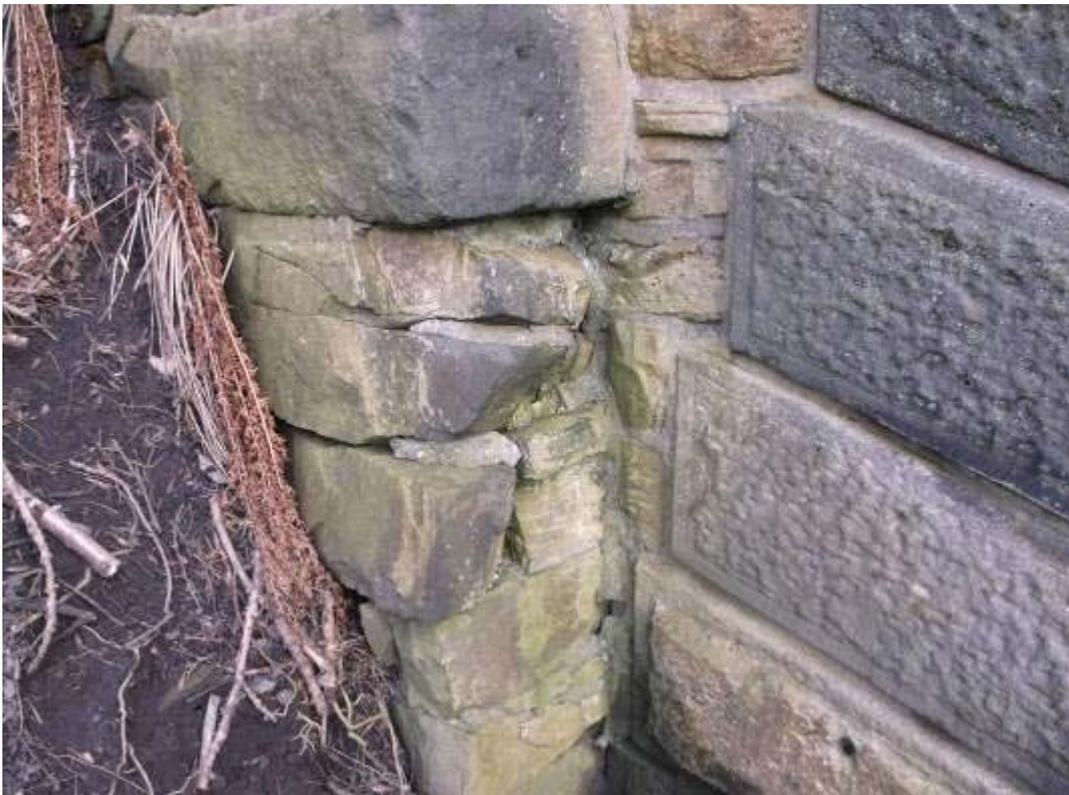
**Photo No. 17: Area of fractured & missing masonry to north wing wall**

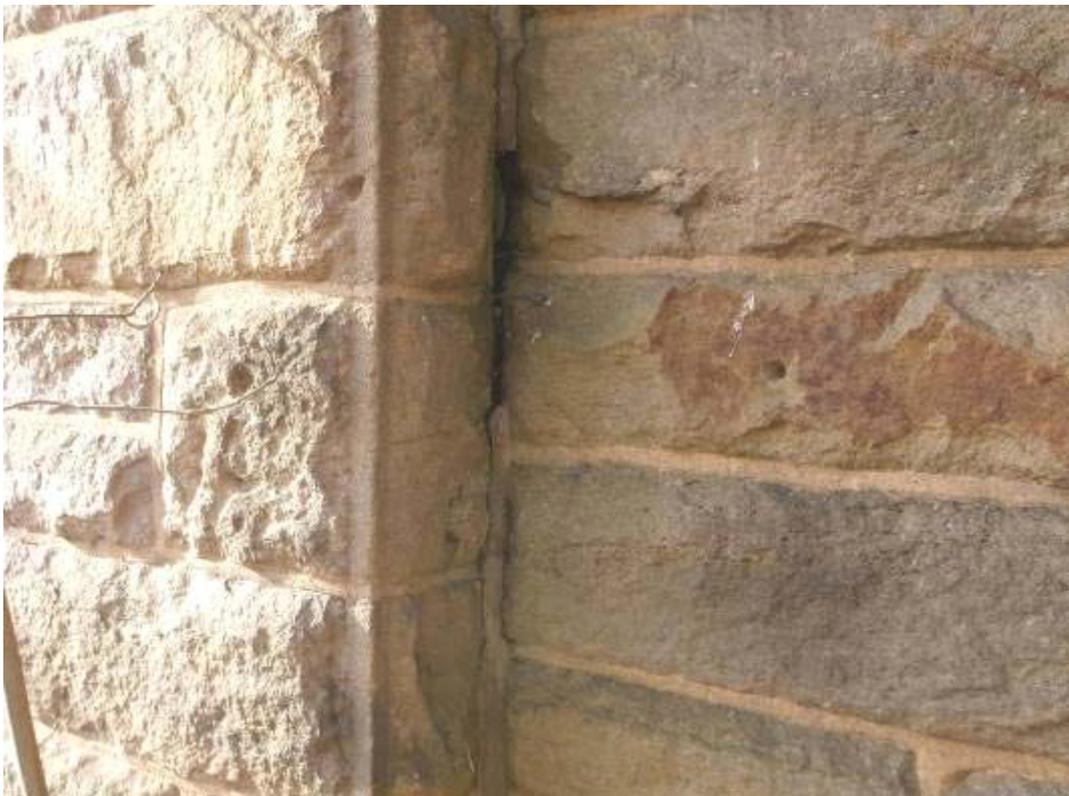
**Photo No. 18: Line of fractured mortar / mortar loss to east wing wall**

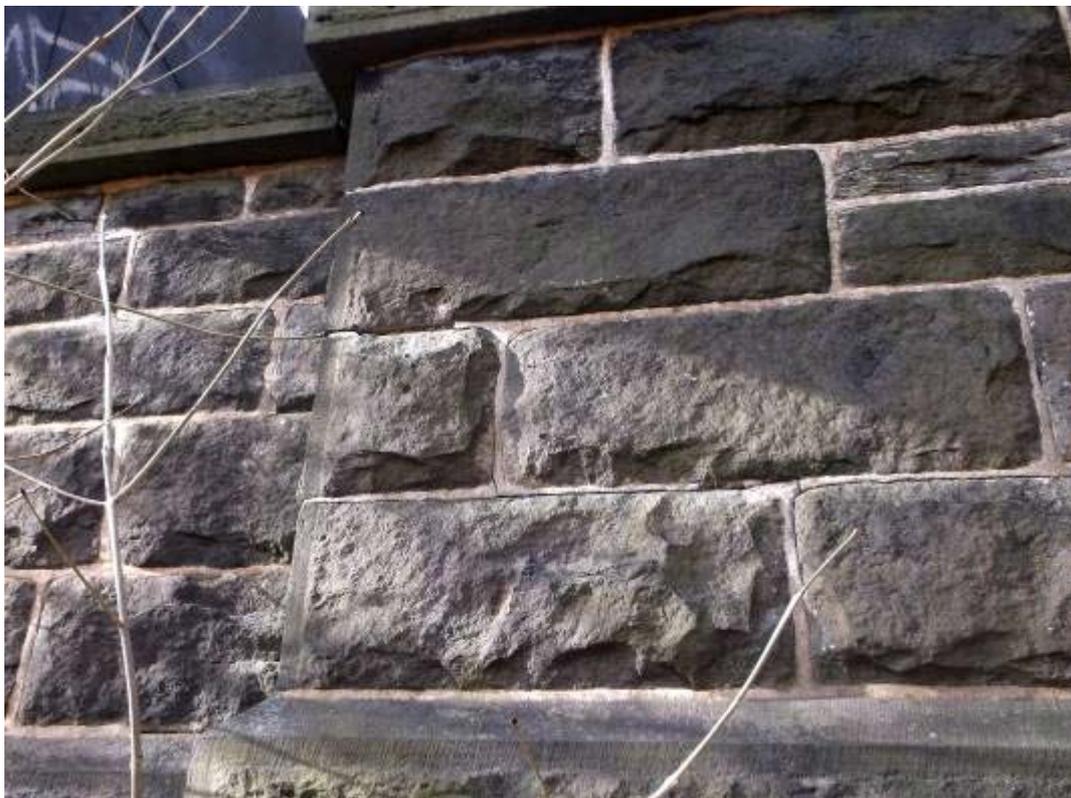
**Photo No. 20: Diagonal stepped fracture to east wing wall**

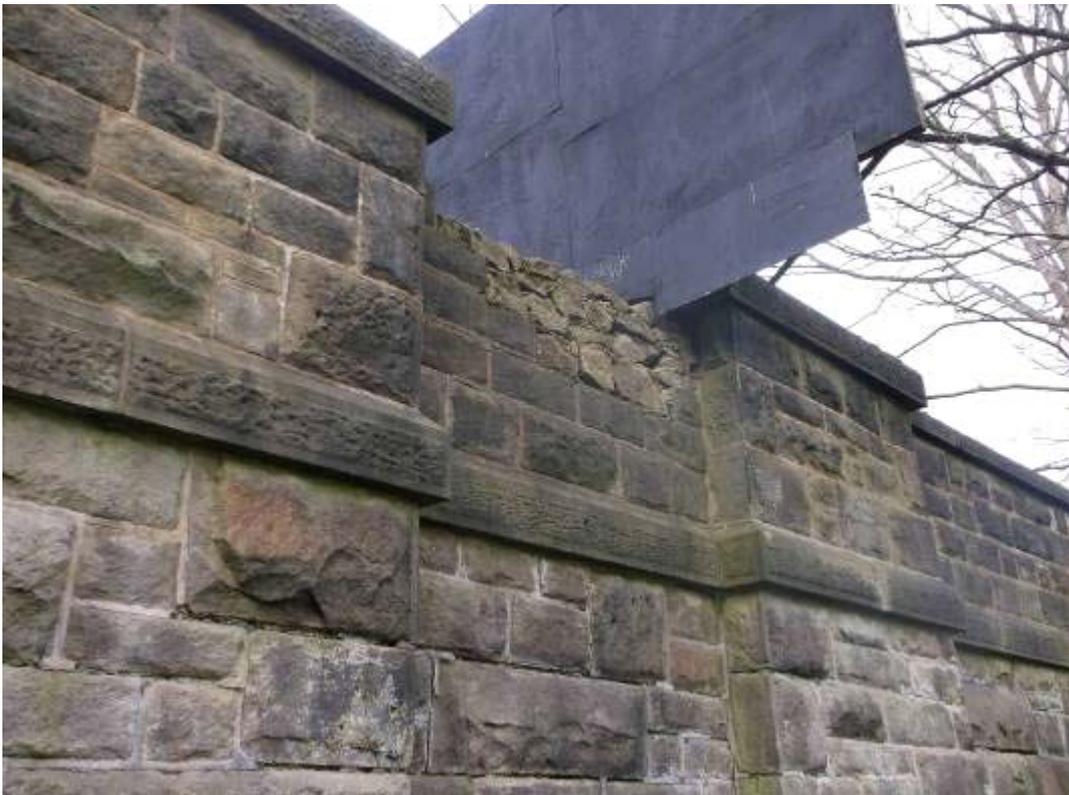
**Photo No. 21: Length of missing coping & poor masonry repair to south wing wall**

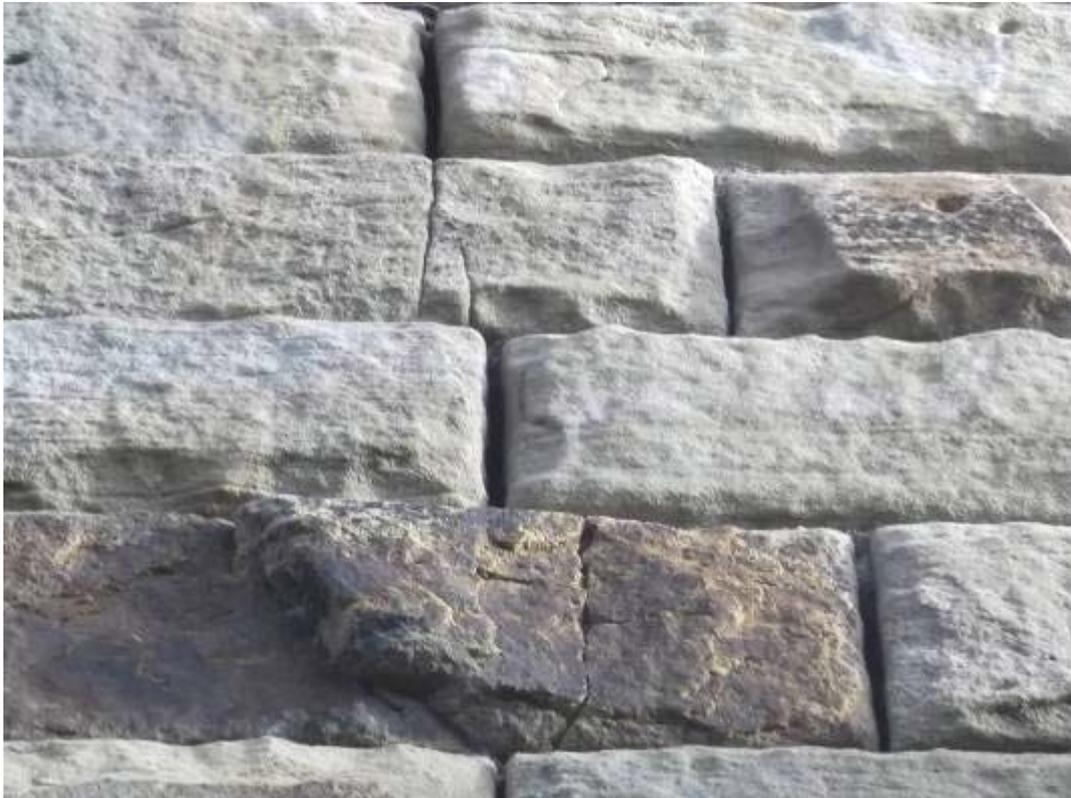
**Photo No. 27: Vertical fractures to south west elevation of pier 1**

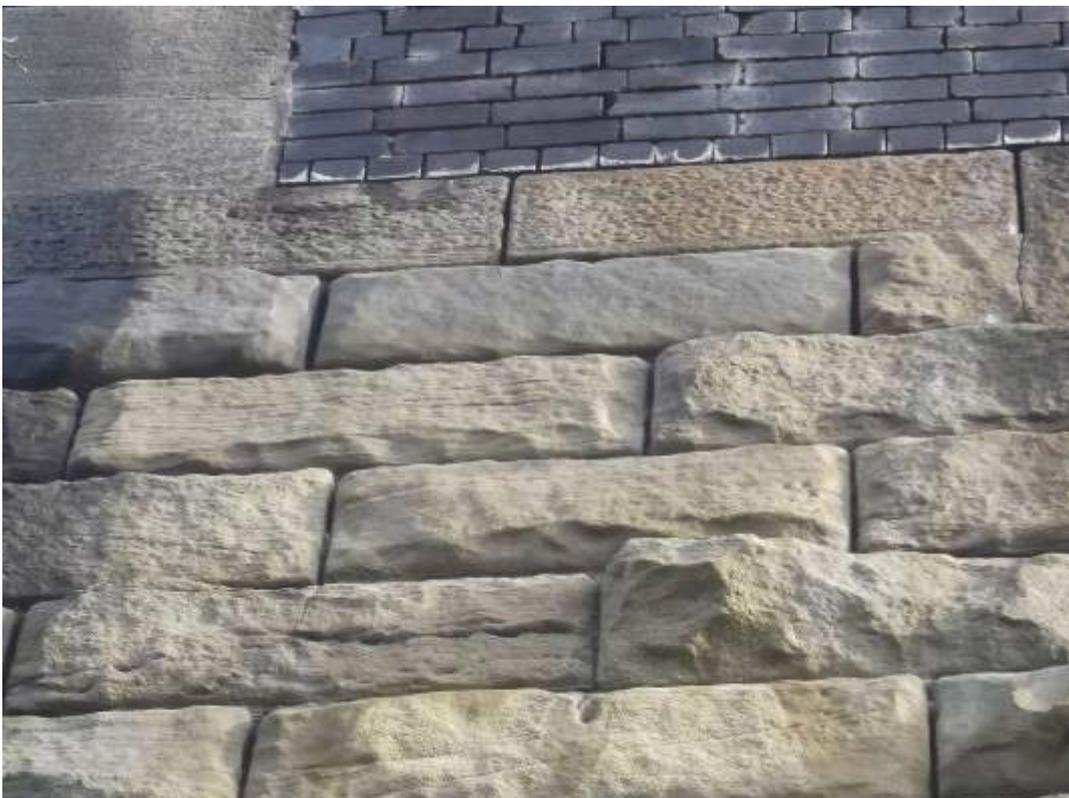
**Photo No. 28: Area of mortar loss to south west elevation of pier 1**

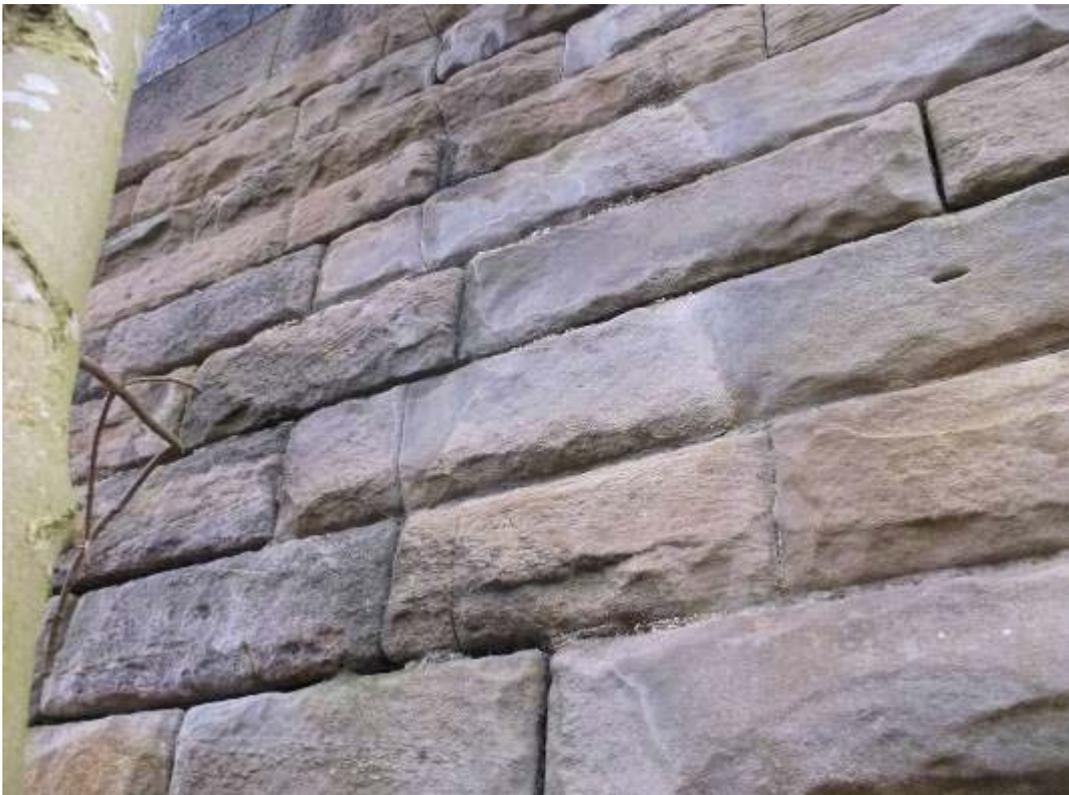
**Photo No. 33: Vertical fracture to north east elevation of pier 3**

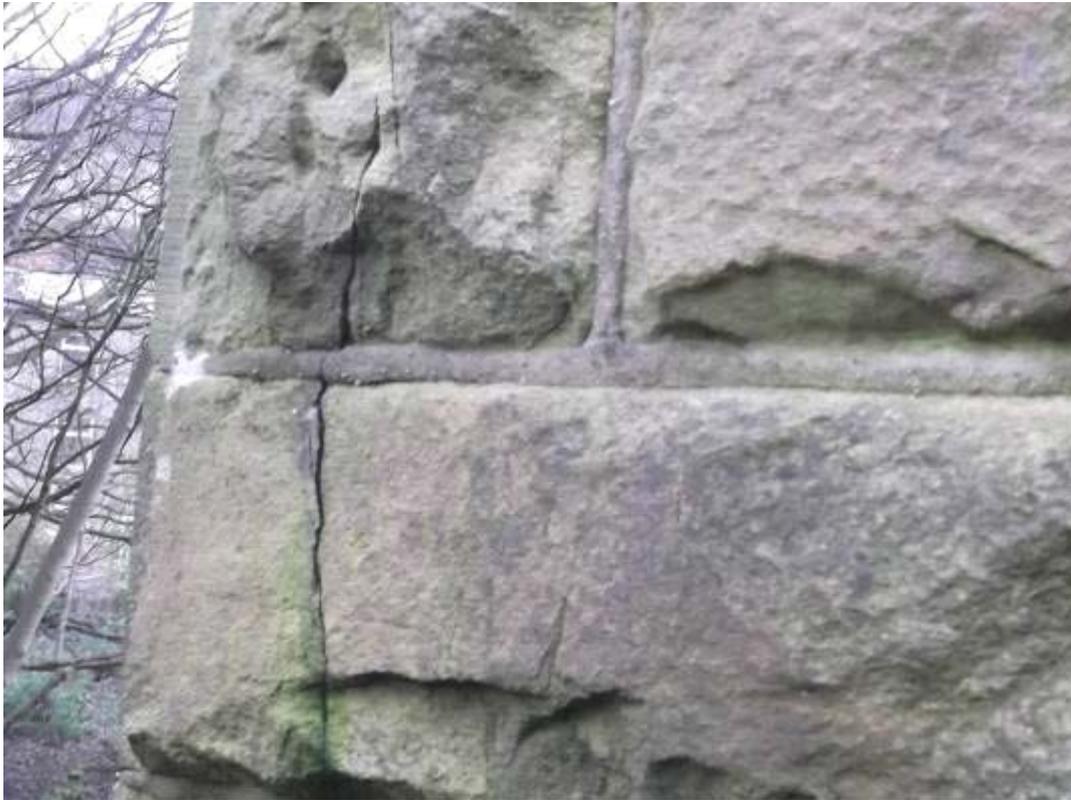
**Photo No. 41: Vertical fracture to north west elevation of pier 5**

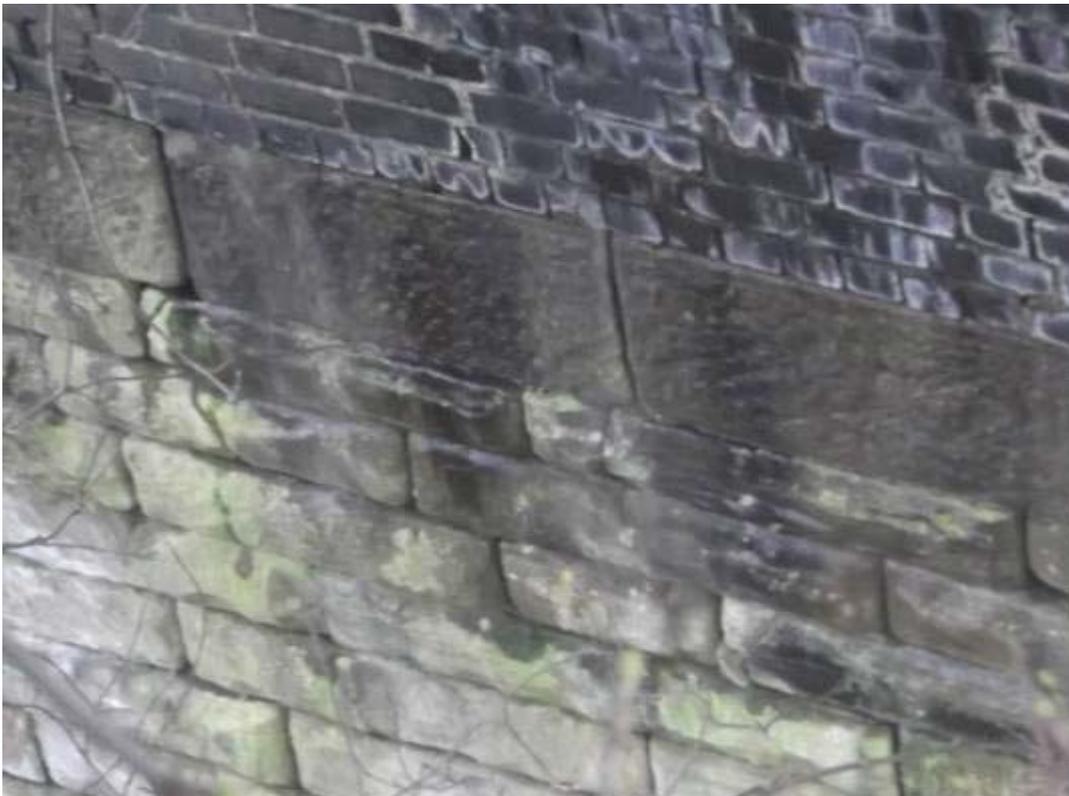
**Photo No. 42: Area of seepage & mortar loss to north east elevation of pier 5**

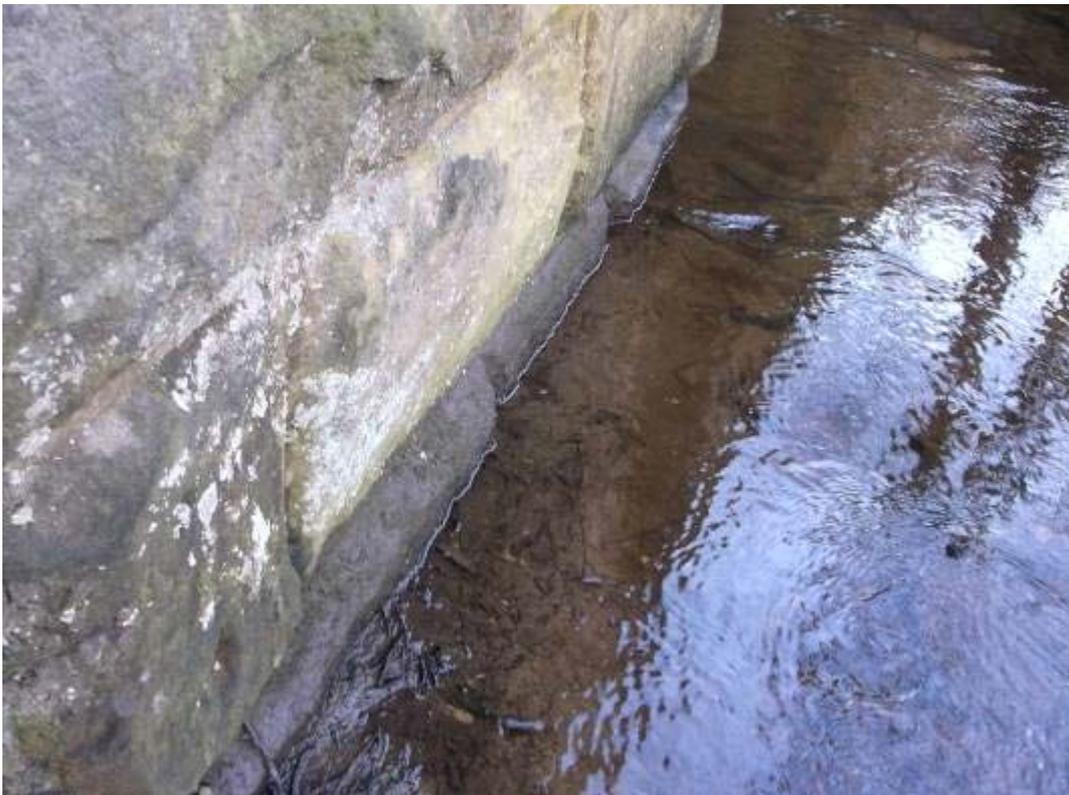
**Photo No. 45: Watercourse from culverts under span 6 running along base of north east elevation of pier 6, no evidence of scour noted**

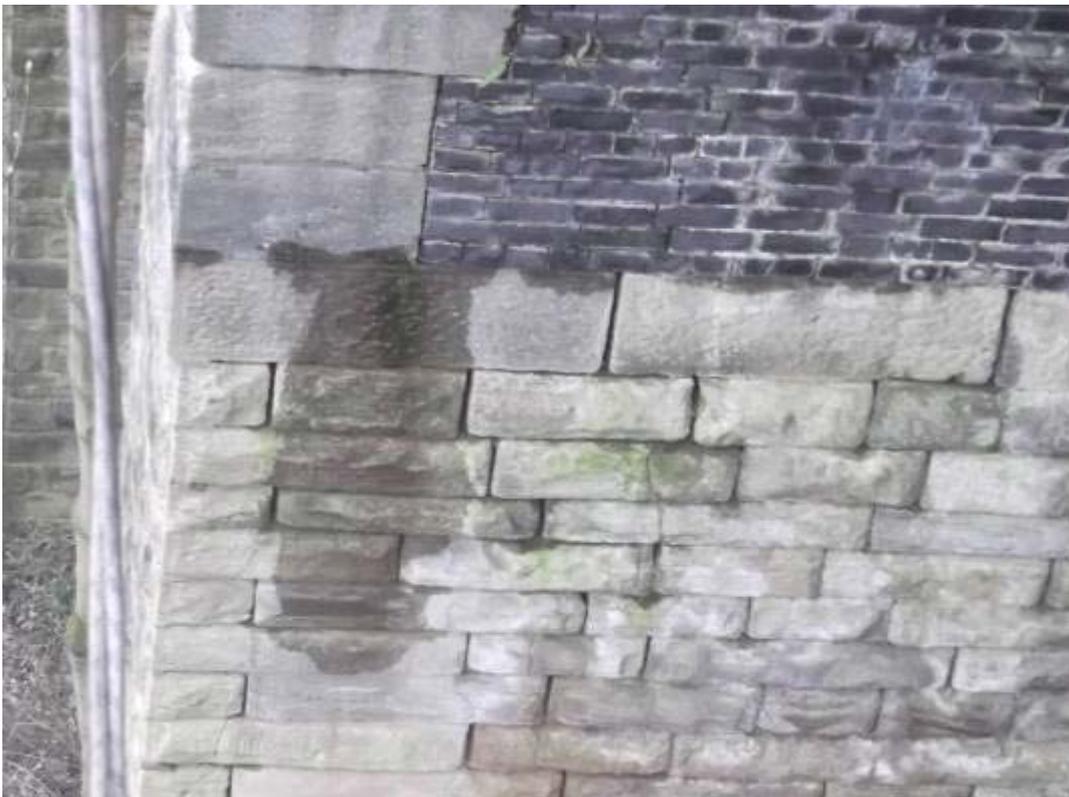
**Photo No. 46: Area of seepage, mortar loss & vertical fracture to north east elevation of pier 6**

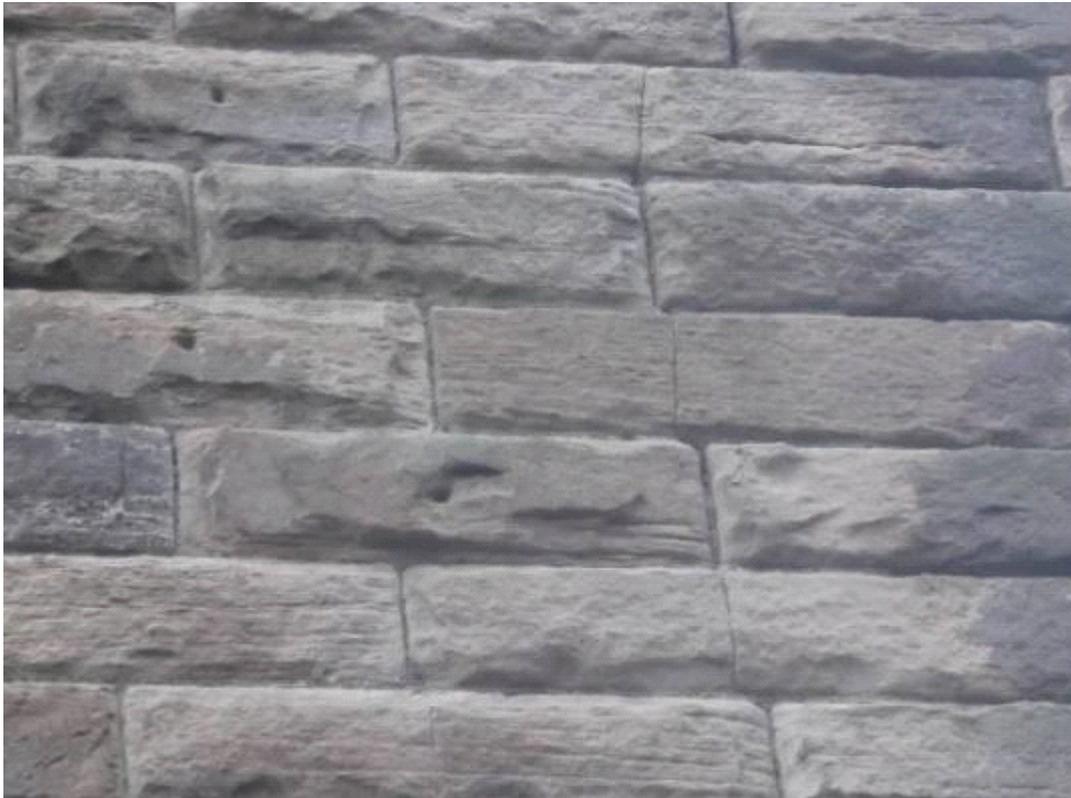
**Photo No. 47: Vertical fracture to north east elevation of pier 6**

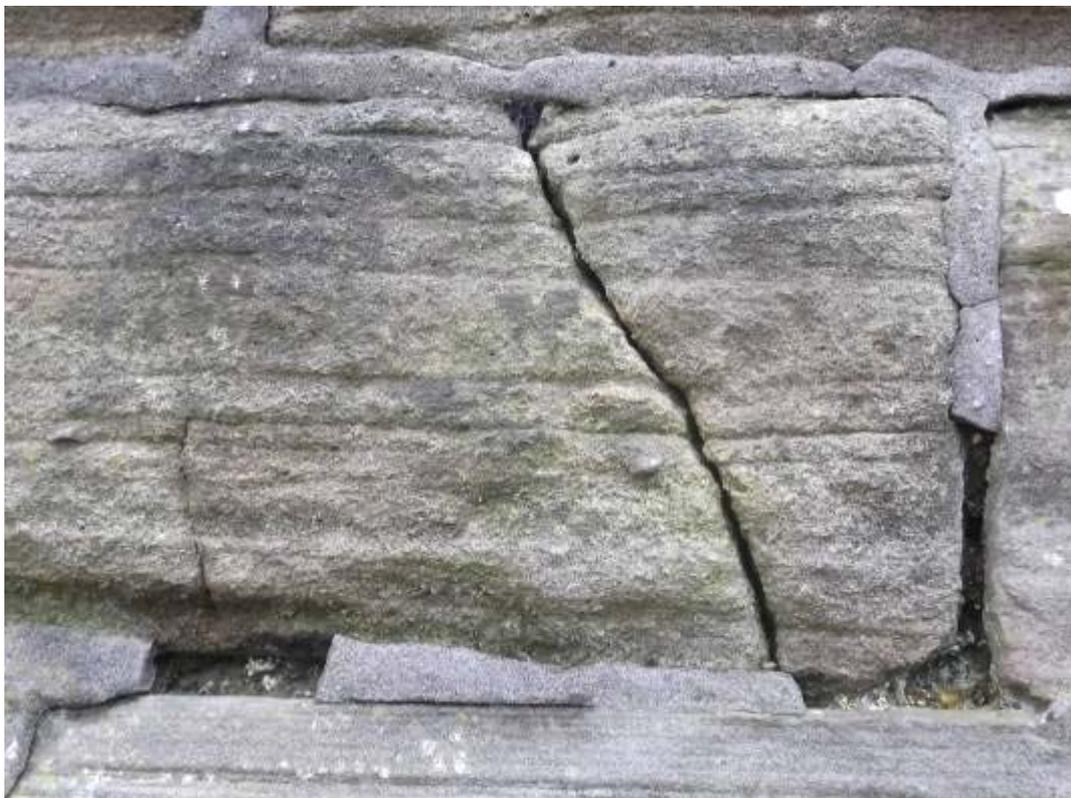
**Photo No. 48: Diagonal fracture to north east elevation of pier 6**

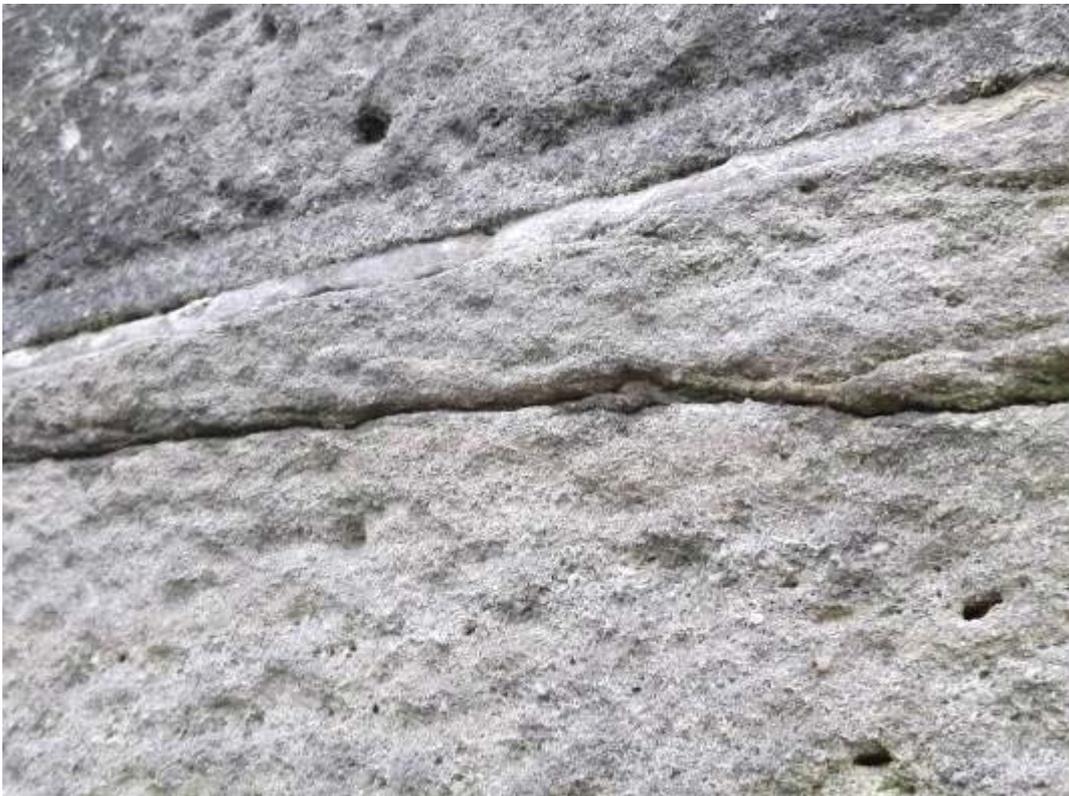
**Photo No. 50: Horizontal fracture to south east elevation of pier 7**

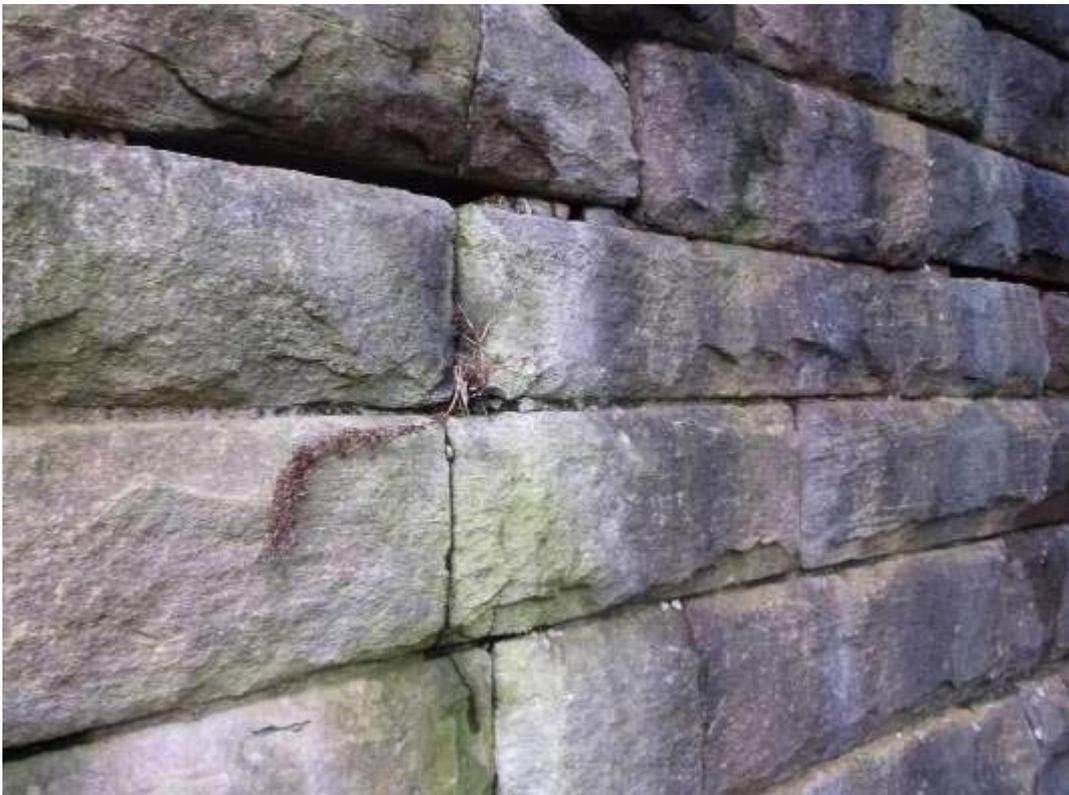
**Photo No. 53: Vertical fracture to north east elevation of pier 8**

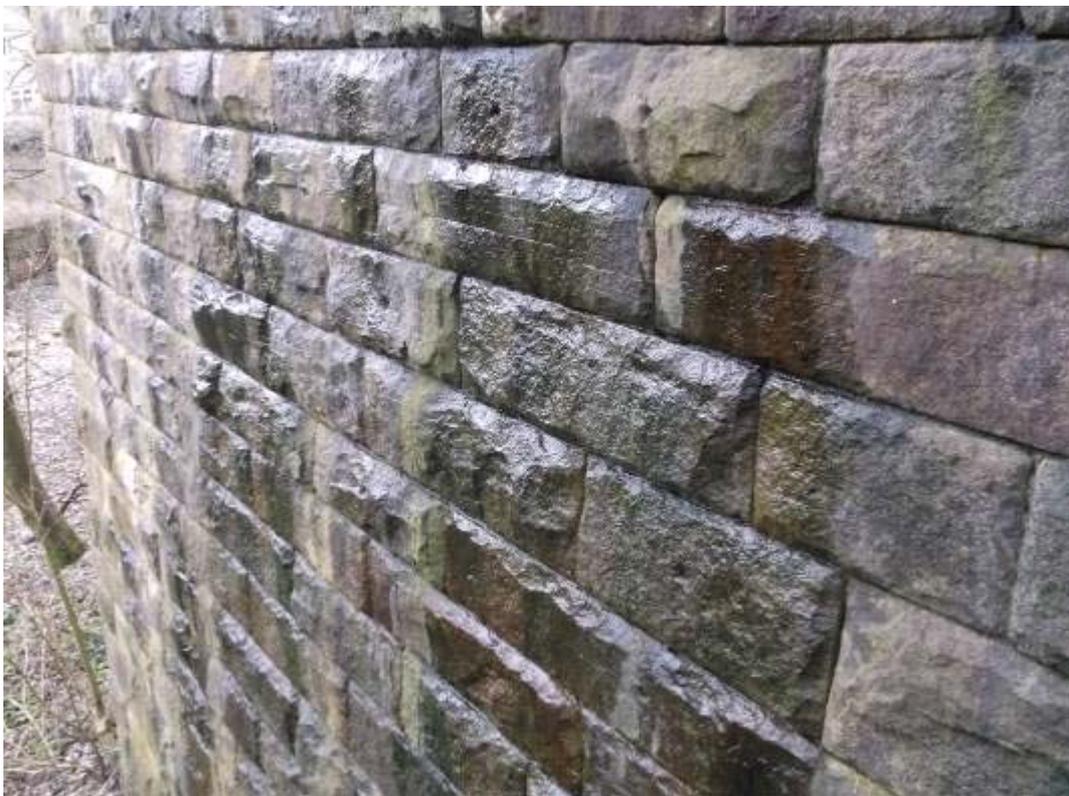
**Photo No. 54: Area of seepage to north east elevation of pier 8**

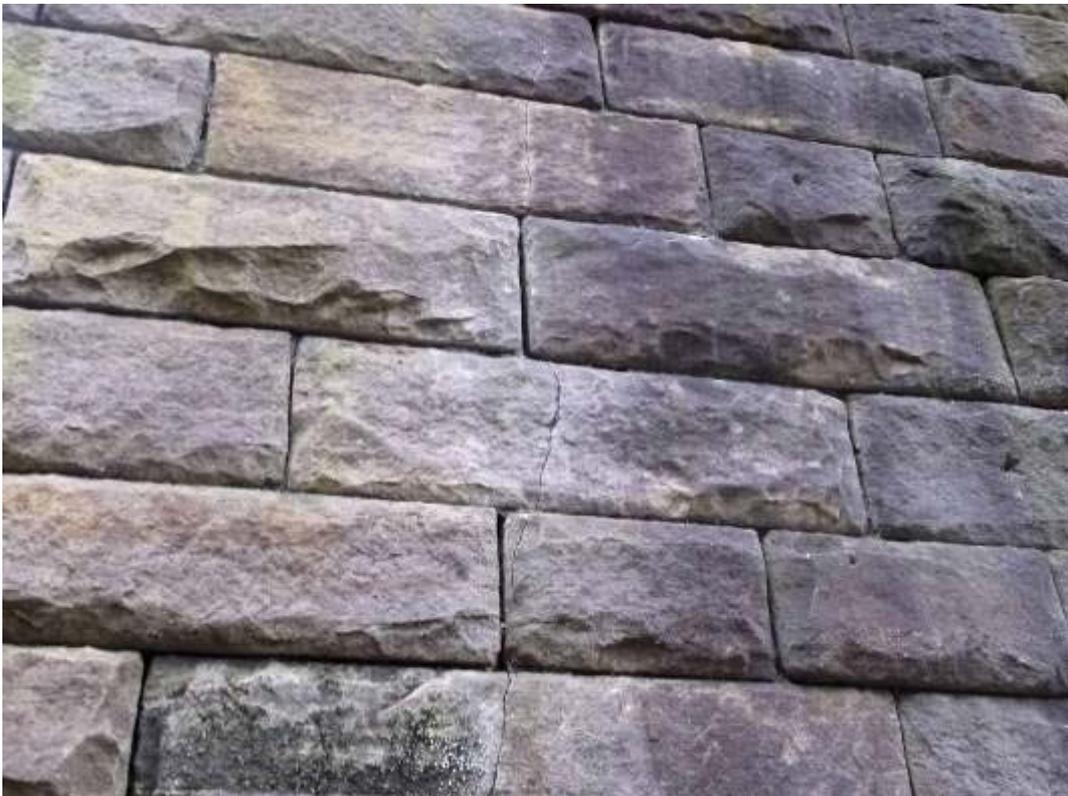
**Photo No. 56: Vertical fracture to south west elevation of pier 8**

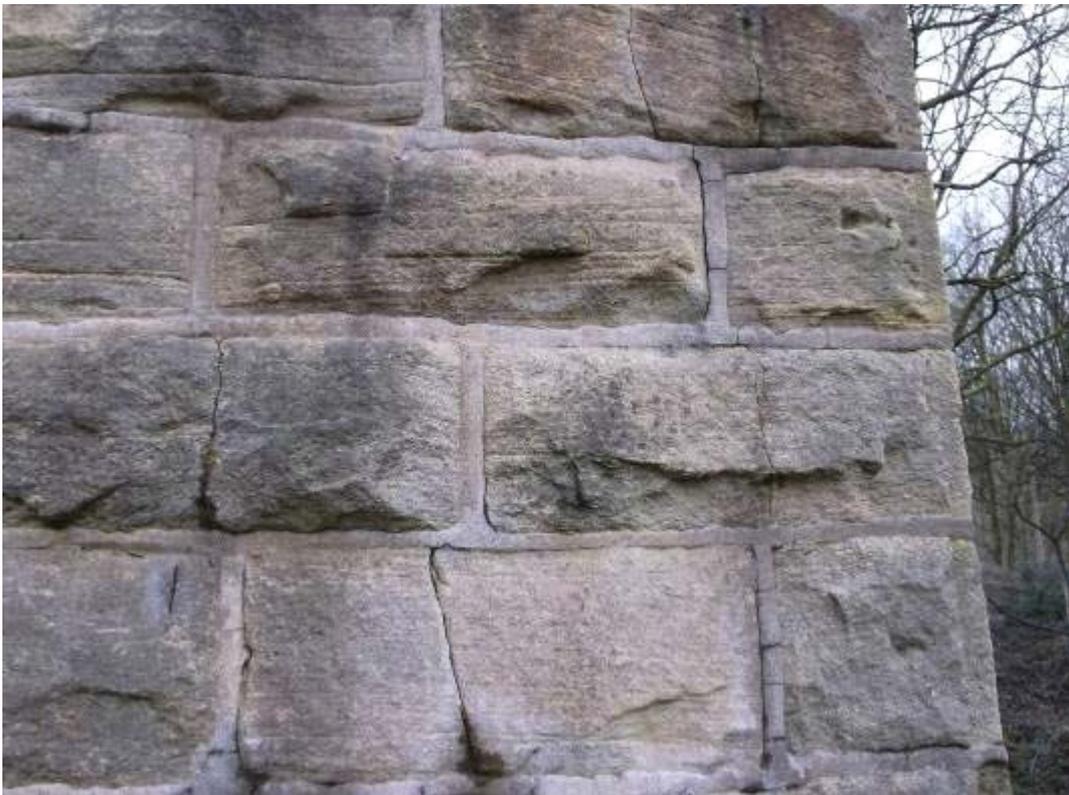
**Photo No. 59: Vertical fracture to south east elevation of pier 8**

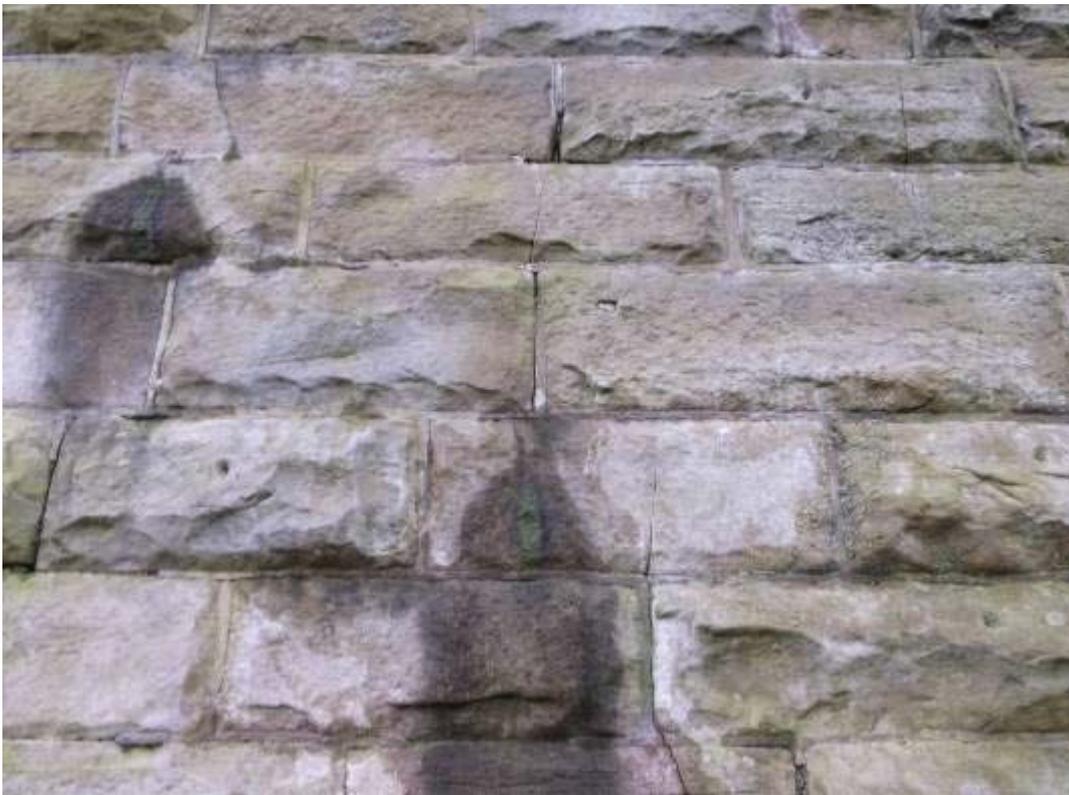
**Photo No. 61: 2No. vertical fractures with seepage to north east elevation of pier 9**

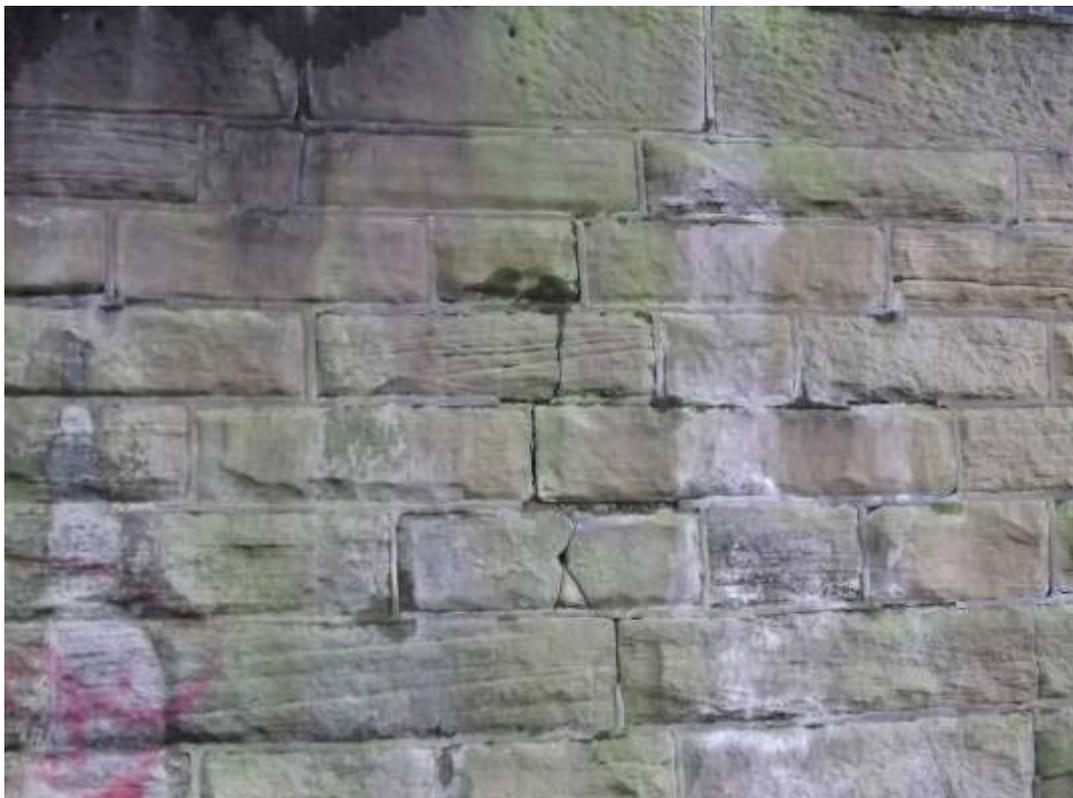
**Photo No. 64: Vertical stepped fracture to south west elevation of pier 9**

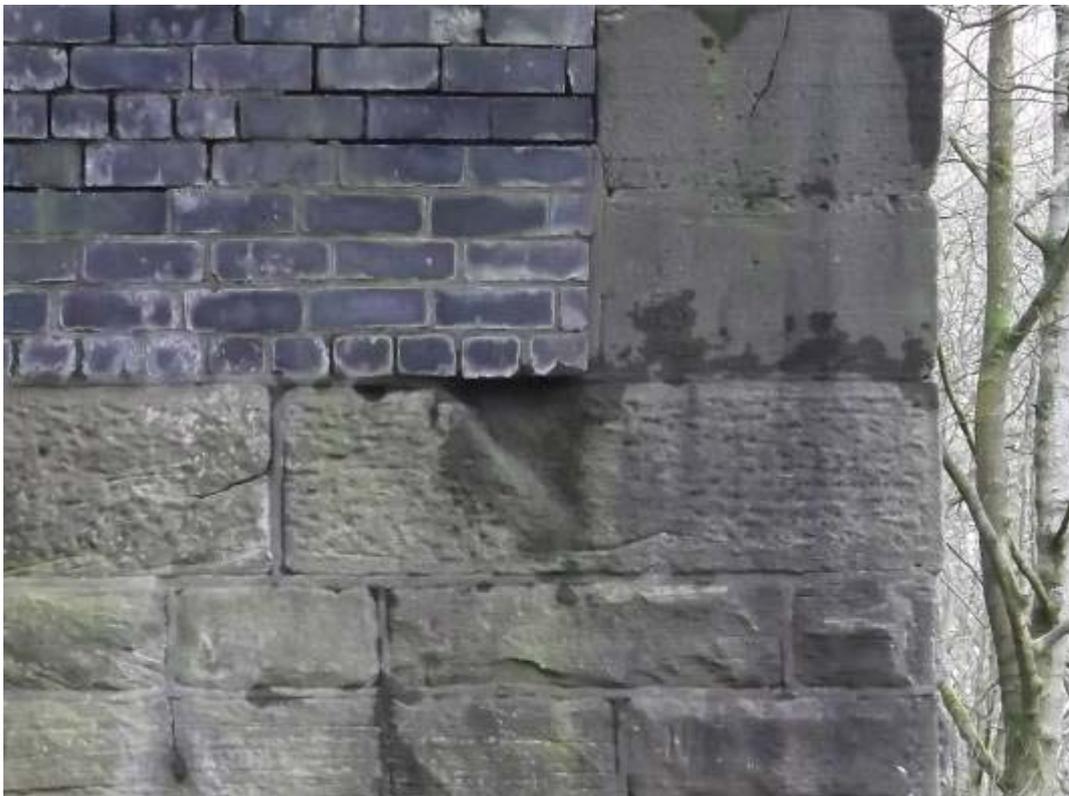
**Photo No. 66: Area of spalled masonry to south west elevation of pier 9**
